## Appendix A- Castle Museum- Defective Lintels

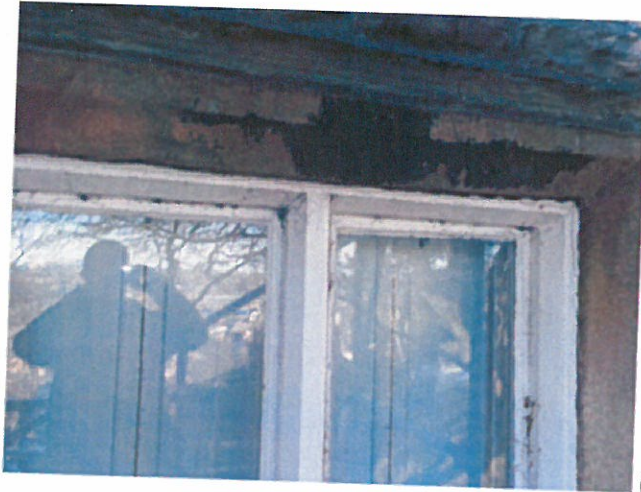
(Image 001)

### Window 001- Lintel Replacement necessary

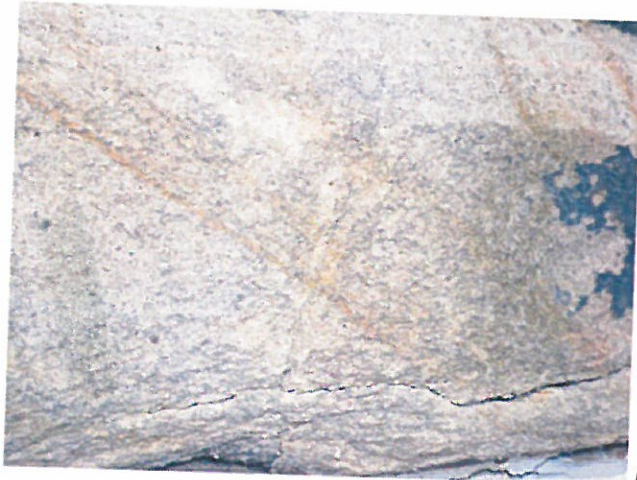
(Image 002, Horizontal split in stone)

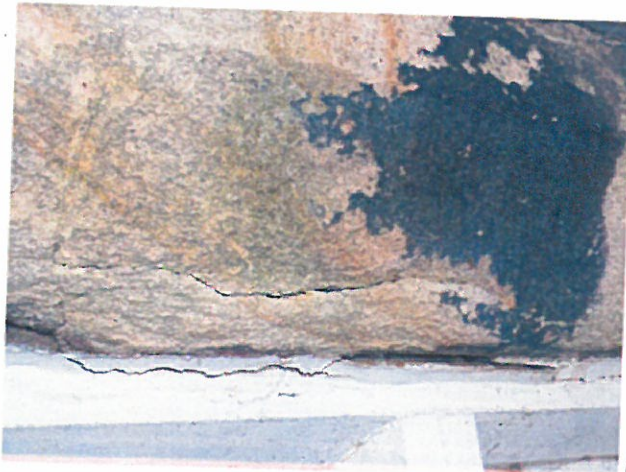
(Image 003, further cracking to lintel)

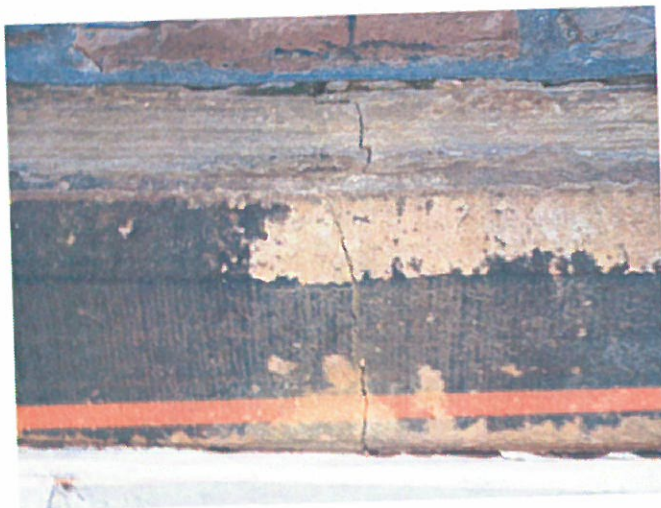
(Image 006, Vertical Crack running through

lintel and masonry above)

**Window 002- Repair if possible**

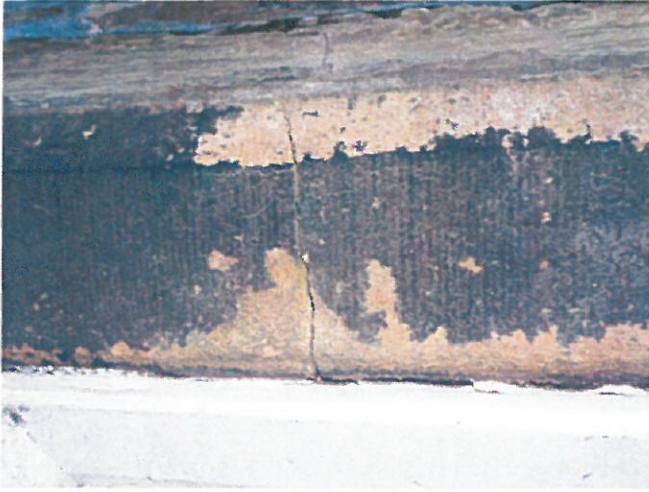
(Image 007, Cracking through stone lintel)

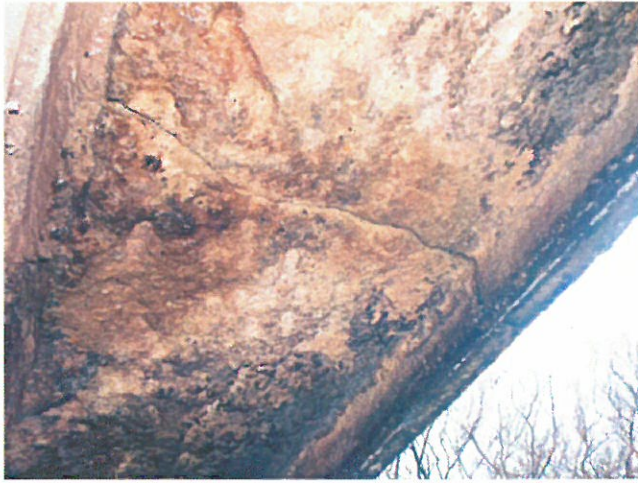
Image 009 (Visible crack on underside of lintel)

Window 003- Stitch Repair if possible

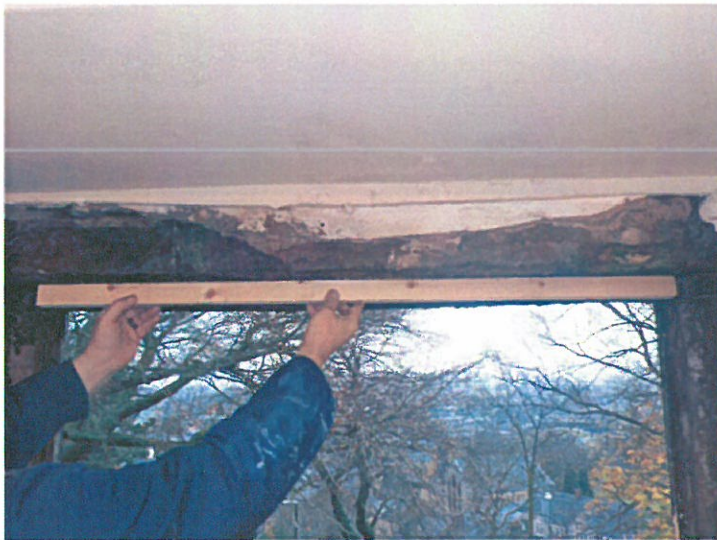
Image 010 (Straight-edge showing 15mm deflection in lintel)

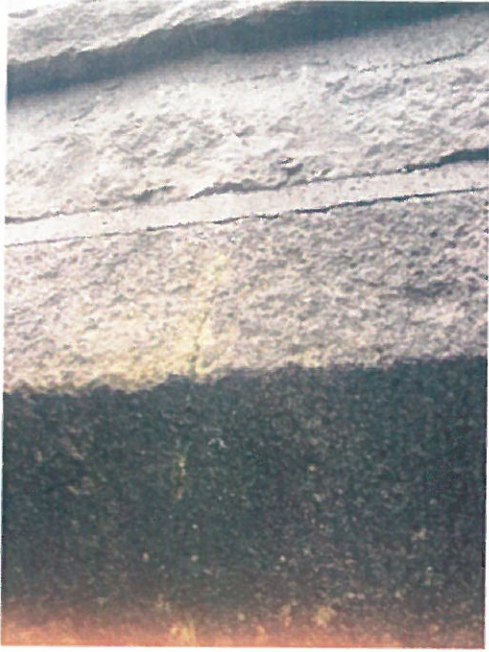
Image 011 (Crack visible from front face of lintel)
