**Barn at Cherry Tree Farm, Chipping Road,  
Chaigley, BB7 3LX**

Structural Condition Survey for Conversion to  
Dwelling

PSC-079

July 2017

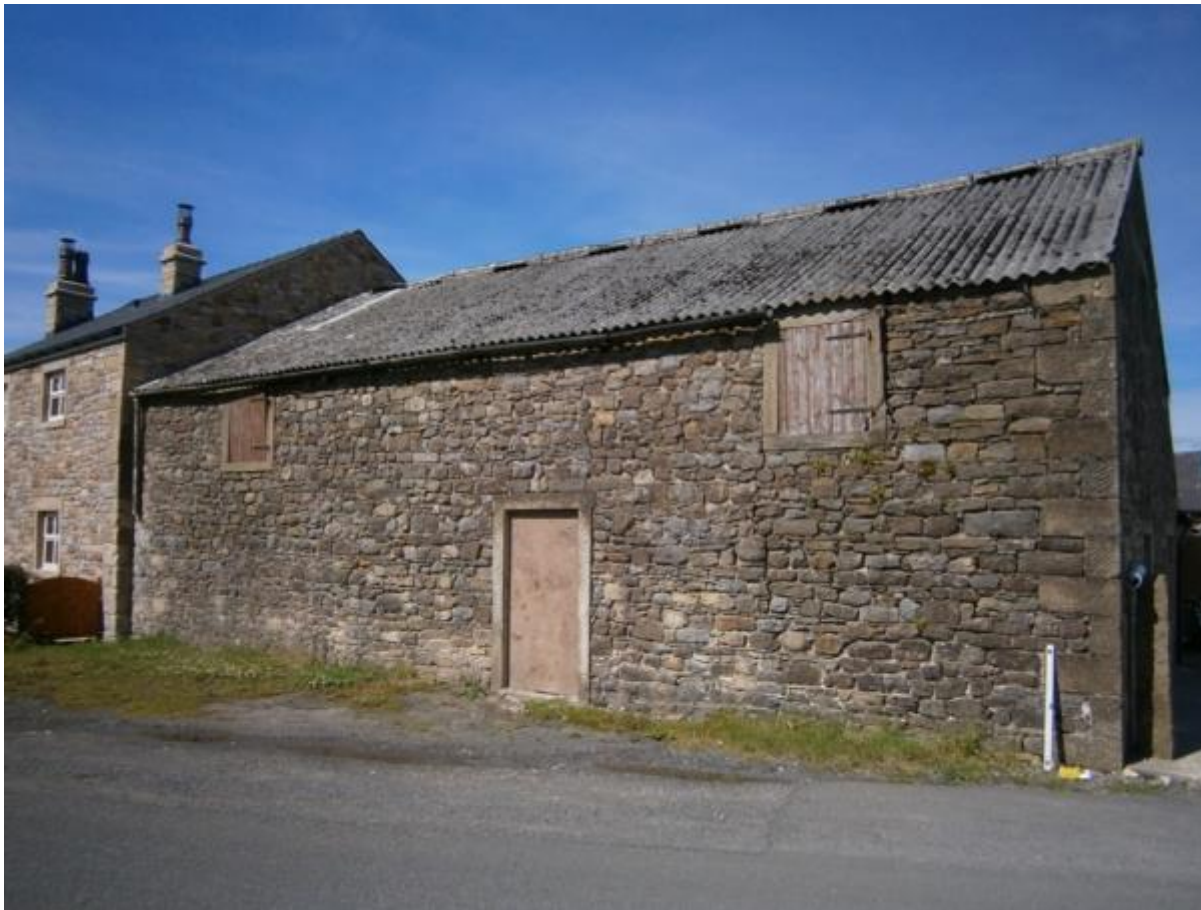
This elevation is of random sandstone construction and 450mm thick. There are three existing openings which are to be retained. The wall is in a good condition, plumb with weathered lime mortar pointing. The wall shows no sign of structural movement.

Photo 1 - Front elevation

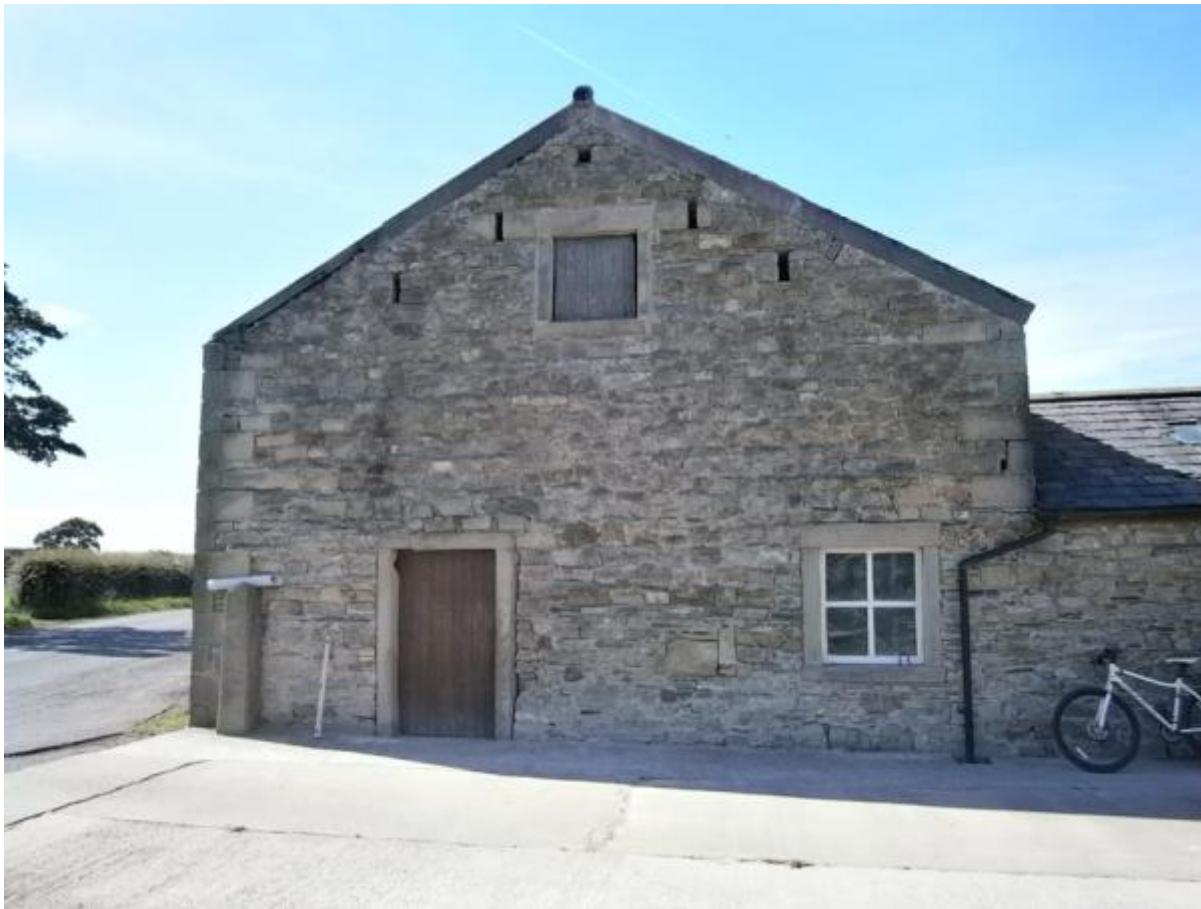
This elevation is again of random sandstone 450mm thick. The wall has a two storey section with three existing openings, and a single storey section to the rear with a large door opening and a further window opening. The wall is reasonably plumb over the majority of its length but there is an area to the rear of the main barn, above the window, which leans into the barn (photo 5). This may be associated with some previous movement associated with re-building the adjacent section of rear wall (photos 4 & 7). This section would benefit from re-building when the rear section is also repaired. An allowance of 6m<sup>2</sup> to be re-built should be made for this elevation. The single storey wall is in reasonable condition. It is not proposed to introduce any further openings in this elevation.

Photo 2 – Side elevation – Main Barn

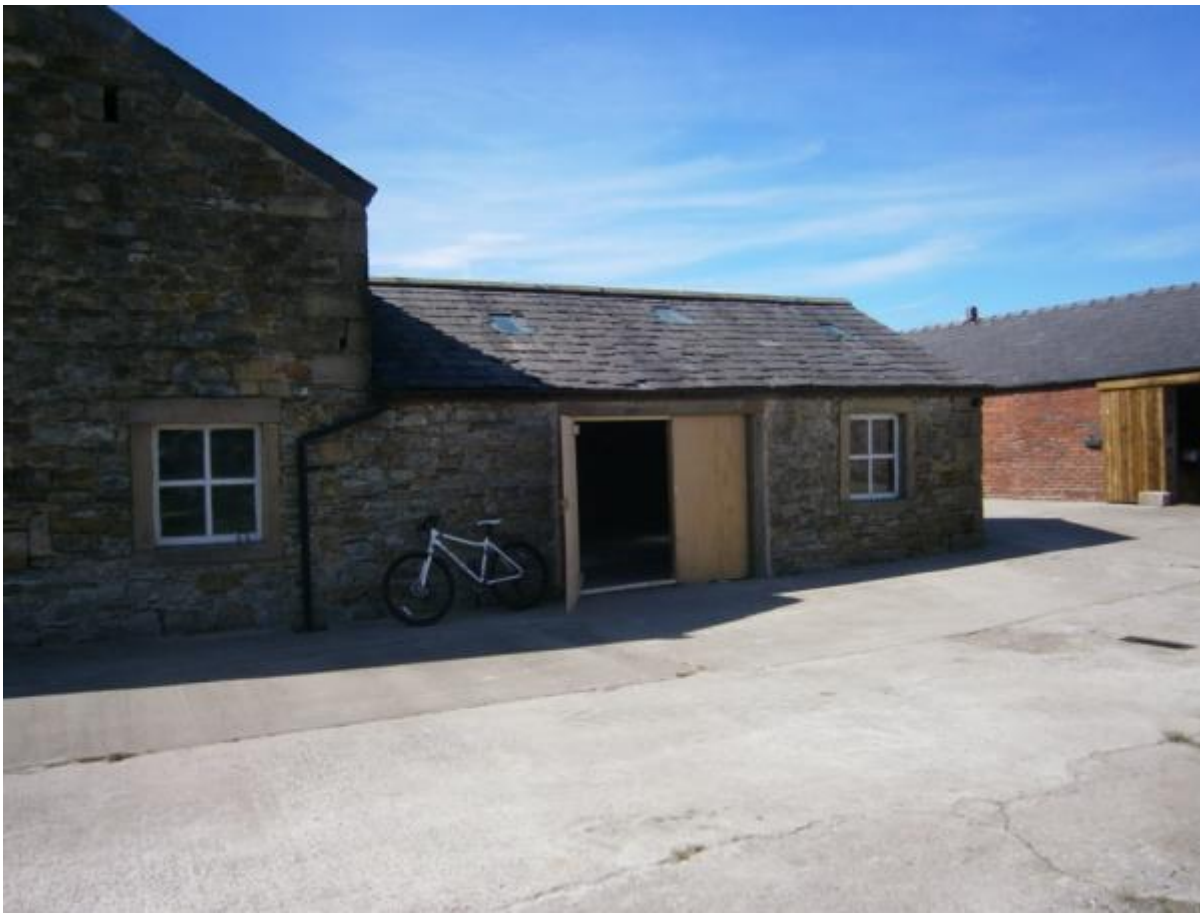
Photo 3- Side elevation – Single Storey Section

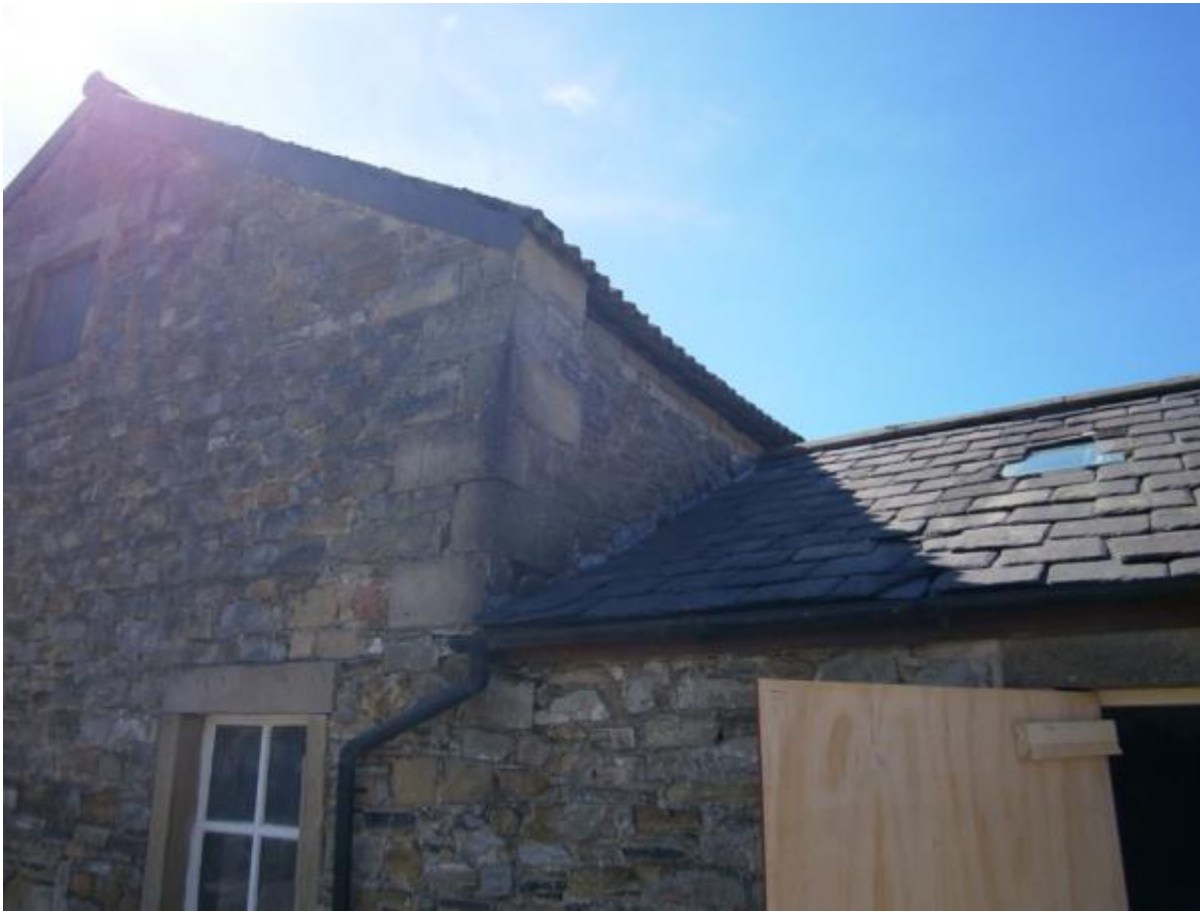
Photo 4 – Side elevation and rear corner

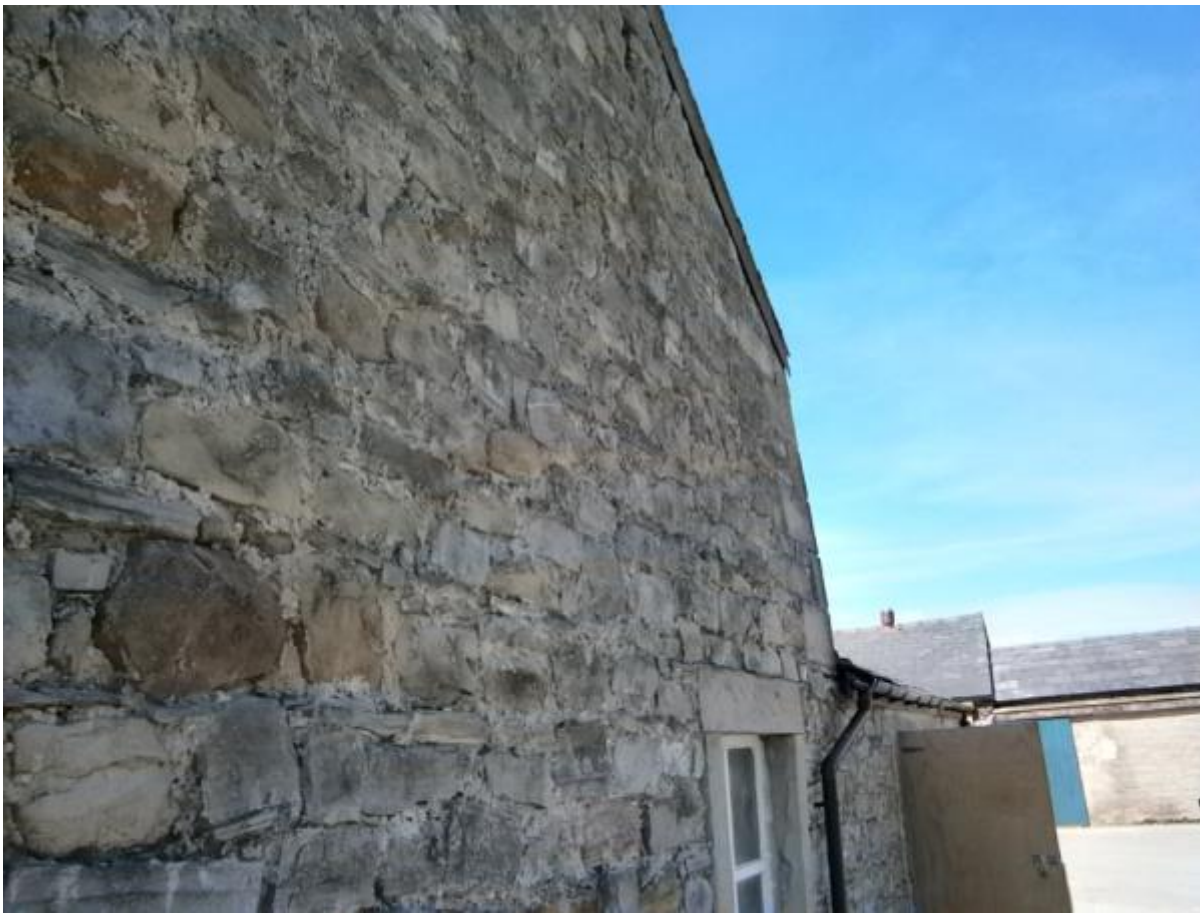
Photo 5 – Side elevation – bow to rear section

As noted above, the existing beams carrying the rear elevation above the single storey roof should be checked for suitability. This area requires re-construction above and to the section of side elevation which is leaning into the barn. It would be appropriate to replace or re-seat the steel beams with the correct/existing sections sitting on new blockwork walls and padstones. In addition, the section of wall to the rear of the single storey leg should be re-built.

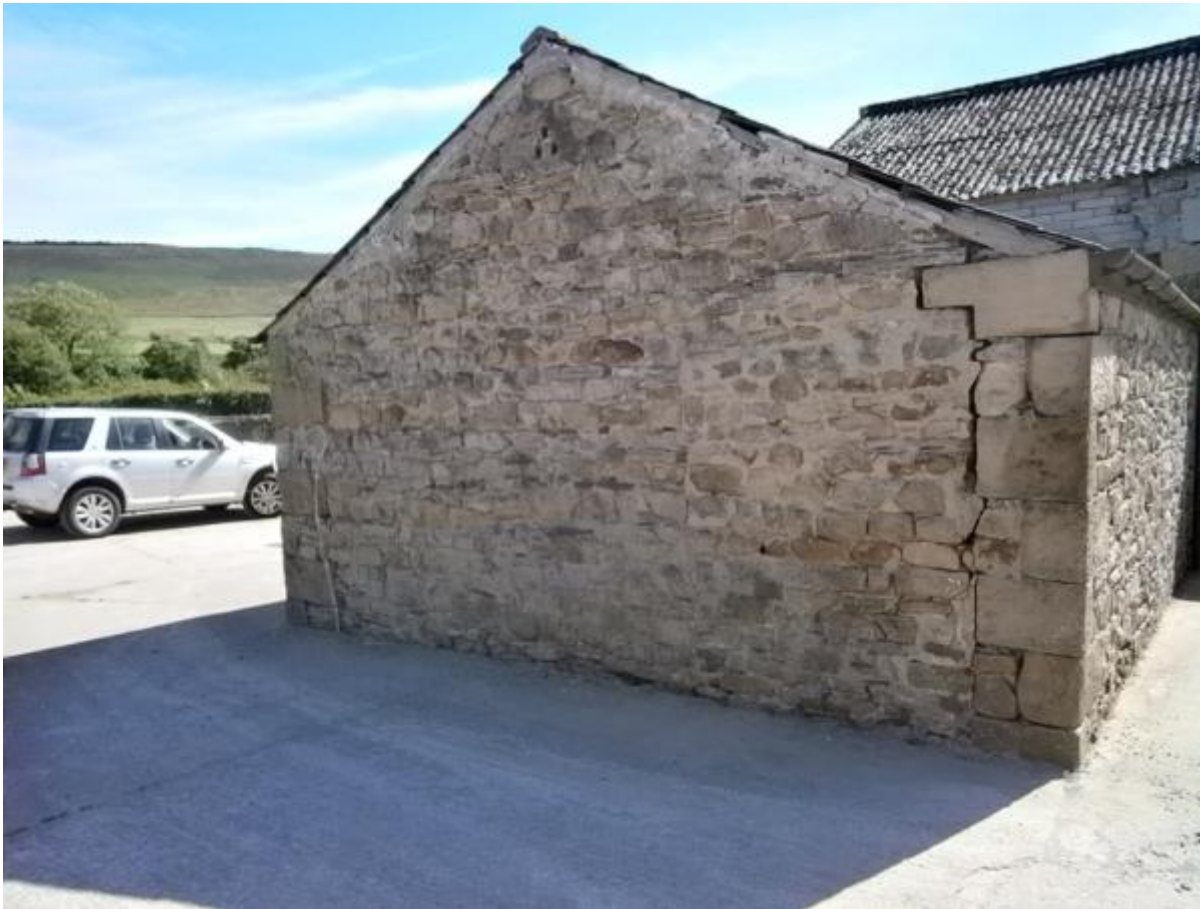
These elevations are 450mm random stone walls and are generally in good condition with weathered pointing. It can be seen from photo 6 that there has been some former movement to one corner of the rear section and close inspection indicates there may have formerly been a door opening here. This will require a small amount of patching or re-building over 1m<sup>2</sup>. There are no existing openings to these elevations and none proposed for the conversion.

Photo 6 – Rear elevation of single storey

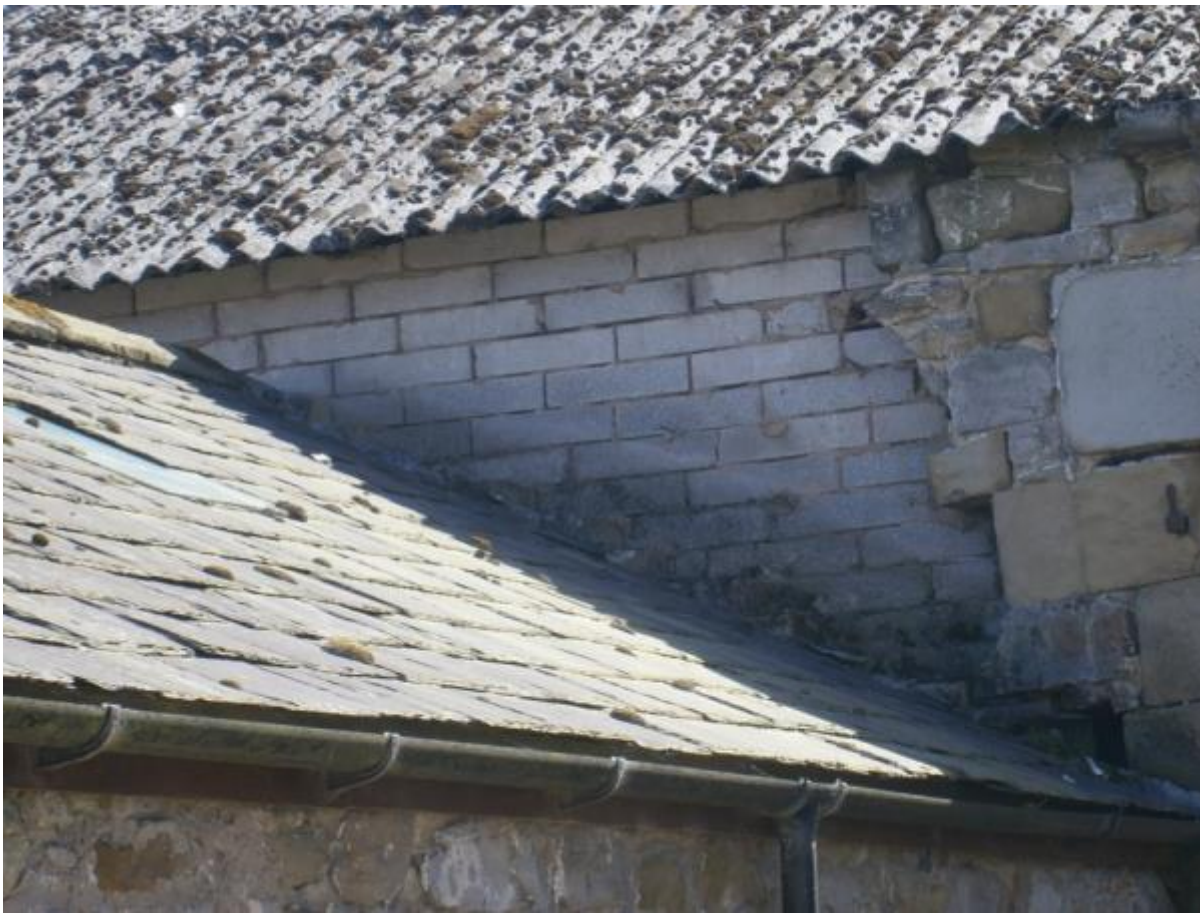
The rear wall is a 450mm random stone wall. The wall is generally in a reasonable condition but the area to the left of the main barn door opening, above the single storey roof, has been partially re-built (photo 7). Internal inspection shows two large steel beams supporting this (photo 17). This re-build may also be associated with the movement noted on the side elevation. This section will need re-building and allowance of 10m<sup>2</sup> should be made for this. The area of wall where there is a ventilation fan will need infilling. There are 4 openings to this elevation and it is proposed to retain these with no further openings introduced.

Photo 7 – Rear elevation block re-build

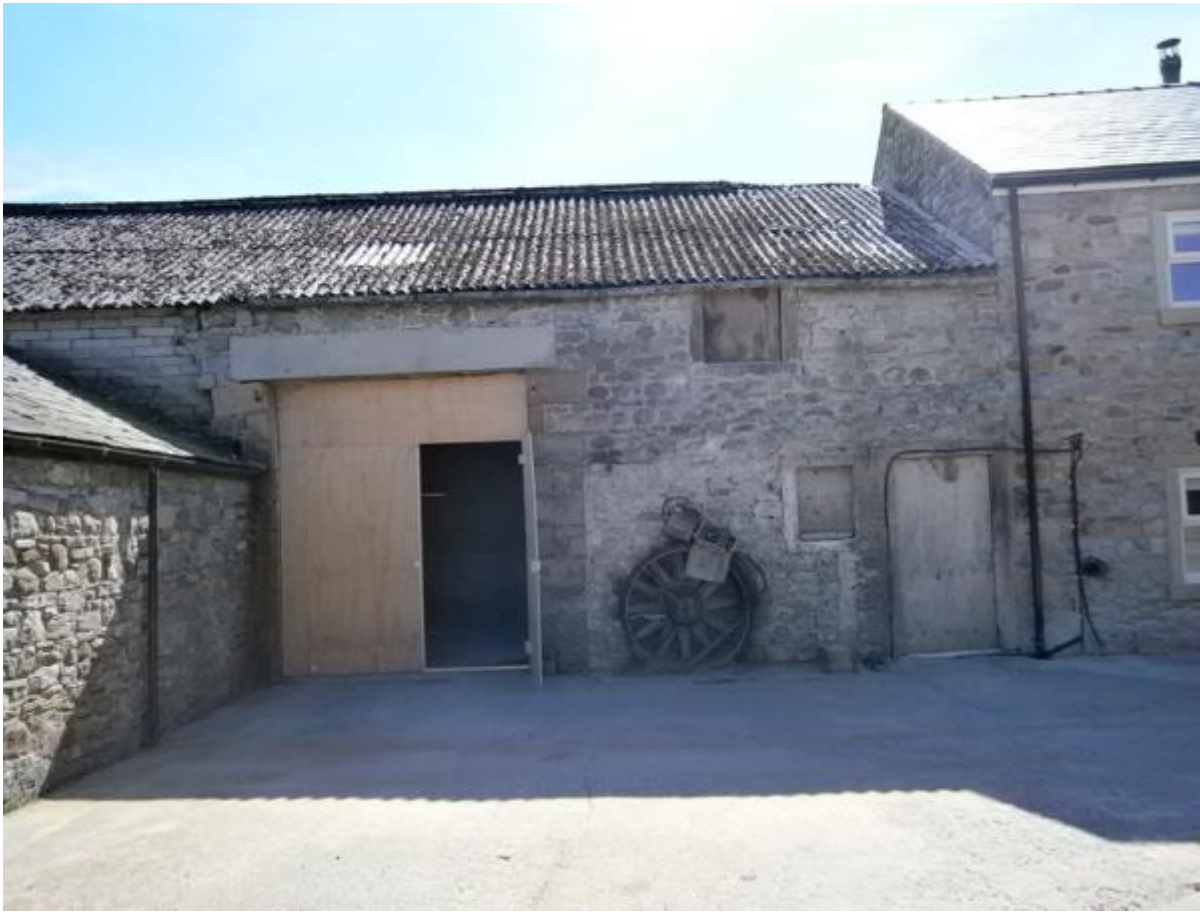
Photo 8 – Rear elevation

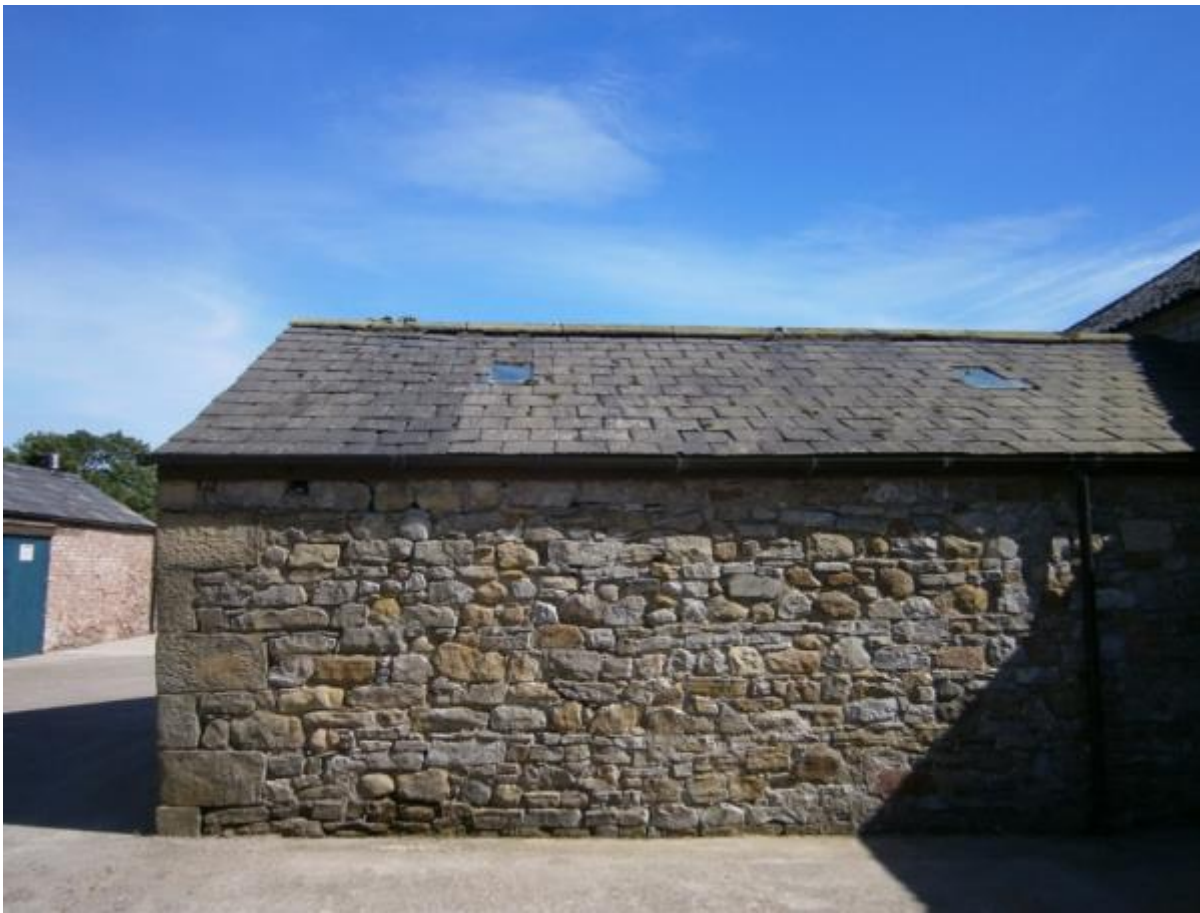
Photo 9 – Opposite side elevation of single story section

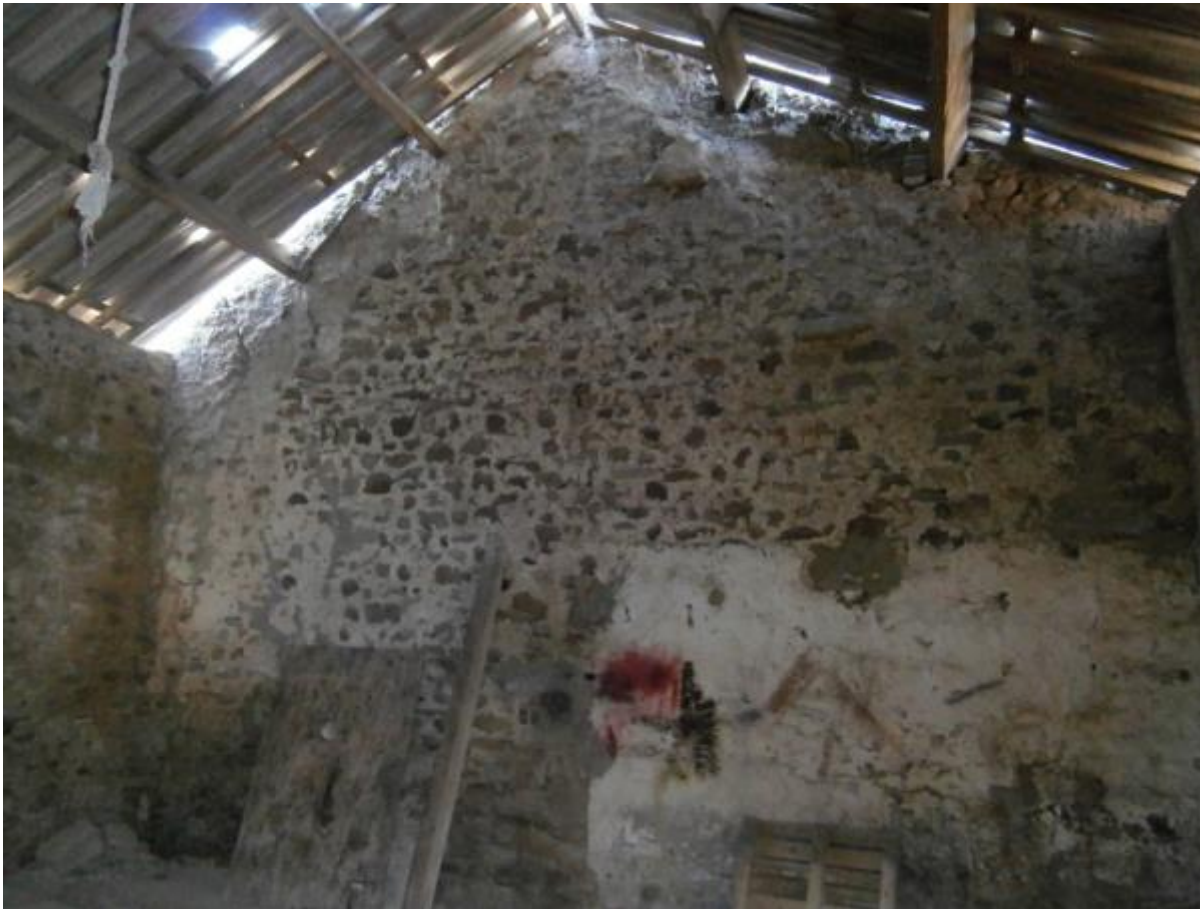
Photo 10 – Main barn internal

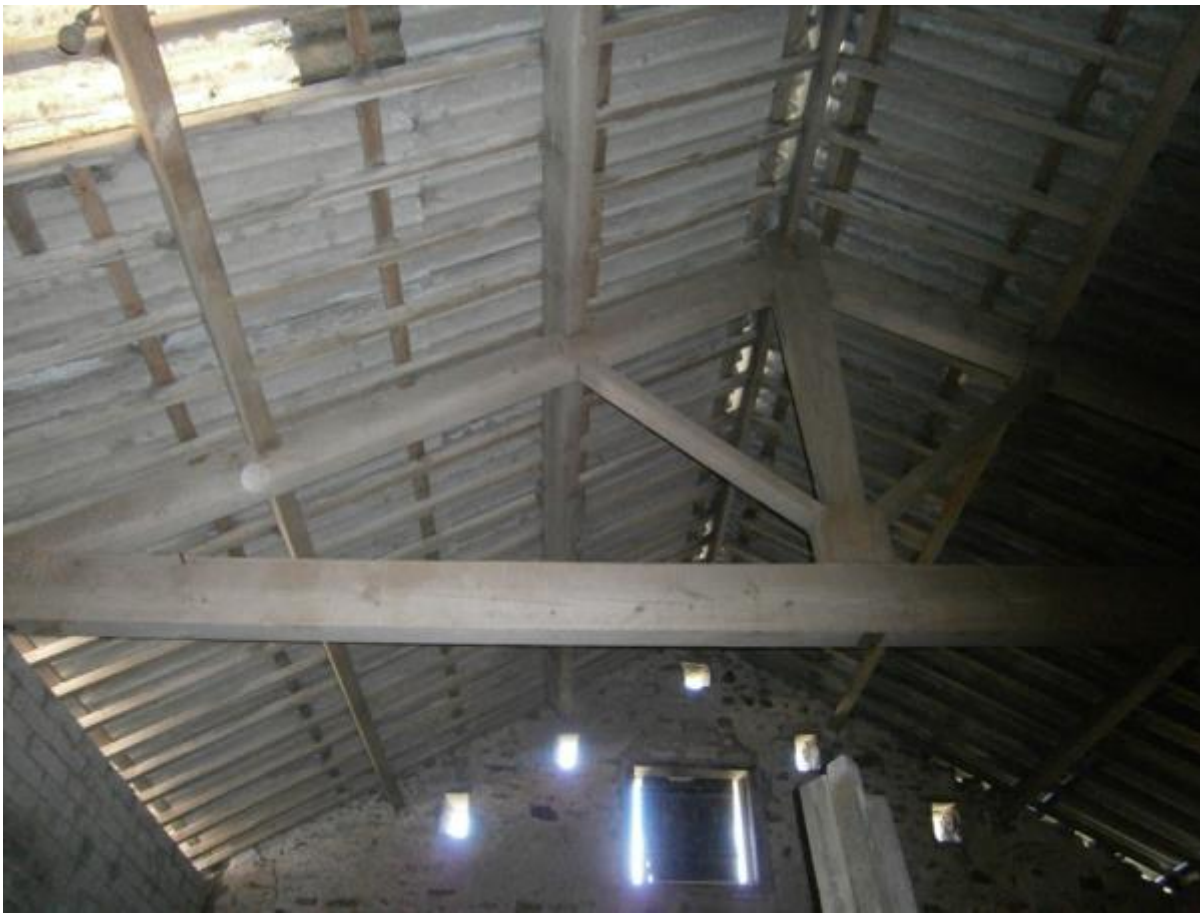
Both roofs have traditional trusses, purlins and rafters. The roof is in reasonable condition with little sign of movement, rot or infestation. The main barn is covered by cement sheeting which may possibly contain asbestos. The single storey section retains traditional slates. The roof will be re-constructed under the proposals but existing elements may be retained subject to structural checks and treatment for rot/infestation. The cement sheeting will need testing for asbestos and disposed of as required under current Health & Safety Regulations.

Photo 11 – Main barn roof truss

The existing trusses, purlins and rafters appear to be in good condition with little sign of rot or infestation. Any timber retained should be assessed by a timber specialist, with regard to rot and infestation. All retained timber should be treated against rot/infestation and an indication of residual section given for structural purposes. All retained timber to be used structurally should be checked for structural adequacy.

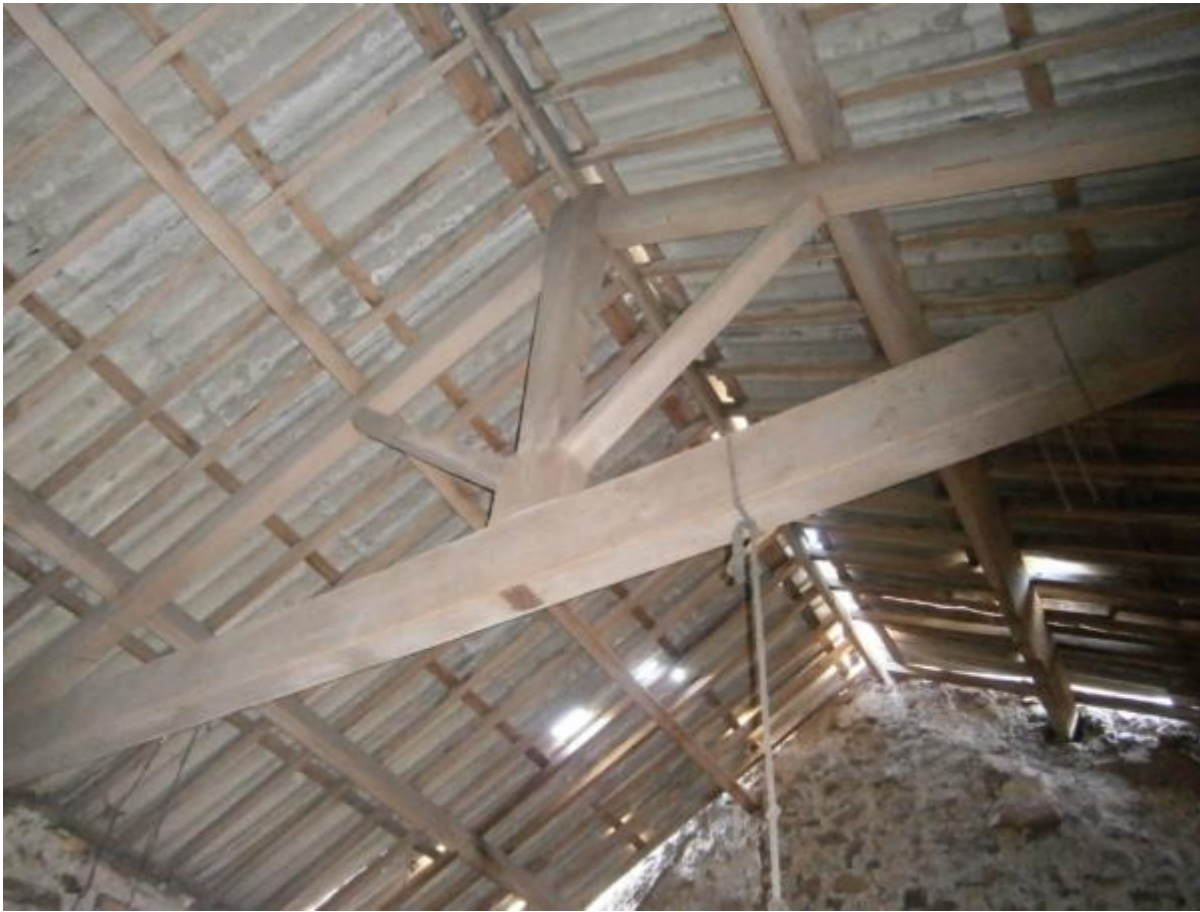
Photo 12 – Main barn roof truss, purlins and rafters

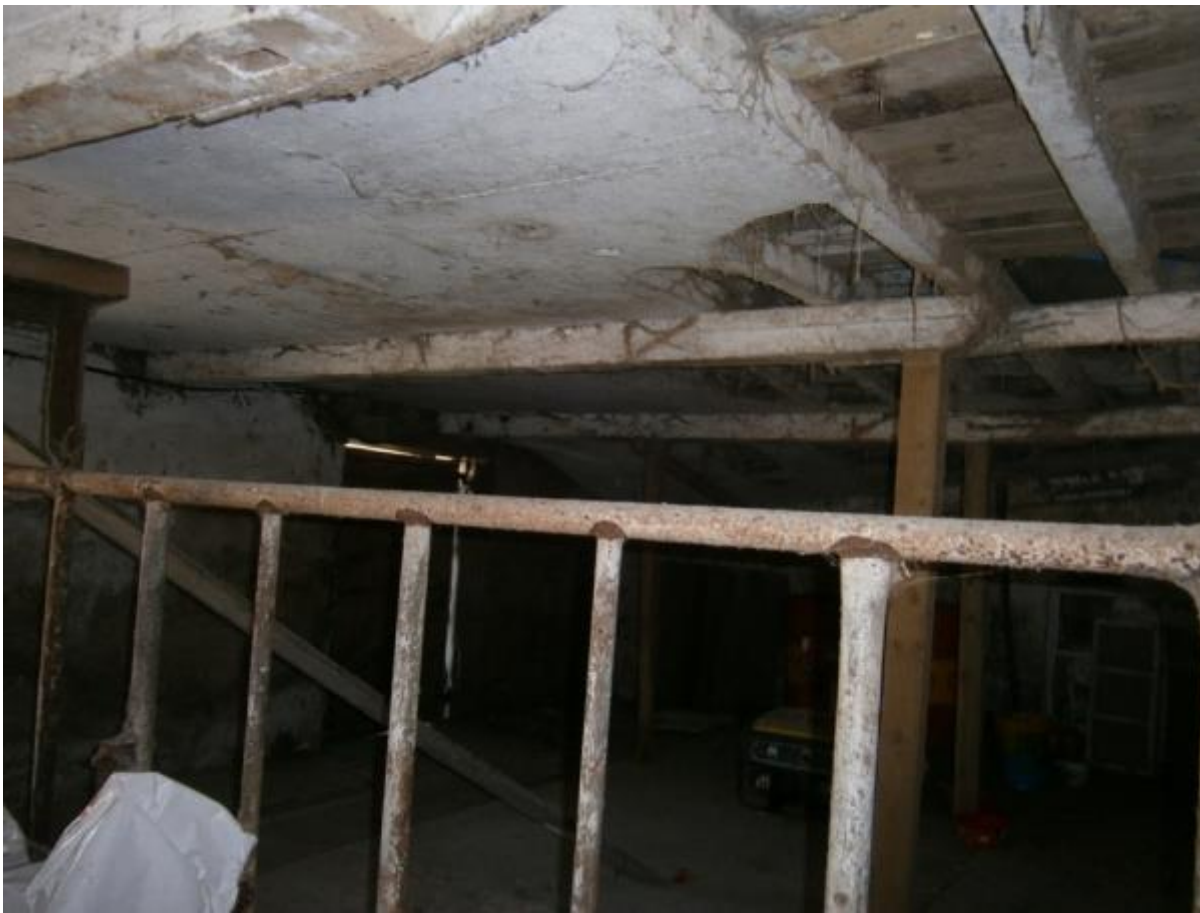
Photo 13 – main barn below below mezzanine

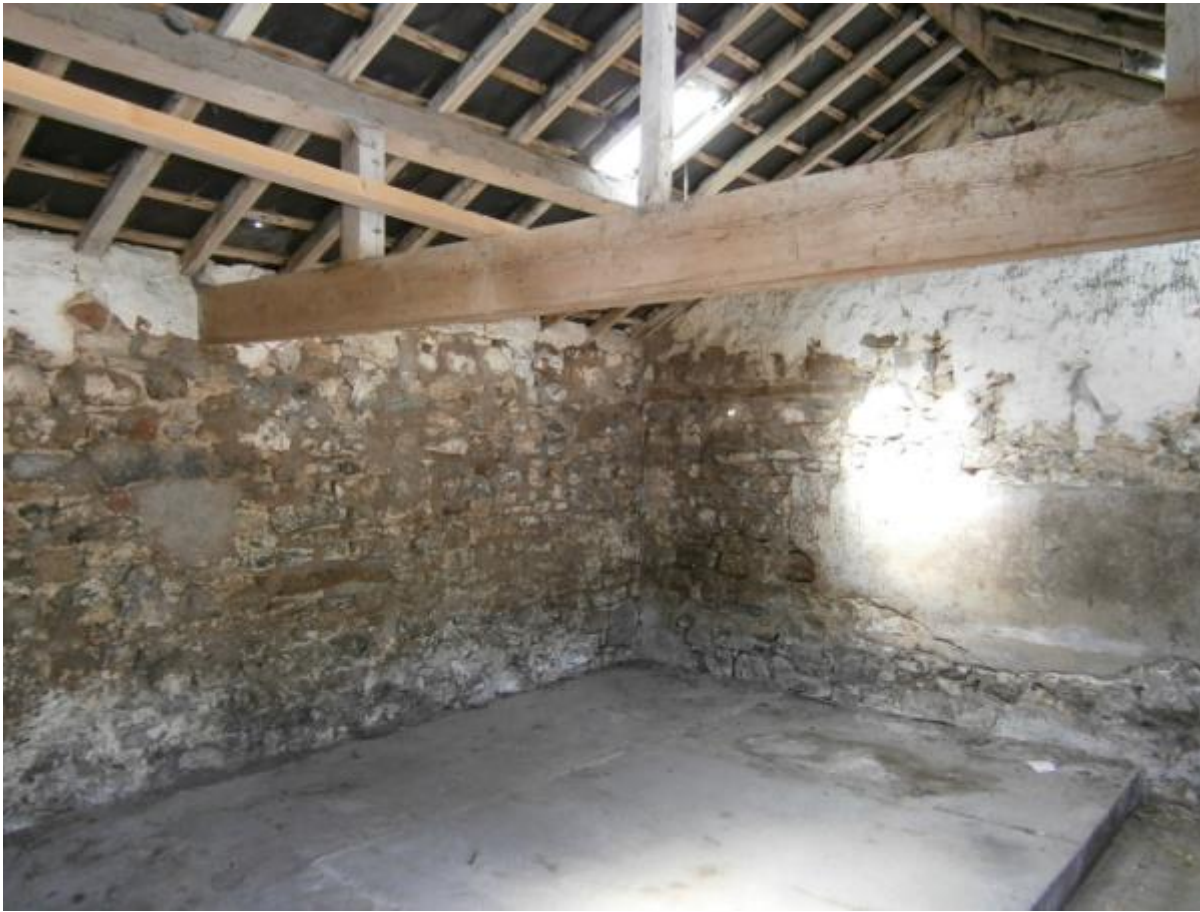
The Single storey section has been used as a shippon with stalls for cattle and a concrete floor. The walls to this area are all in good condition with rendering to the lower sections. The original rear wall to the main barn has been removed in the past to form one long room. The steel beams shown on photo 17 were introduced to facilitate this and the wall partially re-built in block above. The movement to the side elevation may be associated with this change.

Photo 14 - Single storey internal

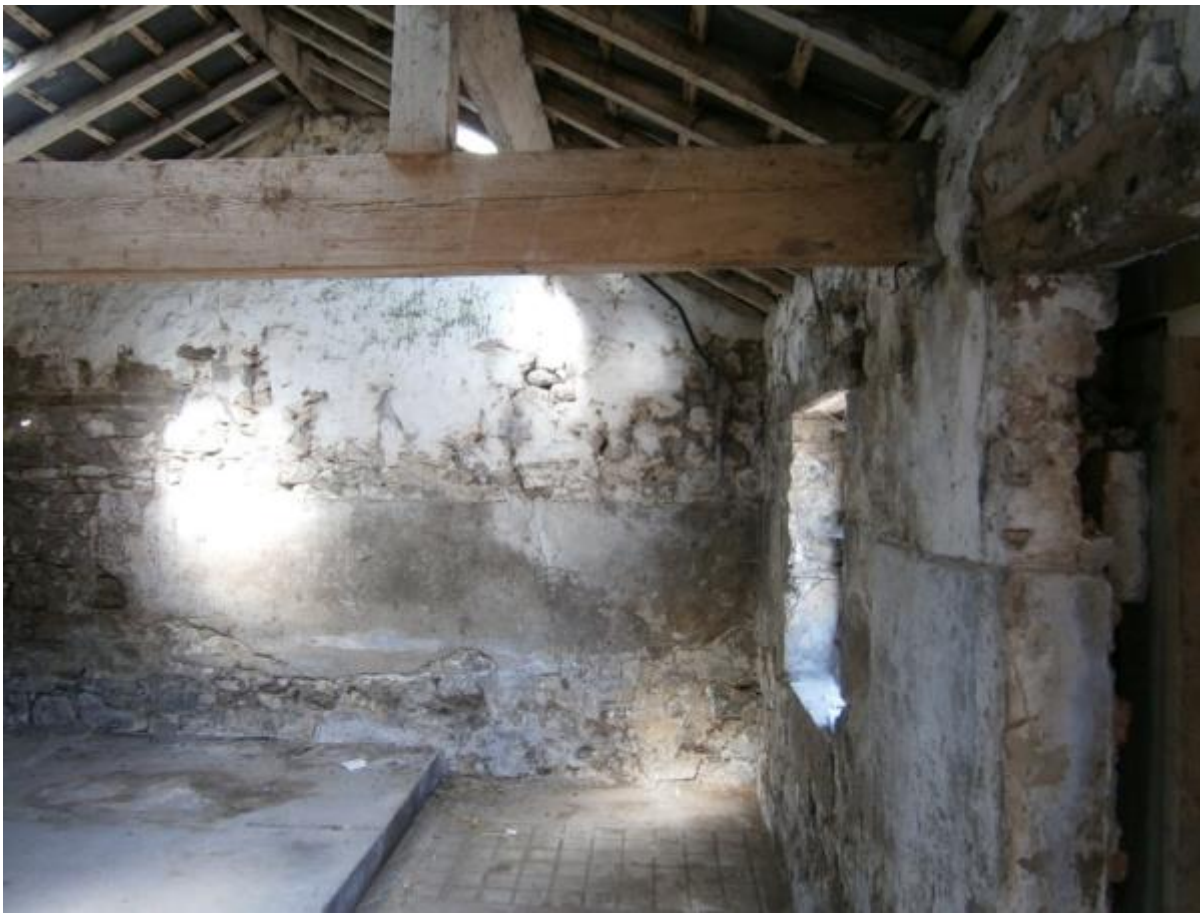
Photo 15 - single stoey internal

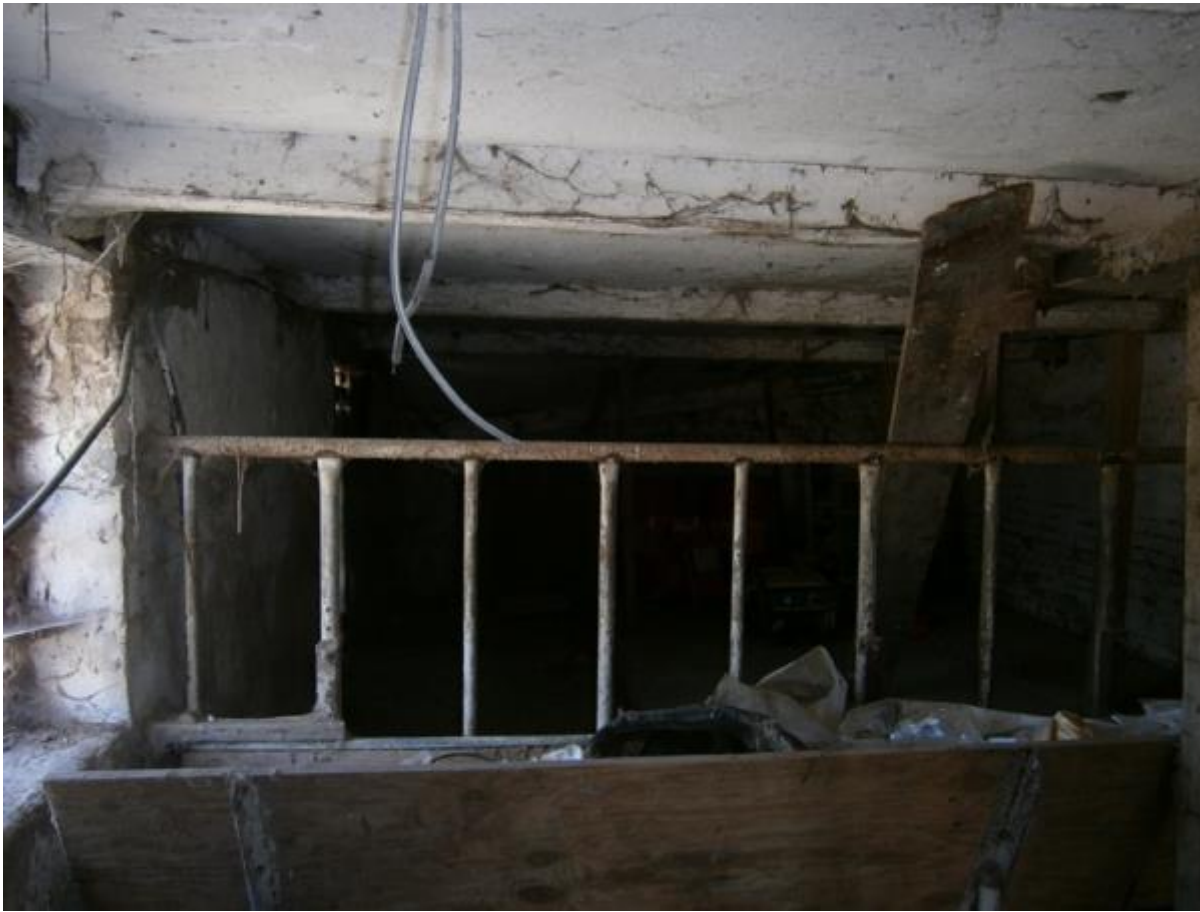
Photo 16 – main barn below mezzanine

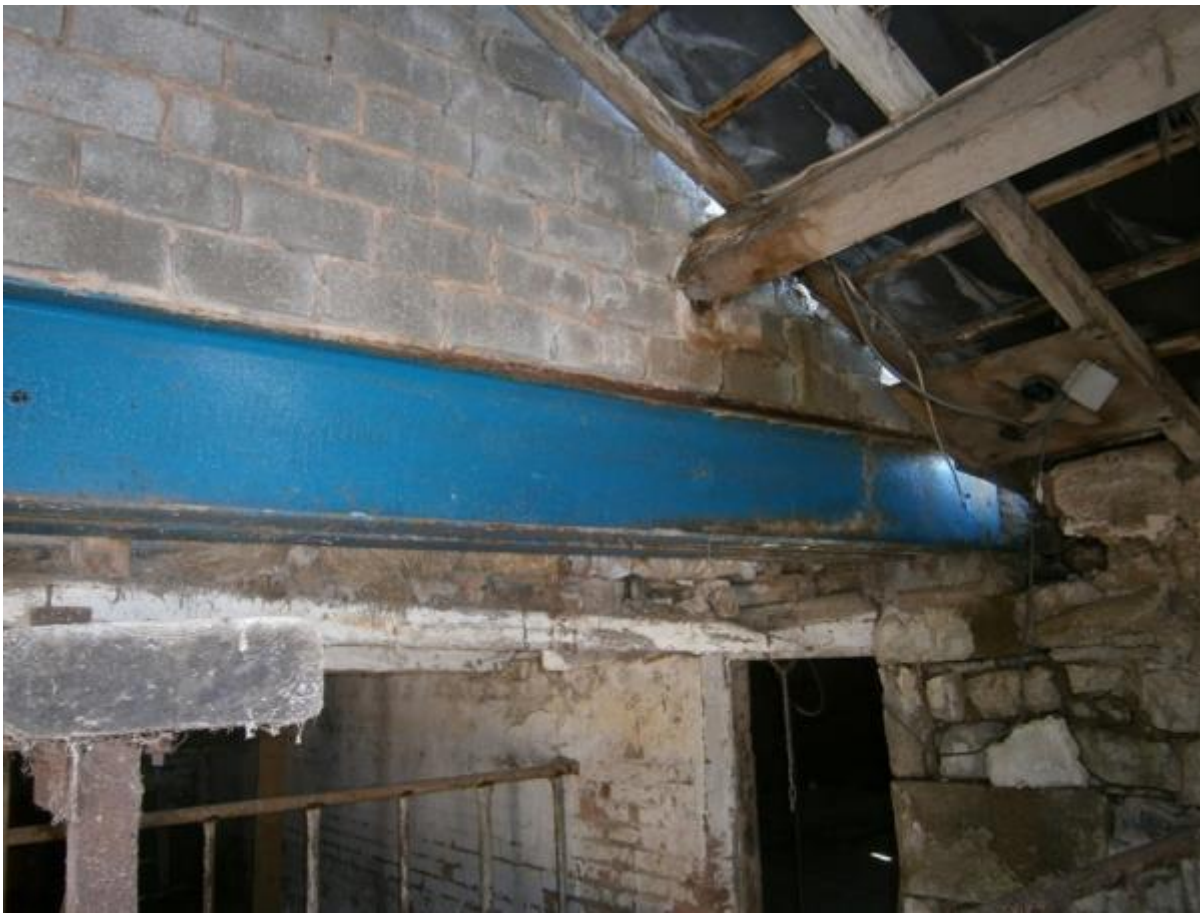
It is proposed to leave this layout in the proposals but investigation and possible replacement of the existing steel beams may be required. If anything, the beams appear to be oversized.

Photo 17 – Double steel beam to rebuilt rear elevation of main barn

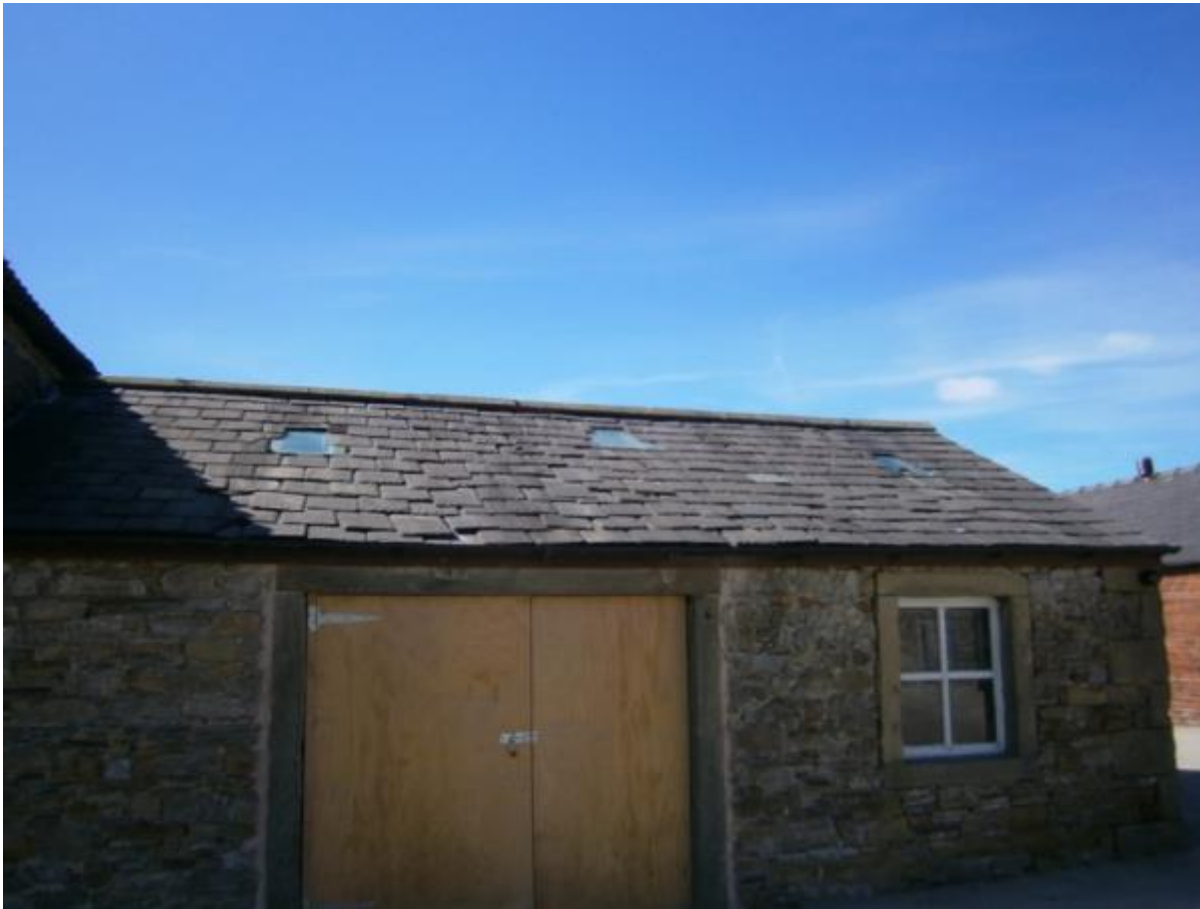
Photo 18 – Roof single storey

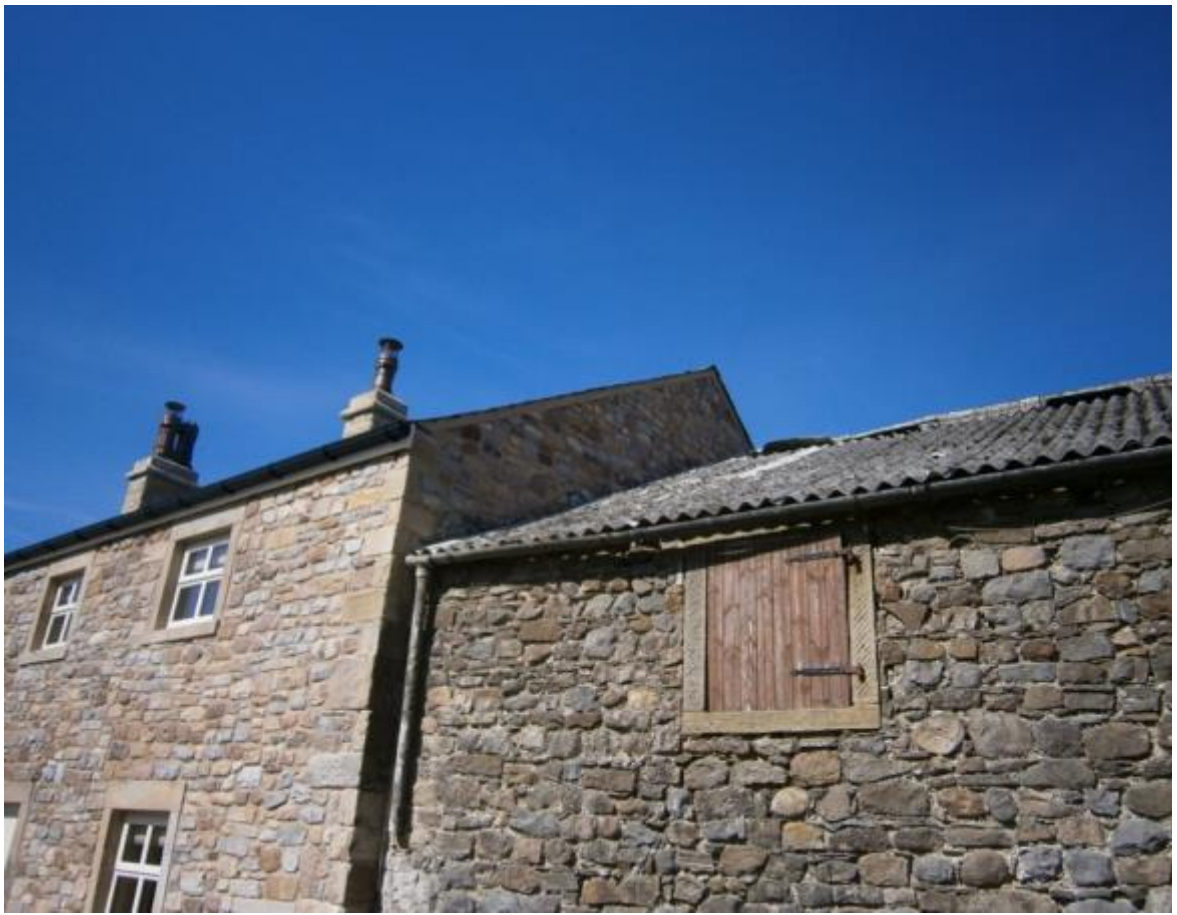
Photo 19 – Roof and junction with house – front elevation
