**Re: Structural Condition Report of the Barn Slated Laithe, off Paa Lane,  
Paythorne, Clitheroe**

### **Terms of Reference**

At the request of Mr J. Athay I have carried-out a visual, structural inspection for the titled property with consideration for converting the existing barn into three-bedroomed family home The inspection was undertaken on 11 November 2017.

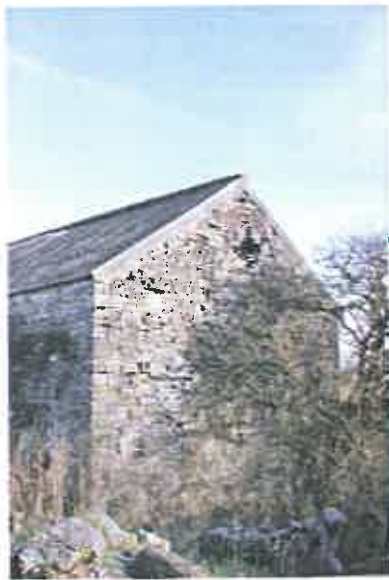
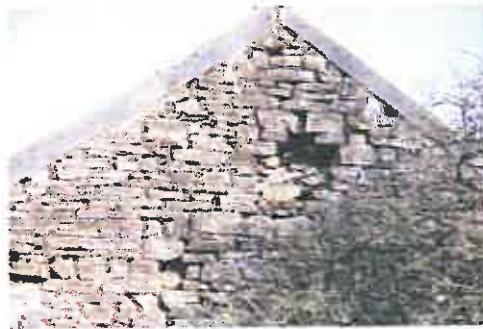
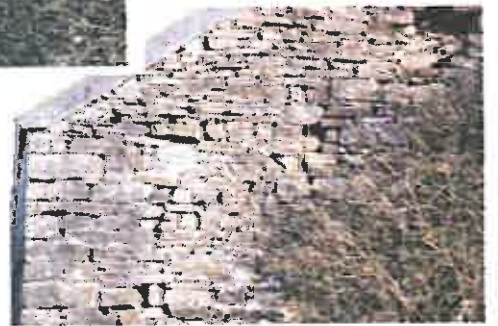
Plates 3, 4 and 5  
Illustrating the South-  
West elevation.

The solid walls of the barn have an outer skin of predominantly, square-coursed, pitch-faced sandstone with some limestone and an internal skin of random rubble. The outer skin jointing is pointed in some areas, but not all, with lime mortar. The inner leaf of random rubble is bedded and jointed extensively with lime mortar. The external corners of the building comprise stone quoins for the full height. The North-West external elevation has a limited amount of random rubble infill that is not original construction (Plates 1 and 2). The South-West elevation, which is the primary elevation for weathering, has some localised collapse (Plates 3 to 5).

The solid external walls are generally in good condition (eaves lines are vertical and true) with limited localised collapse, particularly confined to the South-West elevation. Much of the principle timber structure supporting the roof is in good condition with no discernible signs of distress. The roof structure, whilst in reasonable condition, will require replacing with a functional, insulated slated roof, for domestic purposes.

The solid walls to the barn are generally in good condition with limited defective areas. There are no signs of subsidence or settlement (the coursing and eaves lines remain relatively true and horizontal). On rectification of the localised collapse and repair/replacement of the pointing, the walls will prove to be more than suitable for the proposed redevelopment. It should be noted that the jointing to the outer skin is 'tight' in places and may prove difficult to point, in which case the inner skin of the solid wall should be re-pointed to make weather-proof, as per the original construction.
