**STRUCTURAL APPRAISAL**

**HAMMOND DRIVE BARNS**

**(PIGGERY AND STORE)**

| <b>CONTRACT NO. B14526</b> | <b>JAMES CROSBIE ASSOCIATES LTD.<br/>CONSULTING CIVIL &amp; STRUCTURAL ENGINEERS<br/>37 CHORLEY NEW ROAD, BOLTON. BL1 4QR</b> |

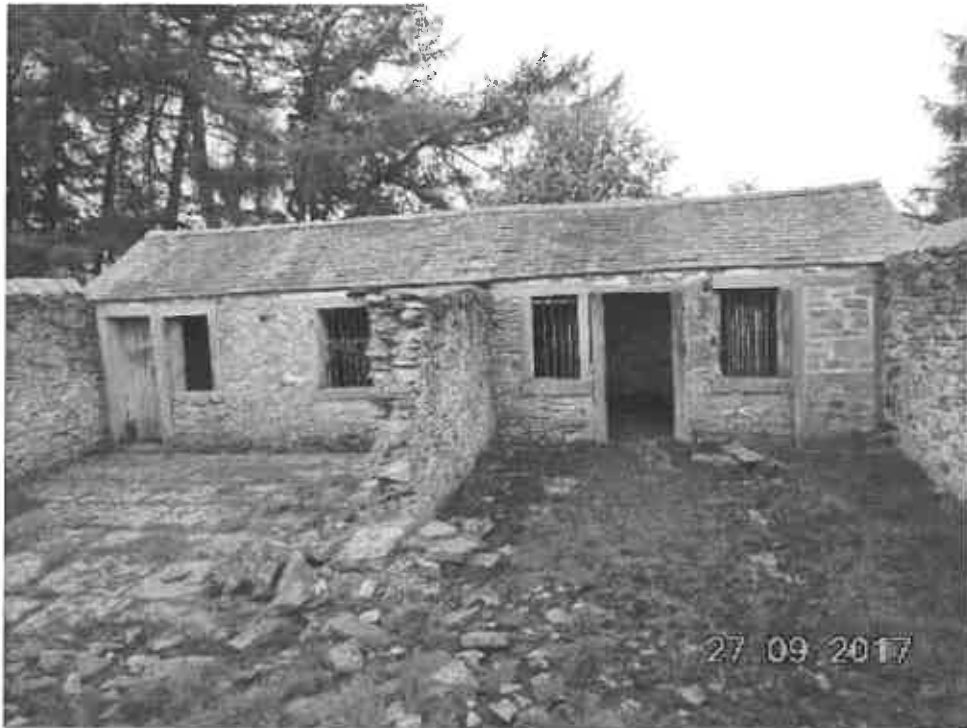
**OVERALL FRONT ELEVATION OF PIGGERY**

The wall to the front elevation of the piggery is split into two distinct areas with a division wall dividing the areas. The left hand side of the elevation incorporates two window openings and two door openings with stone surrounds. The stone cill to the left hand window was noted to be missing. The wall to the right hand side of the elevation incorporates two windows with central door. To the right hand window the stone jamb to the left hand side was missing and the right hand jamb was loose. The stone head over the door was also noted to be loose and the left hand jamb was not bonded. Generally the wall was reasonable plumb within acceptable tolerance.

To the piggery there was evidence of some movement to the rear right hand corner with cracking noted and distortion of the wall which will require the corner to be locally rebuilt either side of the crack. To the rear wall of the left hand pen the vertical crack is required to be locally made good by taking down the stonework and rebuilding. To the front elevation the stone surrounds to the openings will require to be made good and locally rebuilt.

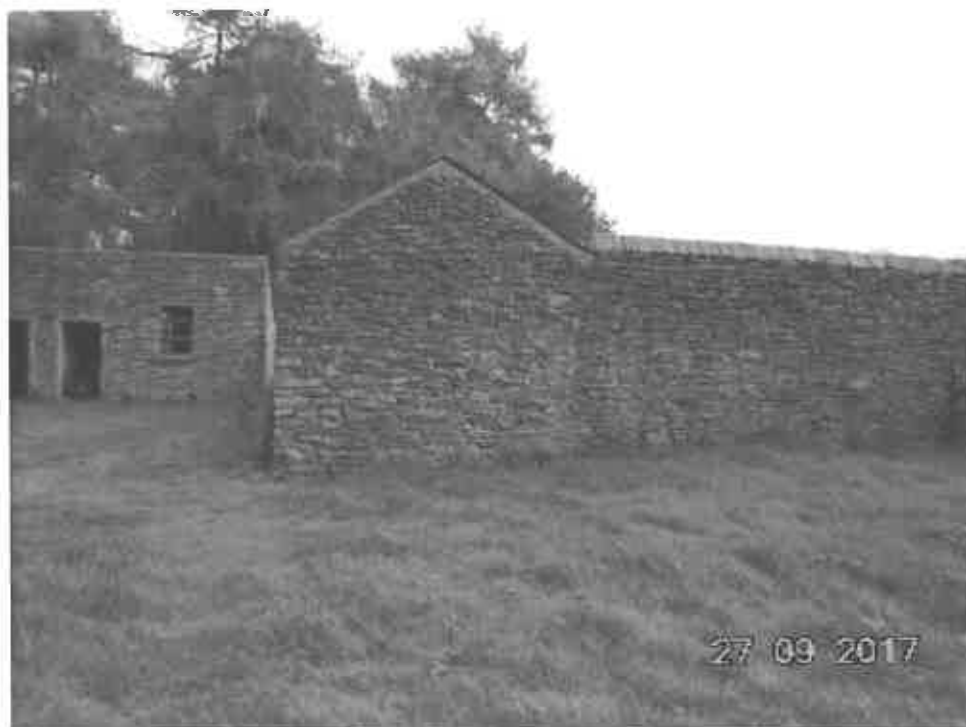
**LEFT HAND ELEVATION (PIGGERY)**

The left hand elevation was in general in a fair and reasonable condition and showed no evidence of any significant distress.

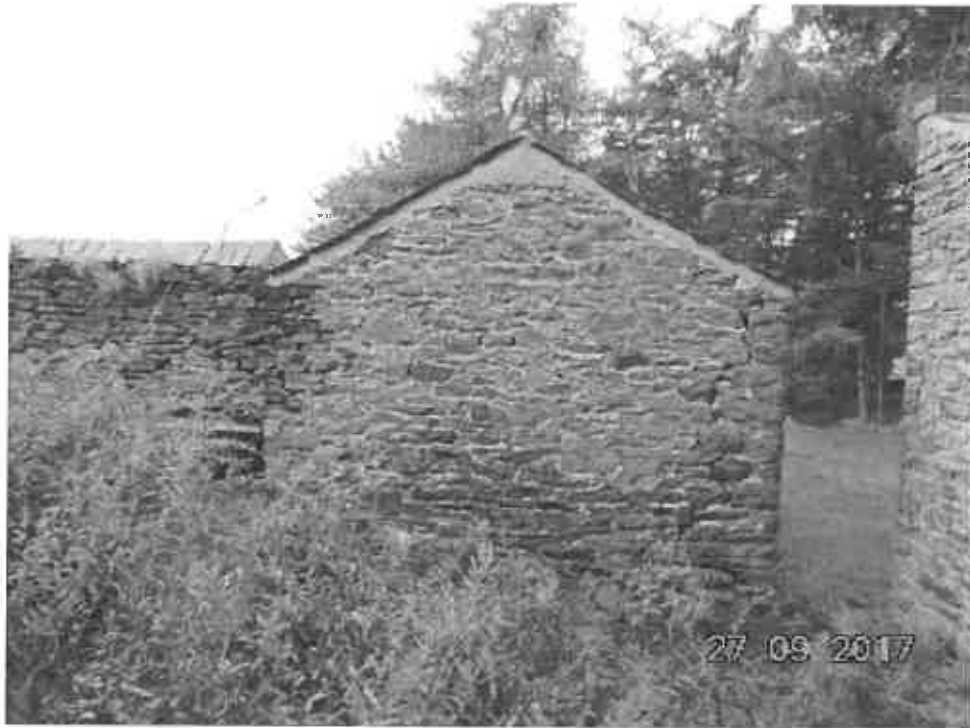
**RIGHT HAND ELEVATION (PIGGERY)**

The right hand elevation shows some evidence of distress to the far right hand corner with a vertical crack running parallel with the rear elevation. The wall was noted to lean outwards by in the region of 30mm over 1200mm.

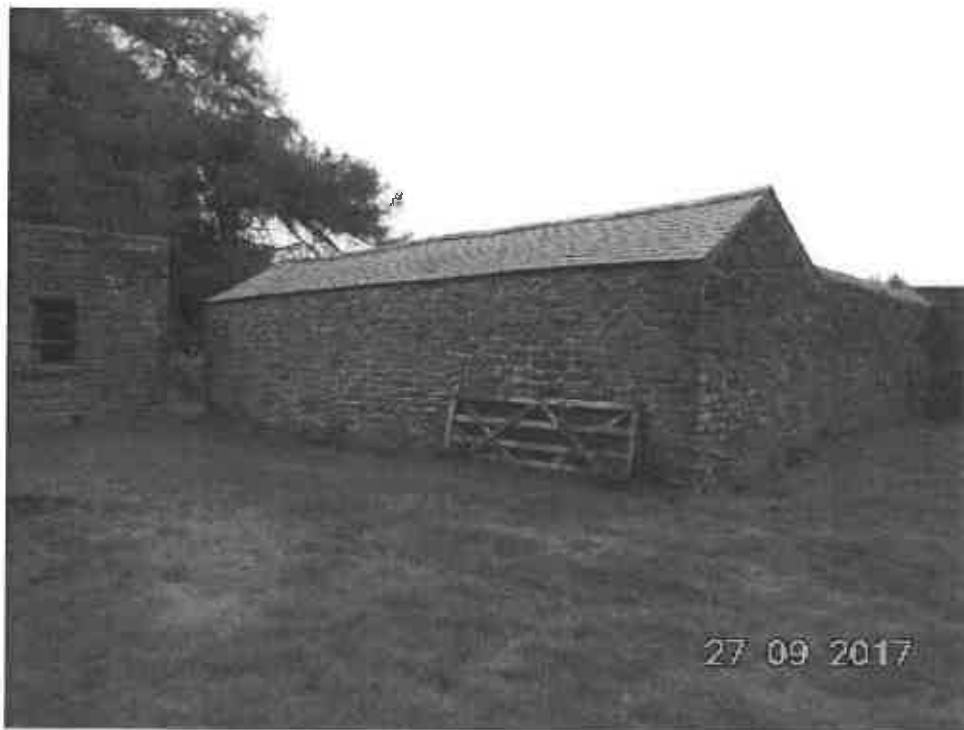
**REAR ELEVATION (PIGGERY)**

The rear elevation faces the area in front of the adjacent store. The wall was in general in a fair and reasonable condition although there

was evidence of visual distortion to the far right hand corner with vertical cracking evident inset from the right hand gable.

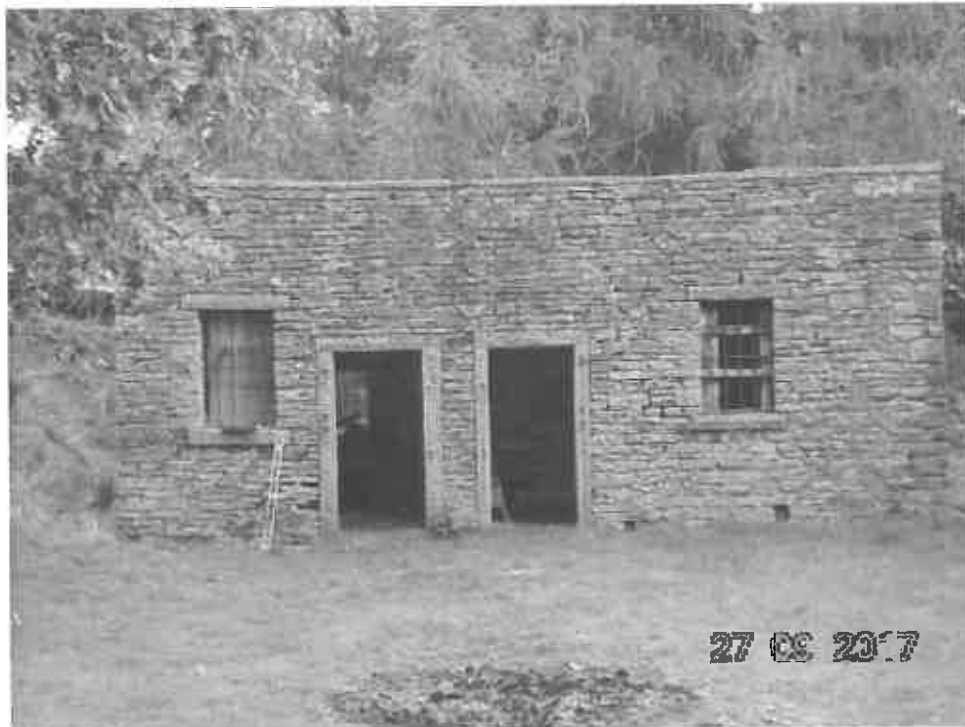
**FRONT ELEVATION (STORE)**

The front elevation forms the higher wall with the ridge of the mono pitch. The wall incorporates two windows and two door openings. The wall was in general in a fair and reasonable condition and showed no evidence of any significant structural distress although some pointing is required. The wall was noted to be reasonably plumb within acceptable tolerance.

To the store there was generally little evidence of structural distress. To the lower courses to the rear elevation there was evidence of water penetration to which require to be made good. Localised repointing will be required.

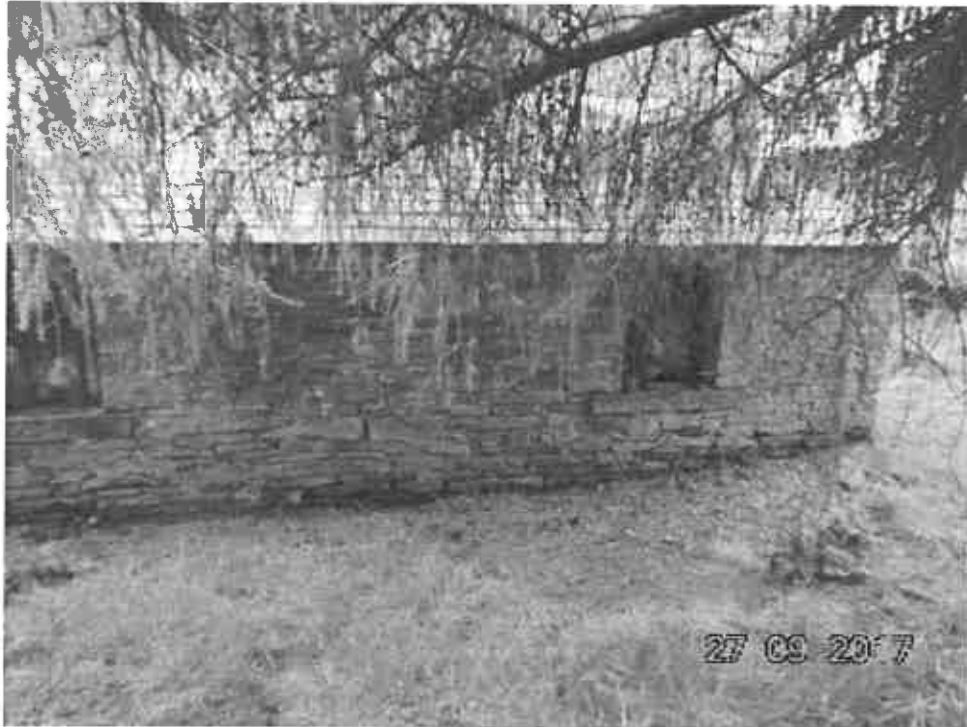
**REAR ELEVATION (STORE)**

The rear elevation being to the low eaves incorporates two window openings. The wall was in general in a fair and reasonable condition however there was evidence of some extensive damp ingress to the lower courses with much evidence of vegetation growth. The wall was noted to be reasonably plumb within acceptable tolerance.

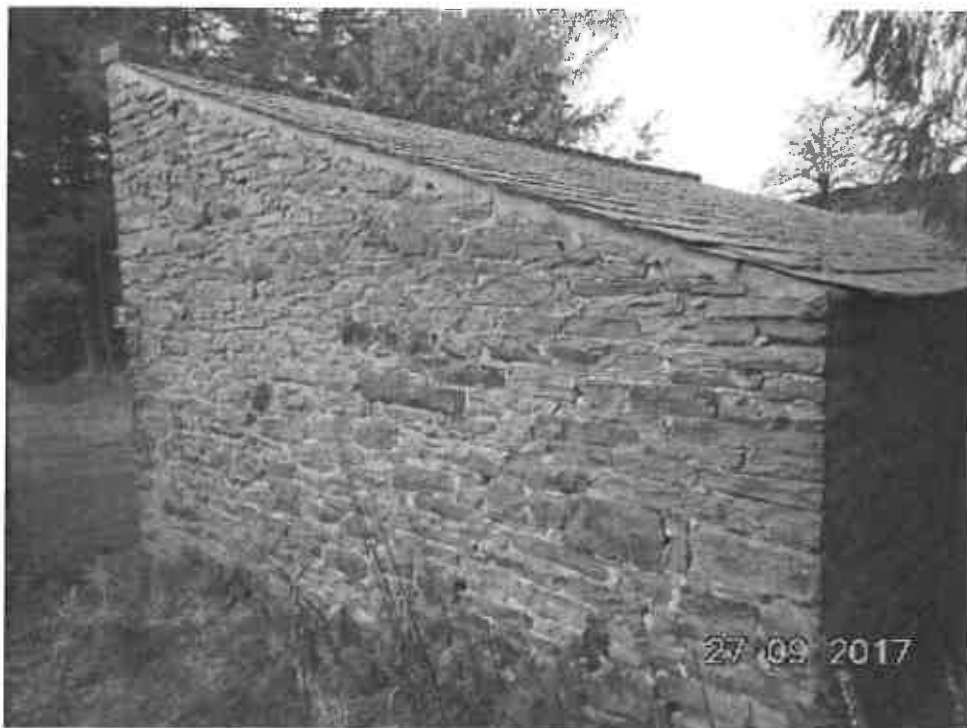
**RIGHT HAND ELEVATION (STORE)**

The right hand elevation was again in a fair and reasonable condition, although some open joints were evident, and was reasonably plumb within acceptable tolerance.

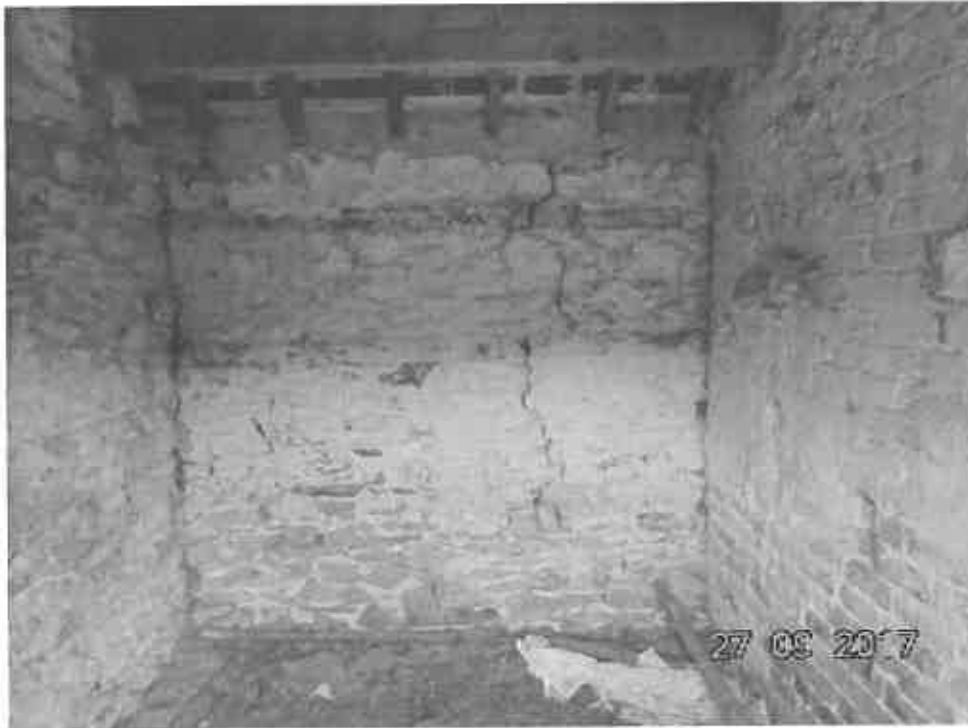
**INTERNAL PIGGERY LEFT HAND SIDE**

Internally the building is split into three pens. To the rear wall of the left hand pen a historic vertical crack was evident. To the right hand pen, to the rear right hand corner the same extent of distress as noted externally was noted with vertical cracking evident.

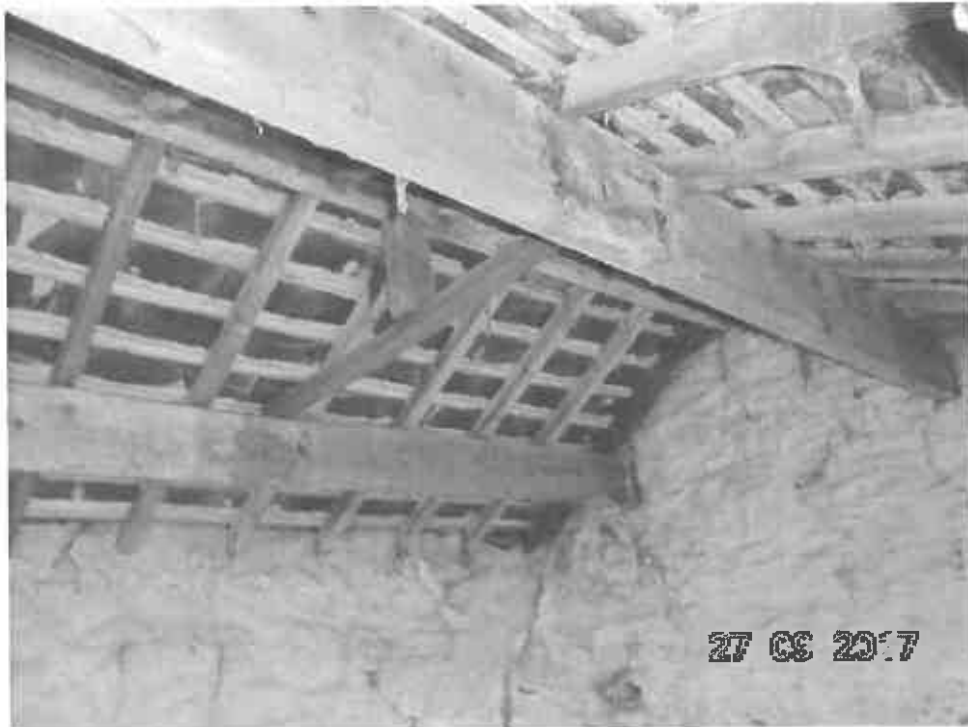
**INTERNAL ROOF TO PIGGERY**

The roof construction was noted to incorporate one purlin per slope which was generally noted to be in a fair and reasonable condition.

To both the store and piggery the roofs were generally in acceptable condition however in consideration of the openings we would consider that replacement of the structural carcassing would be required.

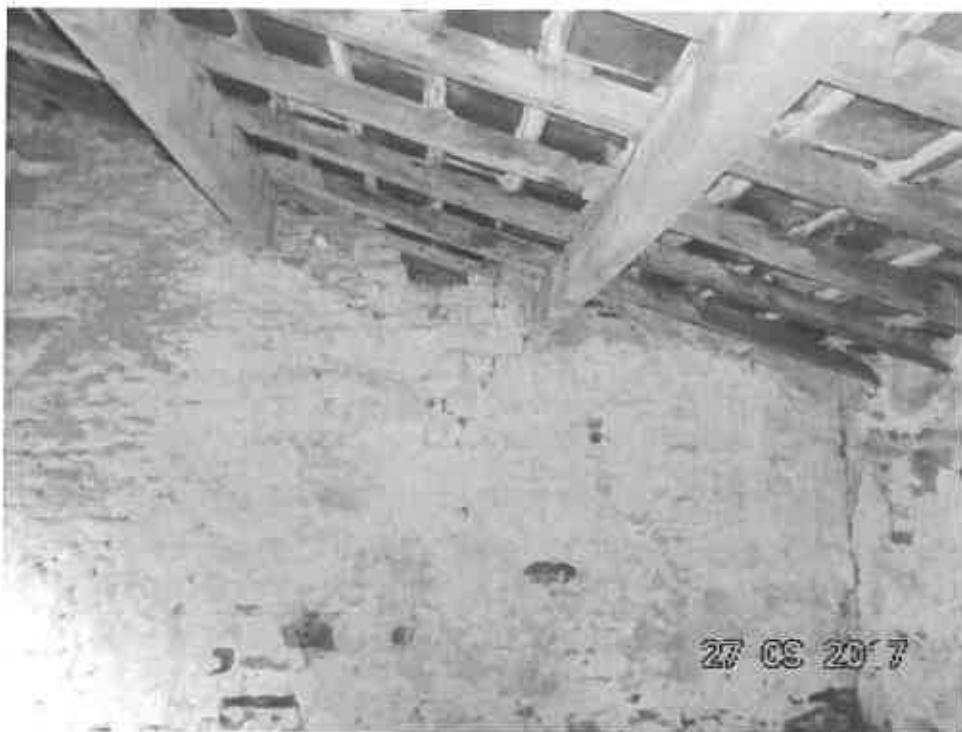
**INTERNAL STORE**

The interior of the barn is split into two areas. In general the building was in a fair and reasonable condition and showed no evidence of any significant distress than that noted externally.

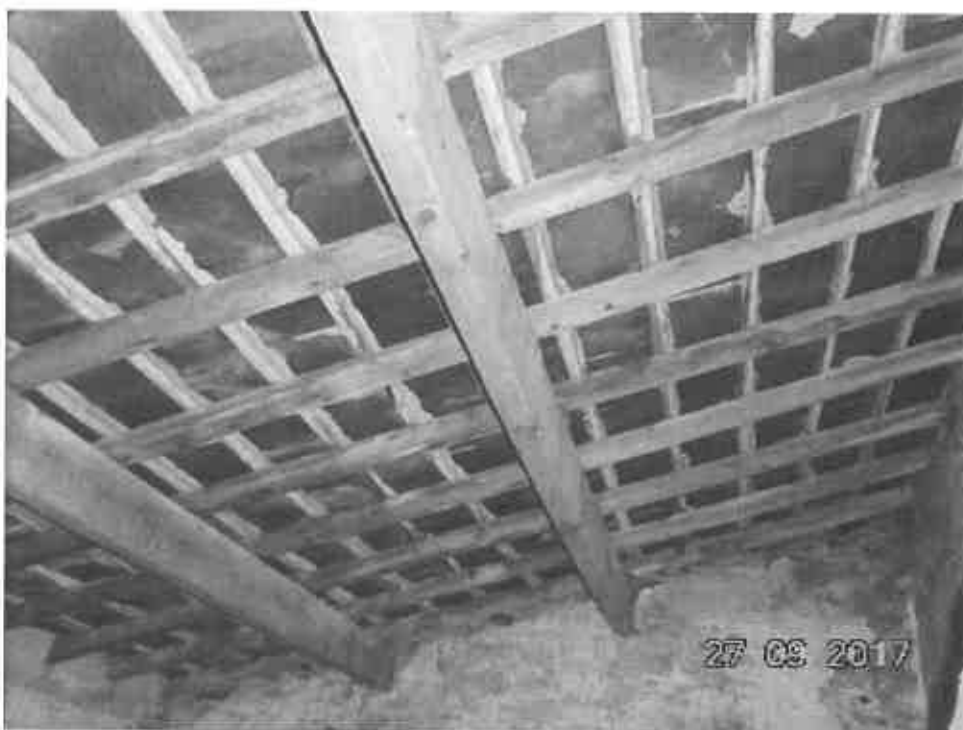
**ROOF TO STORE**

The roof incorporates two purlins per slope which were generally noted to be visually in a fair and reasonable condition although some decay of the rafters was evident.
