# **EVALUATION OF CONDITION OF TREES AT THE ROOKERY, OVERLOOKING CROW TREES GARDENS AND ADJACENT PROPERTIES.**

**Client:** Mr J J Clayton, The Rookery, Crow Trees Brow, Chatburn, Clitheroe, Lancs

**Date of Tree Inspection:** 28.3.18

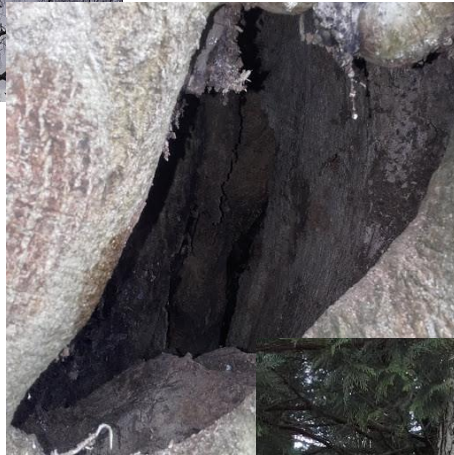
Cavity in ash T12

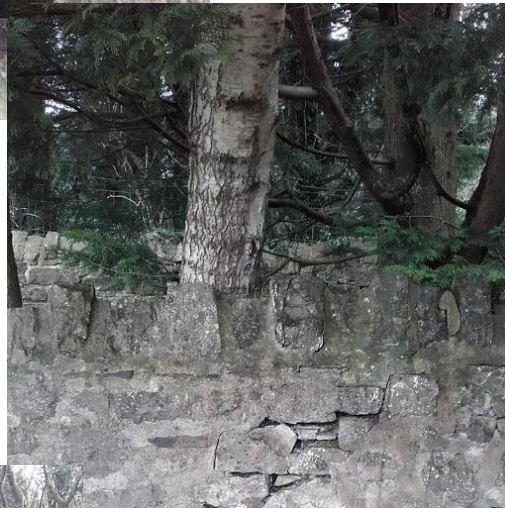
Wall damage by Birch T9
