# HERITAGE STATEMENT

RESUBMISSION 3/2017/1065

Crabtree Cottage  
Back Lane  
Wiswell, Clitheroe  
BB7 9BU

MARCH 2018

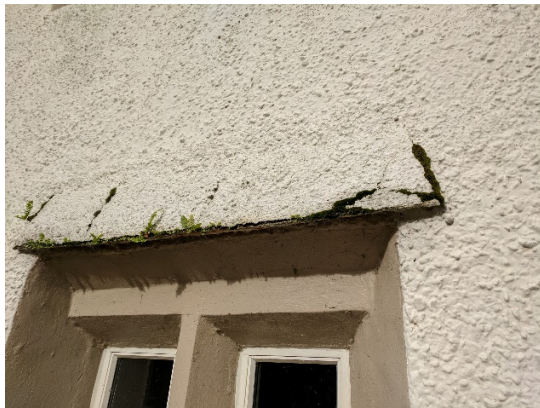
The current render that has been applied to the majority of the property is in a poor condition. The render has been patched and repaired in several locations over the years, which are clearly identifiable from the below pictures. This deterioration of the render is leading to water ingress into the building fabric which is leading to damage structural elements of the building.

Figure 2 - Moss growing in the cracks of the building

The existing sand and cement render is to be removed using hand tools only and the waste is to be disposed of appropriately offsite. From inspection there are large areas of delamination of render from the face of the building. This will mean that there will be minimal additional damage caused by the contractors when removing the render. At this stage the condition of the stone wall, window and door surrounds will be assessed and any repairs required identified. At this stage we would invite the council's conservation officer down to discuss the requirements and any further action he believes is required (i.e. a further Listed Building Consent Application). Then the existing pointing to the stonework will be tested to determine the mix. The previously identified mix will then be used to repoint the entire external walls of the property. Once the lime mortar has cured the walls will be treated with BBA Approved Sovereign Weather-check Façade Cream. This product impregnates the surface of the wall adding additional water replant properties while not affecting the appearance or breathability of the stone wall.

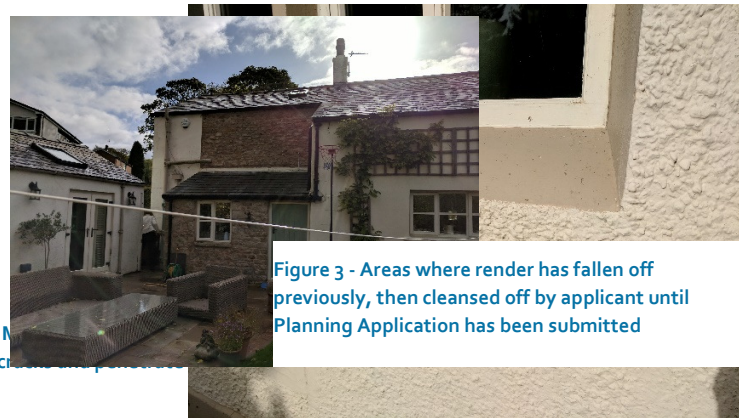
Figure 3 - Areas where render has fallen off previously, then cleansed off by applicant until Planning Application has been submitted

The current owners of the property have been living in the property for over a decade and have been gradually carrying out improvements to the property both internal and external. After the issues with the render to the rear of the property (shown in Figure 3 previously) they have realised that the render requires renewing as a whole to prevent further damage to the fabric of the building.
