Re: Chimney Stack At Victoria Mill, Watt Street, Sabden

Chimney Stack

Victoria Mill – Watt Street – Sabden.

Report.

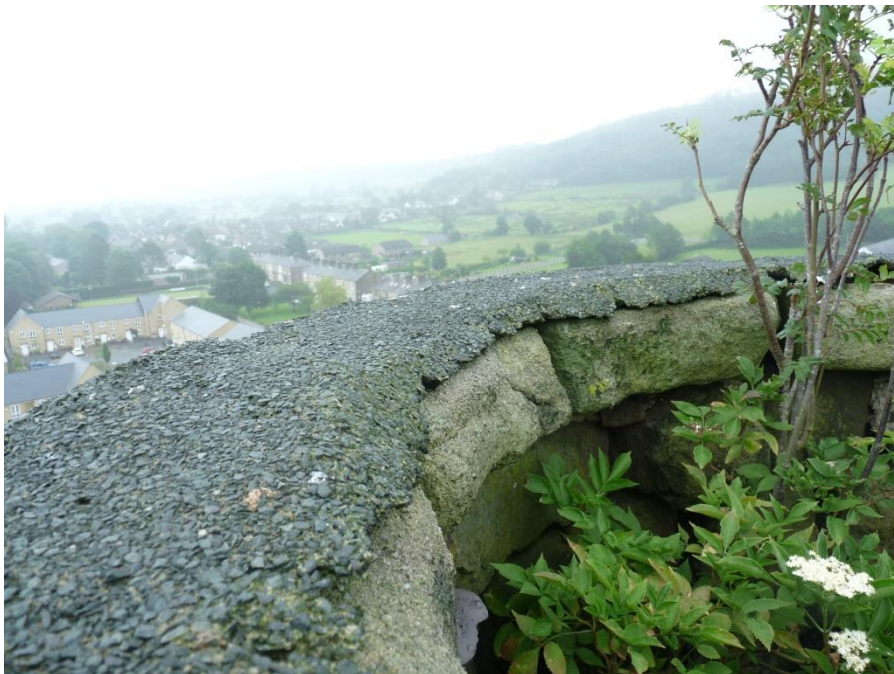
No. 1

- The granite capping at the summit has lifted and become dangerous.

Summit Capping

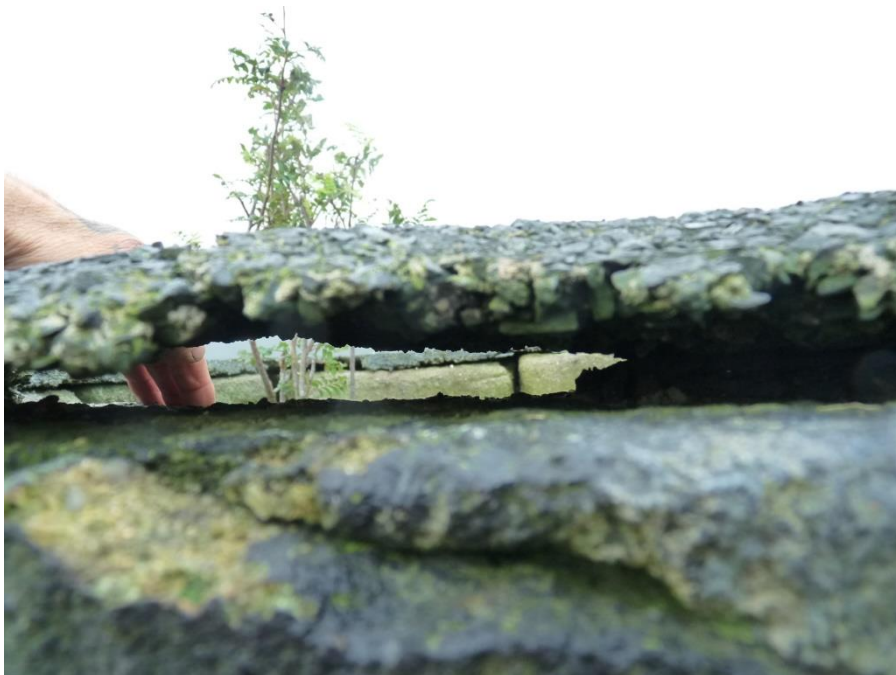
No. 3

Cleary see the lifted granite capping

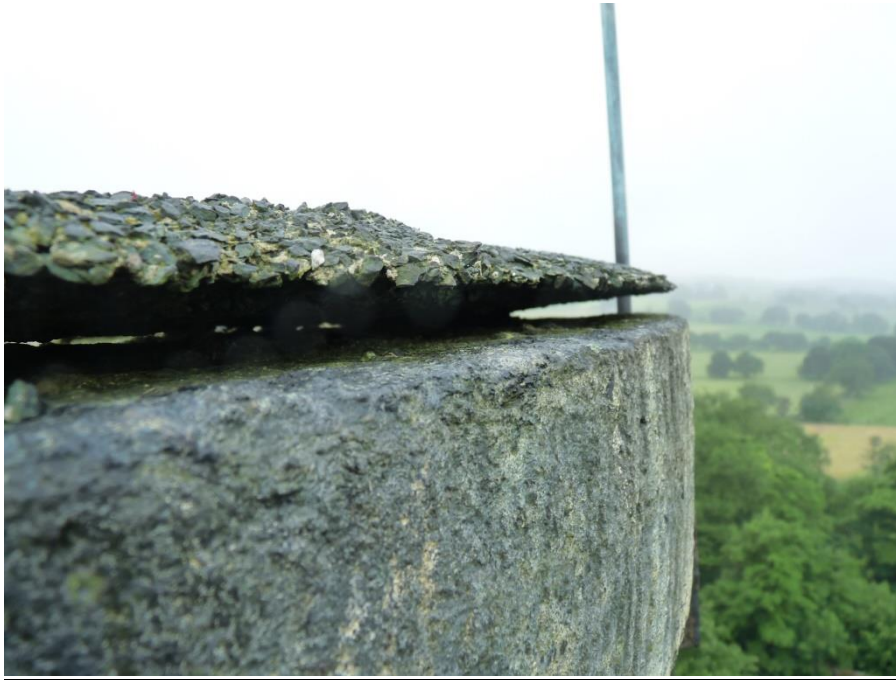
No. 4

Summit Capping

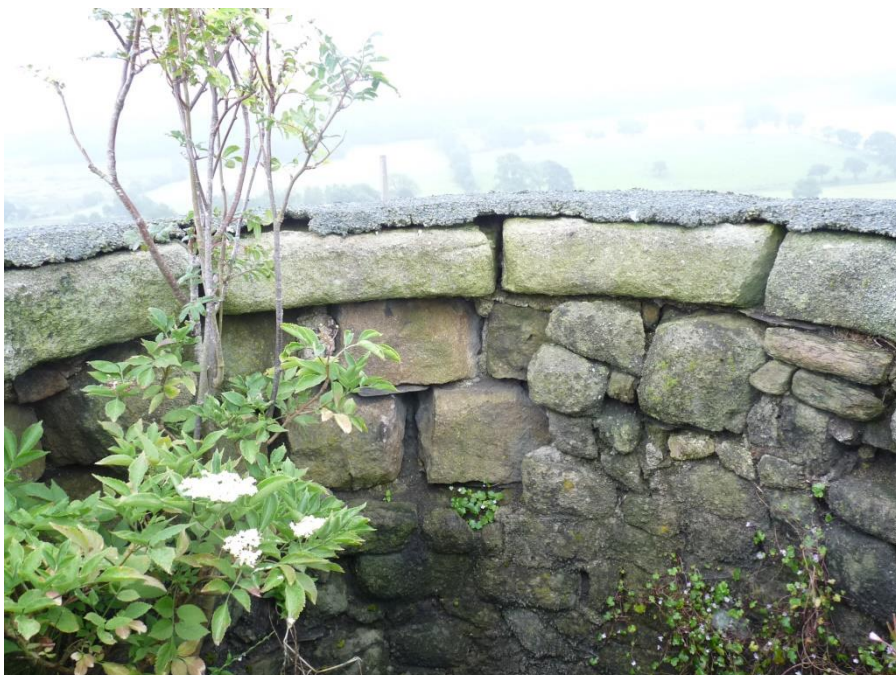
No. 5
Victoria Mill – Chimney Stack

- The internal stone work face has collapsed in several places over the top 1m.
- Large amounts of vegetation growth is evident to the top internal stone work.

Internal Stone Work.

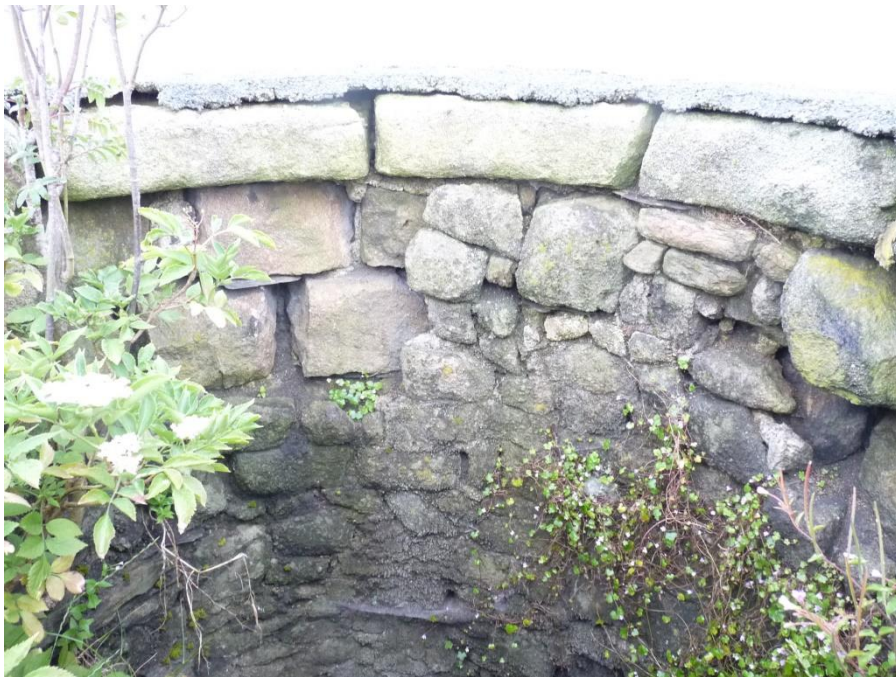
No. 7

Internal Stone Work Collapsed.

The above photos show the collapse of the top internal stone work in several places.

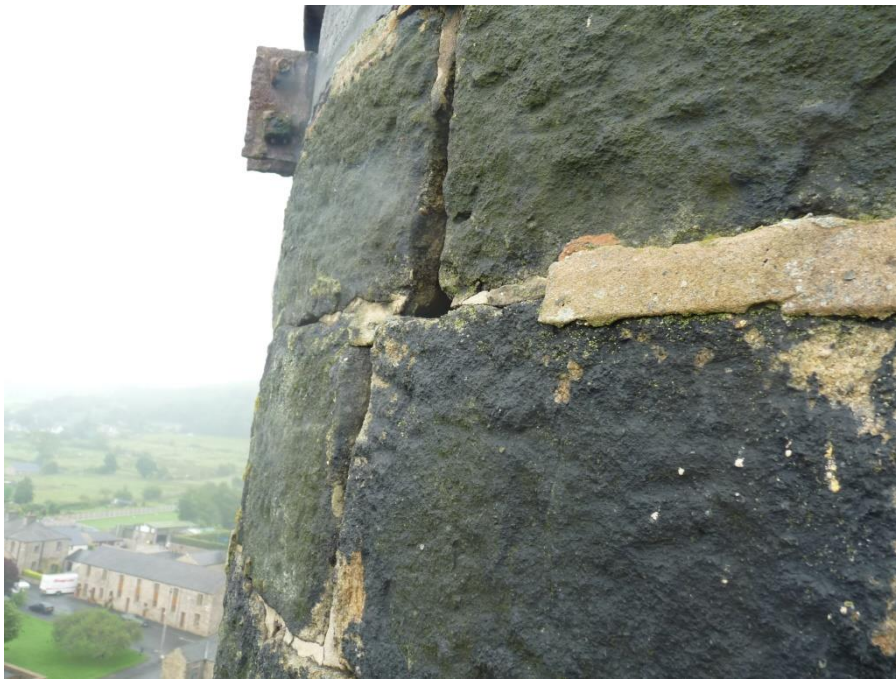
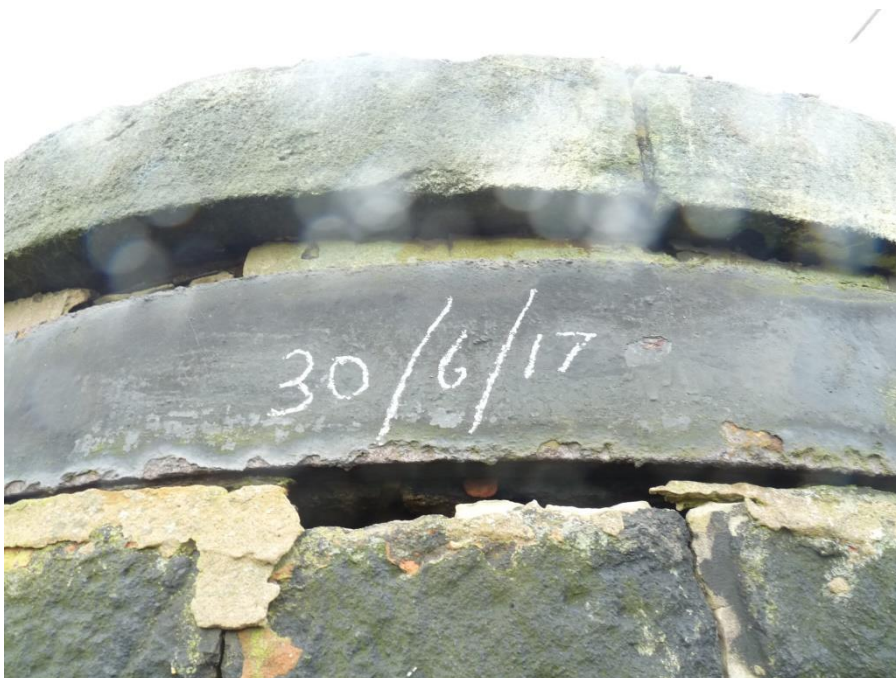
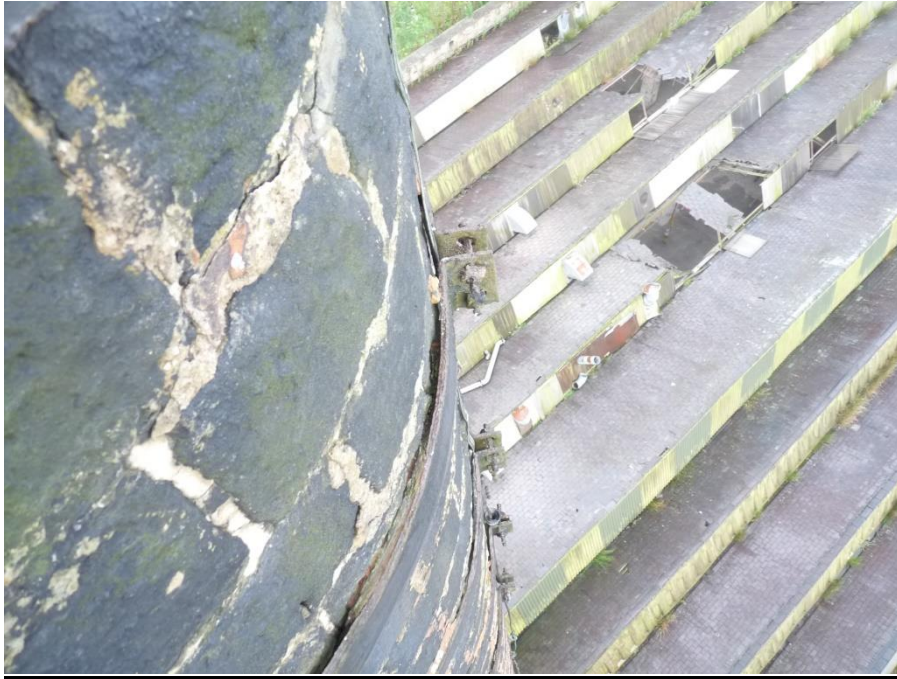
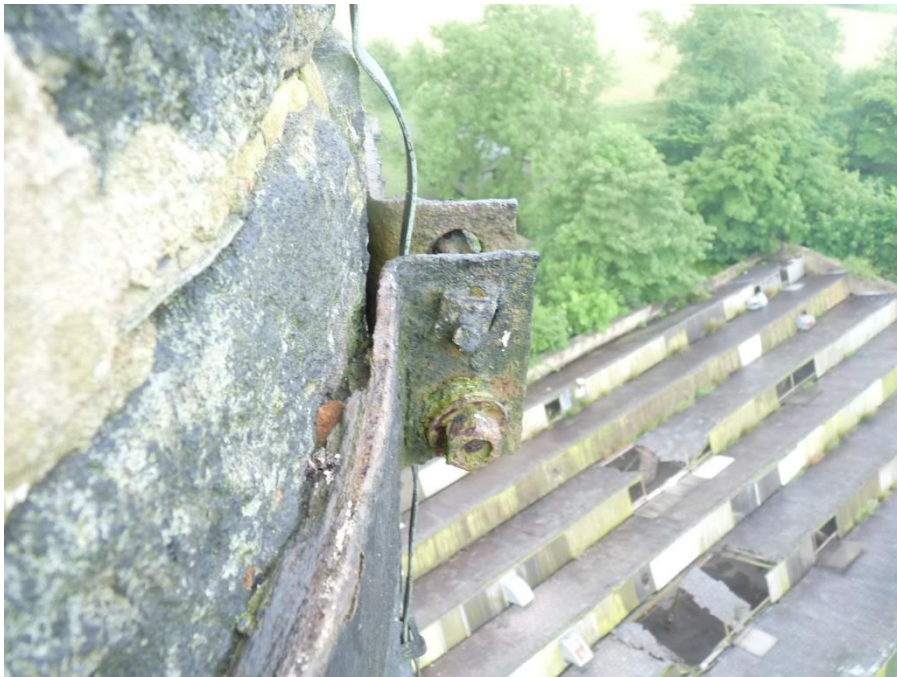
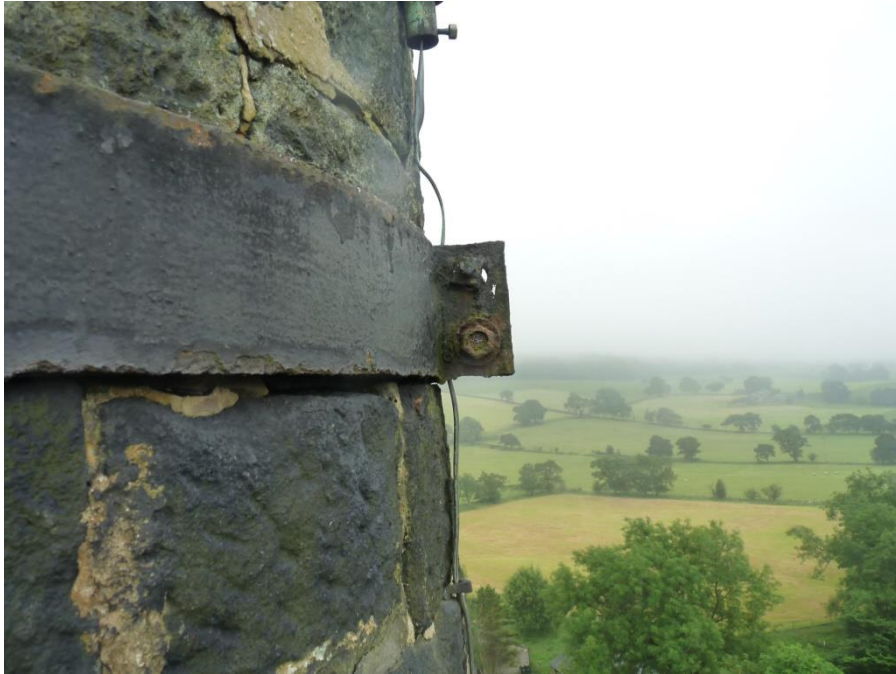
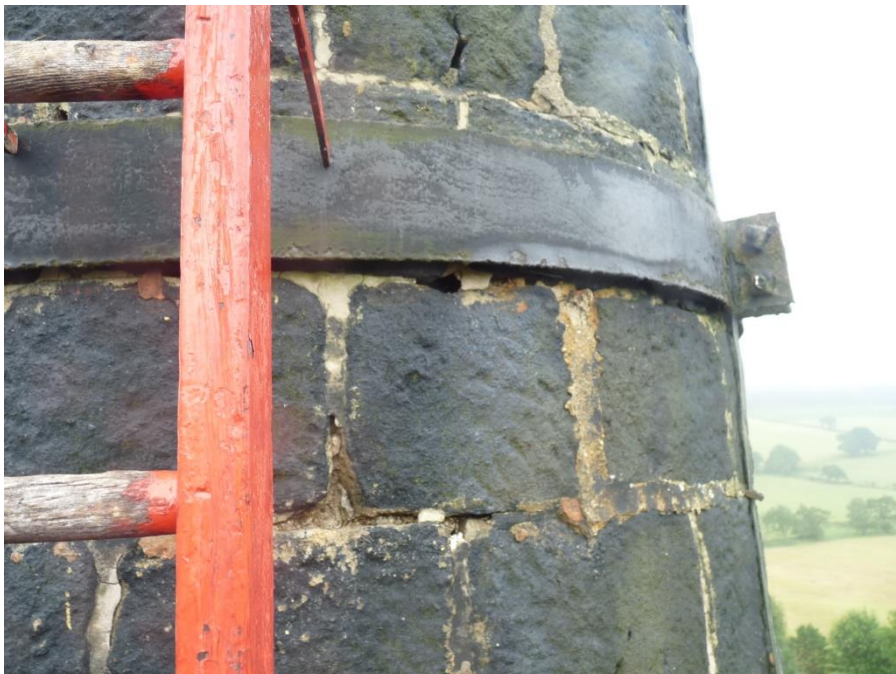
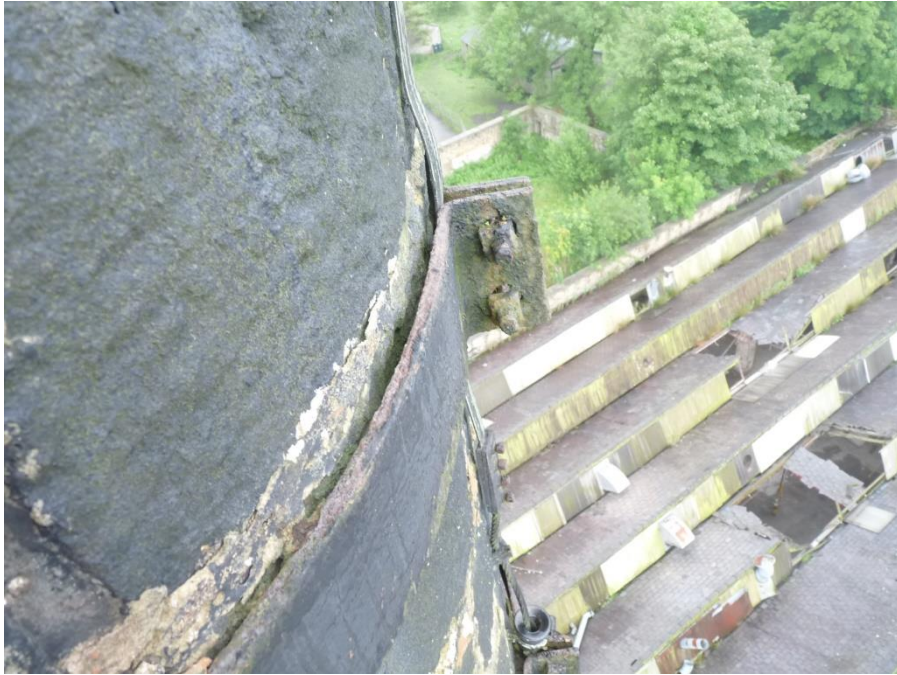
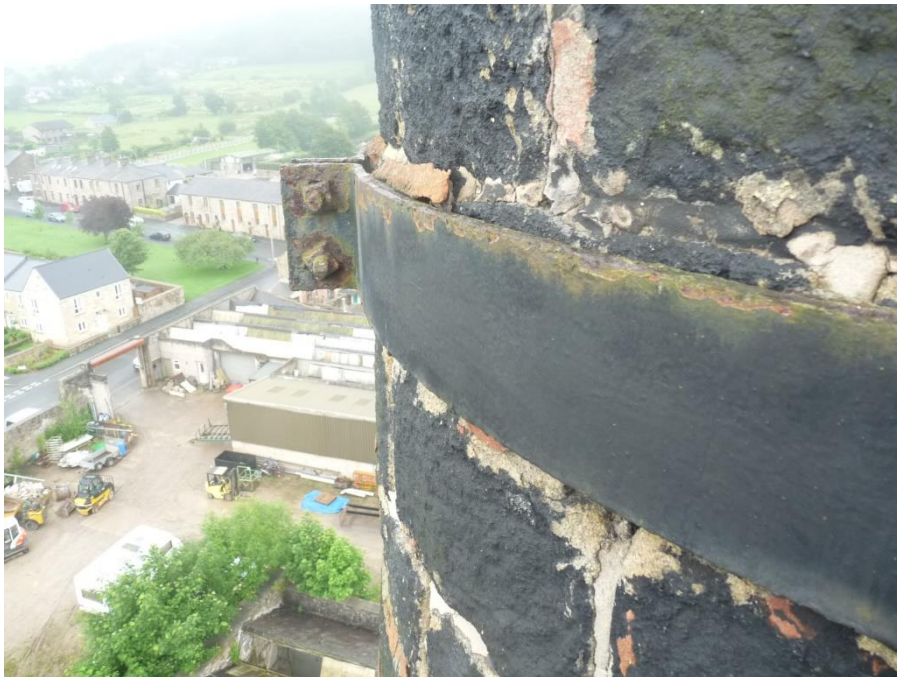
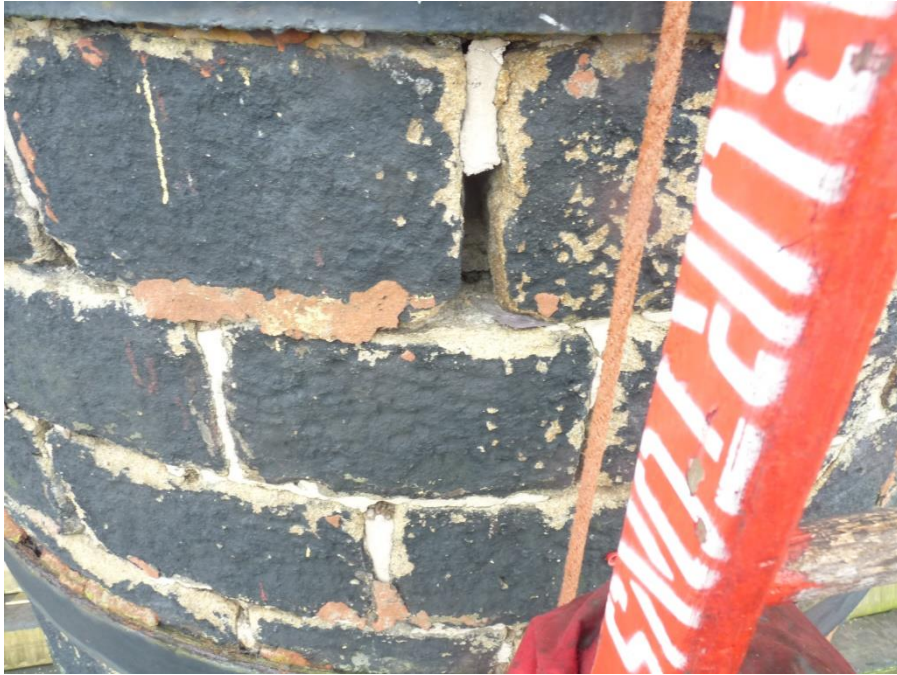
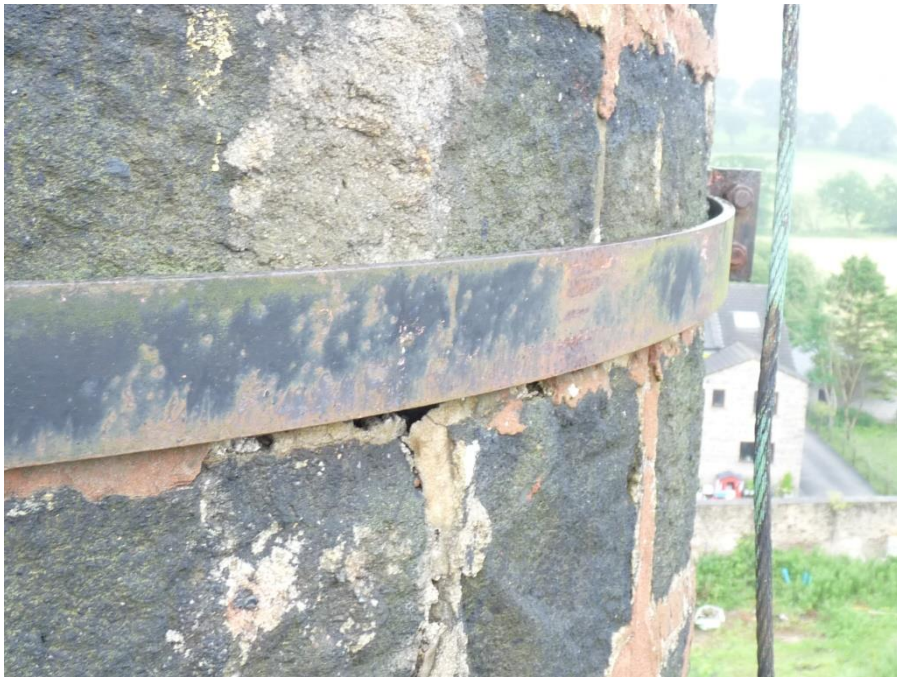
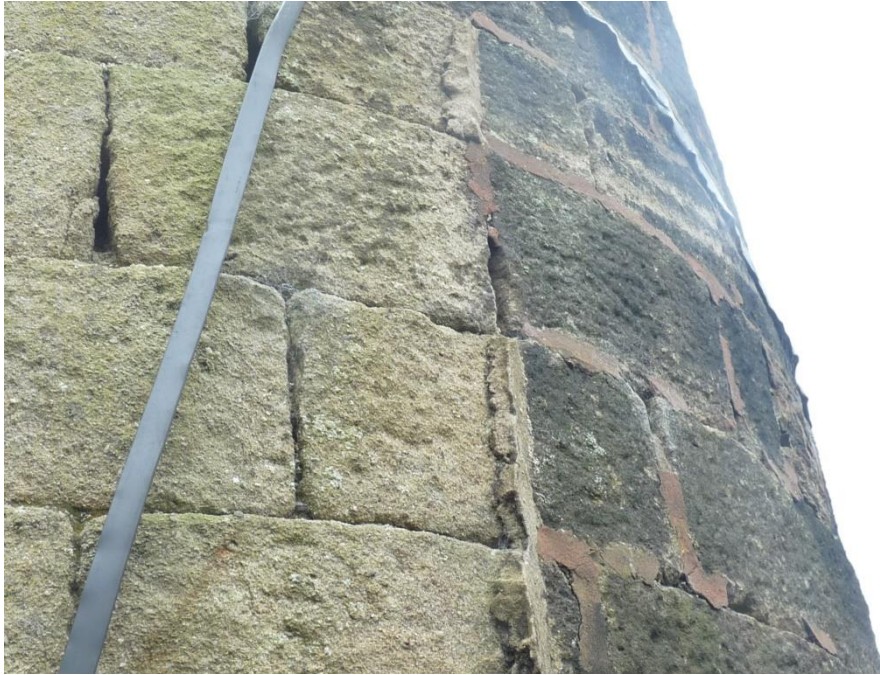
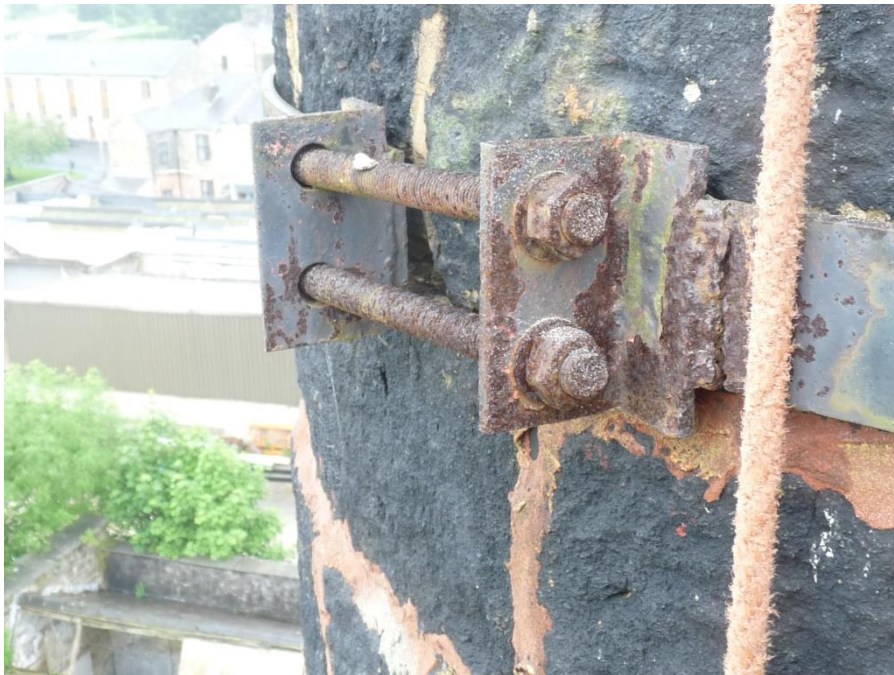
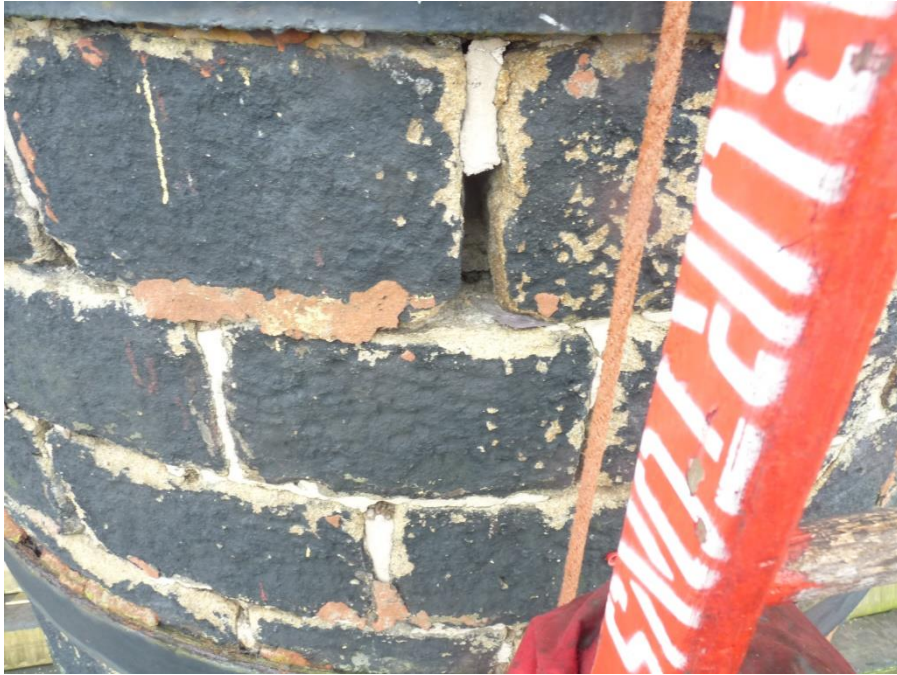
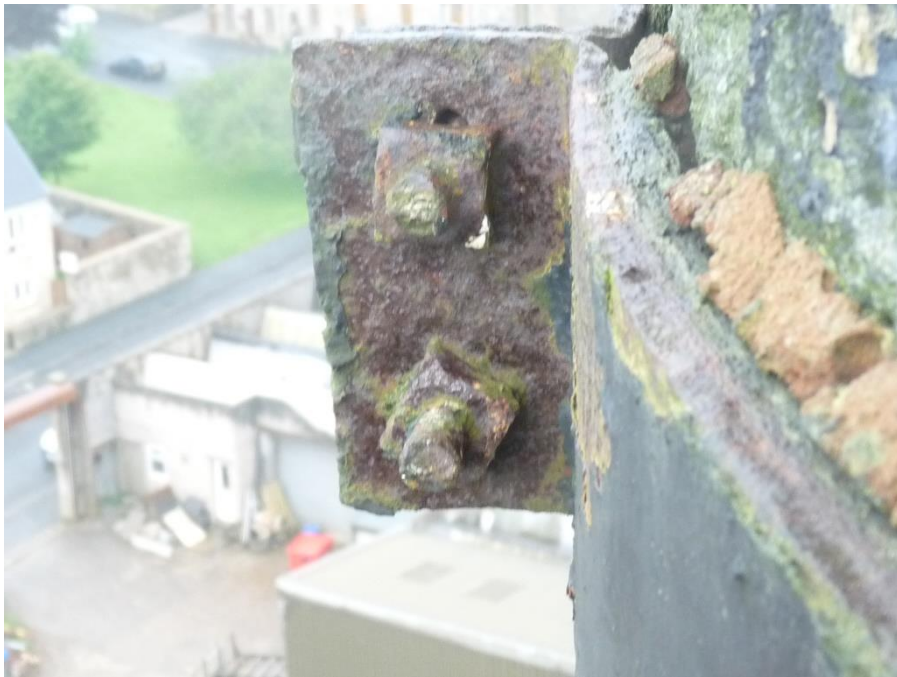
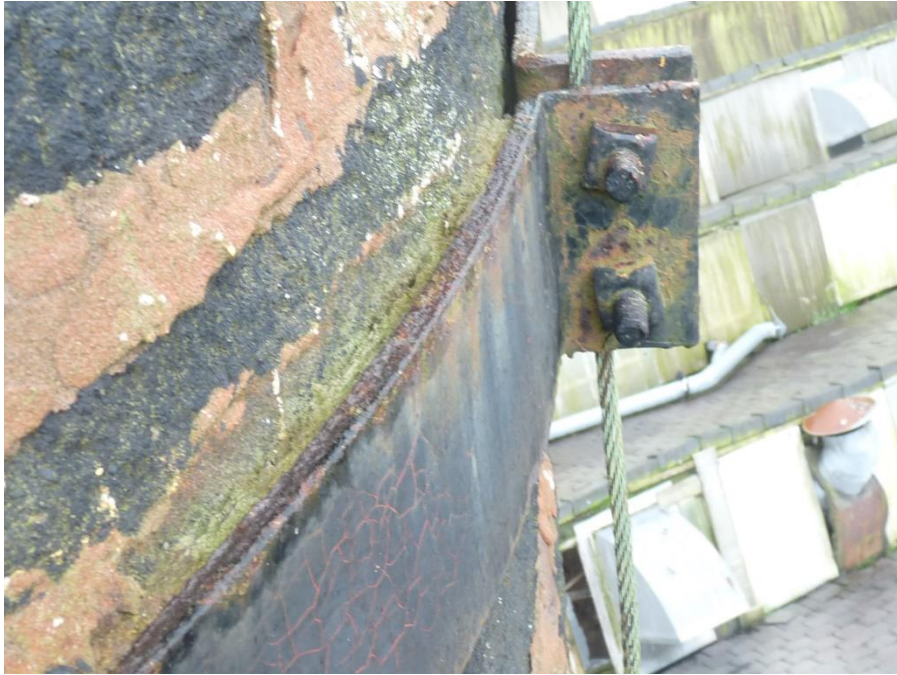
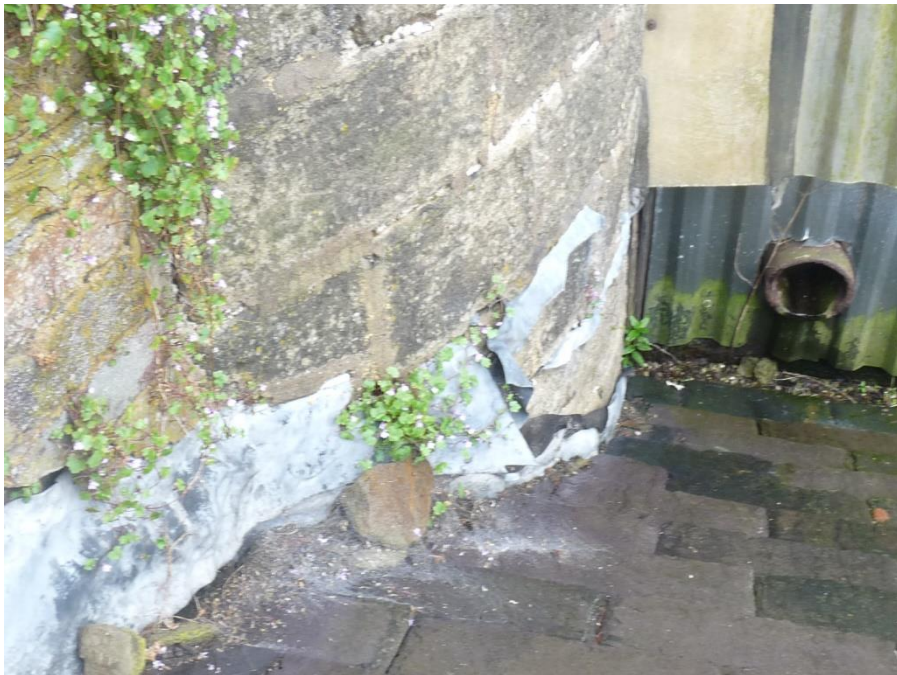
- The Lime mortar throughout the chimney barrel has perished.
- The whole of the chimney stone work external and internal was found to be very damp and porous.
- There are 14 mild steel bands fitted throughout the chimney.
- The majority of the mild steel bolts were found to have corroded to less than half their original diameter.
- They are in a very dangerous condition as a rust build up behind the bands and stone work has caused extra pressure to the bolts.

- The majority of the steel banding and bolts are dangerous and at bursting point, these were fitted to the chimney to hold the stone work together.
- Due to a build up of heavy rust between the stone work and banding any one of the bolts and banding could fail at any point causing stone work to collapse internal and external. This in turn would cause very serious damage to any remaining buildings and public.

- Chimney stone work is bulging between each band to the uppermost part of the chimney. This can be considered highly dangerous.
- The growth at the crown of the chimney has caused considerable disturbance of the stone work and masonry where roots have become embedded in the joints causing internal stone work to collapse and fail.

- The immediate hazards are the risk of components falling from the chimney.
- Demolition works should be undertaken immediately in order to remove health and safety risks.

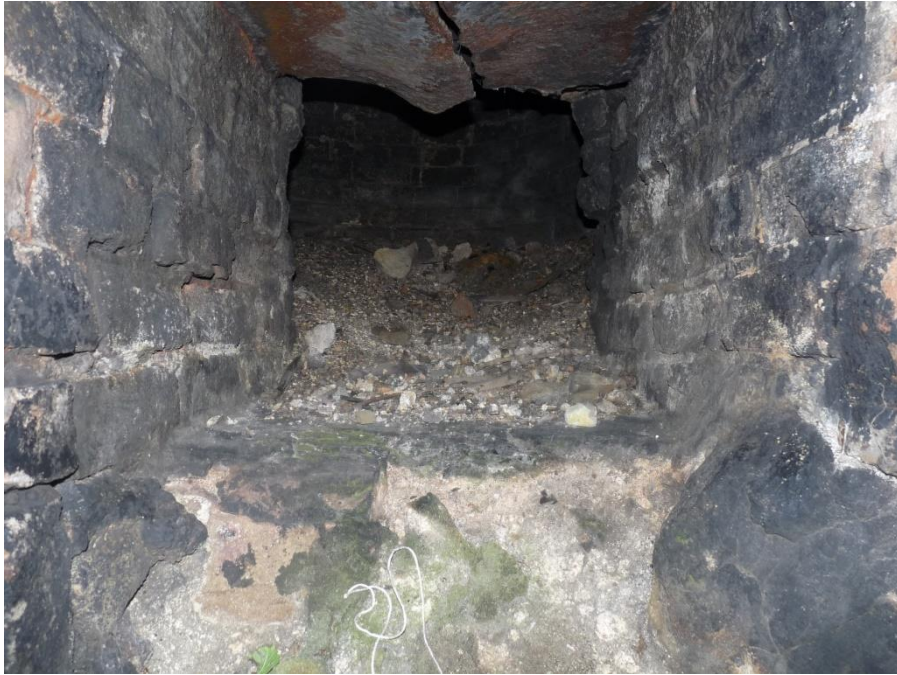
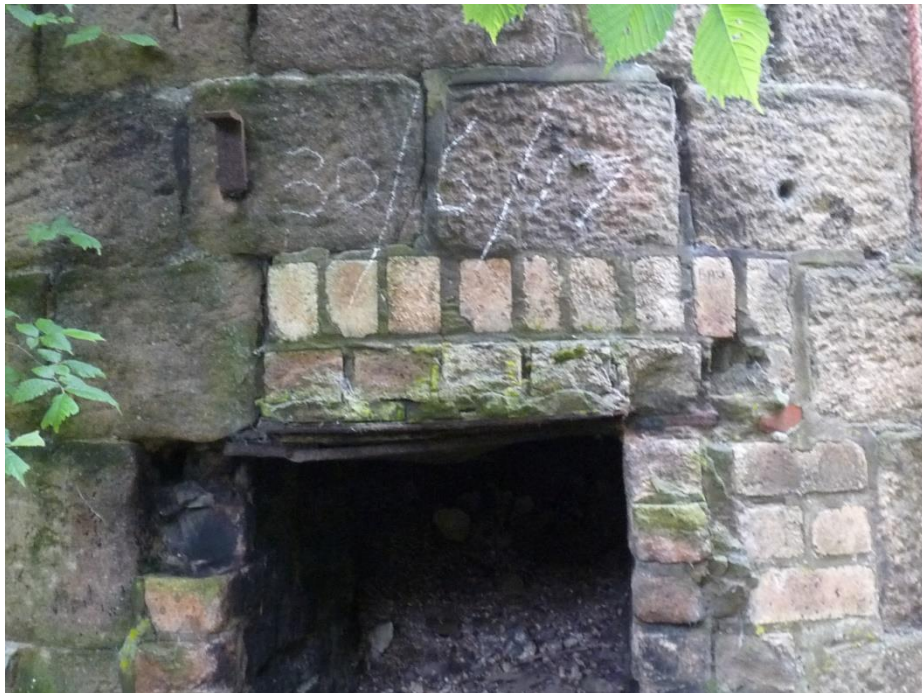
The open flue at the base has a cast iron plate, this has totally slip and corroded away.
