## St Peter's Church, Salisbury

### Preliminary Bat Roost Assessment

**SPCBAT01**

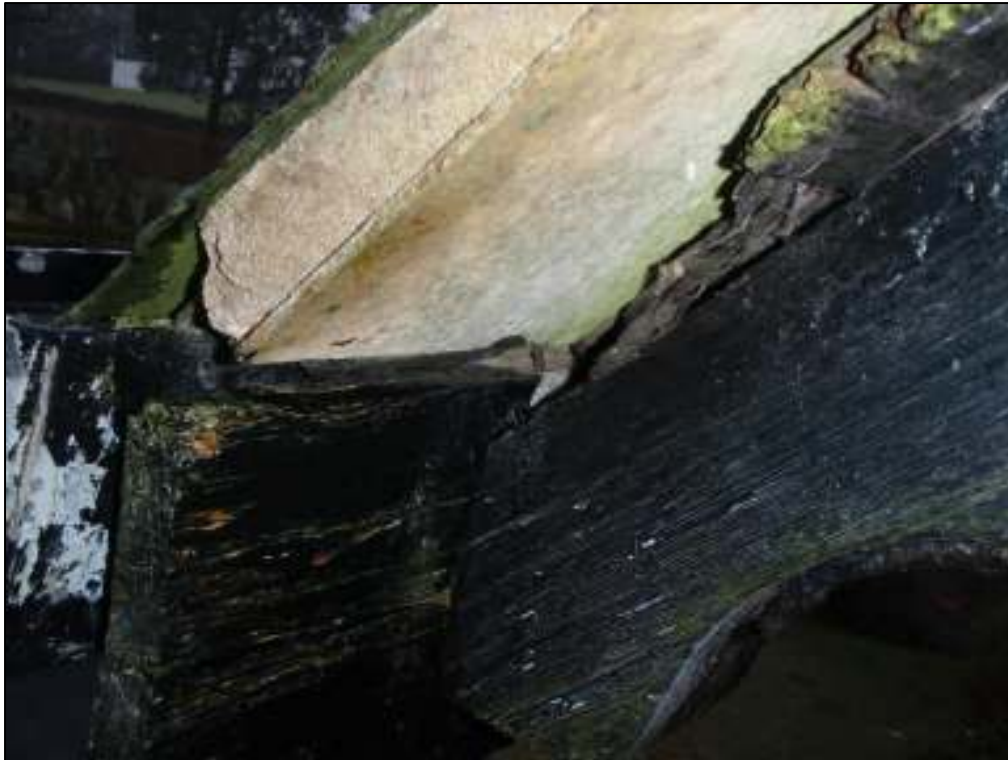
**1a:** Two gaps above bargeboards at the north-west corner of the western gable end

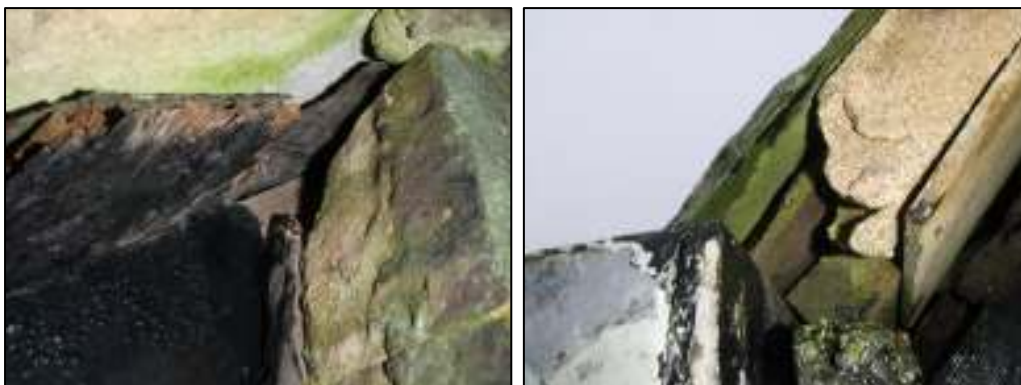
**1b and 1c:** Close up view of the two gaps above bargeboards at the north-west corner of the western gable end

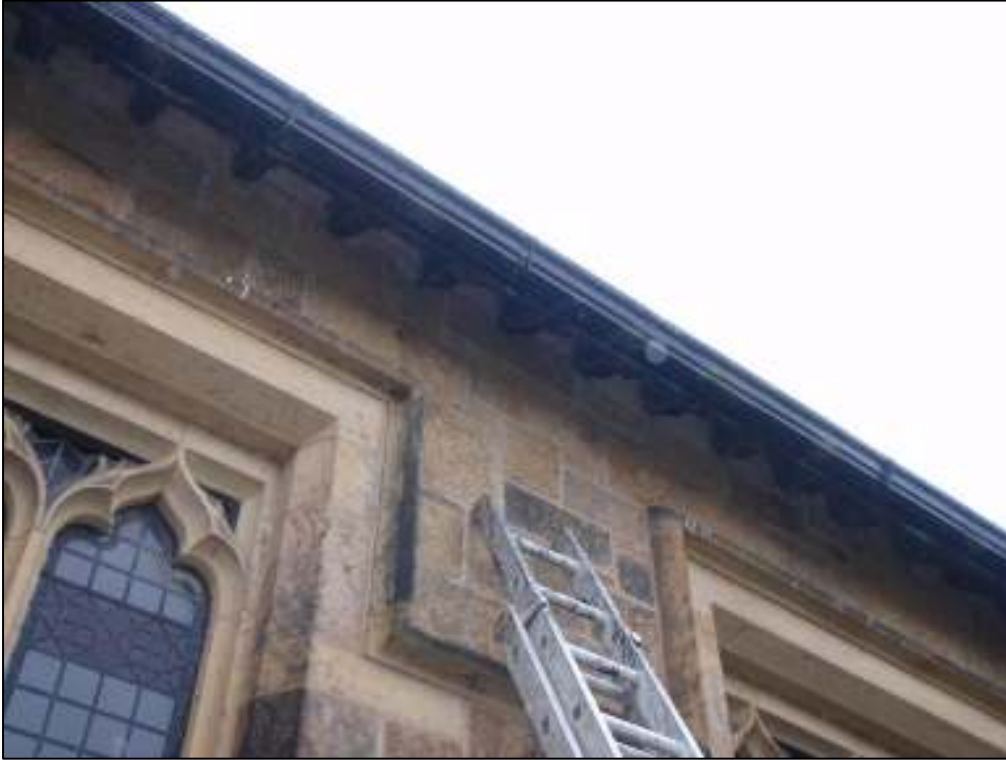
**2a:** North wall above second window (counting from the north-west corner of the church), showing the protruding rafter ends abutting the guttering

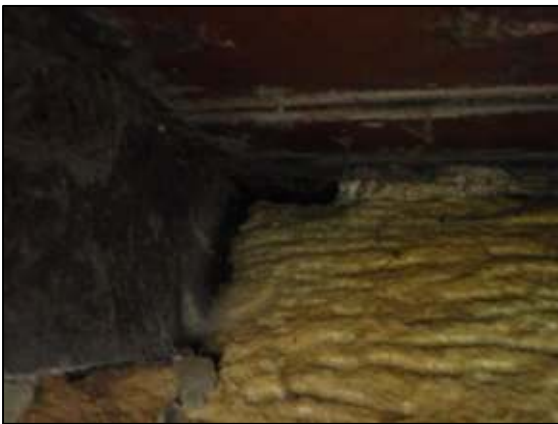
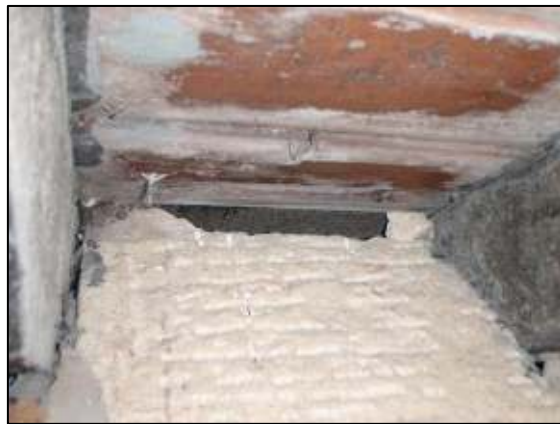
**2b and 2c:** Examples of gaps at top of north wall around second window, where mortar between the upper stones and the soffit and protruding ends of rafters has fallen out, giving access to a cavity

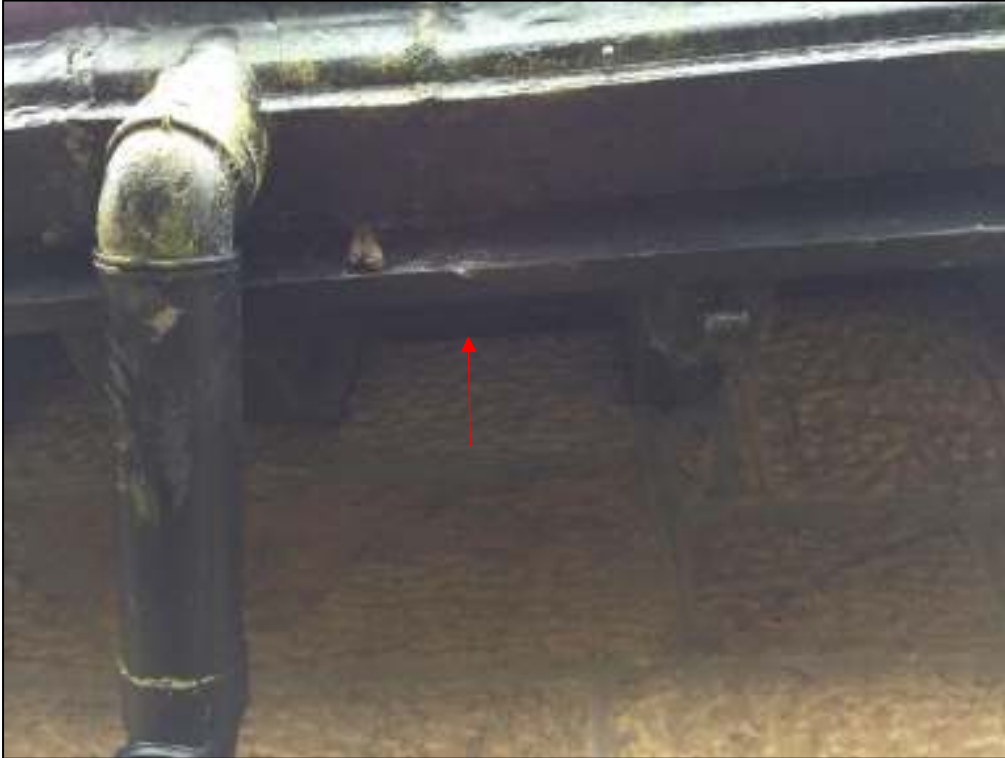
**3a:** 3.5 cm wide gap at join between wall and soffit, under main roof opposite choir vestry. Evidence of use by roosting birds (droppings visible in photograph)

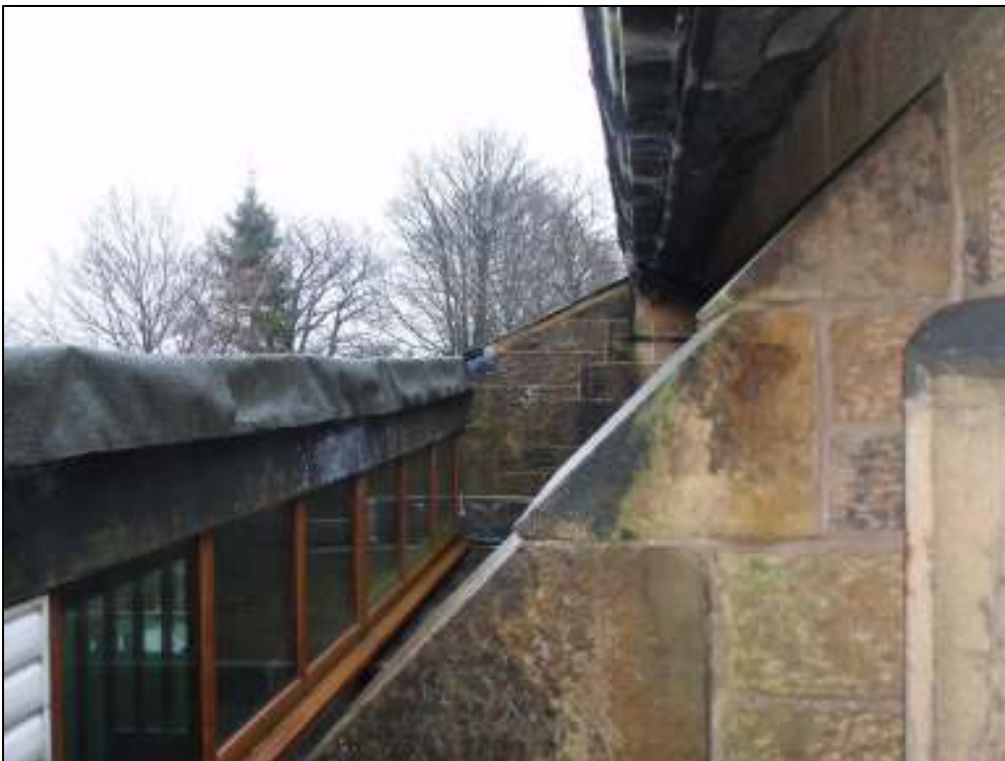
**3b:** looking along the gap between the main church roof (on the right) and the choir vestry roof (on the left). PRF 3 is located under the guttering/soffit of the main roof on the right; PRF 4 is located under the roof felt on the choir vestry roof on the left

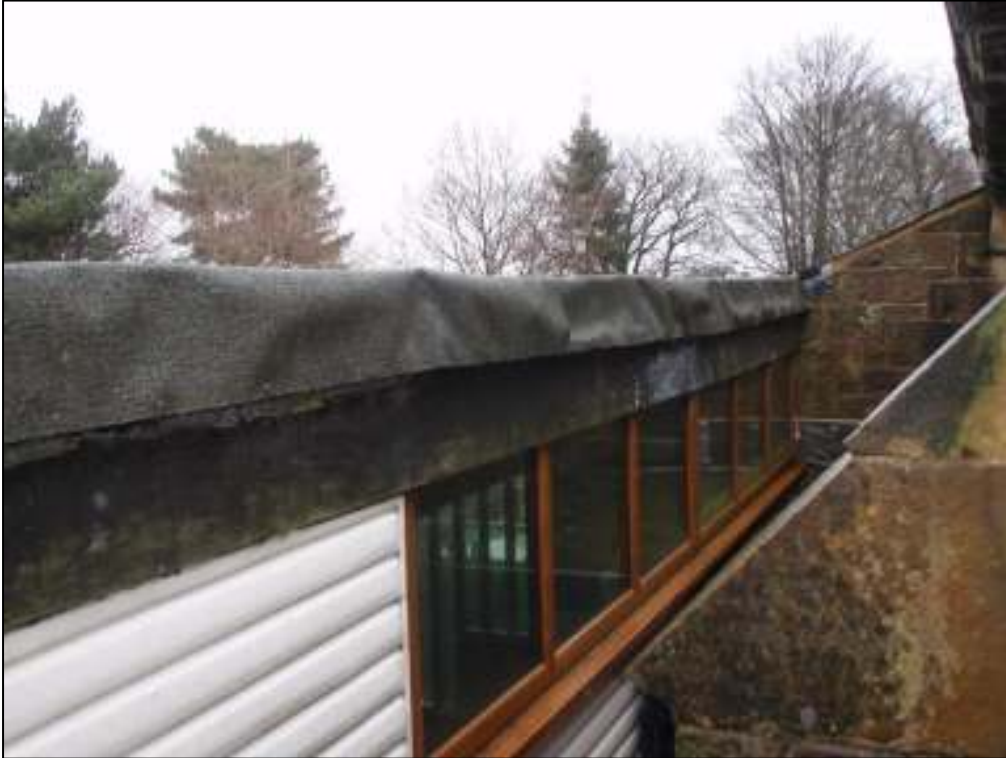
**4a:** Flat roof on choir vestry with roofing felt lifting, providing cavities in several places along this face

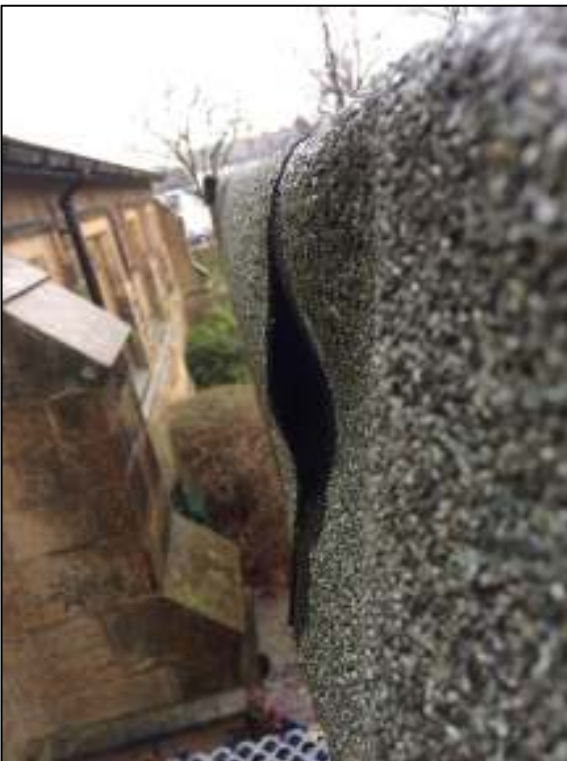
**4b:** Looking along the edge of the flat roof, showing the entry point into one of the cavities behind the roofing felt

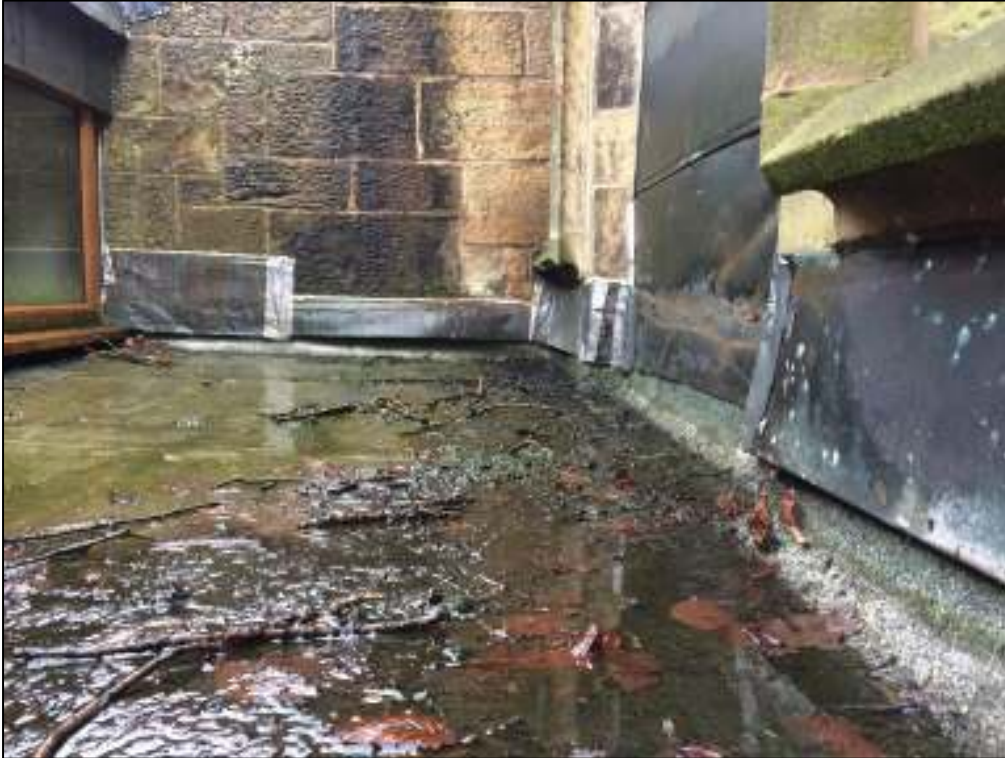
**5:** Lead flashing lifting in several places above the small flat roof between the choir vestry and the main church building

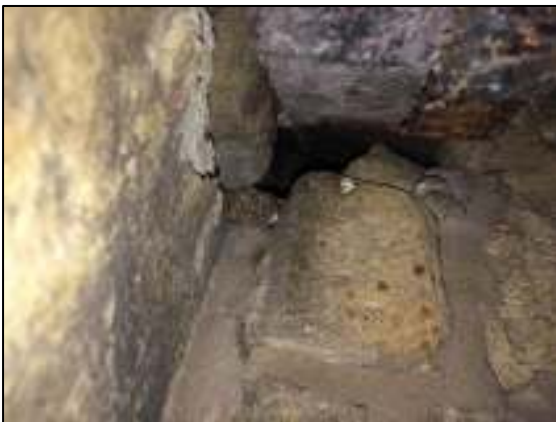
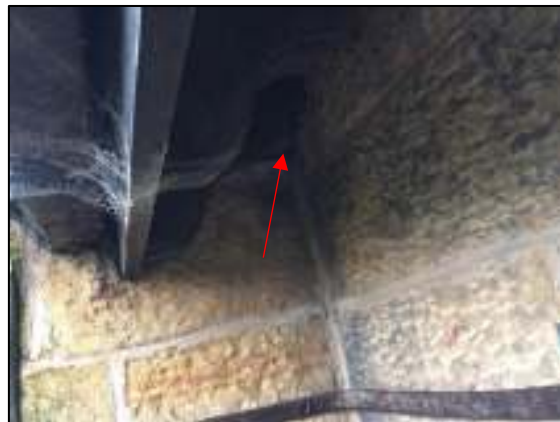
**6a and 6b:** Access point into roof underneath soffit at join between main church building and kitchen area, above the south-east corner of the flat roof behind the choir vestry

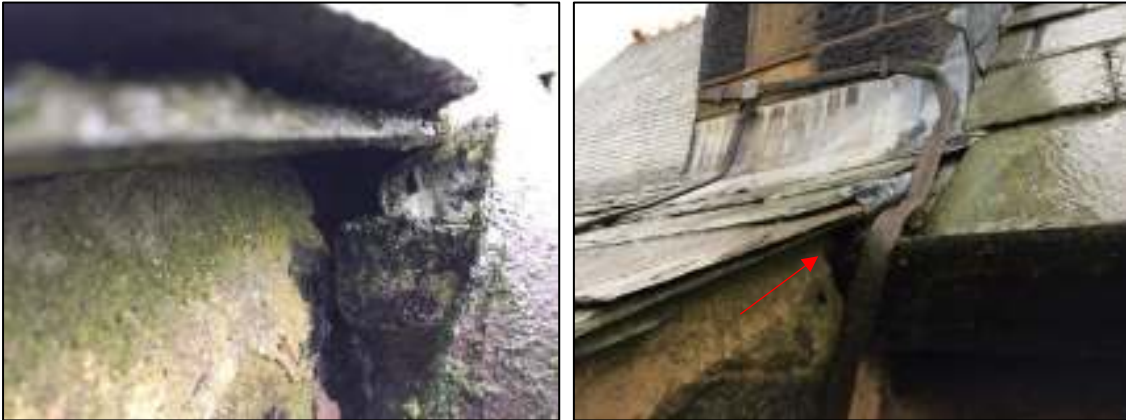
**6c and 6d:** Access point into roof underneath tiles, at join between main church building and kitchen area, above the south-east corner of the flat roof behind the choir vestry

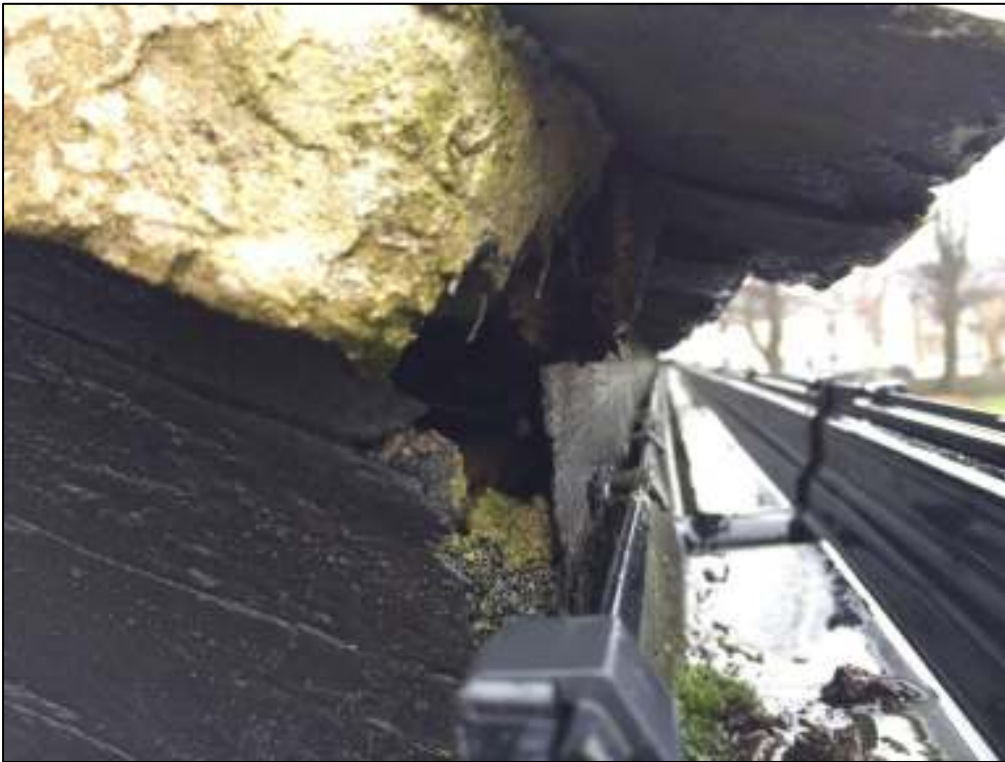
**8:** Hole in rotten fascia board at north-east corner of choir vestry roof, accessing cavity under roof tiles running along the north side of the choir vestry

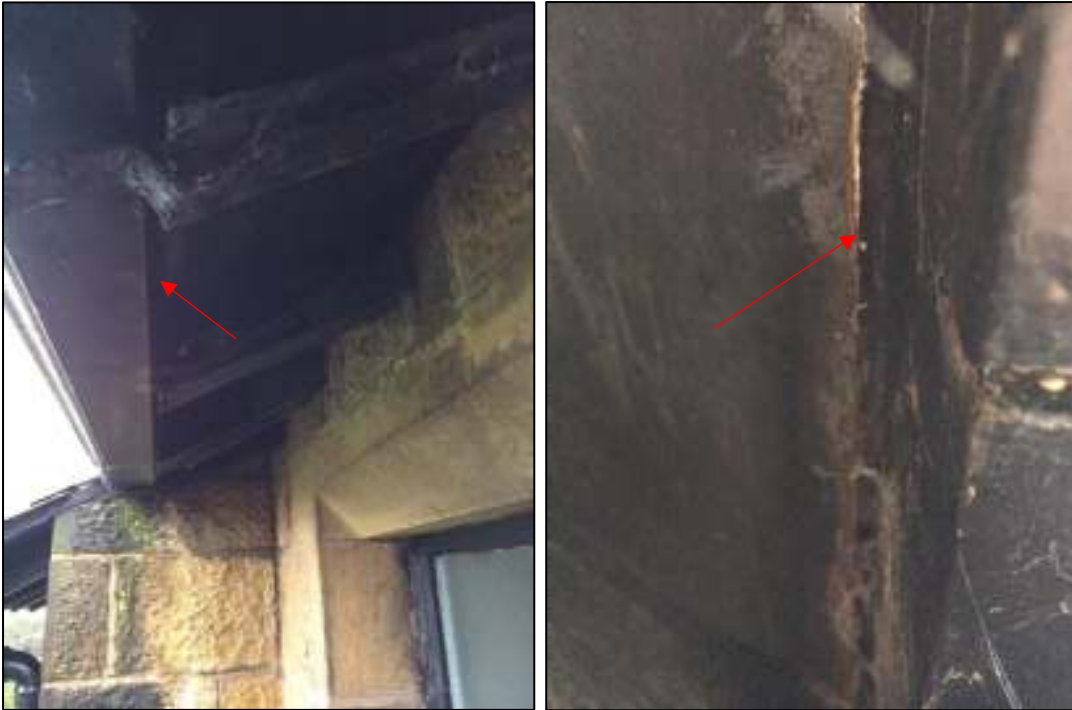
**10a and 10b:** Probable gap behind soffit along north side of kitchen roof, where soffit abuts guttering rather than fascia boards. 10a taken looking east, 10b taken looking west

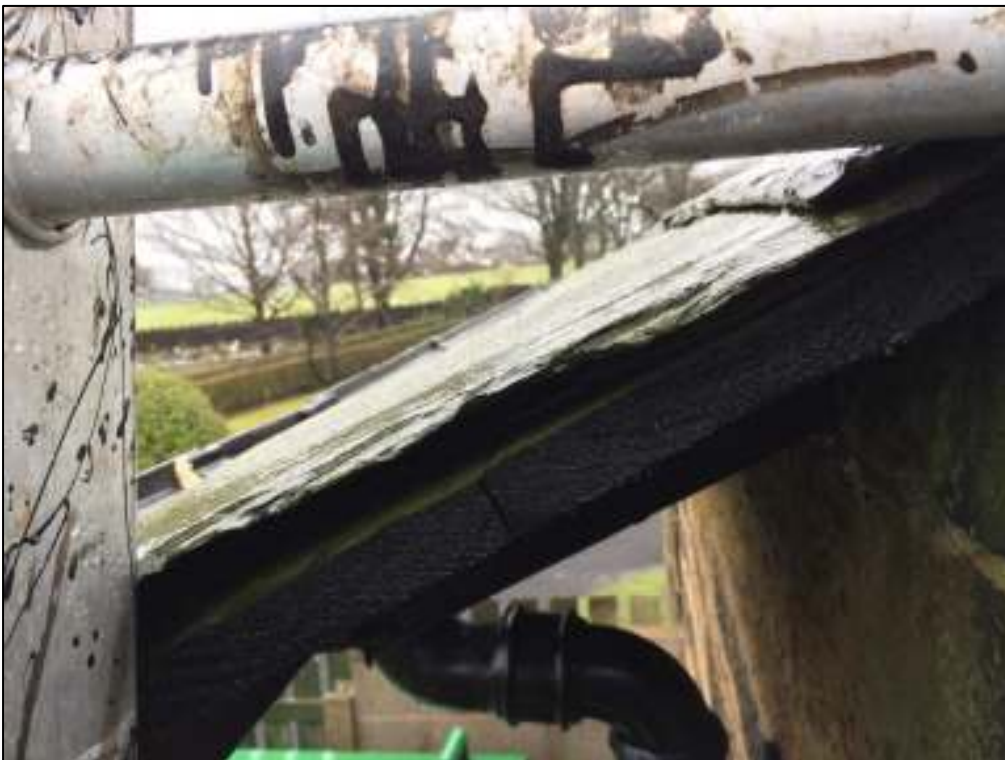
**11:** Sizeable gap under roof tiles at west end of the kitchen, creating potential roost space

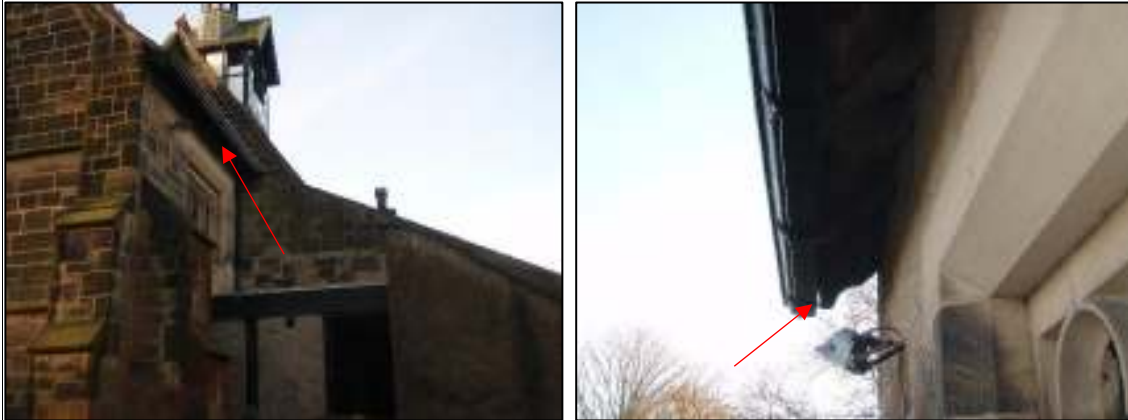
**12a and 12b:** Main church roof at north-east corner of church, with loose-fitting soffit creating gap between guttering and soffit boards. The gap can be seen against the sky in photograph 12b (marked by arrow)

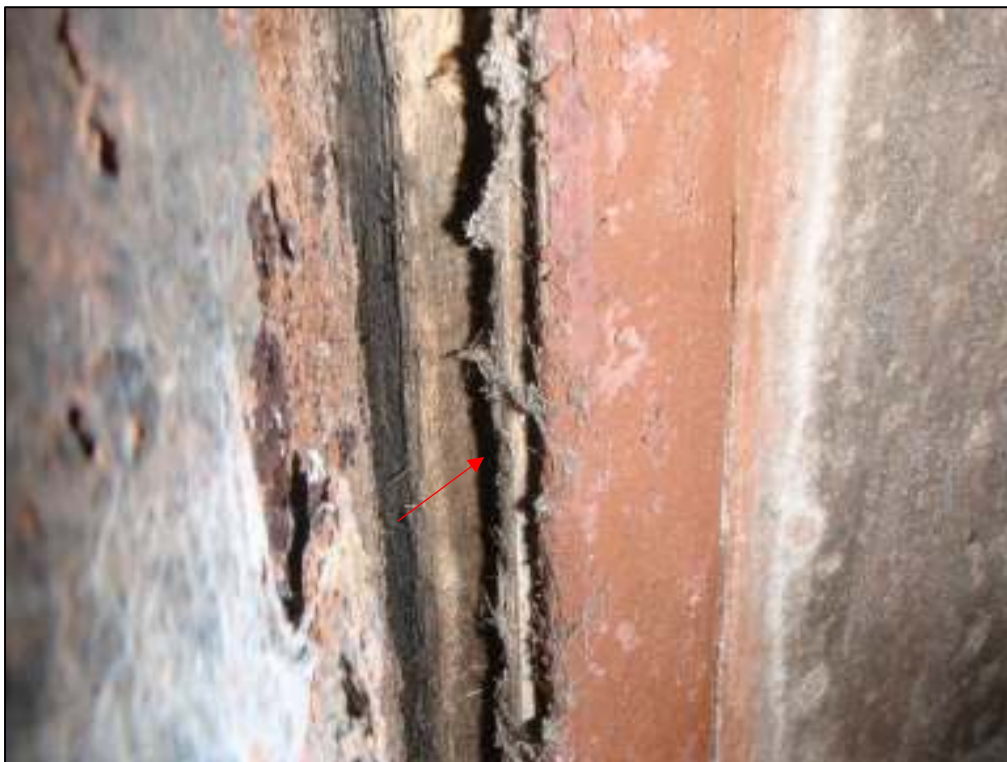
**12c:** Gap between soffit boards on right and guttering on left, marked by arrow, potentially leading into roof space

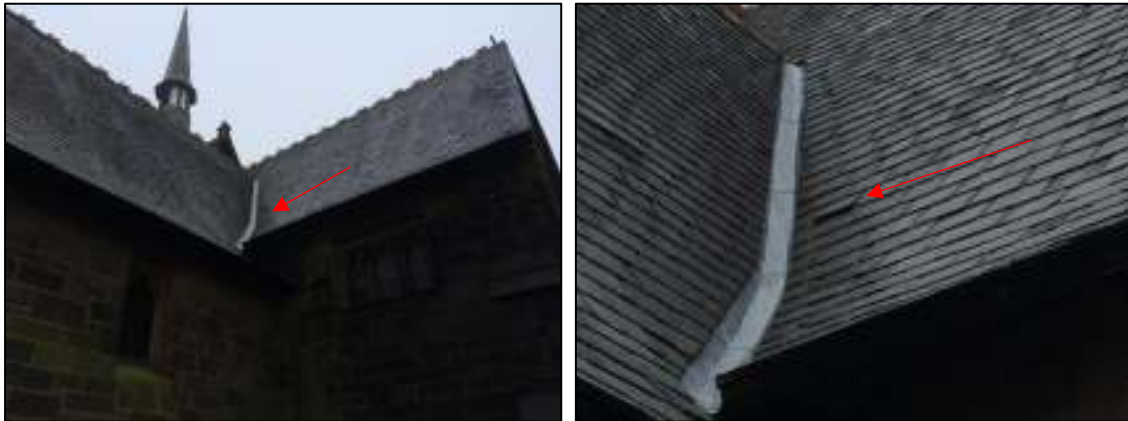
**13a and 13b:** Example of lifting roof slate on the main church roof, to the east of the Lady Chapel

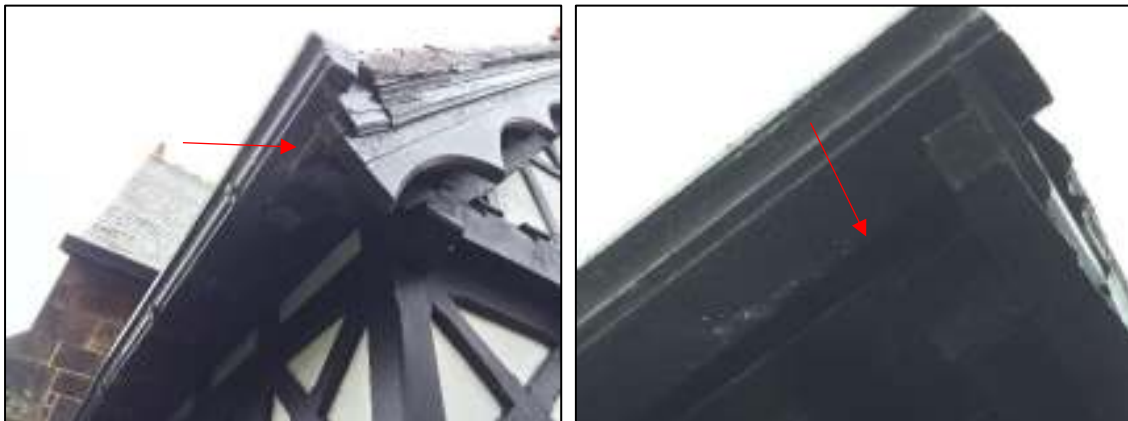
**14a and 14b:** Example of a large gap behind soffit, providing a potential access point into the roof space, at the south-west corner of porch on south side of main church building

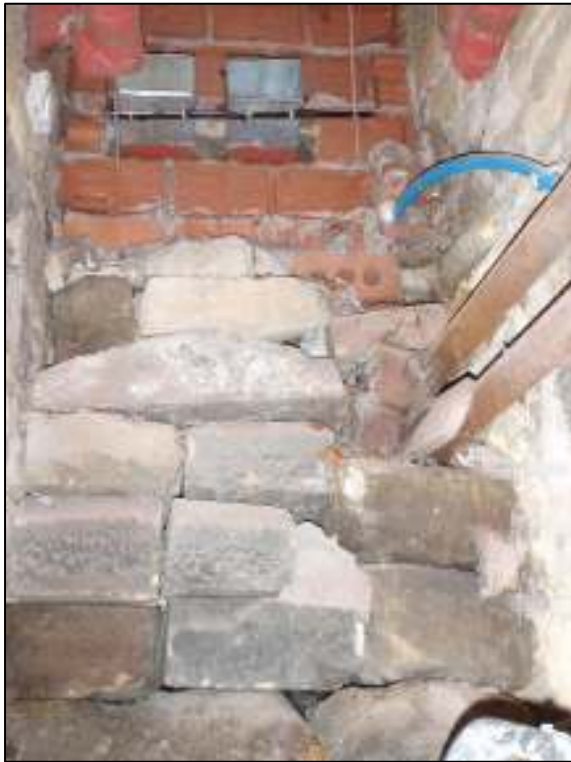
The boiler room contained two air vents with bat access potential (leaf build up was noted under these). The wall under these vents consisted of stones with little mortar and many cavities, offering PRFs for bats. A crevice in the stones forming the lintel over the air vents was also considered a PRF.

**15:** North wall of the boiler room, part of the cellar complex. The two metal tubes are vents to the outside, potentially passable by bats. The wall underneath the vents has very little mortar between stones and many cavities. With a warm, dry climate, external access and numerous PRFs, this room was considered highly suitable for roosting bats

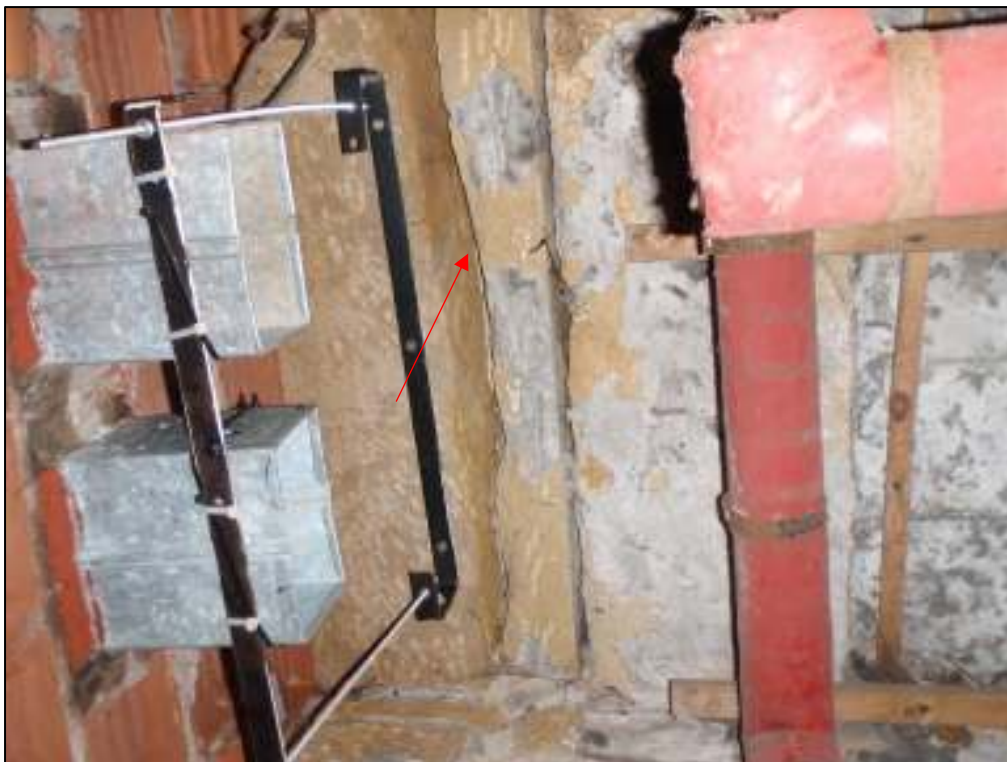
**16:** Lintel above the air vents in the north wall of the boiler room, with a crevice forming a PRF

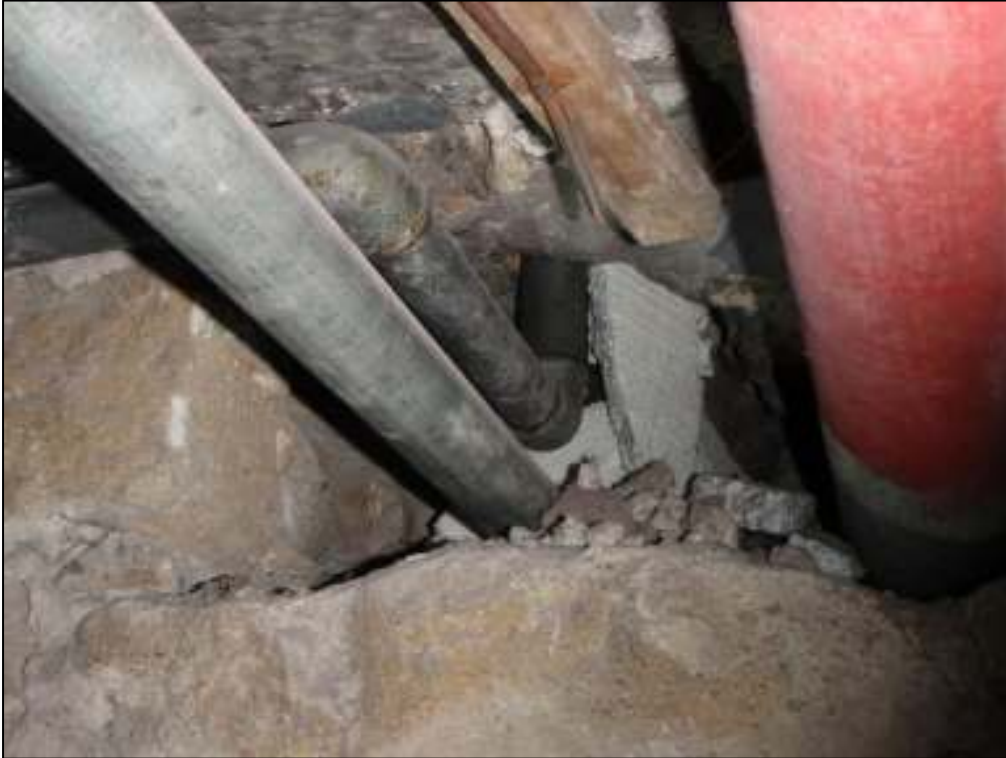
The other walls of the boiler room also contained PRFs, including holes between stones leading into the wall space. Where piping led through the walls between rooms, it was noted that the insulation used in the gaps around the pipes consisted of polystyrene chunks rather than expanding foam insulation, allowing potential access for bats into the walls.

**17:** Pipework entering the west wall of the boiler room. Insulation in the pipework cavities consisted of pieces of polystyrene rather than expanding foam type insulation, allowing potential bat access into the walls

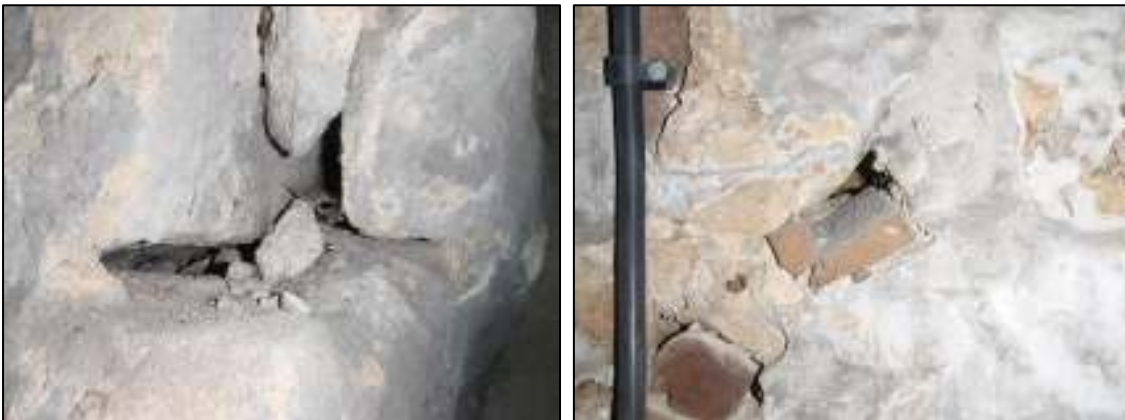
**18a and 18b:** Examples of cavities in the east wall of the boiler room, giving access into the wall space

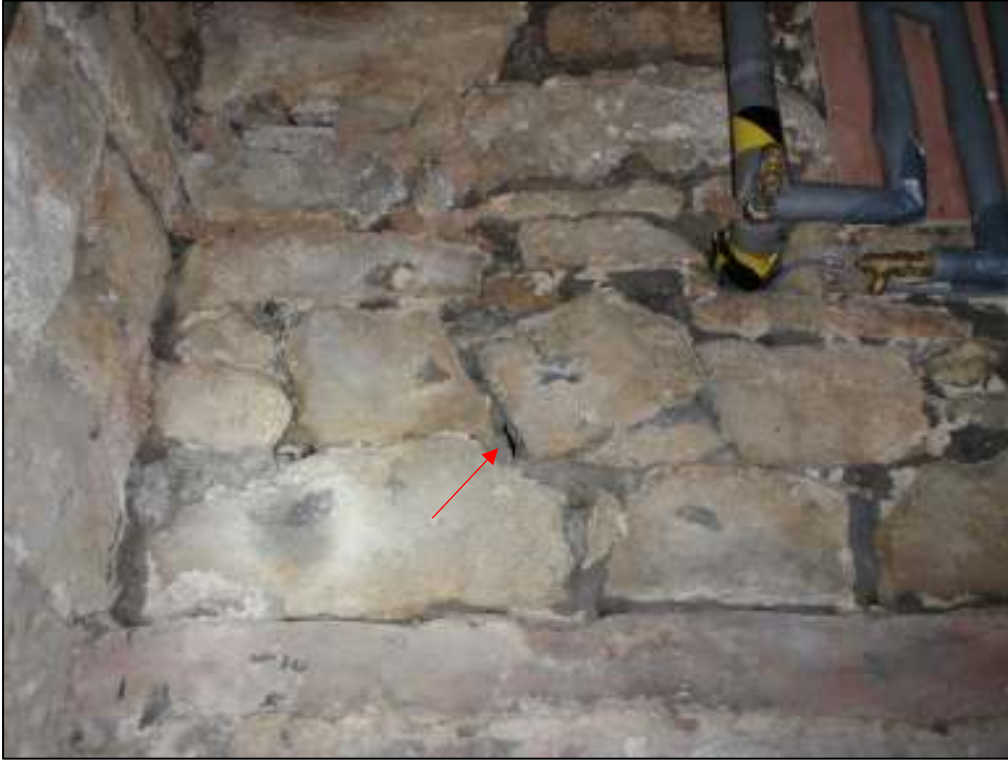
PRFs were also noted in the walls of the main cellar and side cellar, consisting of cavities between stones leading into the wall space, and entry points where pipes pass through the walls. Photograph 19 in Appendix 2 shows an example of these.

**19:** Wall in the side cellar, with cavities between stones providing potential bat access into the wall

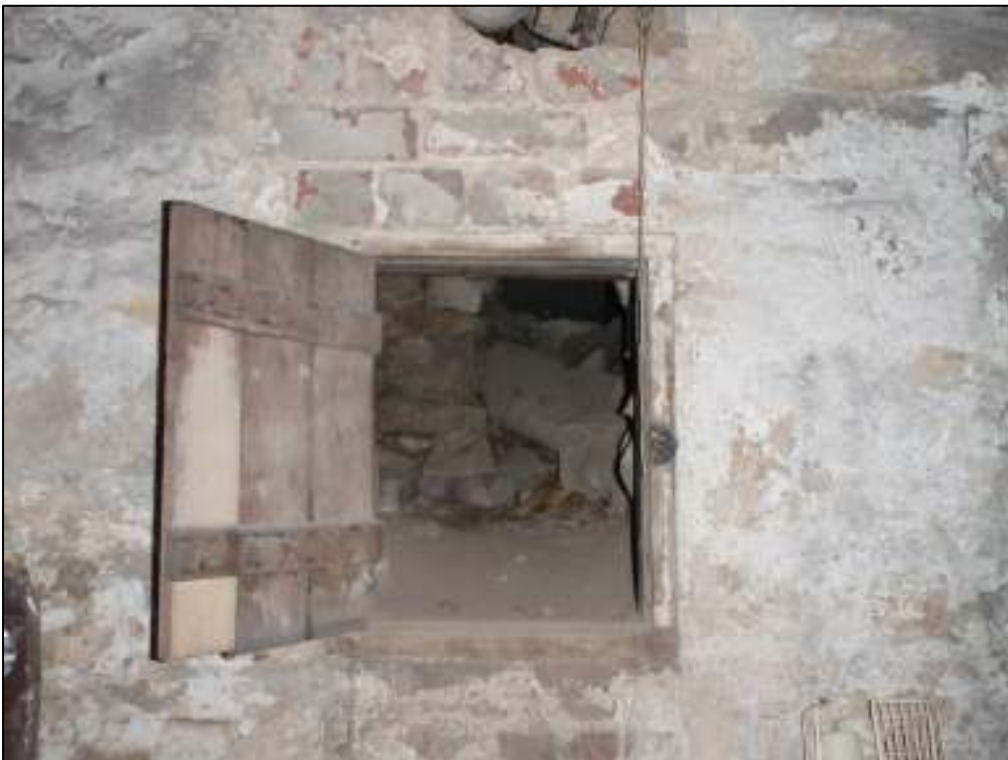
**20:** Door leading from the side cellar into the undercroft. This door was ajar at the time of the survey, and other cavities around the pipework etc. suggest that bats could move between the undercroft and the cellars

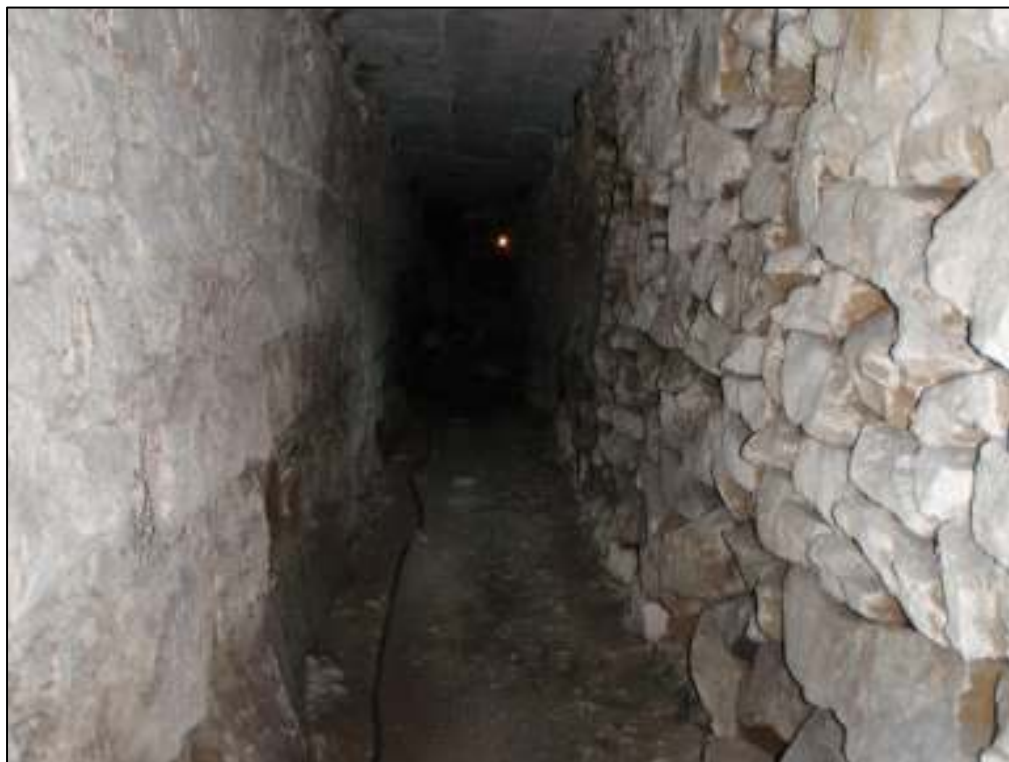
Within the undercroft, no evidence of bats was noted. Some of the walls within the undercroft were not well pointed, and provided PRFs for bats between the stones. In some places, cavities allowed wall spaces to be accessed. Photograph 21 in Appendix 2 shows an example of a wall with bat roost suitability in the undercroft.

**21:** Looking along a section of the undercroft. The wall on the right, without extensive pointing, was typical of some areas and provided PRFs for bats and, in places, cavities accessing the wall spaces

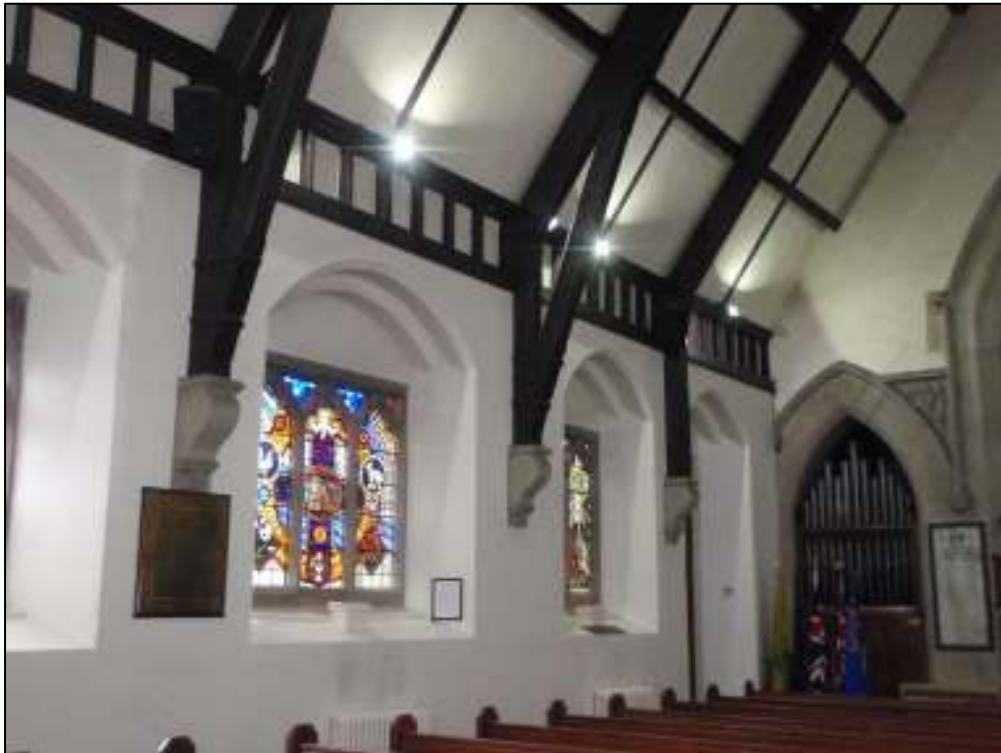
The main interior of the church offered few opportunities for roosting bats. Internal walls were well finished and maintained, and the window panes and traceries were well fitting, with no opportunity for bat access noted. Photographs 22 and 23 in Appendix 2 show the main interior of the church.

**22:** View of the interior of church, looking along the north wall. Internal walls were well finished and maintained, with little opportunity for bat access

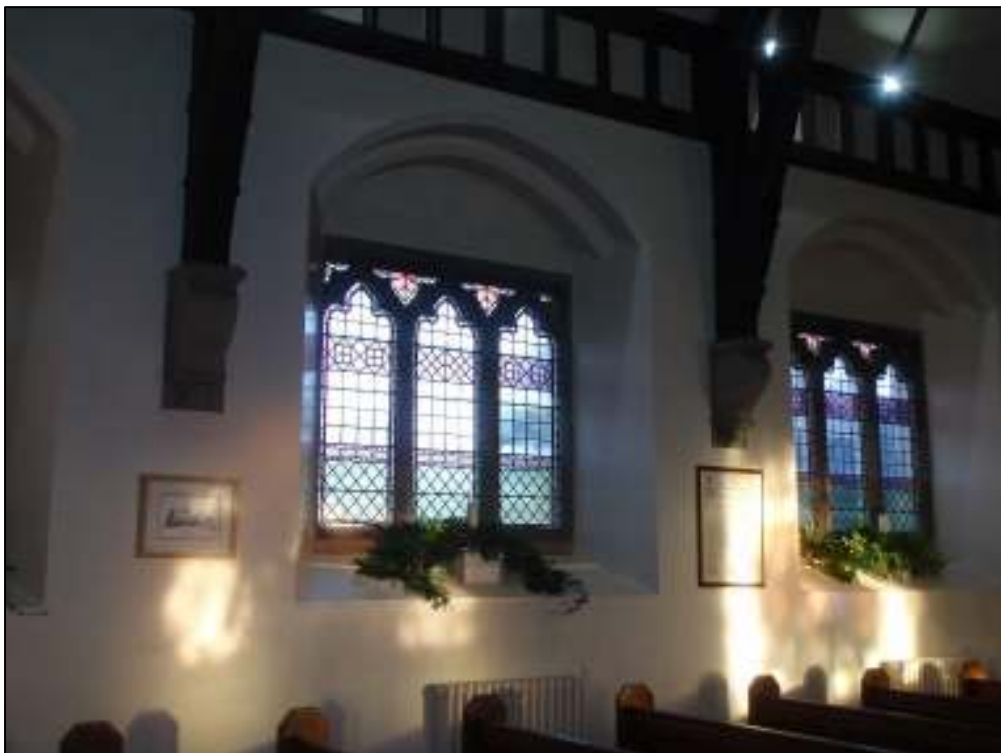
**23:** The second window in the north wall, counting from the west. This window will be removed to enable access from the main church building to the proposed development. The panes and their surroundings were well fitting, with no opportunity for bat access noted

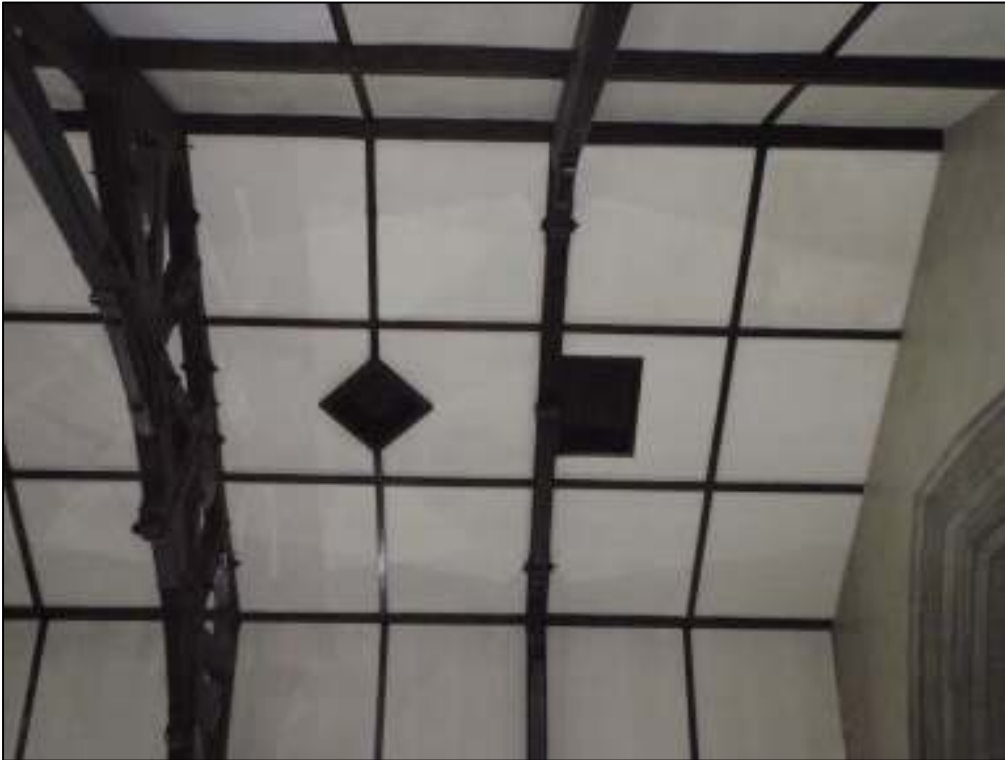
**24:** Two hatches leading into the upper roof space and providing access to the church spire. These were not accessed during the bat roost suitability survey, as scaffolding would be required

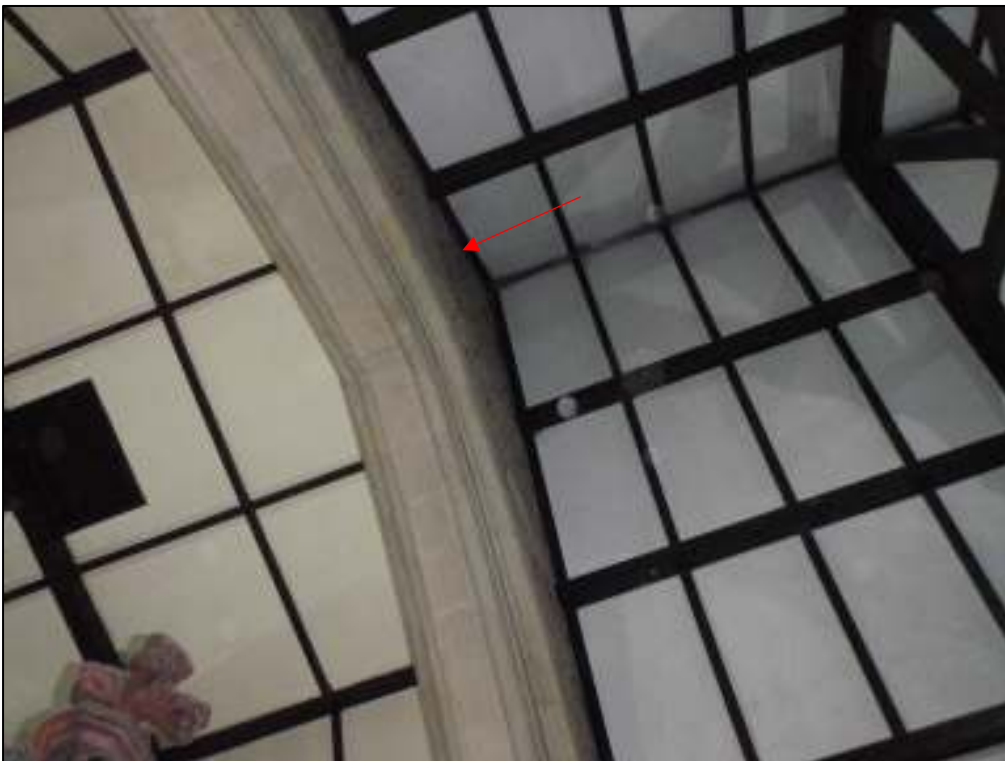
The roof of the nave, choir stalls and altar was inspected with binoculars. Access to the roof space itself was not possible, as scaffolding would be required (see Photograph 24, Appendix 2). Few PRFs were identified, the exception being the junction between the choir stalls and the nave, where it was noted that the timbers on the roof above the choir stalls were not sat flush with the stone arch, creating a possible roost space (see Photograph 25, Appendix 2).

**25:** At the junction between the choir stalls and the nave, it was noted that the timbers on the roof above the choir stalls were not sat flush with the stone arch, creating a possible roost space. This was too high to examine, but based on the condition of the church interior, access into the roof space is unlikely

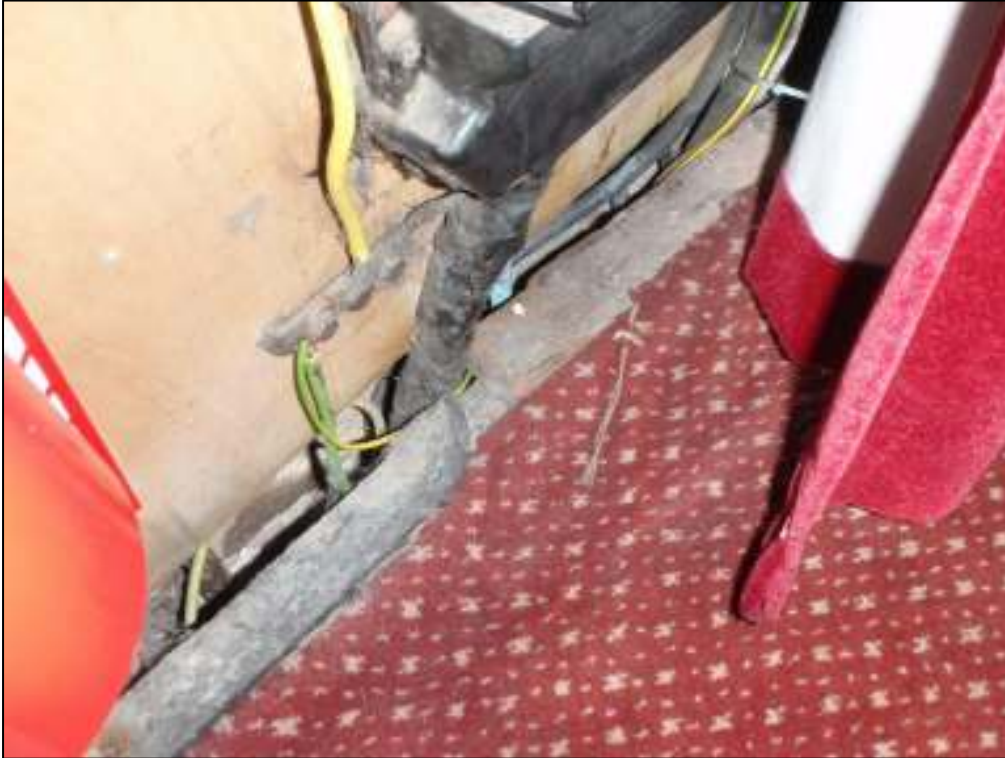
Access points from the main church interior into the undercroft were noted at two locations where cables and pipes passed through: by the Churchwardens' pew in the south-west corner of the main church building, and at the base of the west wall of the Lady Chapel. Potential access into a roof space was also noted in a cupboard adjacent to the toilet, at the north-east of the church building. These features are shown in Photographs 26-28 in Appendix 2.

**26:** Access point into the undercroft where electric cables pass through floor, by the Churchwardens' pew in the south-west corner of the main church building

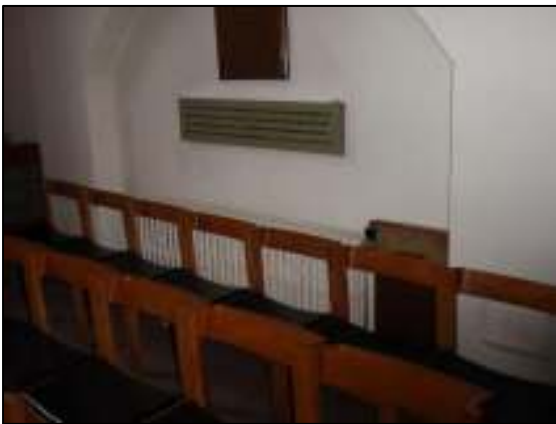
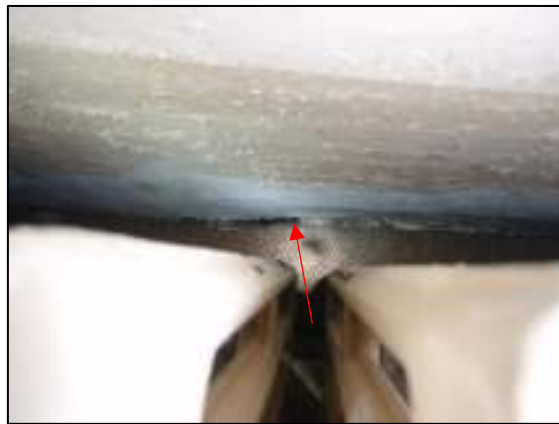
**27a and 27b:** West wall of the Lady Chapel, with an access point into the undercroft at the base of the radiator (shown on the right-hand photograph)
