## St Peter's Church, Salisbury

### Preliminary Bat Roost Assessment

**SPCBAT01**

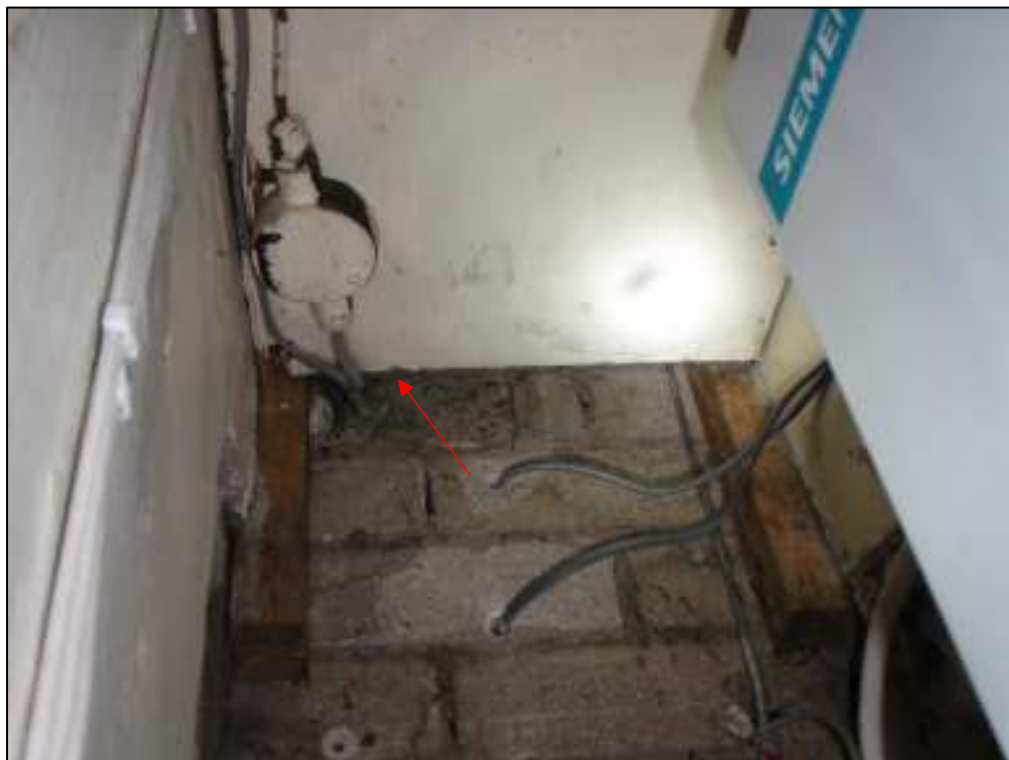
**28:** Access into the roof space at the north-east corner of a cupboard adjacent to the toilet, at the north-east of the church building

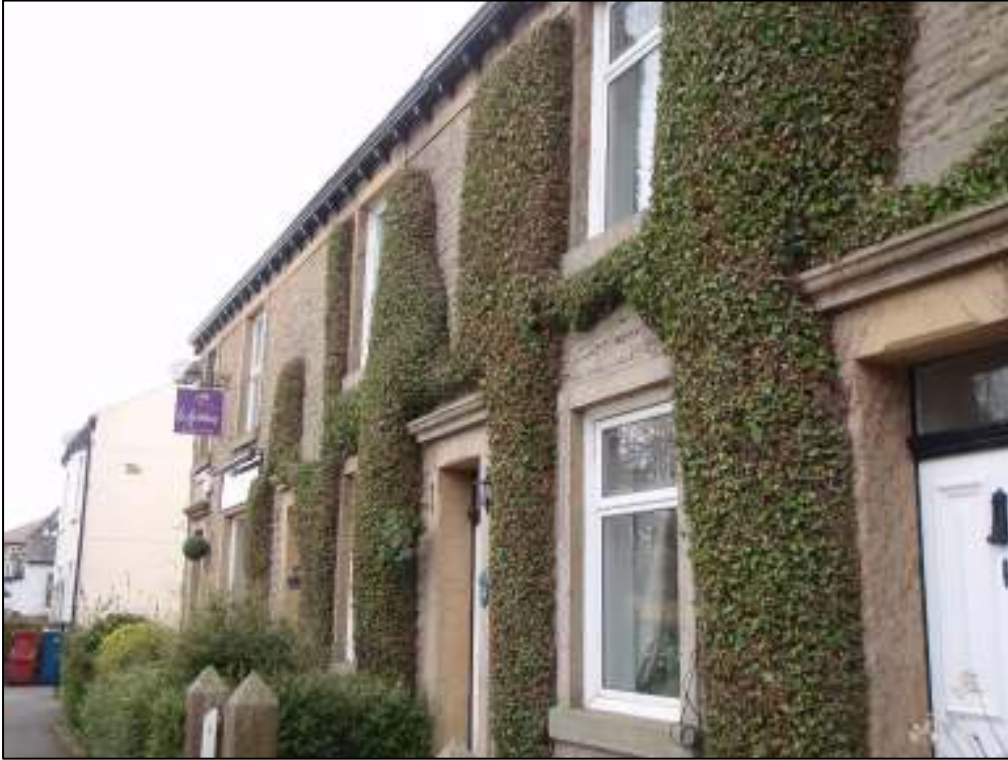
The adjacent residential buildings include some buildings pre-dating the church itself, as well as more modern buildings, and these may also offer potential roosting sites for Pipistrelle species. These buildings were not inspected for PRFs, but it was noted that the row of terraces on the west of Lovely Hall Lane, opposite the church, had walls covered in dense shrubbery, which may provide suitable bat roosting habitat (particularly for single males or small groups in the summer). This row is shown in Photograph 31 in Appendix 2.

**31:** Part of the row of terraced houses on the west side of Lovely Hall Lane, opposite the church. No checks for PRFs were carried out here, but it was noted that the dense shrubbery on the walls offered shelter and potential roosting habitat for bats
