Jon Oliver Arboriculture

Client: Mr G Blezard

– The Woodlands, Hothersall Ln PR3 2XB

Arboricultural Impact Assessment

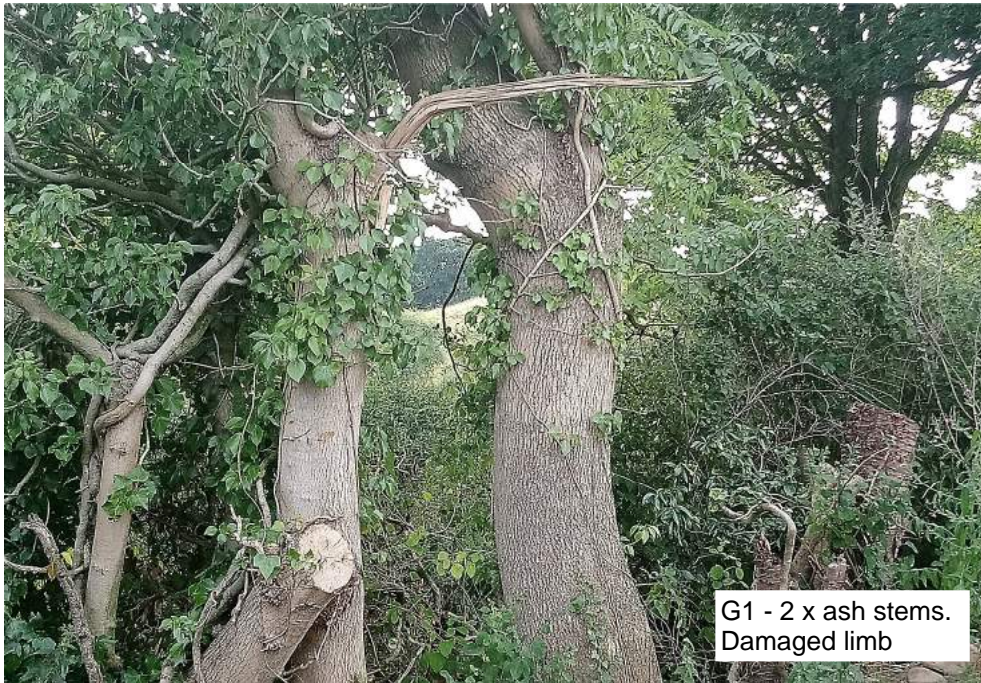
G1 - 2 x ash stems.
Damaged limb

G1	Fraxinus excelsior (Ash)	M	<400	10	5	5	5	5	4	Fair	20+	2 x ash. 1 ash multi-stemmed. Ivy. Pruning wounds on smallest stem	Sever ivy. Tidy pruning wounds. Monitor for decay	4.8	72.39	C2
G2	Fraxinus excelsior (Ash), Crataegus monogyna (Hawthorn), Cypress, Ulmus glabra (Wych Elm), Acer pseudoplatanus (Sycamore)	M	max est 600	12		4	4	5	4	Fair	20+	Unmaintained boundary trees. 3 x dead stems. Deadwood. Poor form	Remove dead stems and deadwood. Consider removal of 2 cypress. Monitor vigour and maintain as required	7.2	162.88	C2
T3	Crataegus monogyna (Hawthorn)	M	350	9	2	4	3	3	2	Good	20+	Minor deadwood in crown	Monitor vigour	4.2	55.42	C2
T4	Acer pseudoplatanus (Sycamore)	M	420	12	7	5	4	2	3	Poor	10+	Low vigour. Sparse crown. Some deadwood	Monitor vigour	5.04	79.81	C2
T5	Quercus robur (Common Oak)	M	est 600	9	4	5	3	6	7	Good	20+	Epicormic growth at base of stem. Minor deadwood. Close inspection of main stem not possible. Presence of such extensive epicormic growth throughout the crown would indicate the tree is potentially under stress. Top of main leader appears to be decayed. Possible storm damage?	Monitor vigour	7.2	162.88	C2

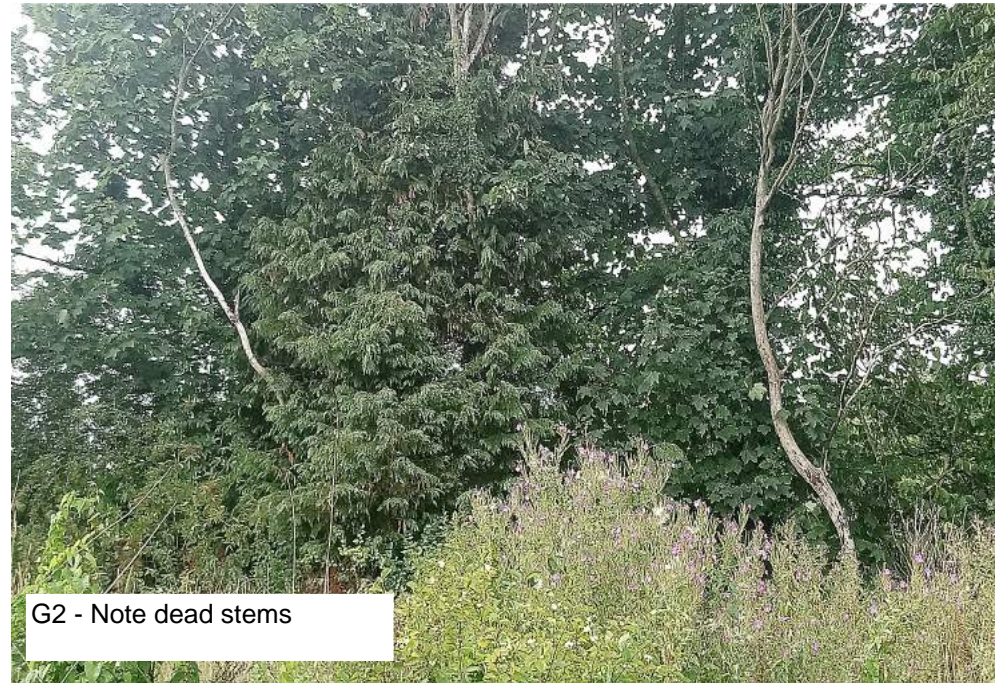
- 4.2.3 G2 is positioned on the northern boundary. This is an unmanaged group of trees that contains some small dead stems and two larger cypress. It is recommended that these dead stems and the two cypress are removed in addition to other remedial works. The RPA of this group will have been confined by the existing garage and hard standing area that has been created for vehicles.

G2 - Note dead stems

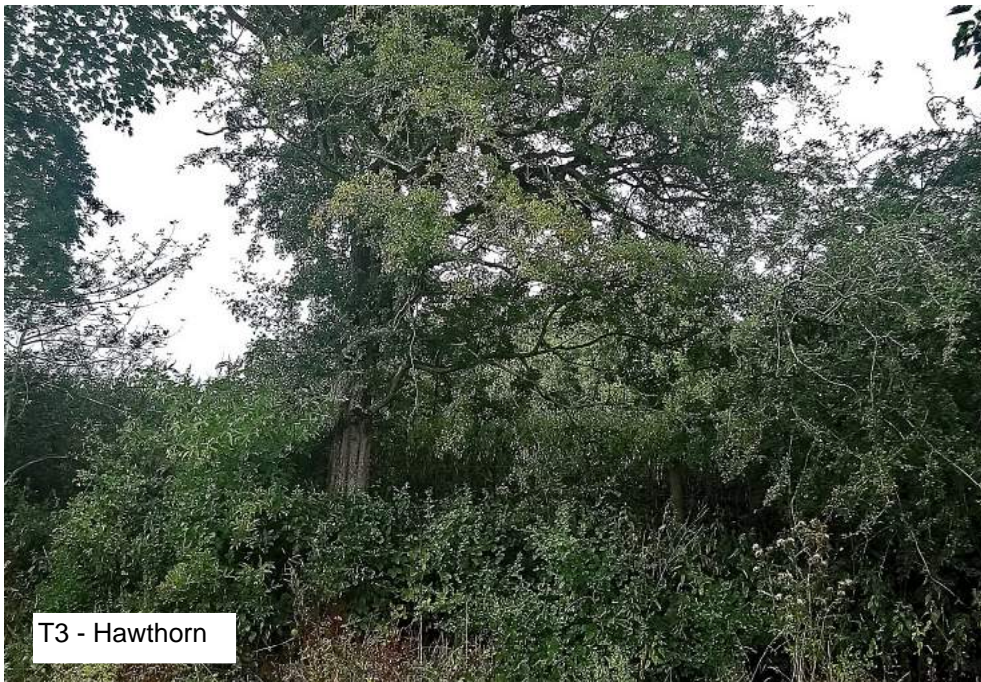
T3 - Hawthorn

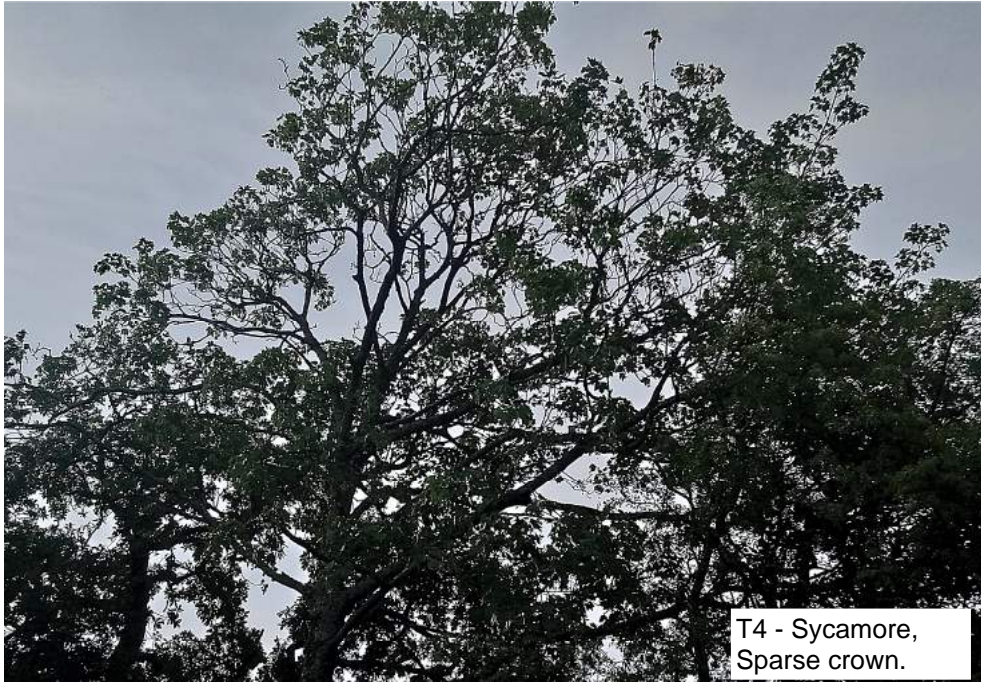
- 4.2.4 T3, 4 and 5 are growing in close proximity on the northern boundary. There is evidence of stress with these trees. T4, sycamore, has poor taper and a very sparse crown and T5, oak, appears to be stunted with significant epicormic growth around the mainstem and throughout the crown. Regular monitoring of these trees for reduced vigour is recommended.

T4 - Sycamore,
Sparse crown.

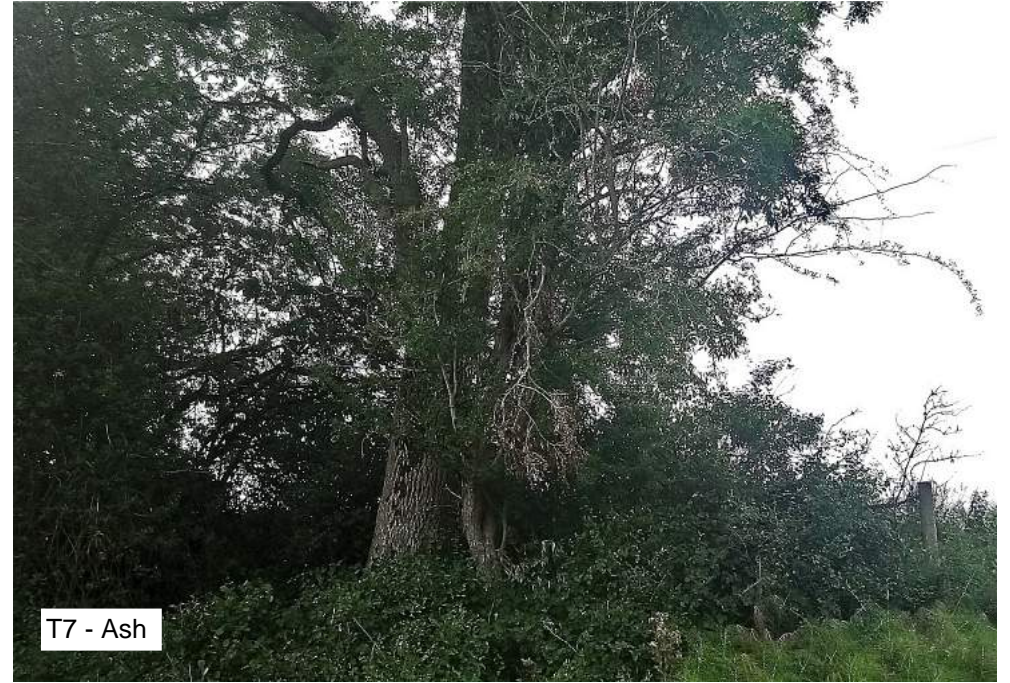
T6	Crataegus monogyna (Hawthorn)	M	est 250	7		2	3	2	2	Fair	10+	Some damage on branches and main stem. Die-back in crown. Suppressed by T7	Monitor vigour	3	28.28	C2
T7	Fraxinus excelsior (Ash)	M	est 700	16	5	6	6	6	6	Good	20+	Growing on banking. Minor die-back in upper crown. Failed limb high on main stem at approximately 12m	Monitor vigour	8.4	221.7	B2

T7 - Ash

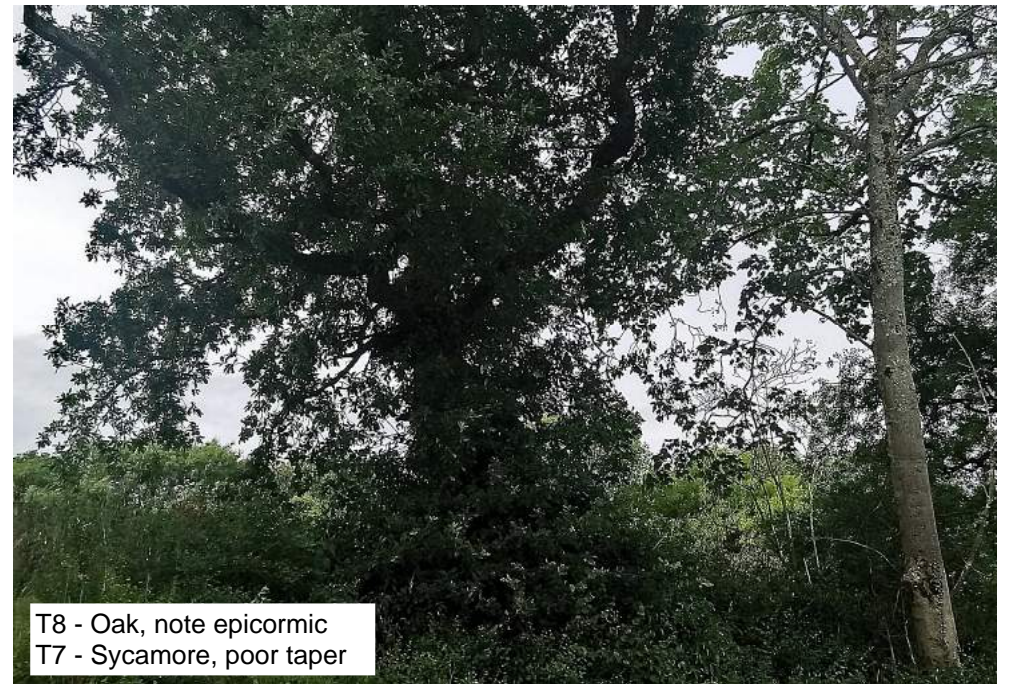
T8 - Oak, note epicormic
T7 - Sycamore, poor taper
