TREE REPORT

Resistograph & aerial Survey
of 2 Beech and a Horse
Chestnut Tree's at Beech
Grove Residential Home,
Clitheroe, BB7 2LS.

Report highlighting the silvicultural issues with 2 Beech Trees and a Horse Chestnut Tree at Beech Grove Residential Home, St Pauls Street, Clitheroe, Lancs, BB7 2LS. With recommendations for the removal of the 2 Beech's and crown reduction of the Horse Chestnut.

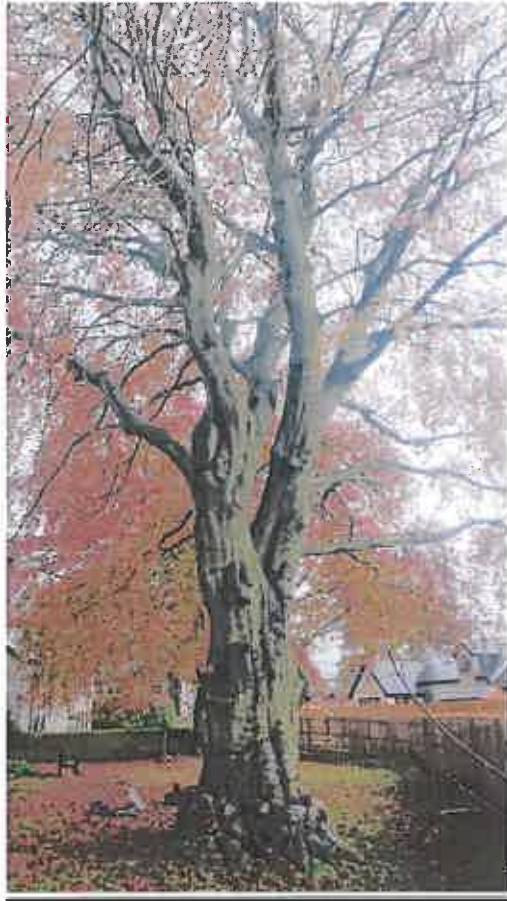
Tree T3 (note lower grafting collar)

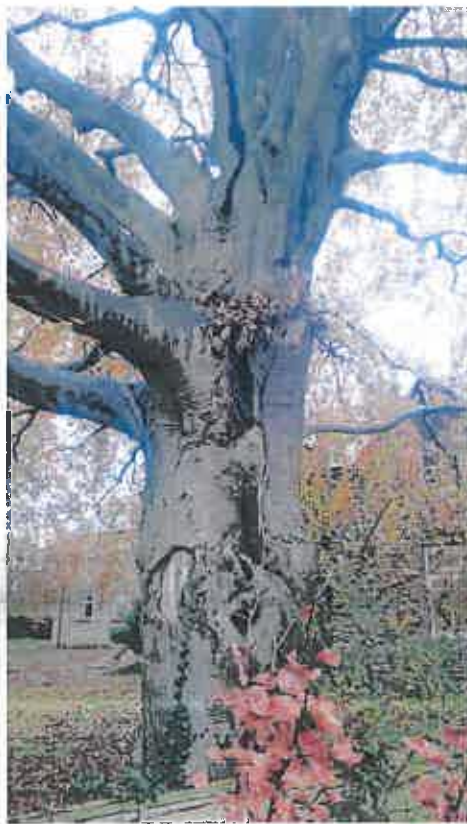
Tree T2; note tears at 2 and 5 metres

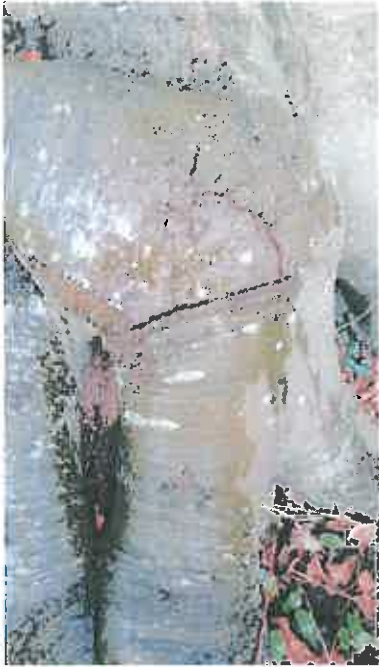
Tree T3; illustrating cambial growth stress from the historical grafted root stock

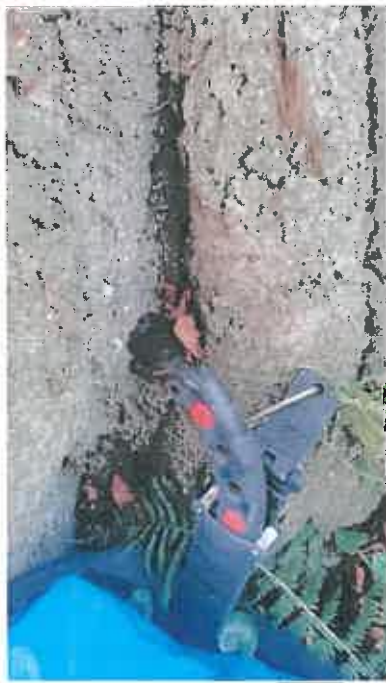
Tree T3 Eastern main stem, fungal presence.

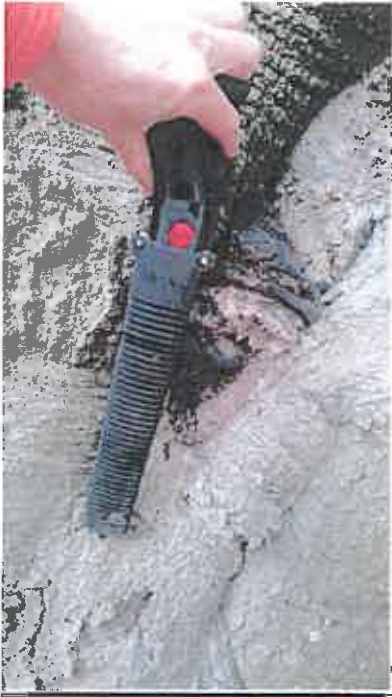
Tree T3; Eastern main stem, fungal presence.

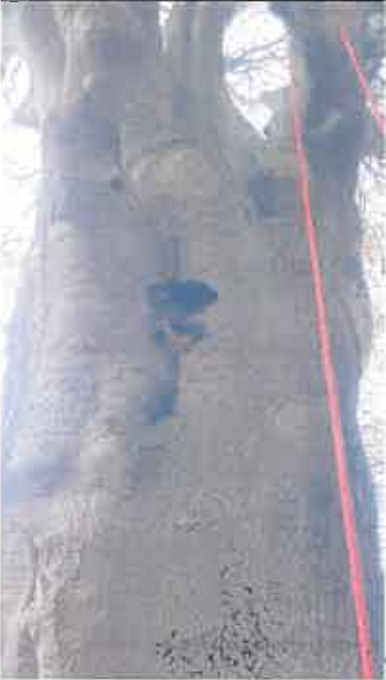
**Tree T3; Eastern Main stem, fungal presence
4metres above ground.**

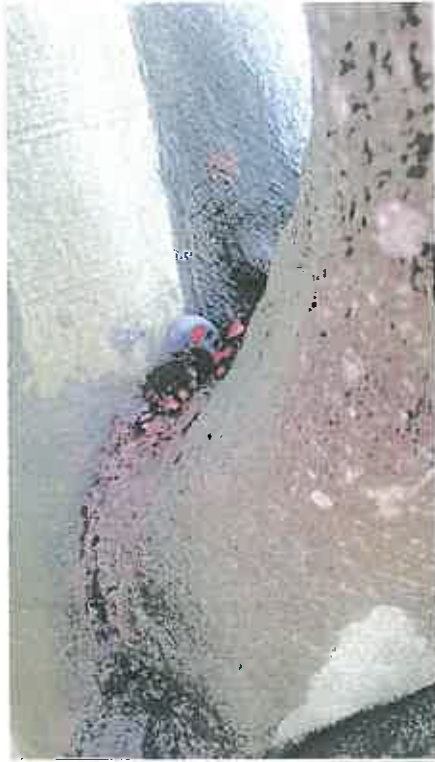
- iii) The aerial inspection of tree T2 (copper beech) highlighted extensive decay pockets occurring within the main stem forked inclusions. The updated BTC report highlights the findings as such; "Aerial inspection of stem bifurcation, substantial included union with cavity in junction probed to 400mm. Aerial inspection of south primary branch junction, substantial included union with cavity in junction probed to 200mm." A large Ganoderma bracket was also found in an un-occluded wound at 5 metres as highlighted in the initial BTC July 2017 report (see photo in appendix).

Tree T2; Silky saw in forked inclusion cavity in central weight bearing limbs.

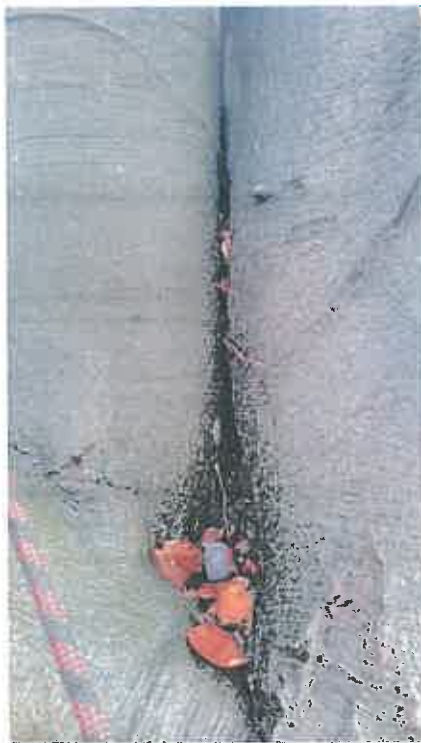
Tree T2; Silky saw in forked inclusion cavity in another primary weight bearing union.

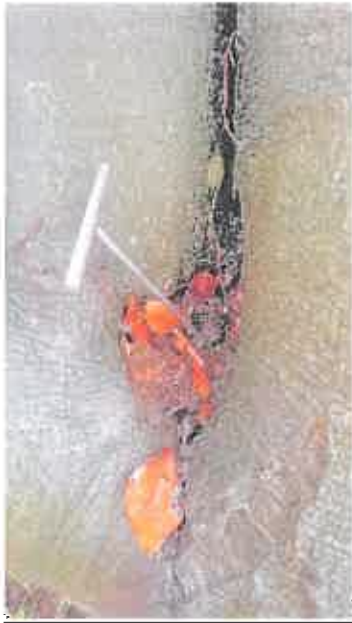
Tree T2; Insertion of depth probe in included decay pocket.

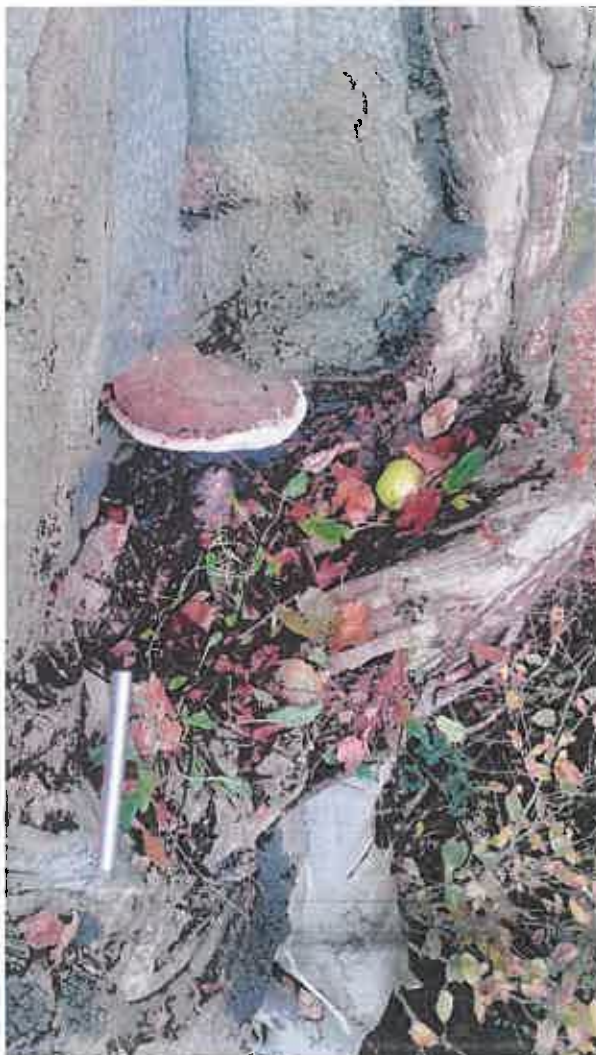
Tree T2; Ganaderma at 5metres in old limb failure tear, note full depth gauge insertion in bottom left corner.

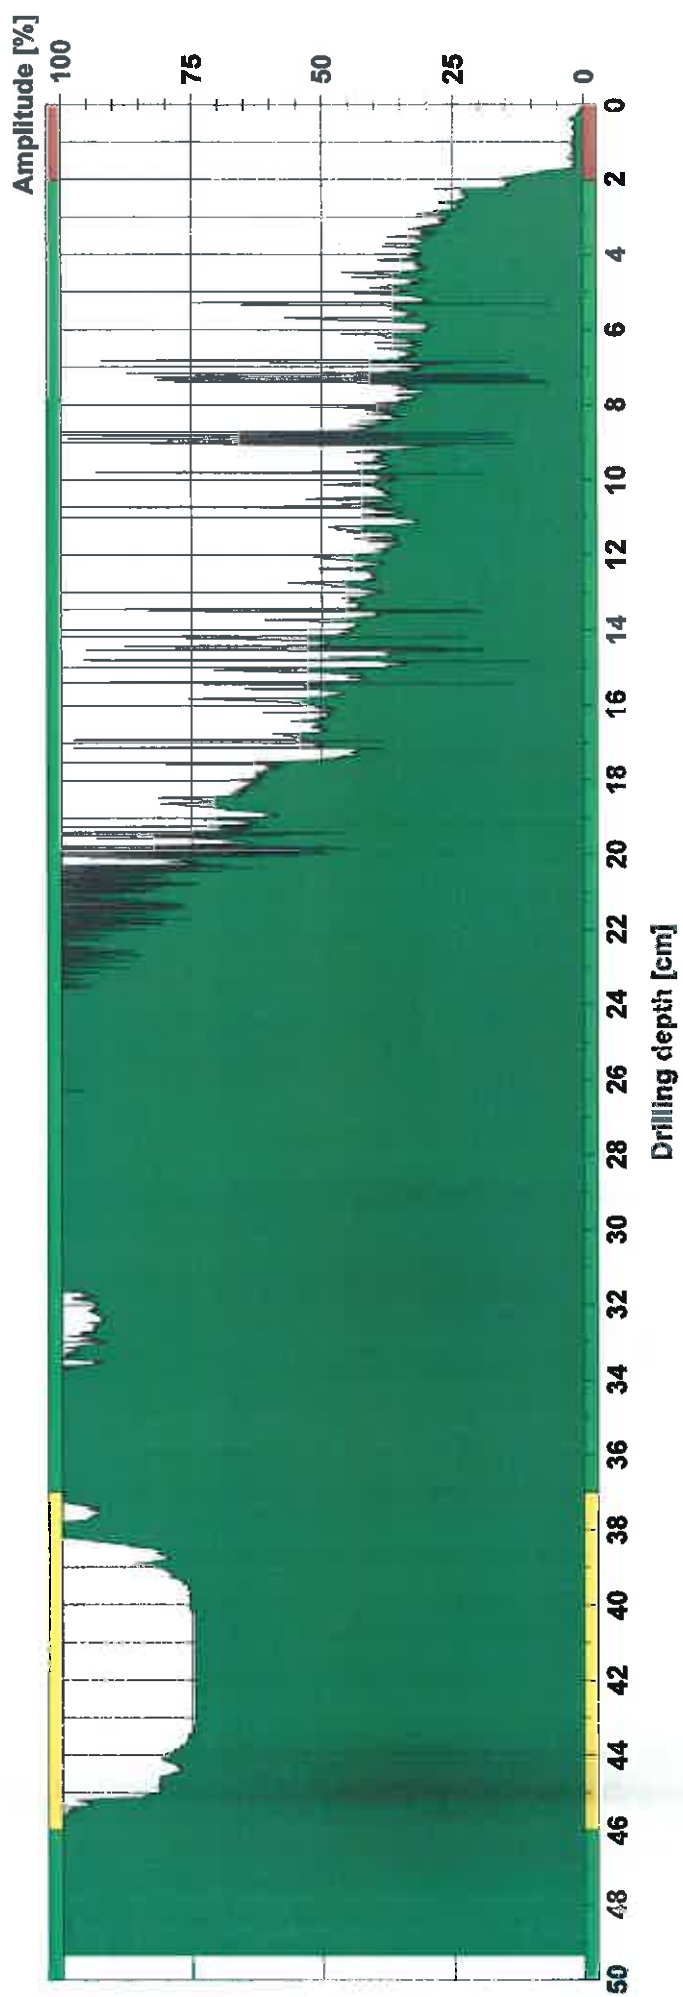
From	0,0 cm	to	2,0 cm	:	Bark
From	2,0 cm	to	37,0 cm	:	Sound Wood
From	37,0 cm	to	46,0 cm	:	Suspect Wood
From	46,0 cm	to	50,0 cm	:	Sound Wood
From	0,0 cm	to	0,0 cm	:	
From	0,0 cm	to	0,0 cm	:

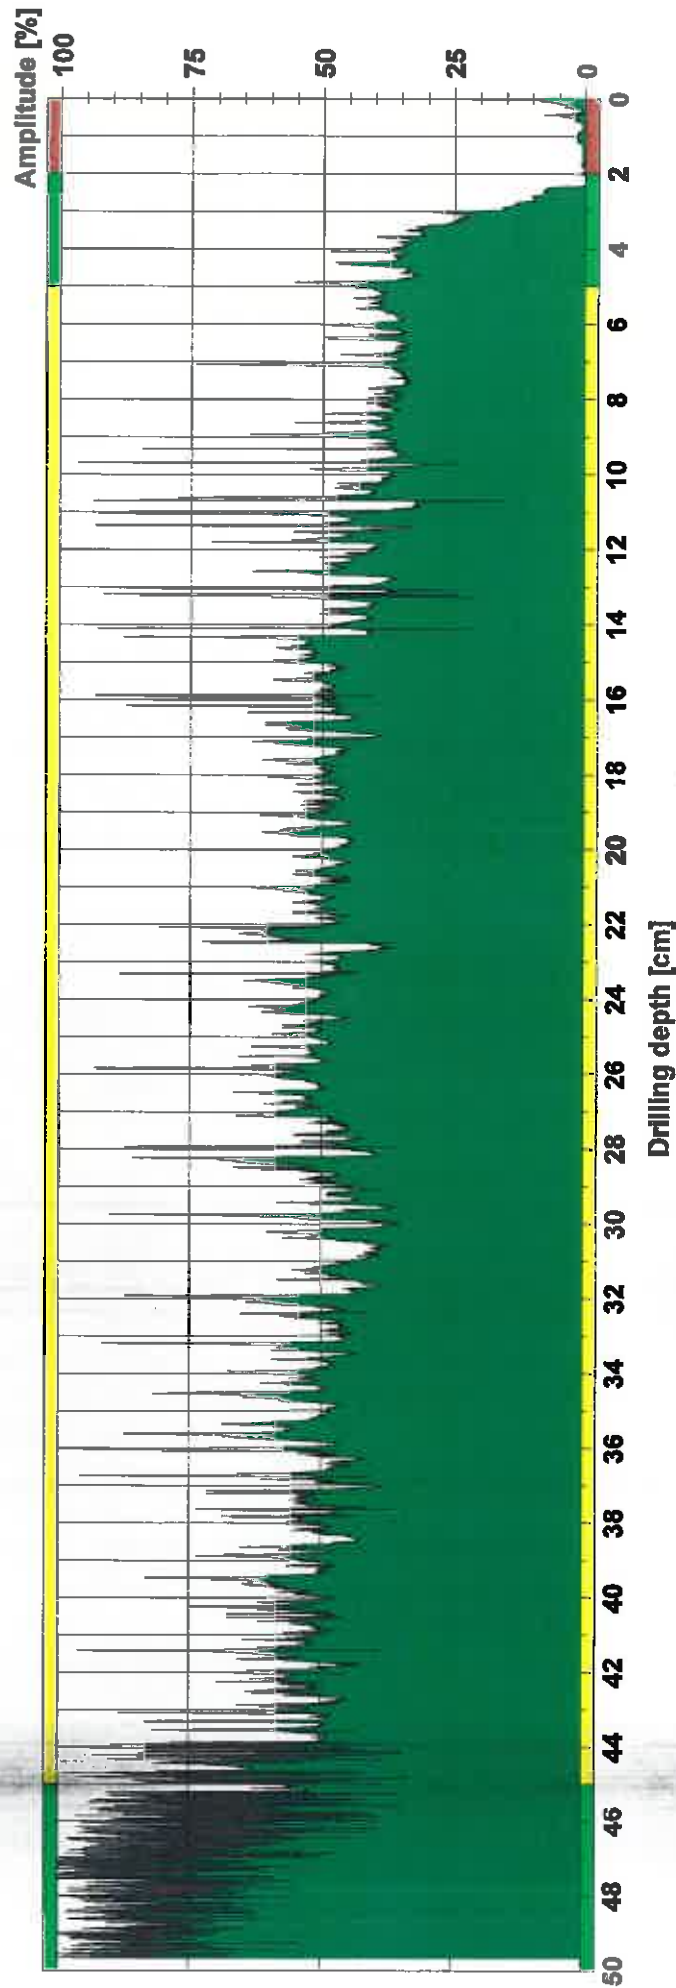
From	0,0 cm	to	2,0 cm	:	Bark
From	2,0 cm	to	5,0 cm	:	Sound Wood
From	5,0 cm	to	45,0 cm	:	Suspect Wood
From	45,0 cm	to	50,0 cm	:	Sound Wood
From	0,0 cm	to	0,0 cm	:	
From	0,0 cm	to	0,0 cm	:

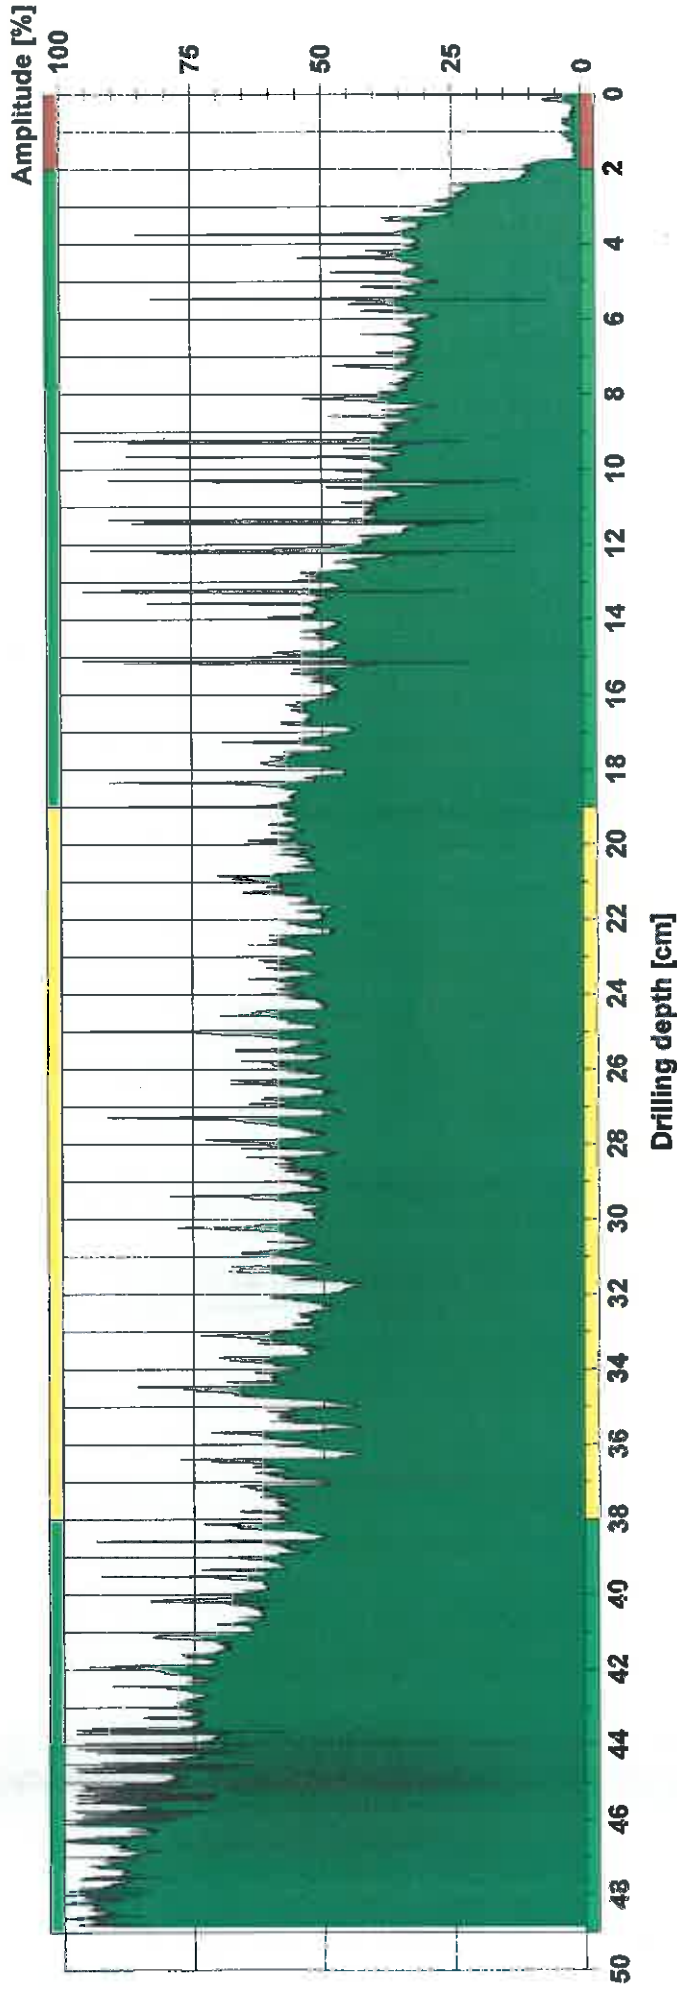
From	0,0 cm	to	2,0 cm	:	Bark
From	2,0 cm	to	19,0 cm	:	Sound Wood
From	19,0 cm	to	38,0 cm	:	Suspect Wood
From	38,0 cm	to	49,0 cm	:	Sound Wood
From	0,0 cm	to	0,0 cm	:	
From	0,0 cm	to	0,0 cm	:

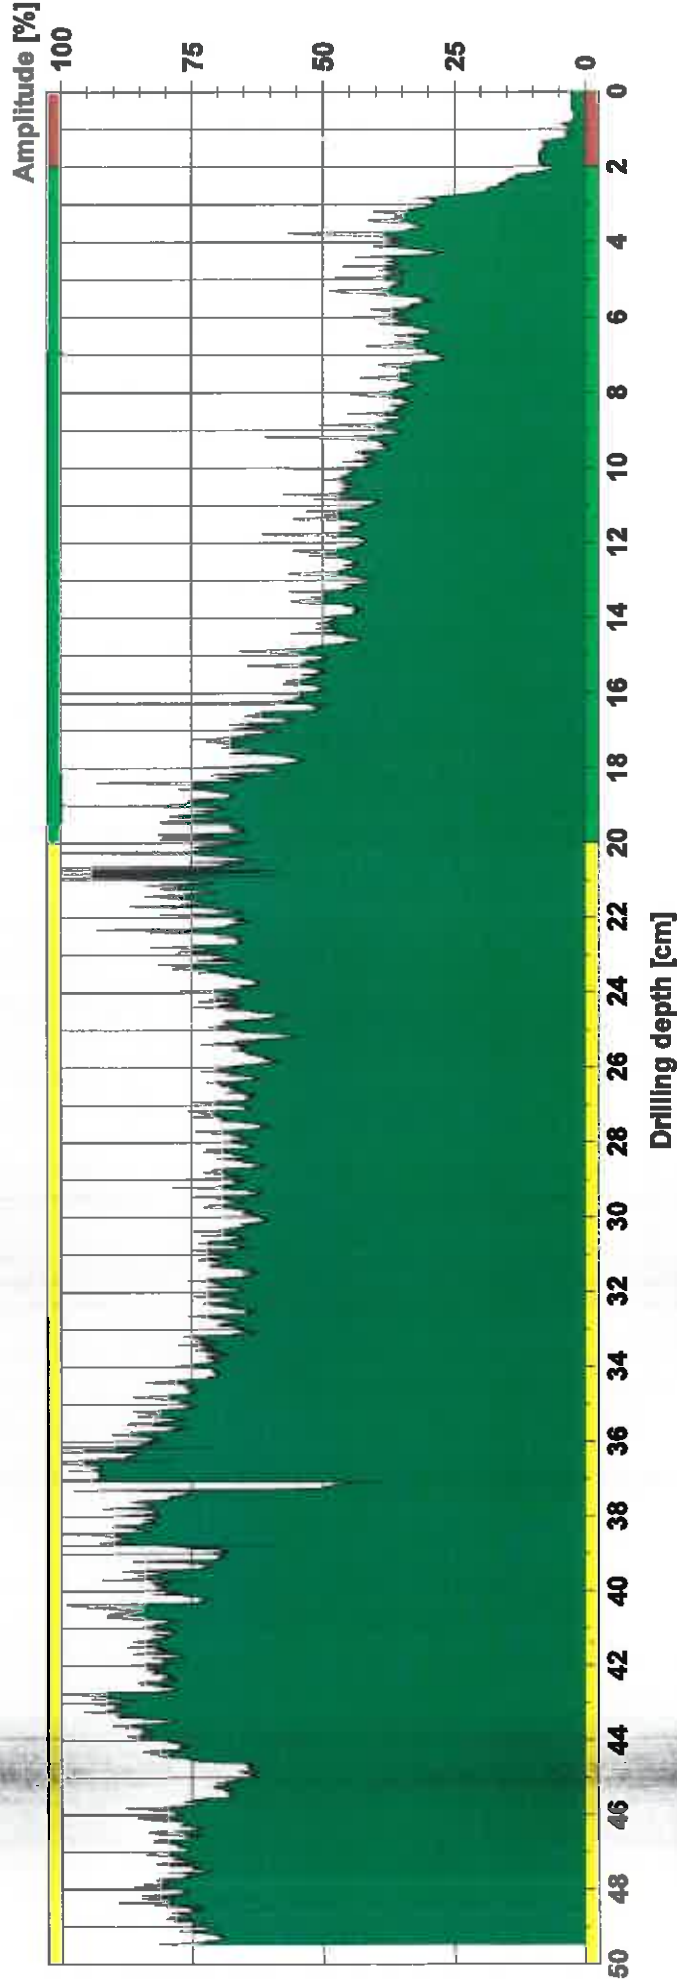
From	0,0 cm	to	2,0 cm	:	Bark
From	2,0 cm	to	20,0 cm	:	Sound Wood
From	20,0 cm	to	50,0 cm	:	Suspect Wood
From	0,0 cm	to	0,0 cm	:	
From	0,0 cm	to	0,0 cm	:	
From	0,0 cm	to	0,0 cm	:

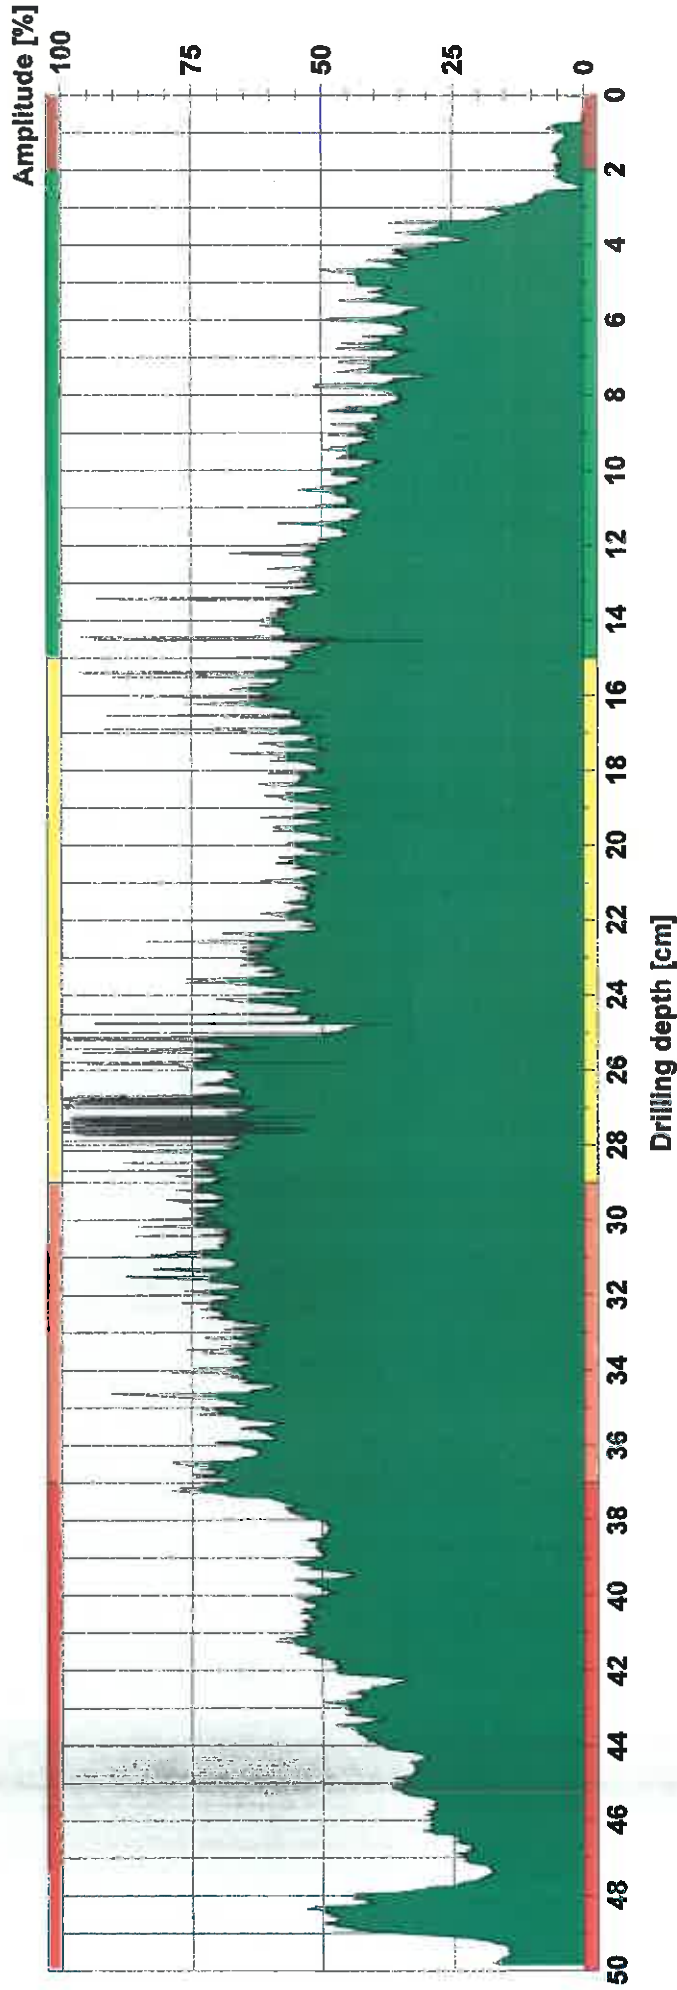
- ii) Trees T2 & T2 should be removed to ground level. The Resistograph drillings of tree T3 highlight a very distinct area of reduced resistance and hence most likely a decay cavity radiating from the eastern aspect of the tree from at least 1 metre above ground level to around at least 4 metres. This would concur with the onsite presence of various bracket fungi occurring on the Eastern side of the tree (see appendix photographs). The readings also indicate that with Tree T3 the decay/suspect wood is also extending into the South and Western regions of the main stem. In most cases on the lower West, South and East sides there is only approximately 300mm of structurally sound timber at best. Given the diameter of the trunk is 1360mm this is suggesting that decay levels maybe around the 70% within the main trunk. It is at this point that many field studies have shown that the failure rate of trees increases rapidly (C. Mattheck – "Updated Field Guide for Visual Tree Assessment" 2007). The option of managed decline or a large crown reduction was considered for both but as beech trees do not respond well crown reductions greater than 15% and the economic management input required would be extensive without either option addressing the primary concern of catastrophic failure they were dismissed as being non-affective to the hazard presented.

From	0,0 cm	to	2,0 cm	:	Bark
From	2,0 cm	to	15,0 cm	:	Sound Wood
From	15,0 cm	to	29,0 cm	:	Suspect Wood
From	29,0 cm	to	37,0 cm	:	Decay
From	37,0 cm	to	50,0 cm	:	Cavity
From	50,0 cm	to	0,0 cm	:

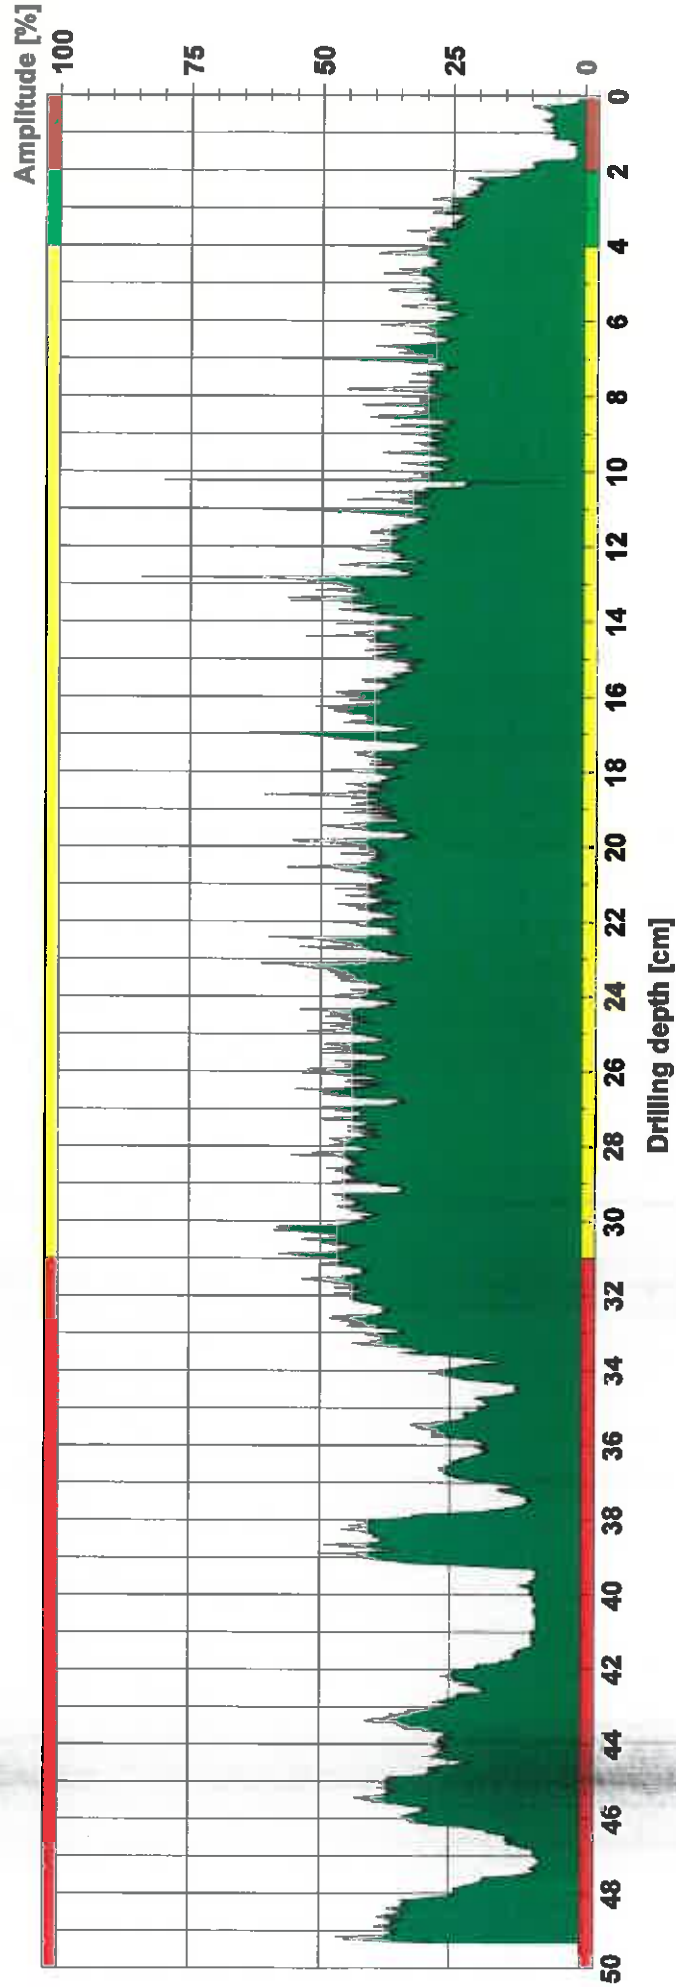
From	0,0 cm	to	2,0 cm	:	Bark
From	2,0 cm	to	4,0 cm	:	Sound Wood
From	4,0 cm	to	31,0 cm	:	Suspect Wood
From	31,0 cm	to	50,0 cm	:	Cavity
From	0,0 cm	to	0,0 cm	:	
From	0,0 cm	to	0,0 cm	:

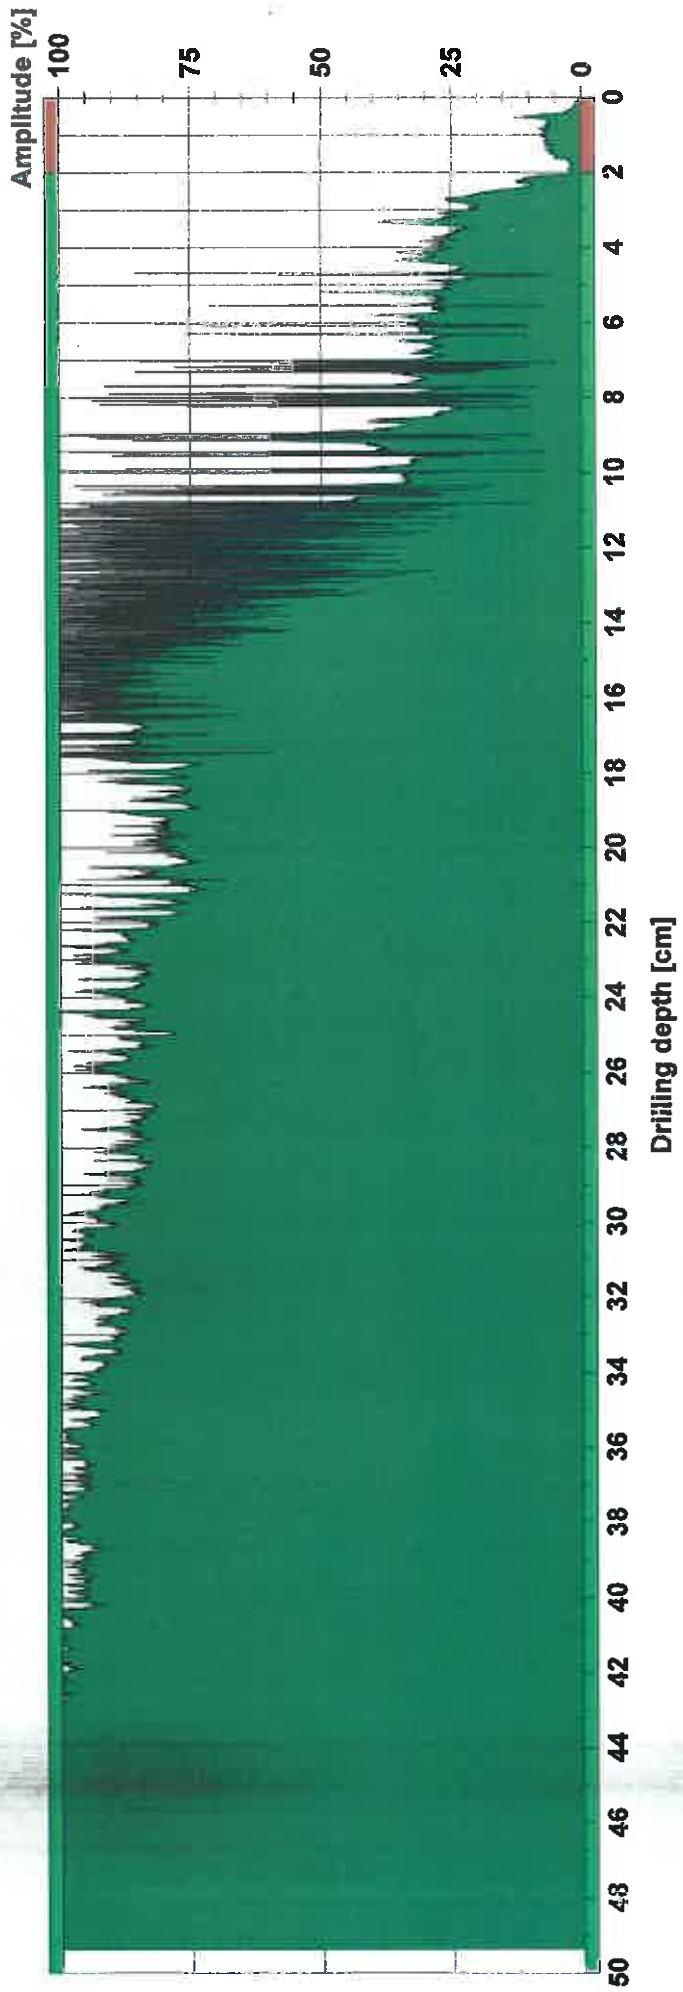
From	0,0 cm	to	2,0 cm	:	Bark
From	2,0 cm	to	50,0 cm	:	Sound Wood
From	0,0 cm	to	0,0 cm	:	
From	0,0 cm	to	0,0 cm	:	
From	0,0 cm	to	0,0 cm	:	
From	0,0 cm	to	0,0 cm	:

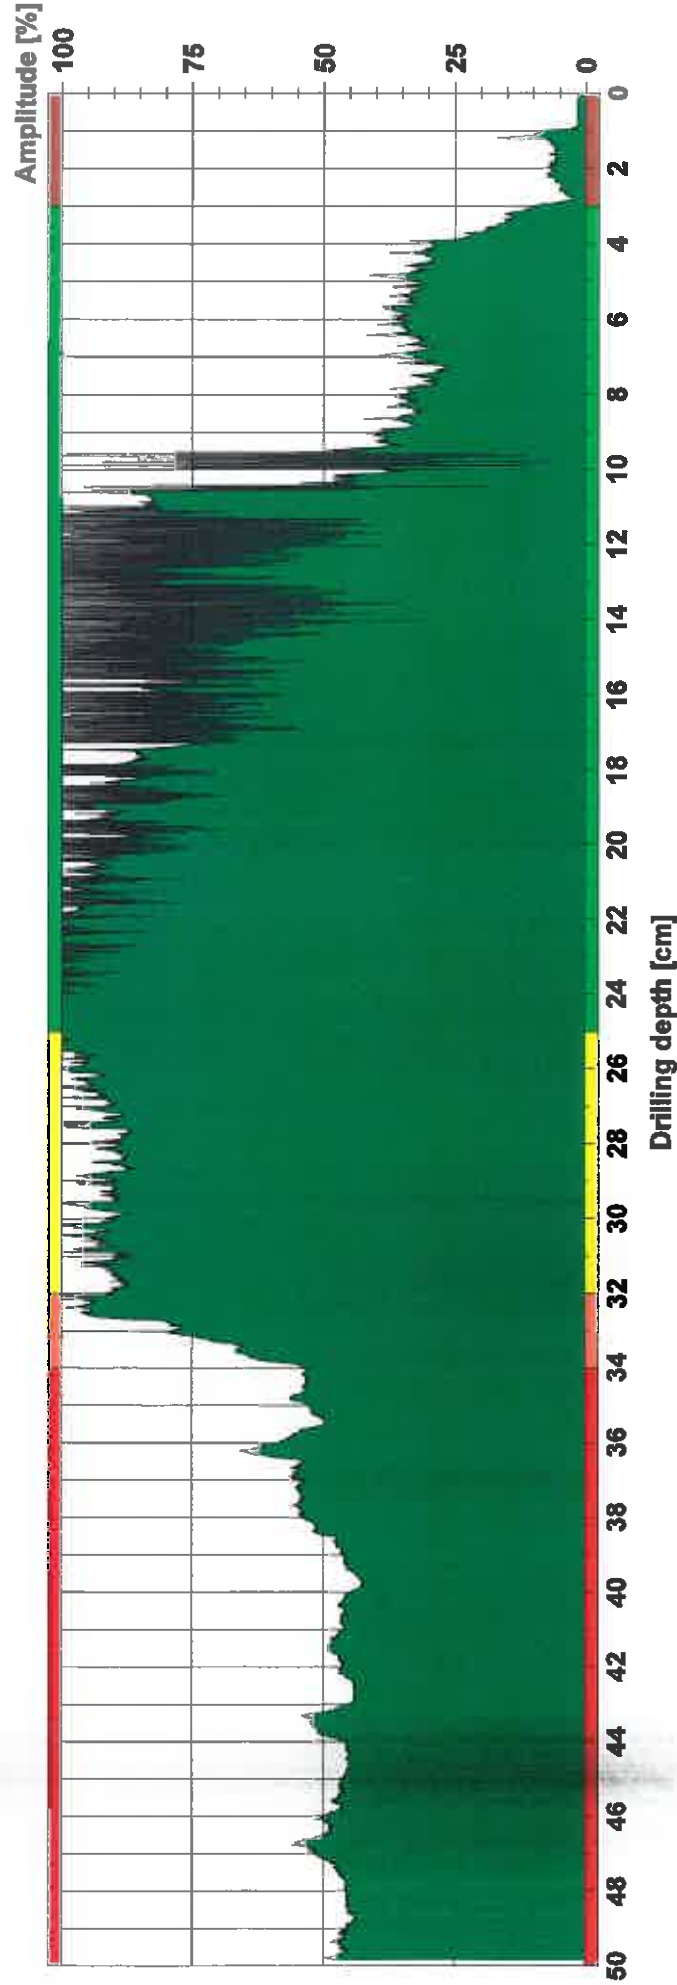
From	0,0 cm	to	3,0 cm	:	Bark
From	3,0 cm	to	25,0 cm	:	Sound Wood
From	25,0 cm	to	32,0 cm	:	Suspect Wood
From	32,0 cm	to	34,0 cm	:	Decay
From	34,0 cm	to	50,0 cm	:	Cavity
From	0,0 cm	to	0,0 cm	:

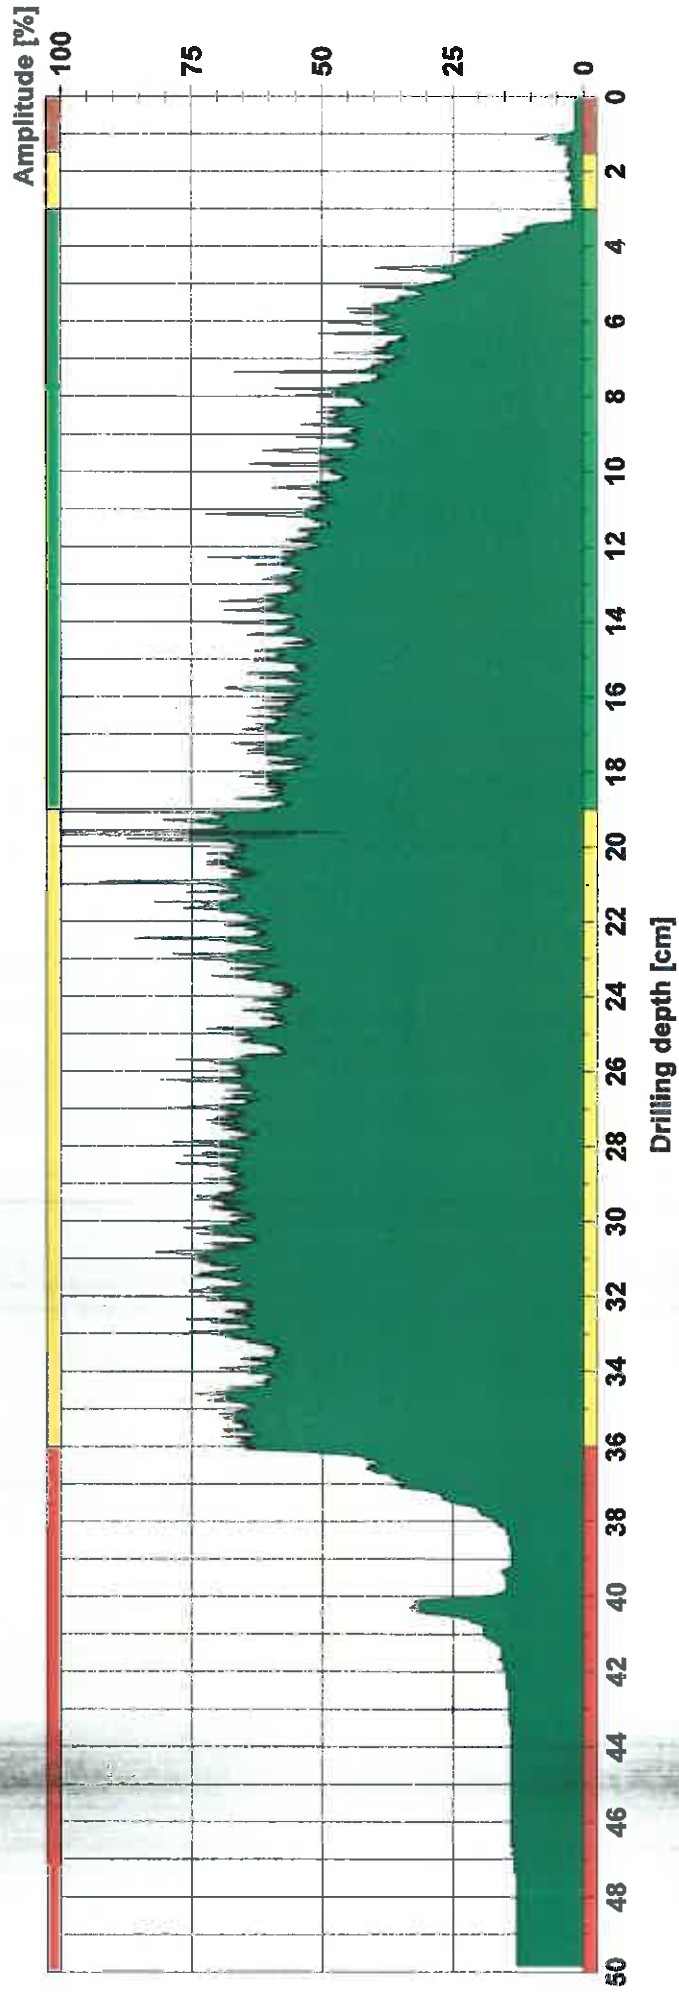
From	0,0 cm	to	1,5 cm	:	Bark
From	1,5 cm	to	3,0 cm	:	Suspect Wood
From	3,0 cm	to	19,0 cm	:	Sound Wood
From	19,0 cm	to	36,0 cm	:	Suspect Wood
From	36,0 cm	to	50,0 cm	:	Cavity
From	0,0 cm	to	0,0 cm	:

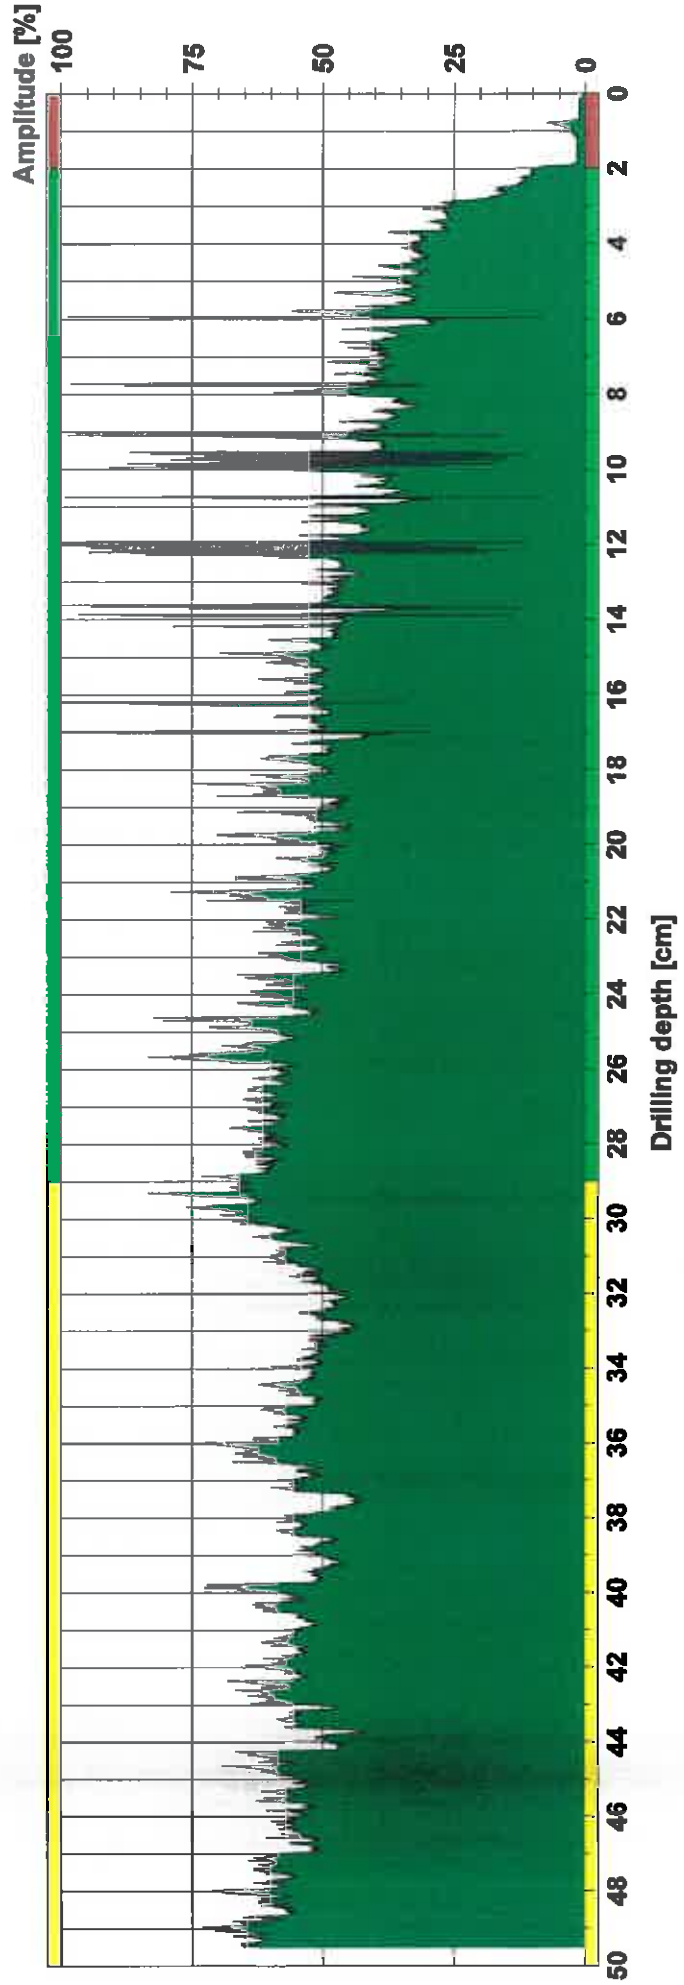
From	0,0 cm	to	2,0 cm	: Bark
From	2,0 cm	to	29,0 cm	: Sound Wood
From	29,0 cm	to	50,0 cm	: Suspect Wood
From	0,0 cm	to	0,0 cm	:
From	0,0 cm	to	0,0 cm	:
From	0,0 cm	to	0,0 cm	:

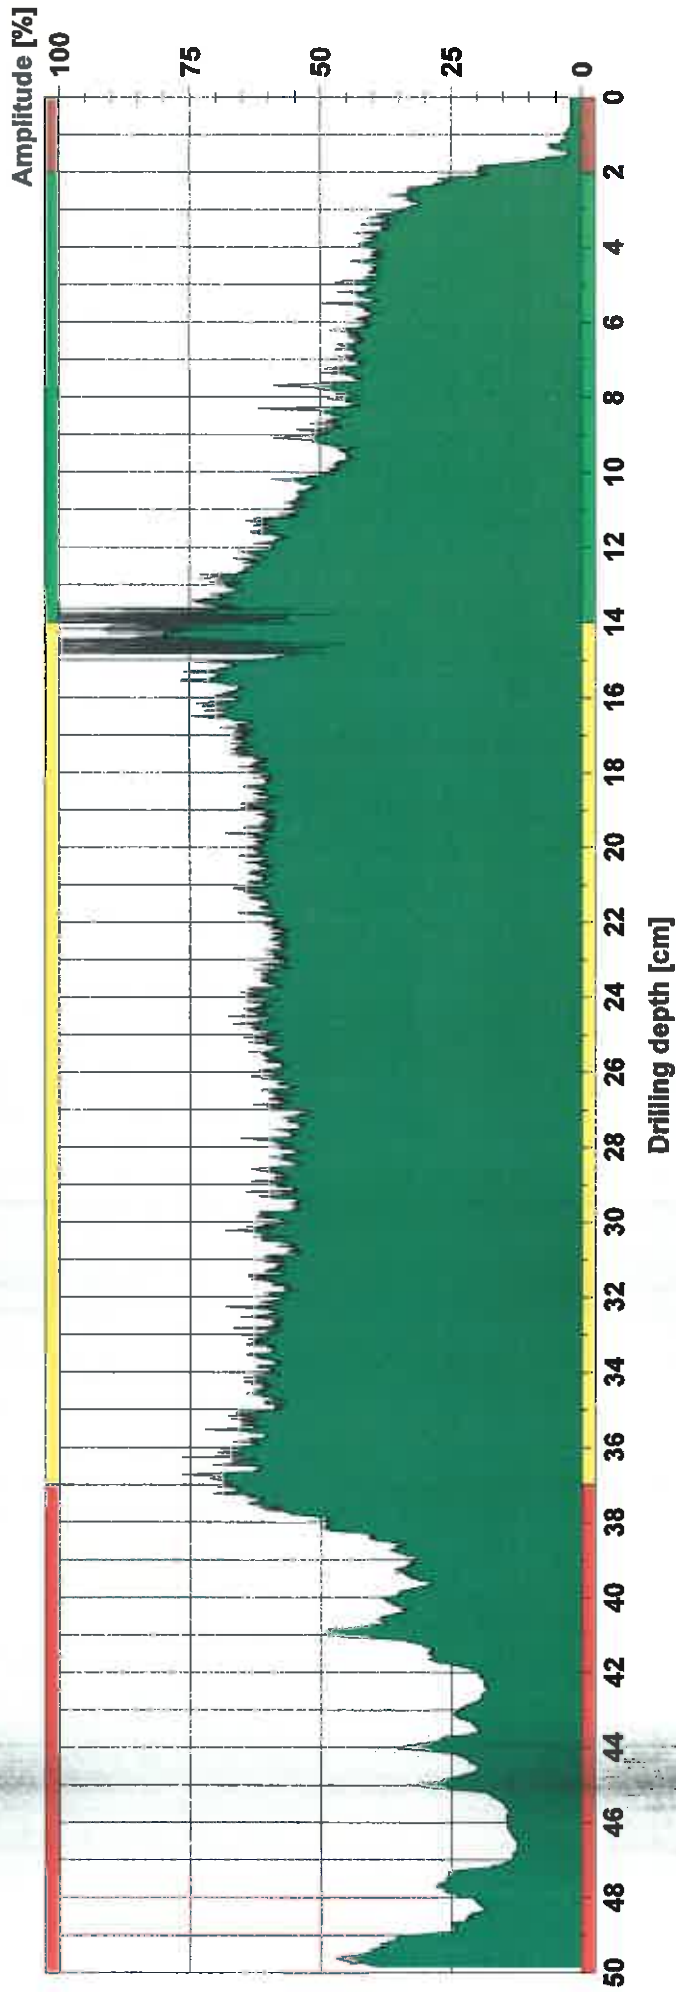
From	0,0 cm	to	2,0 cm	:	Bark
From	2,0 cm	to	14,0 cm	:	Sound Wood
From	14,0 cm	to	37,0 cm	:	Suspect Wood
From	37,0 cm	to	50,0 cm	:	Cavity
From	0,0 cm	to	0,0 cm	:	
From	0,0 cm	to	0,0 cm	:

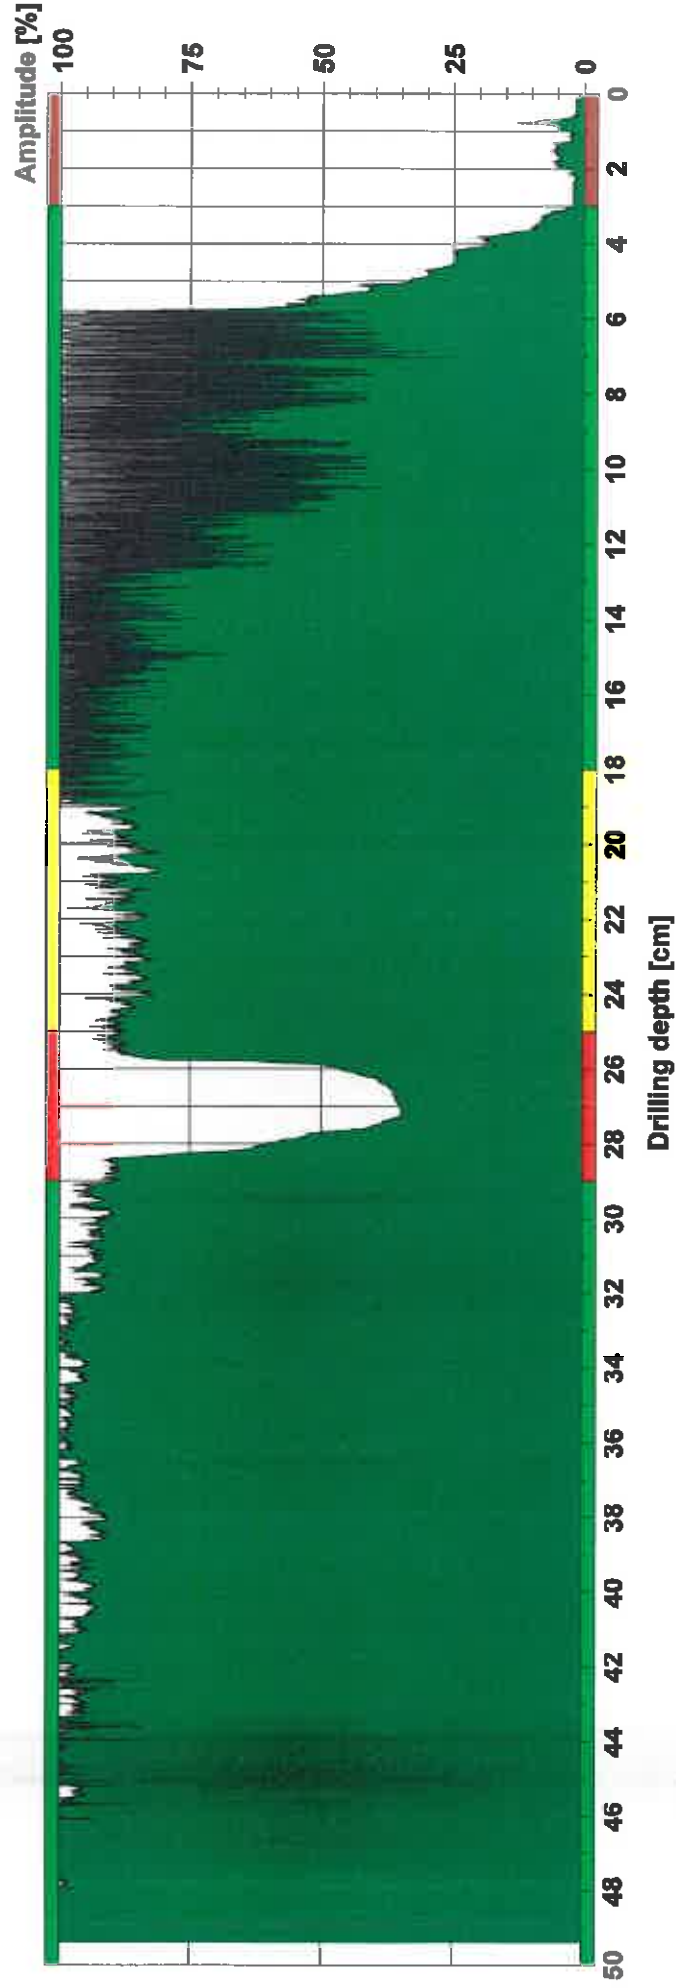
From	0,0 cm	to	3,0 cm	:	Bark
From	3,0 cm	to	18,0 cm	:	Sound Wood
From	18,0 cm	to	25,0 cm	:	Suspect Wood
From	25,0 cm	to	29,0 cm	:	Cavity
From	29,0 cm	to	50,0 cm	:	Sound Wood
From	50,0 cm	to	0,0 cm	:

Beech Grove Residential Home; Copper Beech T3, drilling at 4metres above ground from the North. Tree diameter 1360, tree height 24 metres, crown spread 19 metres.
