BUILDING CONDITION SURVEY REPORT

PROPERTY ADDRESS: Horton Grange Cottage, Horton, Skipton BD23 3JT

DATE OF INSPECTION: 7th May 2017

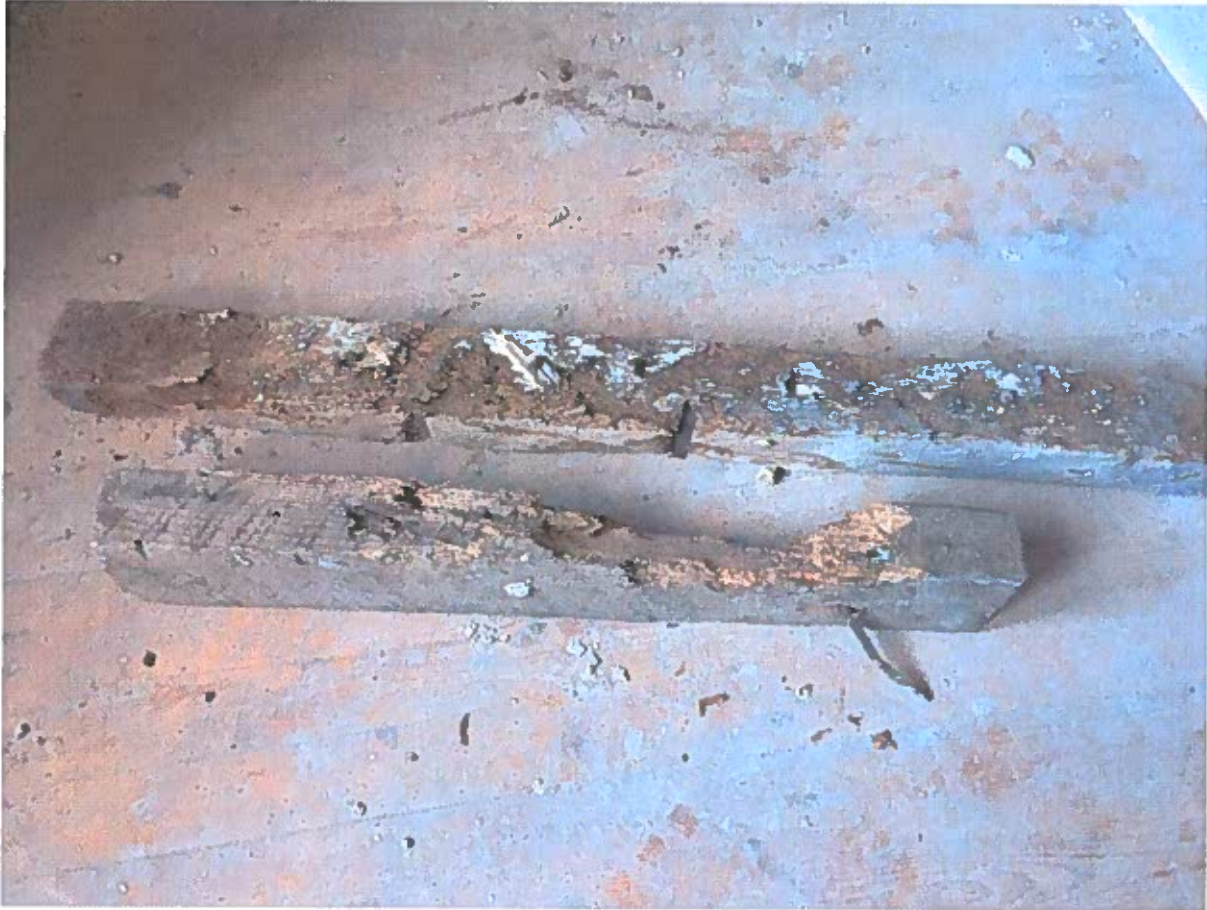
There is significant woodworm infestation and wet rot deterioration to the timber roof laths and approximately 10% of the stone slates are damaged.

Example of rotted and woodworm damaged roof timbers

I recommend that the roof covering is removed and replaced using as many of the original stone slates as possible and that all damaged timber is replaced.

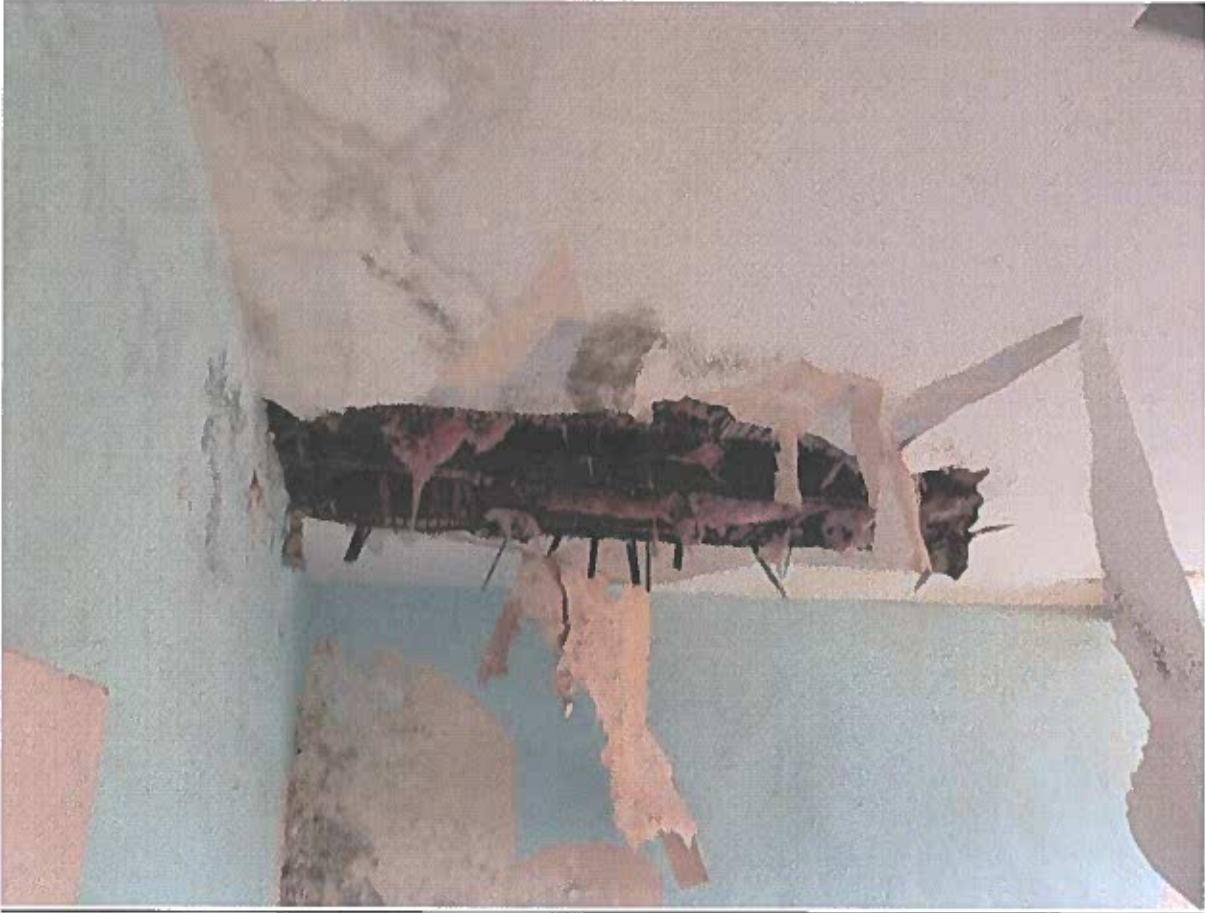
The laths and plaster have suffered from significant, wide spread damage and deterioration due to a combination of woodworm infestation and wet rot caused by the long term penetration of rain water through the roof covering and around the chimney stacks which has collected in the rock-wool insulation.

Example of damage to first floor ceilings

The urgent removal of all horizontal first floor ceilings is required to prevent collapse, possible injury to the occupants and to prevent the further passage of rain water to the first floor stud-walls, timber floors and lower areas of the building.

I recommend that the ceilings are replaced on the same plane and position as would have originally been installed. Insulation should be provided at the horizontal ceiling location to alleviate any concerns over the installation of insulation on the pitch line of the roof.
