**Land at Henthorn Road, Clitheroe, Lancashire**

**Arboricultural Assessment**

July 2018

**FPCR Environment and Design Ltd**

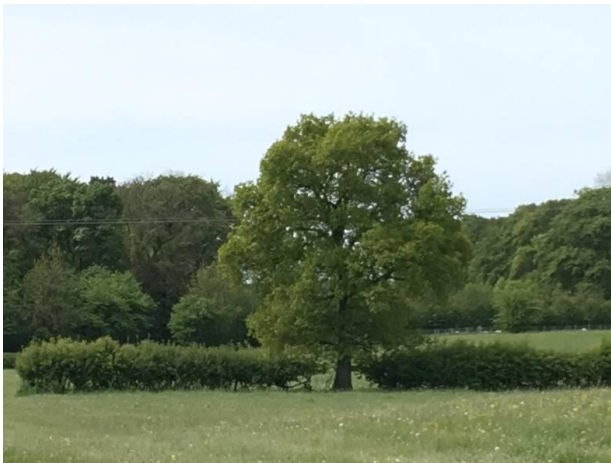
- 3.4 Tree T1 was a Category A oak growing from amongst hedgerow H2 and which was considered to be an early field boundary. This tree is of the highest value as a sole specimen and notwithstanding the neighbouring electricity service wayleave has room for retention into full maturity.

**Photograph 1: Tree T1 growing from hedge H2**

| Tree No | Species | Height | Stem Dia. | Crown Radius | Age Class | Overall Condition | Structural Condition | RPA | RPA Radius | BS5837 Cat |
|---|---|---|---|---|---|---|---|---|---|---|
| T1 | English oak<br><i>Quercus robur</i> | 16 | 790 | N - 6.5<br>S - 7<br>E - 7<br>W - 7.5 | EM | G | Growing from hedge H2 with a gap of around 2m to either side of trunk. Historic livestock compaction/poaching around buttress roots due to sheltering livestock. The crown shows good vigour and is free from significant defect with only small diameter deadwood. Epicormic growth clads trunk from 2.5m to 4.5m. Presently around 4m clearance off electricity service to south west.<br><br><b>WORK RECOMMENDATION</b><br>Trim back epicormic growth to aid access for hedge cutting. | 282 | 9.5 | A (i) |

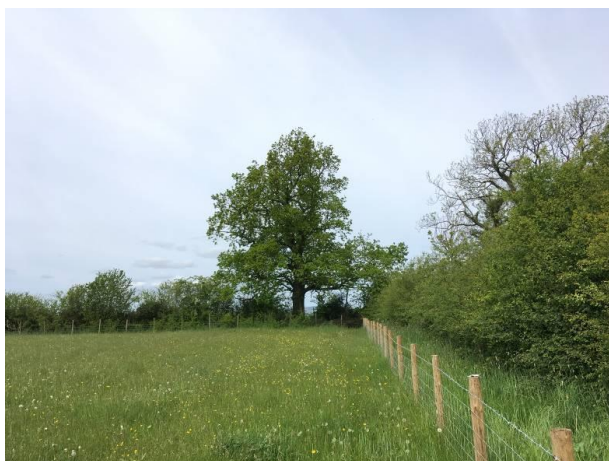
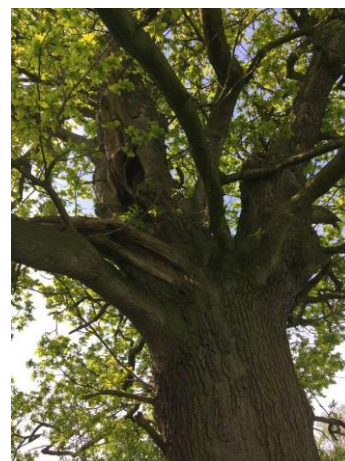
- 3.6 T11 is a category A mature oak standing at 17m and was located on the northernmost boundary of the site. There was evidence of previous livestock poaching around the base of the main stem which also possessed a substantial basal flair. The opening between the root buttress had revealed the lower stem of the tree to be substantially hollow. Overall, the tree exhibited good vigour with minimal deadwood overhanging the site, however a single hanging dead branch was noted in the lowest crown on northern side and as such remedial management, in the interests of safety should the site be developed, would be recommended.

**Photograph 2: Tree T11 and close up view of cavity on main stem**

| Tree No | Species | Height | Stem Dia. | Crown Radius | Age Class | Overall Condition | Structural Condition | RPA | RPA Radius | BS5837 Cat |
|---|---|---|---|---|---|---|---|---|---|---|
| T11 | English Oak<br><i>Quercus robur</i> | 17 | 970 | N - 7.5<br>S - 6.5<br>E - 9<br>W - 7 | M | F | Current overhang beyond stock fence due east is 4.5m. Tree lies slightly due west of hedge H3. Evidence of previous livestock poaching around trunk base. Substantial basal flair, particularly on western side with opening between root buttress revealing lower trunk to be substantially hollow. Opening in trunk at 4.5m on northern side where decay has resulted following failure of a primary branch a great many years ago. Overall, tree has a crown growth bias to the south and currently shows good vigour. Minimal deadwood where overhanging site, however substantial part failed yet hung up deadwood in lowest crown on northern side but only overhanging hedge H3. Tree considered to be of heightened biodiversity value. | 426 | 11.6 | A (i) |

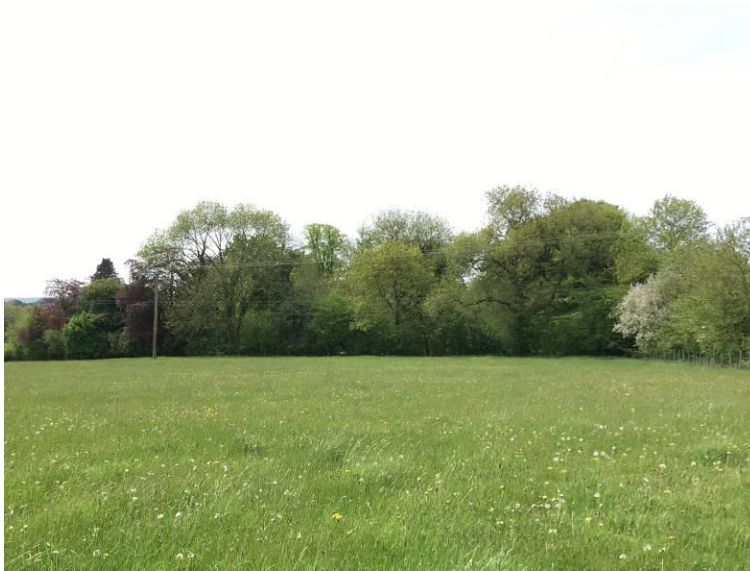
- 3.7 T2 to T8 inclusive along with an outgrown hedge surveyed as G1, were regarded as being off-site within the garden, curtilage to the neighbouring Siddows Hall. The early mature copper beech T4 and the over mature ash T8 aforementioned are especially notable within this collection.
- 3.8 Although some of the component trees were in poor condition (either in terms of physiological or suspected structural configuration), collectively they form a prominent landscape feature that provides excellent screening from the existing hall grounds and could play a valuable role in protecting the historic landscape character of the hall whilst helping to better integrate the proposed development into the local landscape.

**Photograph 3: Trees T2 to T8 inclusive**

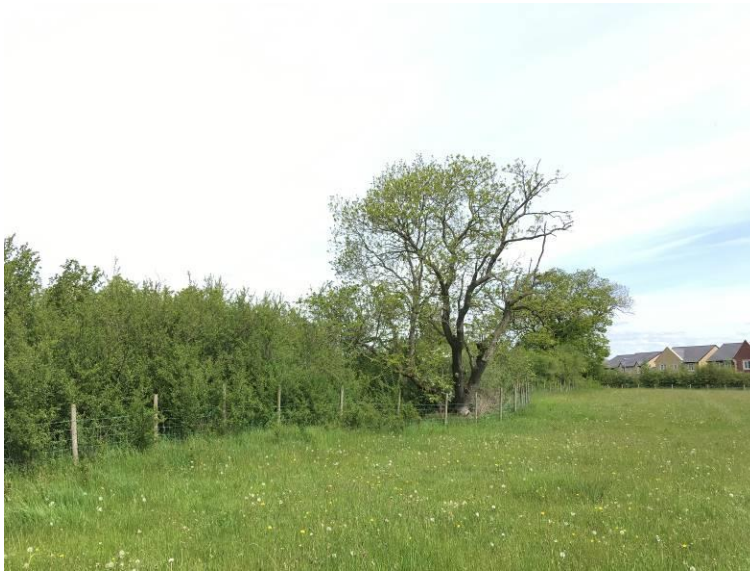
- 3.9 Hedge H1 lies along the Eastern boundary (adjacent to Henthorn Road) and has been subjected to regular management in the past. It displayed a boxy profile with consistent structure, only interrupted by an established gateway acting as the primary entrance to the site.
- 3.10 Hedge H3 growing along the western boundary had been fenced at some distance from the hedge, limiting access for maintenance and as a result is becoming outgrown. Located along this hedge line (H3) were trees associated with seasonal ponds, such as a single ash tree (T10). This tree exhibited unusual form with multiple areas of dieback and decay. This category C tree also hosted King Alfred's cake fungus (*Daldinia concentrica*) a saprophytic deadwood decomposer.

**Photograph 4: Ash tree T10**

| Tree No | Species | Height | Stem Dia. | Crown Radius | Age Class | Overall Condition | Structural Condition | RPA | RPA Radius | BS5837 Cat |
|---|---|---|---|---|---|---|---|---|---|---|
| T10 | Ash<br><i>Fraxinus excelsior</i> | 9 | 750 | N - 7<br>S - 7.5<br>E - 7.5<br>W - 6 | M | F | Tree of unusual form located to the northern margins of a low lying seasonal pond (dry at time of survey). Based upon twin stems with that to the north west being lightly clad in ivy whilst the much larger stem lies to the south eastern side and grows horizontal to the ground to approximately 3.5m offset from the stump before rising up with a generally multi-stemmed form. Multiple areas of dieback and decay with King Alfred's cake fungus ( <i>Daldinia concentrica</i> ) frequent on deadwood.<br><b>WORK RECOMMENDATION</b><br>Remove dead and defective branches only where necessary on health and safety grounds. Tree's primary value is on biodiversity grounds. | 254 | 9.0 | C (i) |
