BUILDING (STRUCTURAL) CONDITION SURVEY

IN CONNECTION WITH
MEADOW BROOK BARN,
SACCARY LANE, MELLOR, BB1 9DW

JOB REF: 5579, **DATED:** 18/04/2018, **VERSION:** 1.02 (Rev - 25/04/2018)

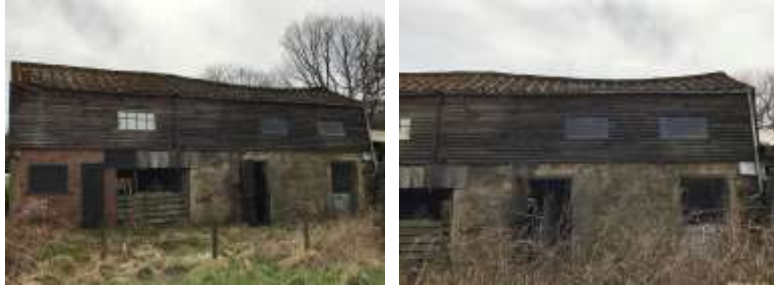
Some roof sag had occurred over that of the main barn which would suggest some deflection by decay or roof spread has occurred previously with section of higher level cement asbestos wall cladding to the rear (South) also observing an outward lean likely as a result. The cement asbestos sheet roof covering itself to the roof was in average to poor condition with slight vegetation build up but with no obvious dislodgements or breaches. Due to the age of the building and the asbestos cement roof covering there are obvious signs of weathering. Important - See Section 1.1 for note relating to ACMs.

PL. 2. Illustrating corrugated cement asbestos sheet roofing covering to that of the North facing roof pitch of the main Barn.

- All asbestos containing materials should be fully removed from site and disposed of by a licenced specialist contractor. (See also Section 1.1 - ACMs note). New roof coverings should be installed possibly to match that of nearby buildings e.g. natural slates, roofing underlay, mineral wool insulation and/or insulated metal/zinc sheeting.

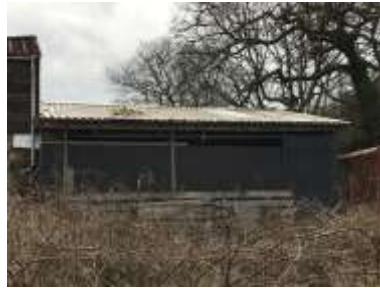
PL. 3. Illustrating light weight metal sheet roofing covering to that of the adjoining North facing agricultural Outbuilding structure.

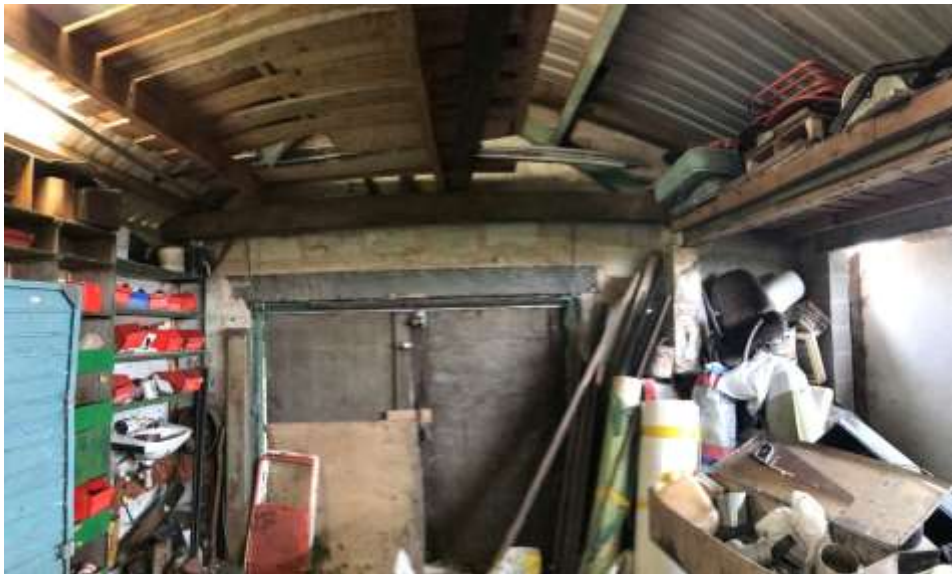
Where visible over that of the adjoining agricultural outbuilding the internal roof structure consisted of 3 no. primary timber roof trusses with secondary timber purlins/cladding rails spanning the length of the roof. These trusses appeared quite ad-hoc in nature having been repairs and pieced together over the years as required. Trusses to be replaced/repairs as part of any future conversion work.

Some decay was noted to the roof structure as to be expected given its age in the form of staining / dampness. It is recommended that the roof be re-roofed and all battens/ secondary roof structure be replaced in order to prevent any further decay and any implications on the integrity of the roof structure and its load bearing capacity.

PL. 4. Illustrating existing roof structure (Trusses, timber purlins/sheeting rails) present within the adjoining agricultural Outbuilding facing West.

- New internal timber staircase to be installed in order to access the first floor space.
- Remedial works should be carried out to the timber roof structure where required. Replacement timber trusses and roof members should be employed if necessary to meet the loading requirements of a new roof covering.

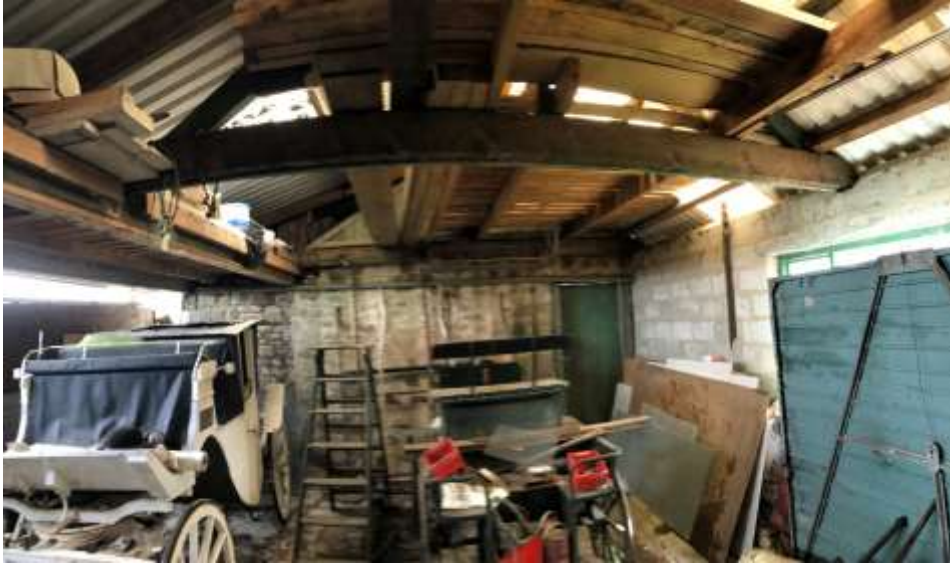
PL. 5. Illustrating existing roof structure (Trusses, timber purlins/sheeting rails) centrally over adjoining agricultural Outbuilding facing West.

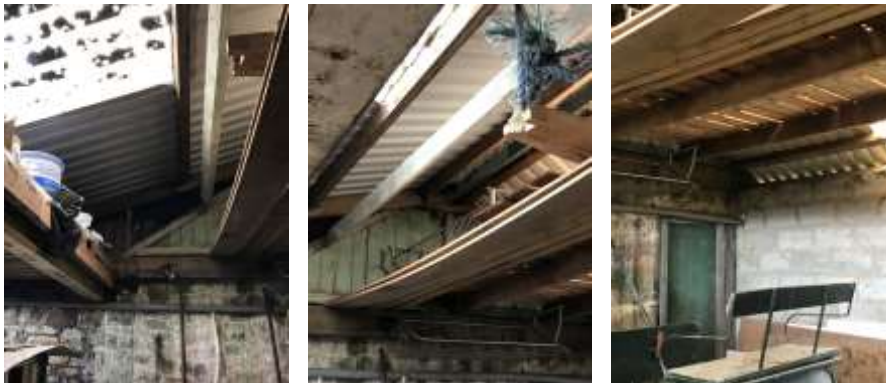
PL. 6. Illustrating existing roof structure (Trusses, timber purlins/sheeting rails) present within the adjoining agricultural Outbuilding facing East to party wall with that of the main Barn.

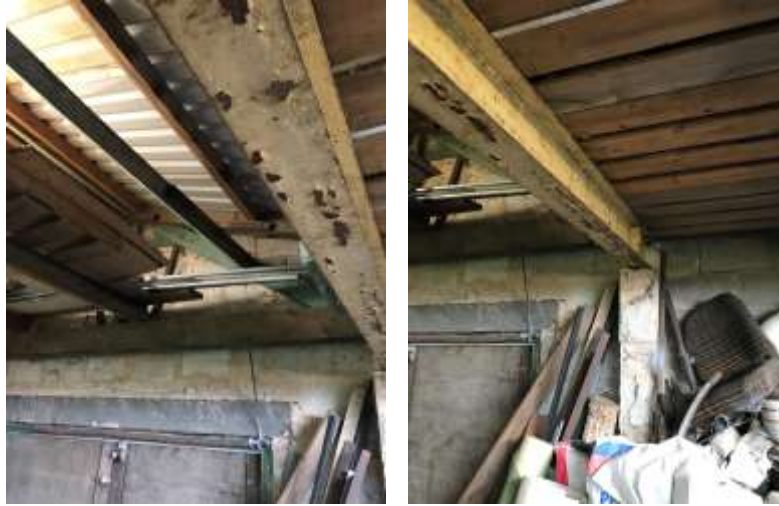
PL. 7. Illustrating section of steel UB currently supported of masonry block piers supporting front North facing section of roof structure over the adjoining agricultural outbuilding structure.

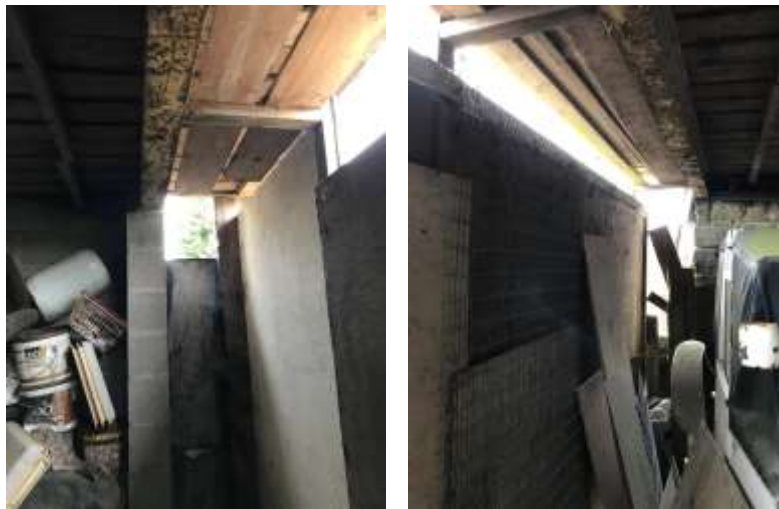
PL. 8. Illustrating section of ad-hoc timber framed infill providing some protection to where the front North facing section of the agricultural outbuilding wall has been removed previously.

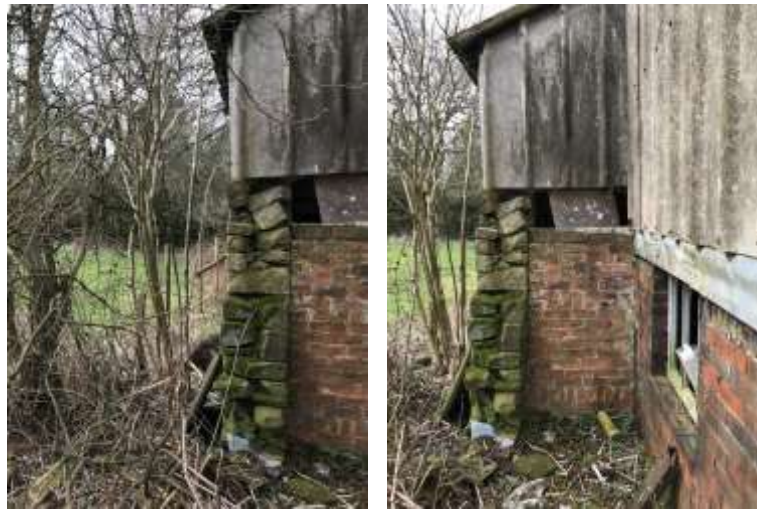
Also a small area of projecting external wall present to the East elevation at the rear of the main barn junction with that of the adjoining agricultural building required re-

building (See Pl. 10) required isolated re-building works in addition to the front North section of the wall which has been removed previously and replaced with an ad-hoc timber infill to that of the adjoining agricultural outbuilding.

PL. 9. Illustrating section of stone work to be made good and re-built.

- Remedial works should be carried out to the external walls where required including isolated rebuilding works to North and West sections.
- Concrete underpinning of existing internal divider walls to be retained to ensure adequate loading capability from installation of new first floor.

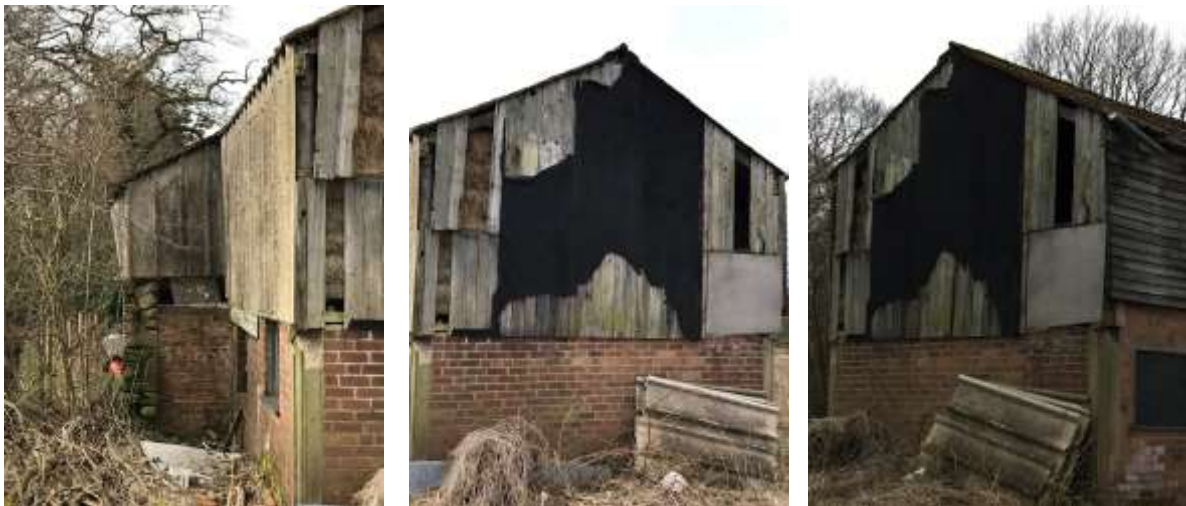
PL. 10. Illustrating low level brick claddings and mixture of high level cement asbestos sheeting and vertical timber boarding to part of the South Elevation and East facing gable.

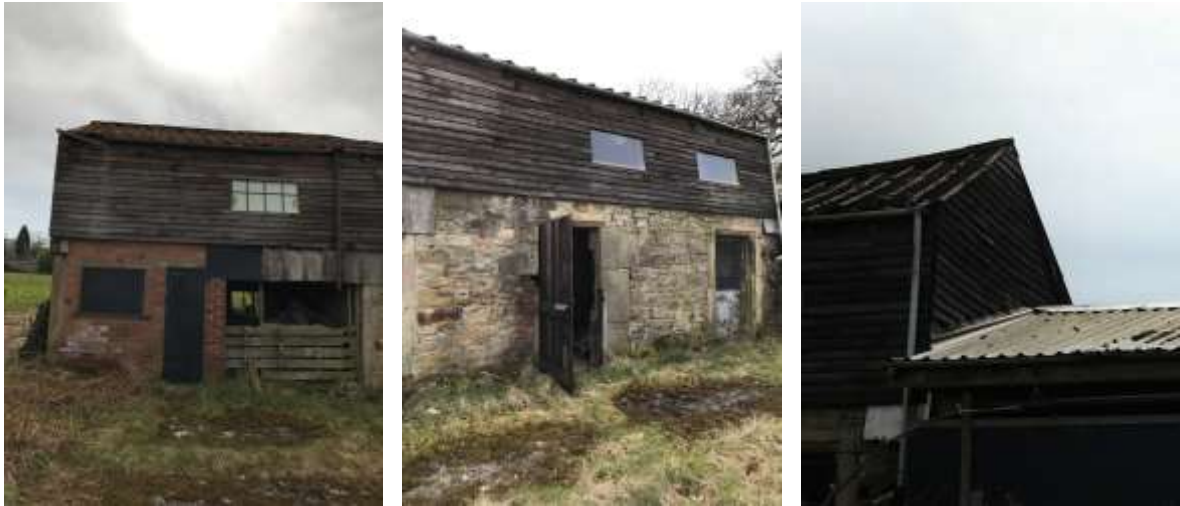
PL. 11. Illustrating low level brick/natural stone claddings and high level horizontal timber boarding to the North Elevation and part of the West facing gable.

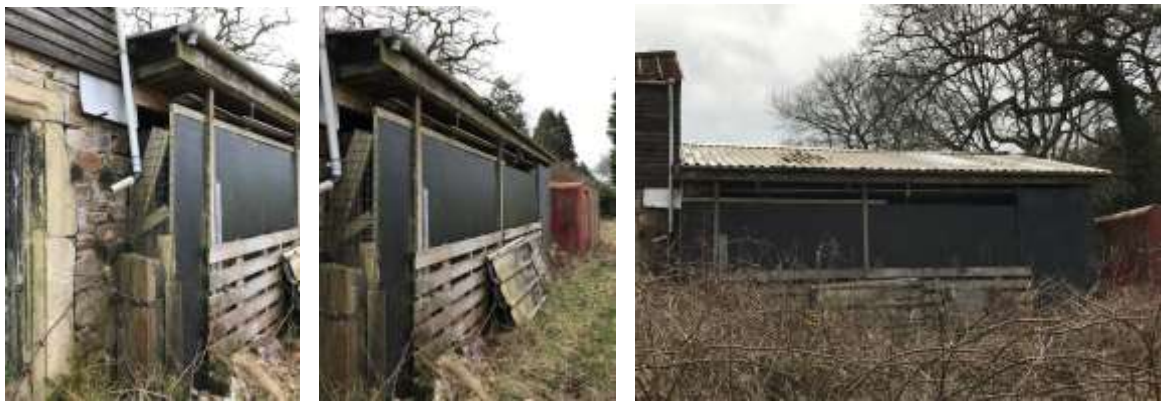
PL. 12. Illustrating section of ad-hoc timber framed infill providing some protection to where the front North facing section of the agricultural outbuilding wall has been removed previously.

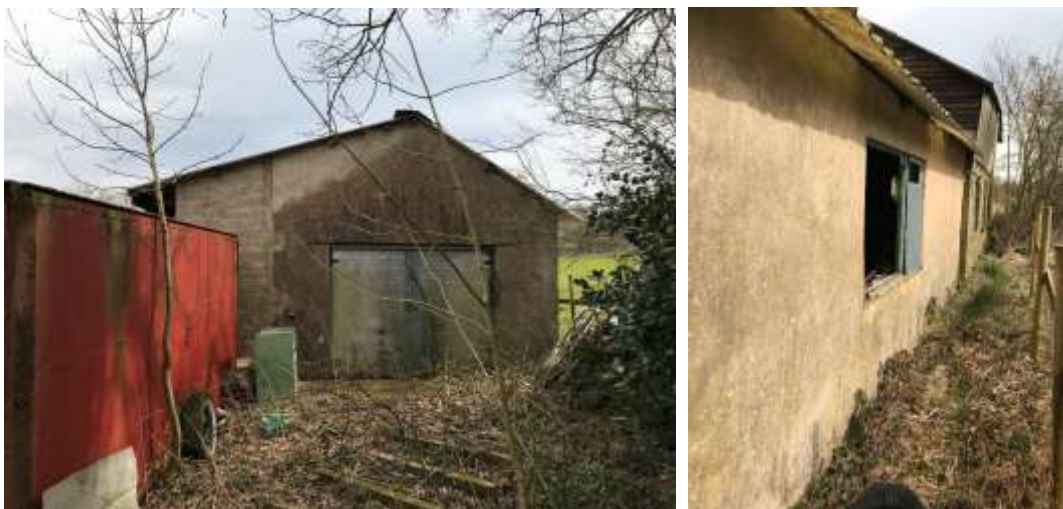
PL. 13. Illustrating cement render finish present to the adjoining agricultural outbuilding to the West and South facing elevation.

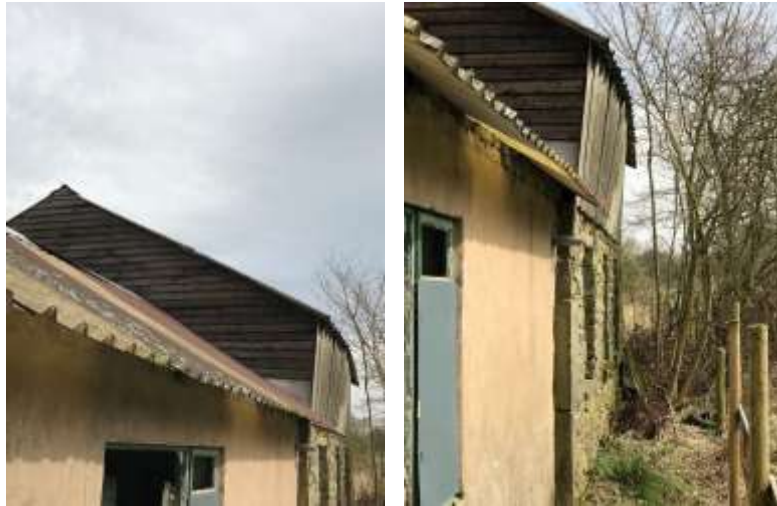
PL. 14. Illustrating the warped timber frame and cement asbestos sheet cladding present to the South facing elevation of the main Barn.

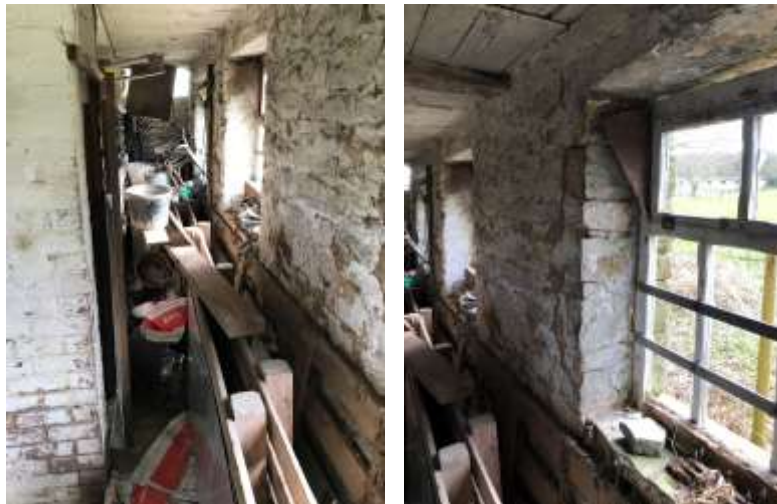
PL. 15. Illustrating internal faces of external masonry walls present at the time of inspection. Generally walls appeared sound, true and level with no significant bowing or undulations noted. Also walls appeared free from any significant and obvious structural movement. In addition, window and door heads generally appeared true and level.

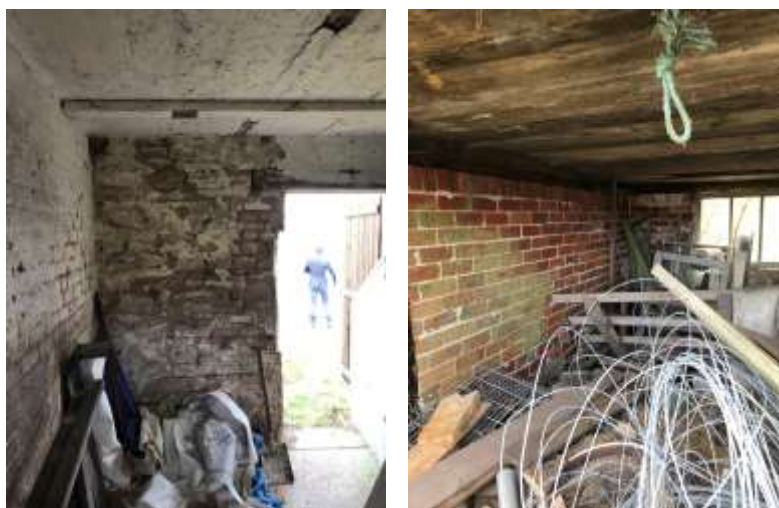
PL. 16. Illustrating internal masonry walls present at the time of inspection. Generally walls appeared sound, true and level with no significant bowing or undulations noted. Also walls appeared free from any significant and obvious structural movement. In addition, window and door heads generally appeared true and level.ss

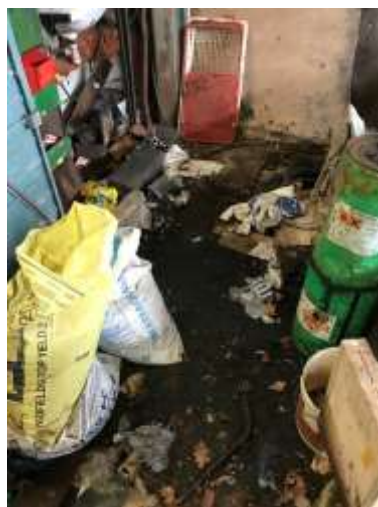
Where concrete ground floors appeared presence these were in moderate condition with no obvious signs of substantial cracking or other damage, however, there is evidence of staining and discolouration of the concrete floor possible through use over time and penetrative external ground dampness having occurred over time.

PL. 17. Ground floors were solid throughout and a mixture of concrete and flagged bases. Dampness was present as expected given the age and type of construction.

- New concrete foundation would be required to accommodate additional loading requirements of the building.
- Existing concrete ground floor should be grubbed up, internal levels reduced and replaced with a new insulated concrete ground floor structure incorporating DPMs with DPCs lapped up to new internal block lining walls.

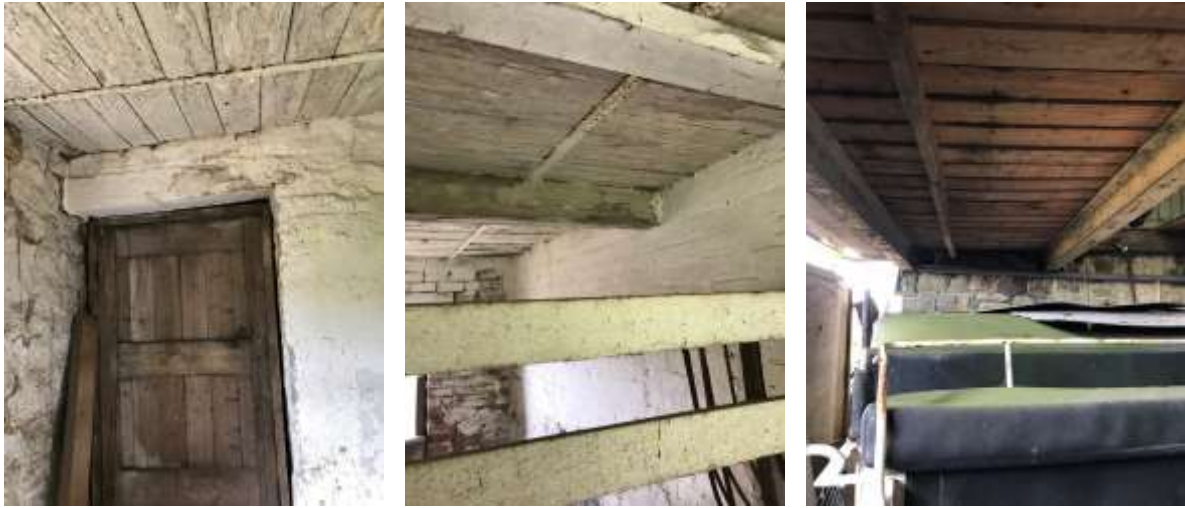
The floor structure and floor covering to the first floor was in poor condition with areas of decay, rot and dampness present (as to be expected given the nature and age of this construction). Remedial replacement to take place as part of any future conversion in order to ensure the lateral restraint of the structure is maintained long-term.

PL. 18. Timber boarded floor supported by timber joists and intermediate metal bracing straps within part of the main Barn.

- Current first floor structure to be removed from site due to timber decay and inadequate sized supporting members. First floor to be replaced with new timber floor structure capable of spanning the required distances with appropriate floor boarding. Primary steel supporting members may also require inserting to break up the spans.

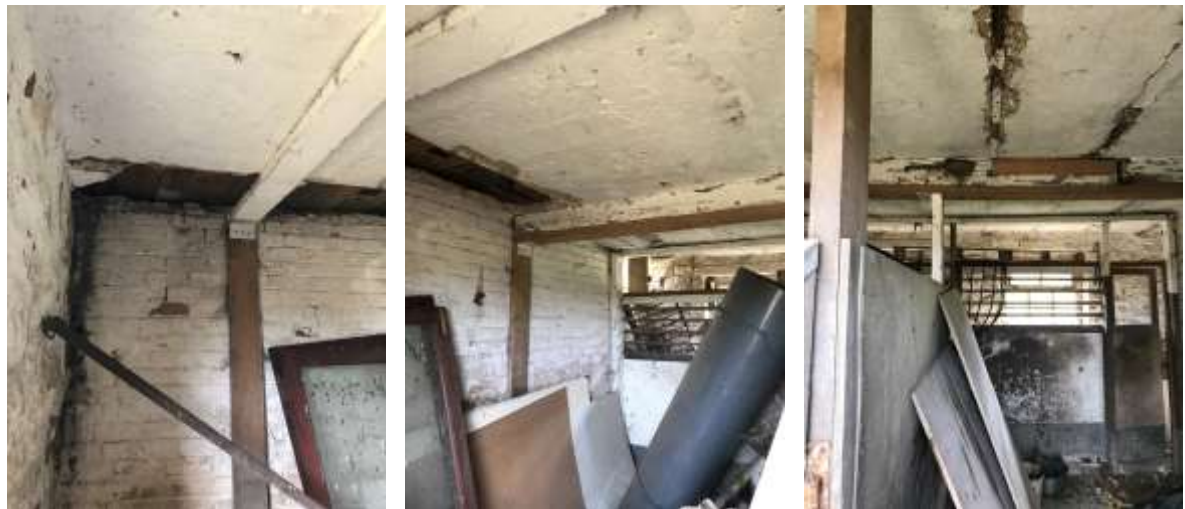
PL. 19. Cement/plaster finishes prevented part of the existing first floor structure over the main Barn from being clarified. Potentially suspended concrete but more likely to be again timber boarded floor supported by timber joists and intermediate metal bracing straps within part of the main Barn. Further intrusive investigations required.

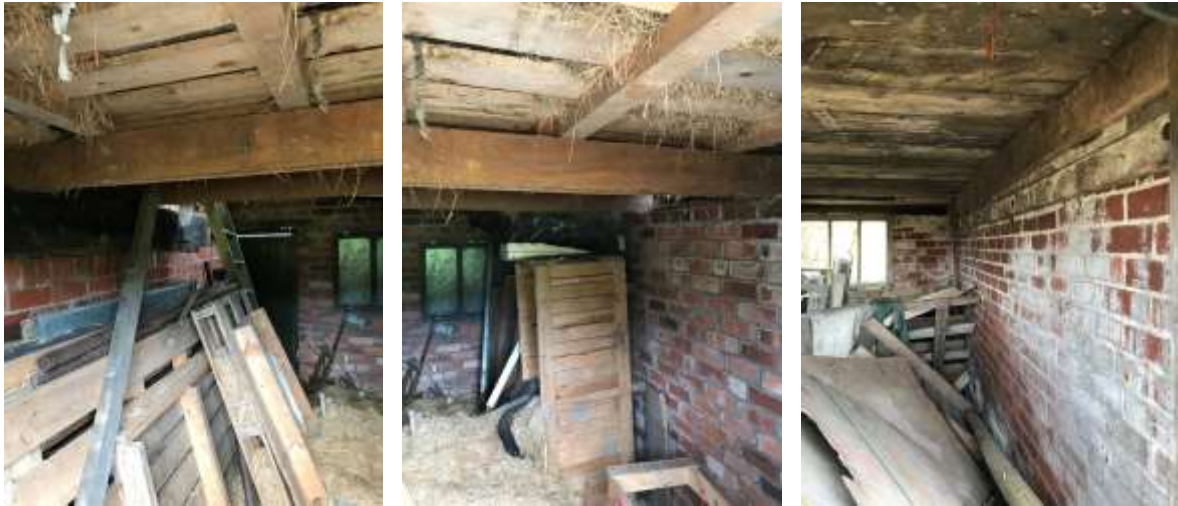
PL. 20. Timber boarded floor supported by timber joists and intermediate metal bracing straps within part of the main Barn.

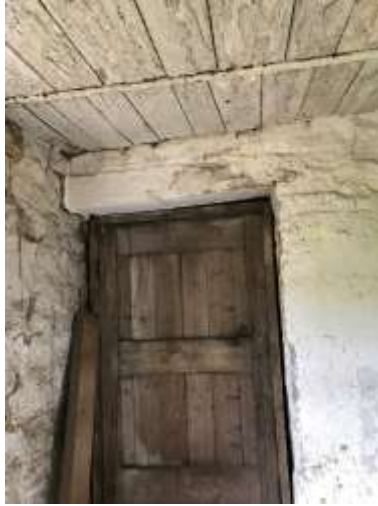
The windows and doors to the building are in poor condition. The doors, door frames and window frames have rotten and decay. Weather proofing in the form of boarding or glazing also wasn't present.

PL. 21. Timber boarded windows and doors throughout illustrated signs of rot and decay throughout due to age (as to be expected).

- Existing timber windows and doors should be removed and replaced with new double glazed timber units to ensure water tightness from wind driven rain at these points.
