A.	Amended at request of L.A.	04/02/19
Revision		Date
<div>HOLDEN Lancashire LIMITED</div>		
83 Blackburn Road, Rishton, BB1 4ER		
Mob: 07738162386 Email : james@holdenlancs.com Website: www.holdenlancs.com		
Drawing Title:		
Proposed External Repairs		
Site Location:		
Crabtree Cottage, Wiswell		
Drawing Status:		
Proposed Plan		
Date:	26/09/2018	Drawn by:
Scale:	NTS/1:50@ A1	Ref:
		002
Revision:		A.
Client:	Mr & Mrs Dodd

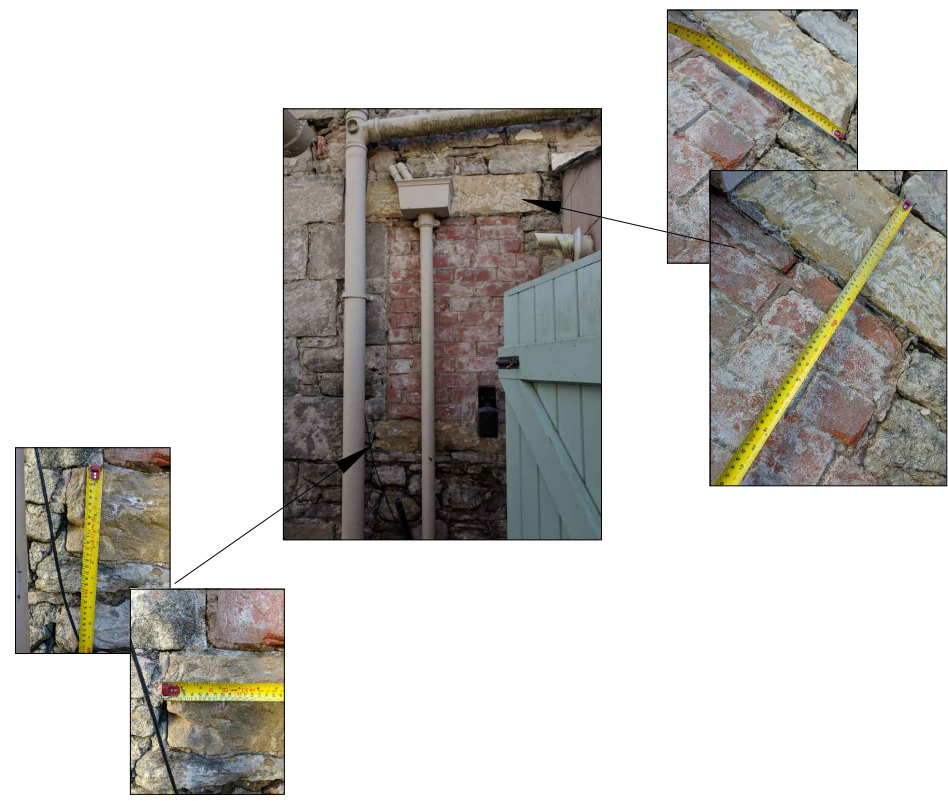
Existing Stone Lintel
& Cill to Barn

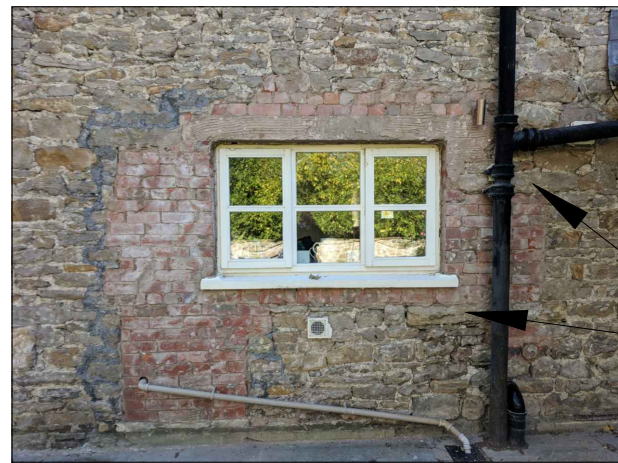
Existing lintel and cill
in place where
previous window was
historically located

16 Provide temporary support to the existing stonework and remove existing window and set aside for reuse. Remove the existing bricks that have been installed around the opening. Install new 230mm deep square edge stone lintels with a 120mm overhand on each side. Install new 150mm deep square edge stone cills with a 60mm overhand on each side. New new stone head and cill will match in with the historic window that once could be found in this area. Reclaimed stone matching in size and colour is to be sourced to patch up where the bricks have been removed. All new stonework is to be fixed in place using the previously agreed lime mortar mix. Finally re-install the previously removed windows.
