# **DAYTIME BAT SURVEY AT DANIELS FARM, PRESTON ROAD, LONGRIDGE, PRESTON, LANCASHIRE**

**JULY 2017**

**RACHEL HACKING ECOLOGY**

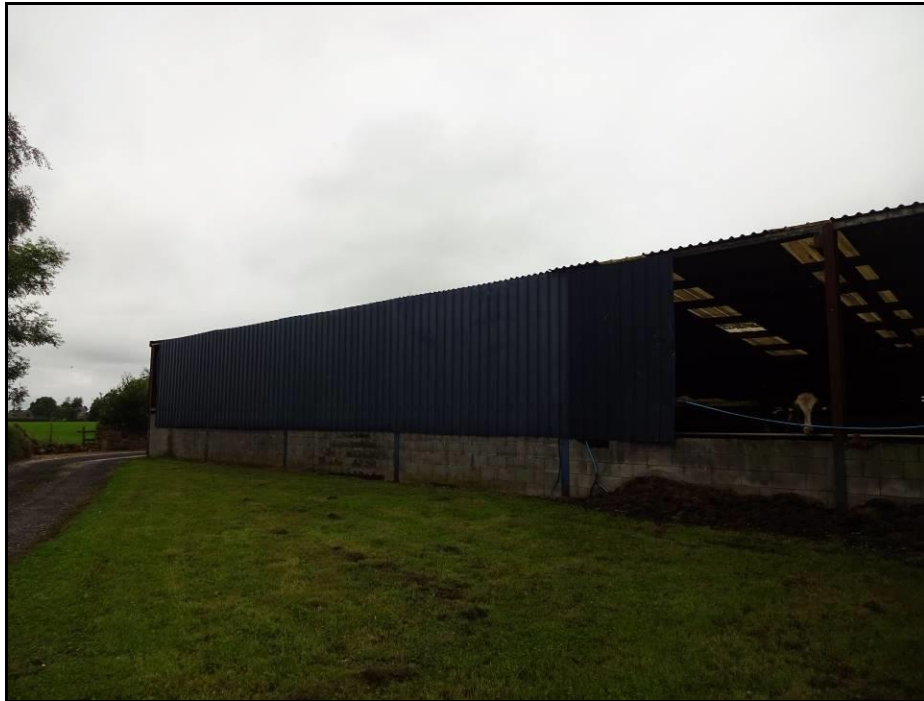
3.2 The main barn has breezeblock walls up to approximately 1.5 metres, then sheet metal or corrugated asbestos panels up to the roof (see Photograph 1). The external walls are intact and in generally good condition. Some of the corrugated asbestos sheeting is damaged and some sections are missing. The mortar between the breezeblocks is all intact. Large parts of the walls are open.

**Photograph 1 showing the exterior of the Large Barn**

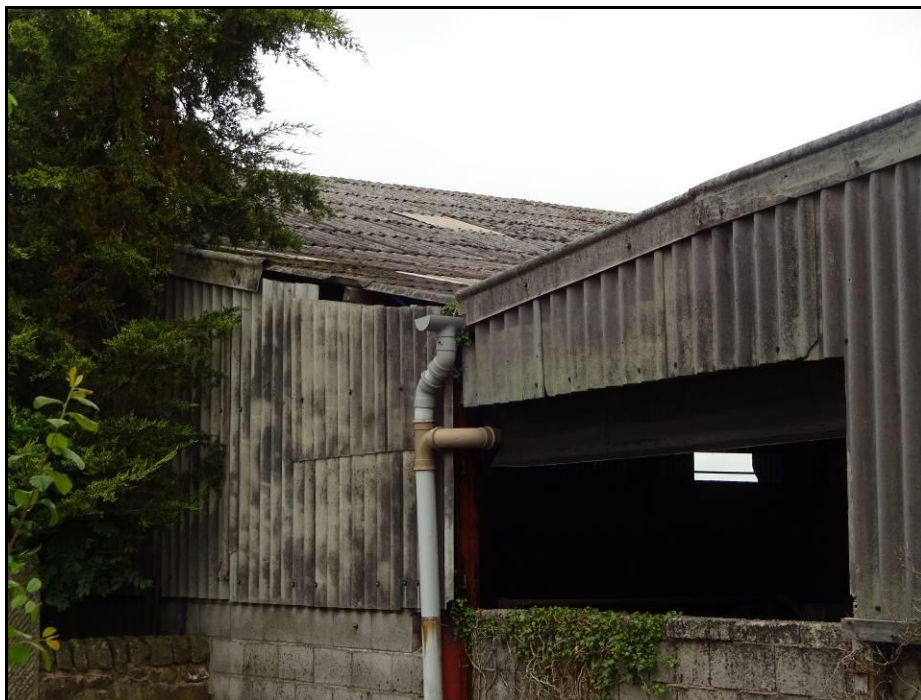
- 3.3 The building has a pitched asbestos cement roof with skylights (see Photograph 2). The roof panels are all complete, intact and flush with each other. Bargeboards cover the join of the walls and roof where present, however these are in poor repair and missing in places. Minor gaps exist beneath, but when inspected these gaps were found not to lead to any suitable roosting opportunities for bats.

**Photograph 2 showing the corrugated asbestos walls and roof**

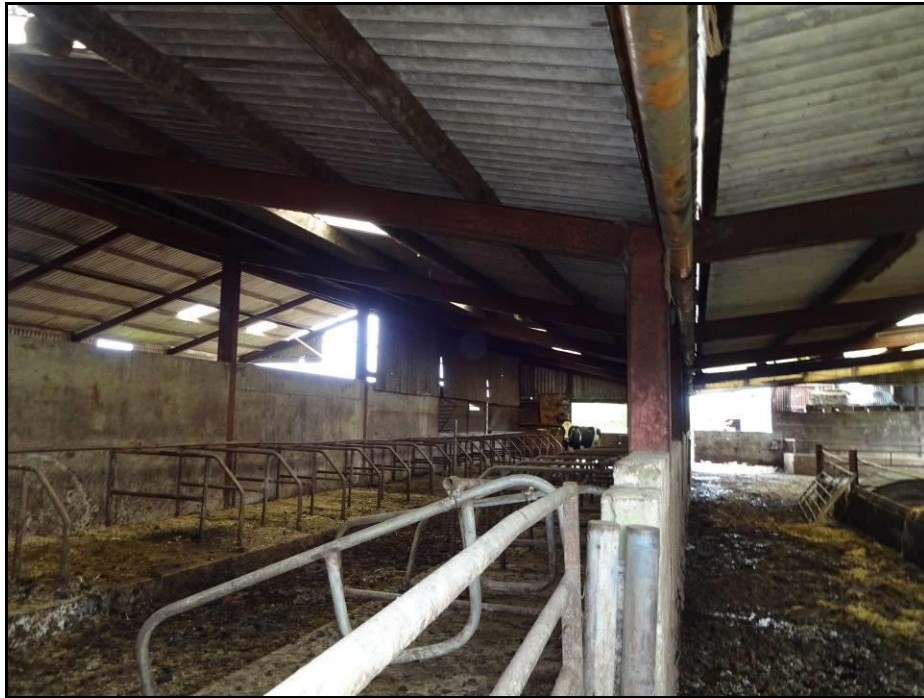
- 3.4 The building does not support a roof void. The entire roof has exposed wooden and steel support beams which are complete and without gaps or significant cracks (see Photograph 3).

**Photograph 3 showing the internal roof beams of the Large Barn**

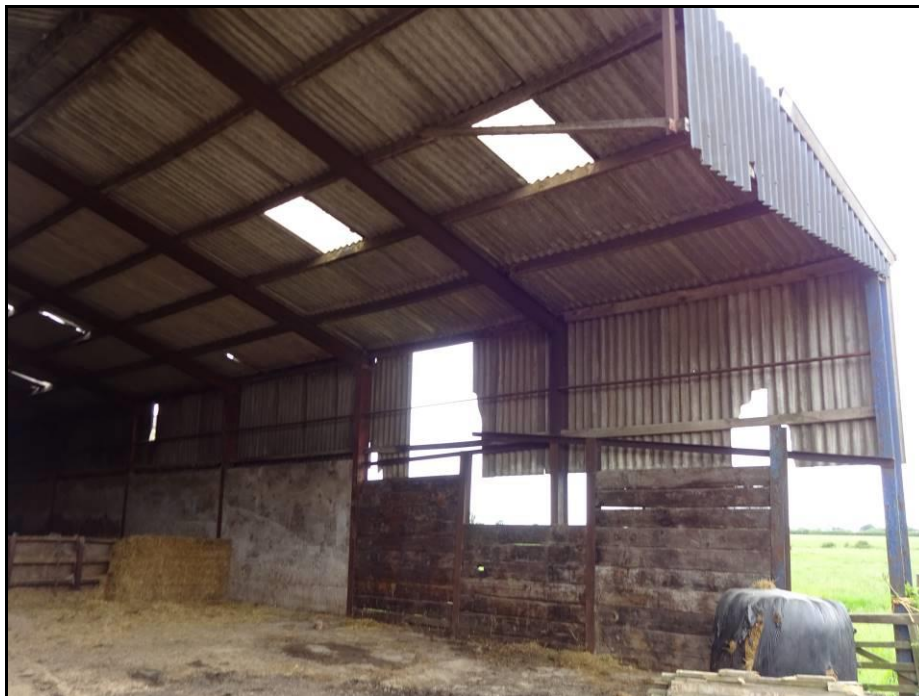
- 3.5 The internal walls have missing panels and are open in places (see Photograph 4). No suitable cavities are present for roosting bats to use.

**Photograph 4 showing the interior gable end of the Large Barn**

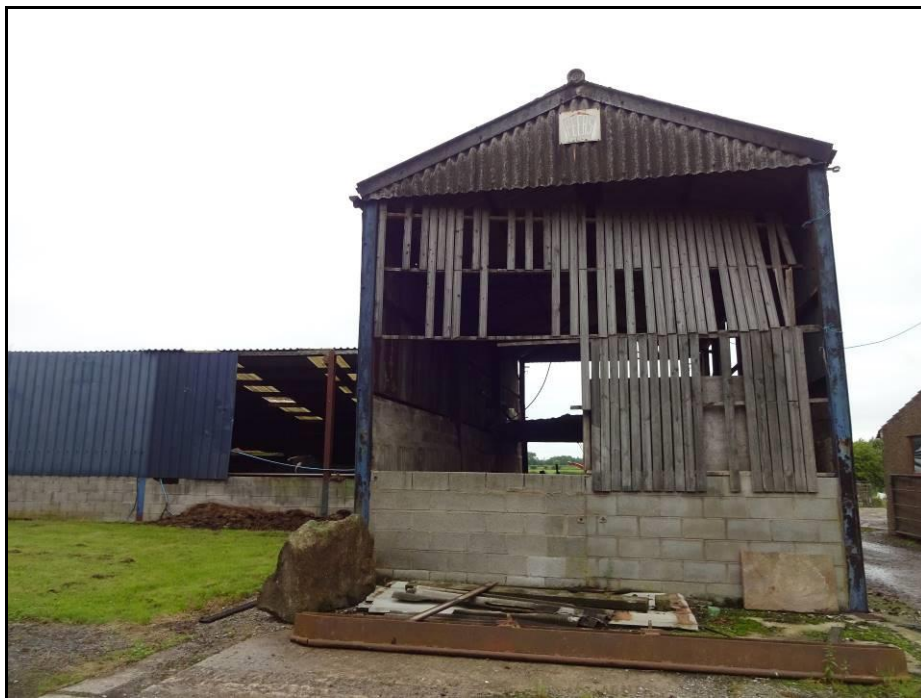
- 3.7 The Small Barn has breezeblock walls up to approximately 1.5 metres then a combination of corrugated metal and wooden panels up to the roof (see Photograph 5). The wooden panelled walls are in poor condition, with missing panels. This leaves the building open and the northern elevation is completely open. The corrugated metal also supports gaps.

**Photograph 5 showing the walls of the Small Barn**

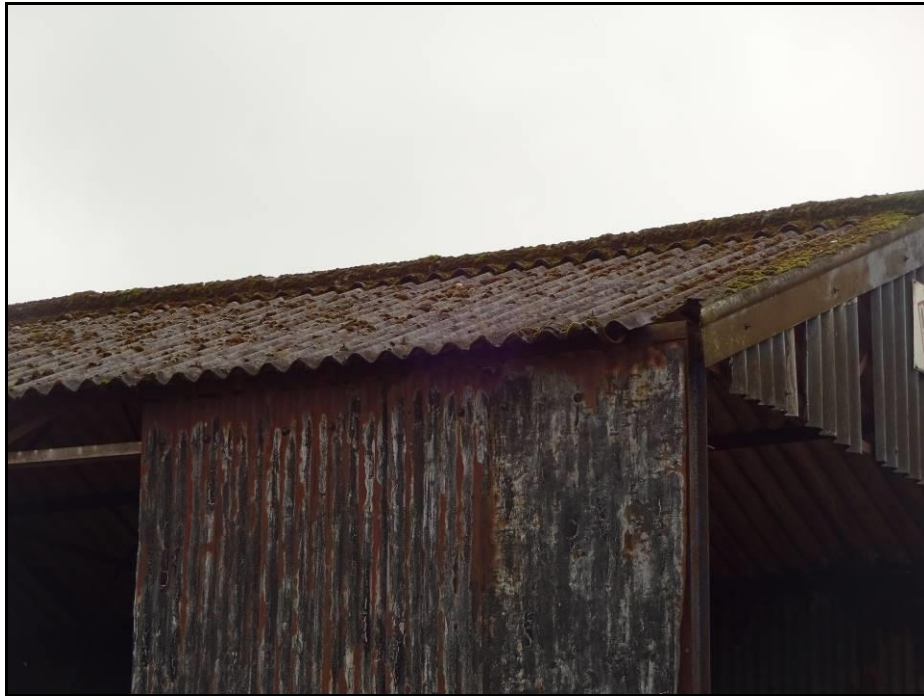
- 3.8 The building has a pitched asbestos cement roof (see Photograph 6). The panels are all complete, intact and flush with each other. The ridge tiles are all present and intact. Bargeboards are present on the gable ends which seal the gaps between the roof and the walls. On the other sides minor gaps exist beneath, but when inspected these gaps were found to be very shallow and not to lead to any suitable bat roosting opportunities.

**Photograph 6 showing the roof of the Small Barn**

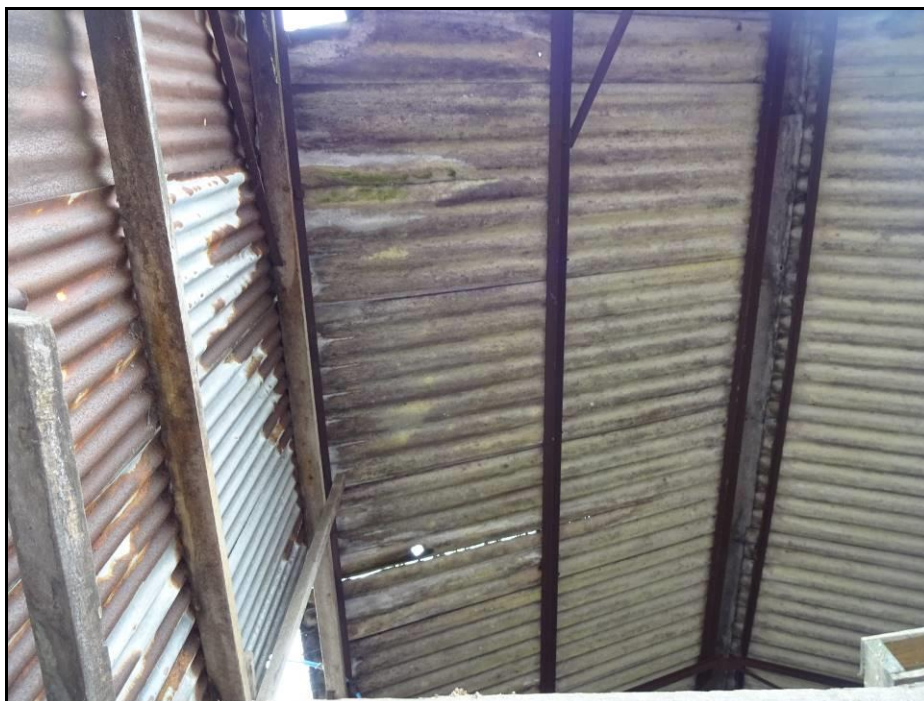
- 3.9 The building does not support a roof void. The entire roof has exposed metal support beams which are complete and without gaps or cracks (see Photograph 7).

**Photograph 7 showing the internal roof beams of the Small Barn**

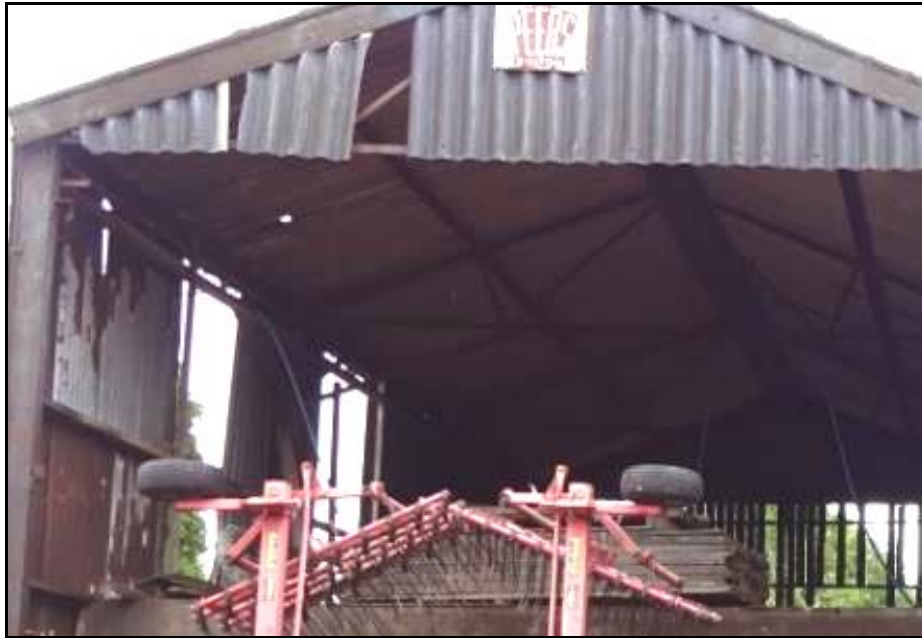
- 3.10 This building is well-lit with daylight and draughty from the open sections (see Photograph 8). No suitable bat roosting cavities were found and no evidence of bat activity, such as bat droppings, was found within the Small Barn.

Photograph 8 showing the interior of the Small Barn

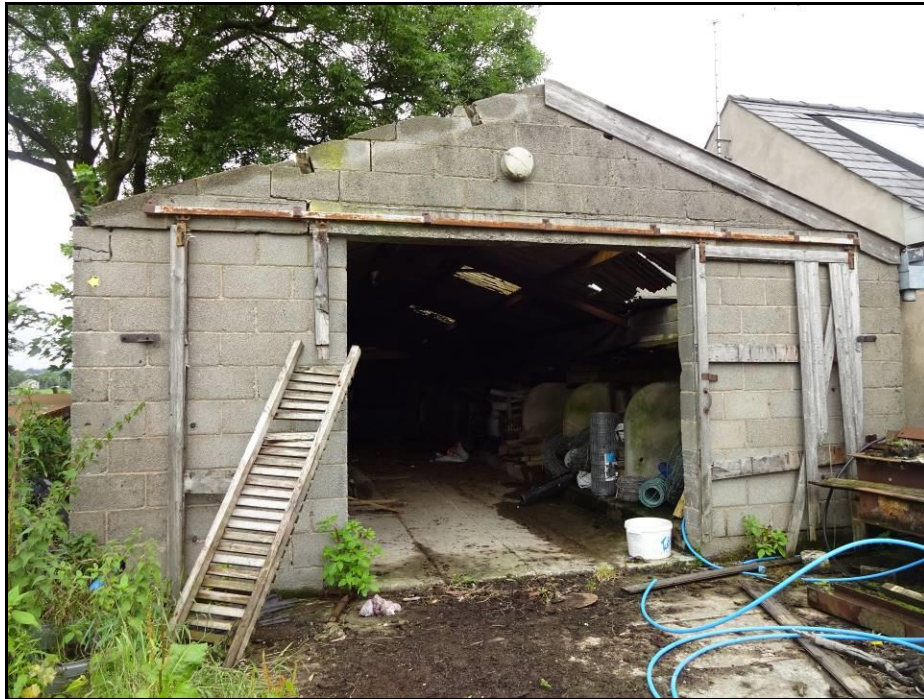
- 3.11 The external breezeblock walls of the Feeding Shed are complete and mostly intact, with only negligible, shallow cracks in the brickwork (see Photograph 9). The wooden door frame it is not useable so the front is left open. Sections of bargeboard are missing, leaving gaps into the building. The pieces left remain flush with the brickwork, with no suitable cavities for roosting bats.

**Photograph 9 showing the front of the Feeding Shed**

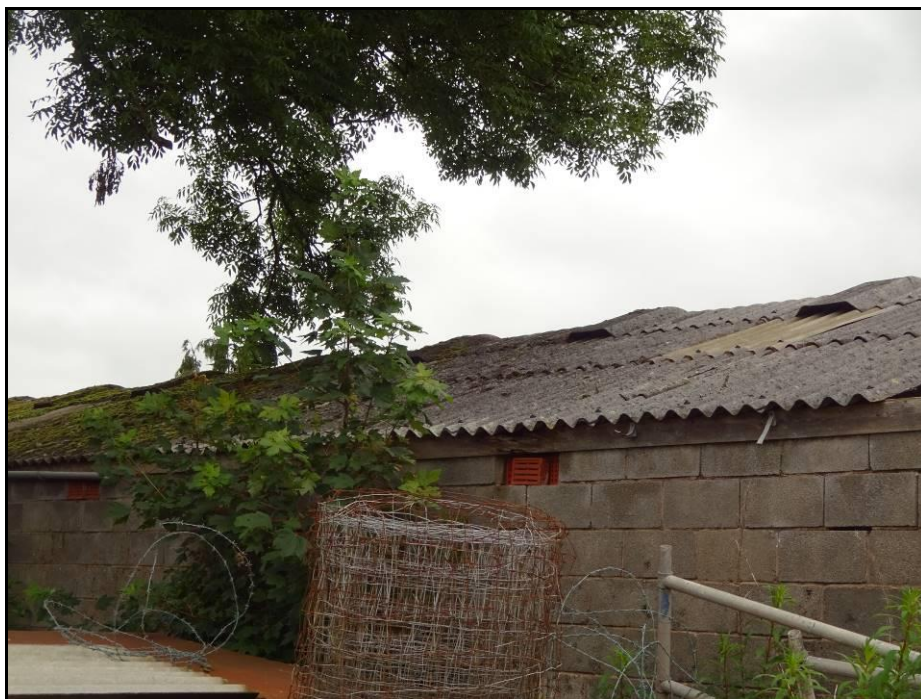
- 3.12 The building has a pitched corrugated asbestos roof with skylights (see Photograph 10). The panels are mainly complete and flush with each other, with some cracks and broken panels. Minor gaps exist between the roof panels and the walls, but when inspected these gaps were found to be very shallow and do not lead to any suitable bat roosting spaces.

**Photograph 10 showing the roof of the Feeding Shed from the north of the property**

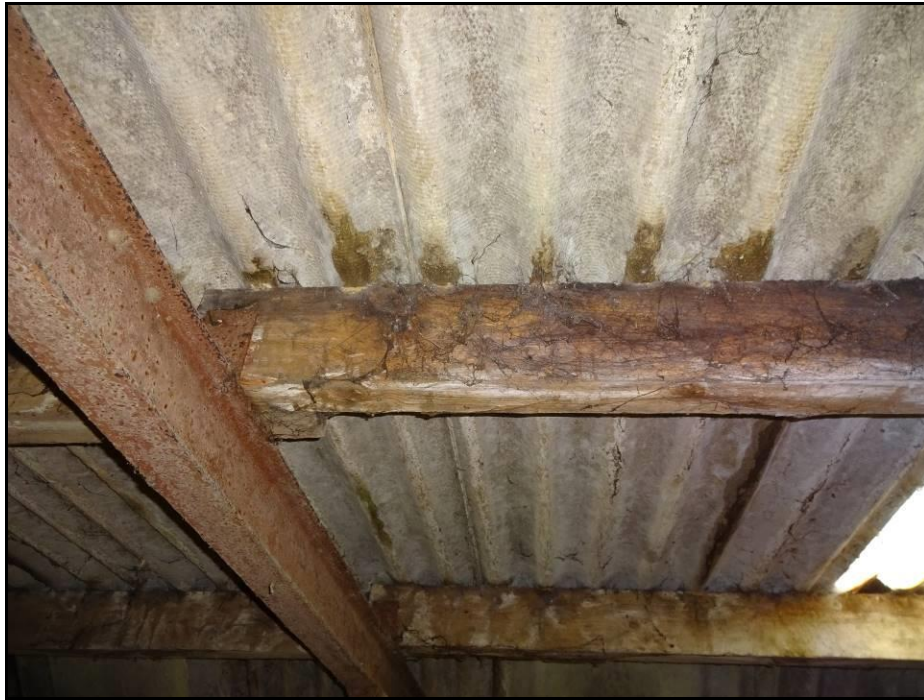
- 3.13 The building does not support a roof void. The entire roof has exposed wooden and metal support beams which are complete and without gaps or significant cracks (see Photograph 11). The ceiling is very dusty and cobwebbed, suggesting that there has been no recent bat activity.

**Photograph 11 showing the roof beams of the Feeding Shed**

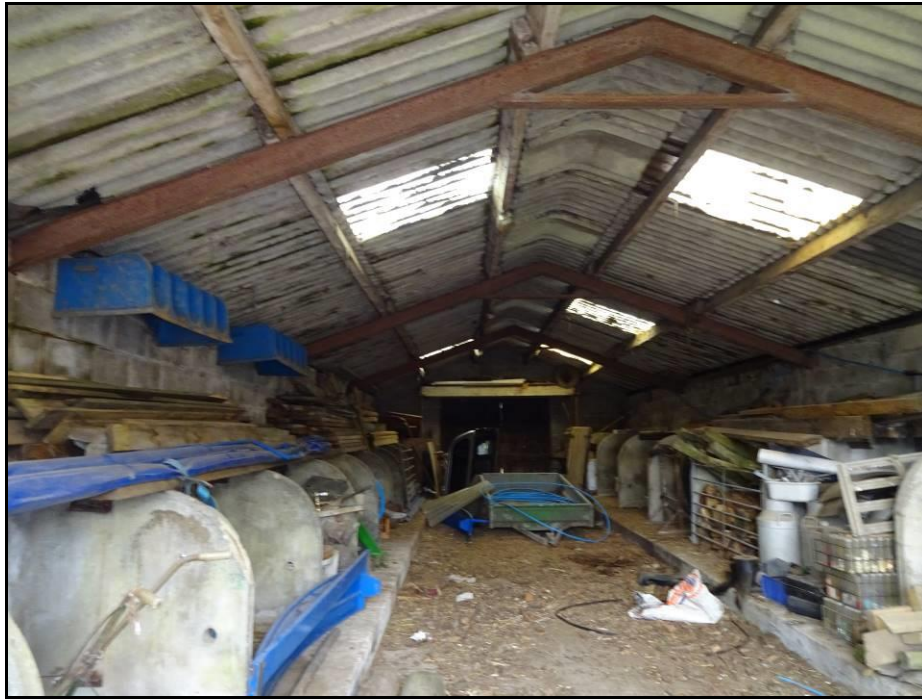
- 3.14 The internal brickwork is in good condition, with minimal missing mortar and damage, leading only to shallow gaps. These recesses were inspected fully and no suitable bat roosting cavities were found. The room is well-lit with daylight visible through the skylights and around the back door (see Photograph 12).

**Photograph 12 showing the interior of the Feeding Shed**

- 3.15 A very small number (<10) of bat droppings were found scattered sparsely on the ground of the Feeding Shed. As there is no concentration of droppings, this appears to be where bats have entered through the open doorway to forage. No other evidence of bat activity was found. No suitable roosting cavities for bats exist. Old bird nests were balanced on roof beams. These were inactive.

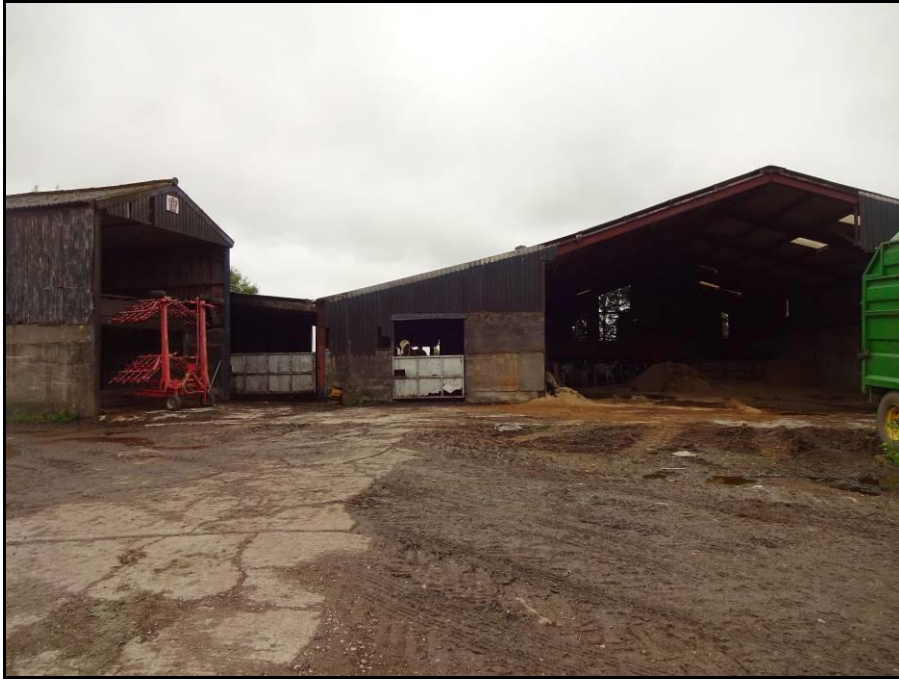
- 3.16 The surrounding buildings have intact tiled, pitched roofs that look preferable for use by bats. All the buildings occur within the farm complex which is a large area of hardstanding (see Photograph 13). Ephemeral vegetation has started to develop over some of the hardstanding, where a large amount of building materials are stored (see Photograph 14). Himalayan Balsam *Impatiens glandulifera* is present within this ephemeral vegetation adjacent to the feeding shed. Himalayan Balsam is an invasive plant species and is listed on Schedule 9 Part II (plants) of the Wildlife and Countryside Act 1981 (as amended). A small area of amenity grassland occurs at the front of the large barn, this is regularly managed through mowing (see Photograph 15). The surrounding pasture with hedgerows and mature trees offers commuting and foraging opportunities for bats.

**Photograph 13 showing the hardstanding around the buildings**

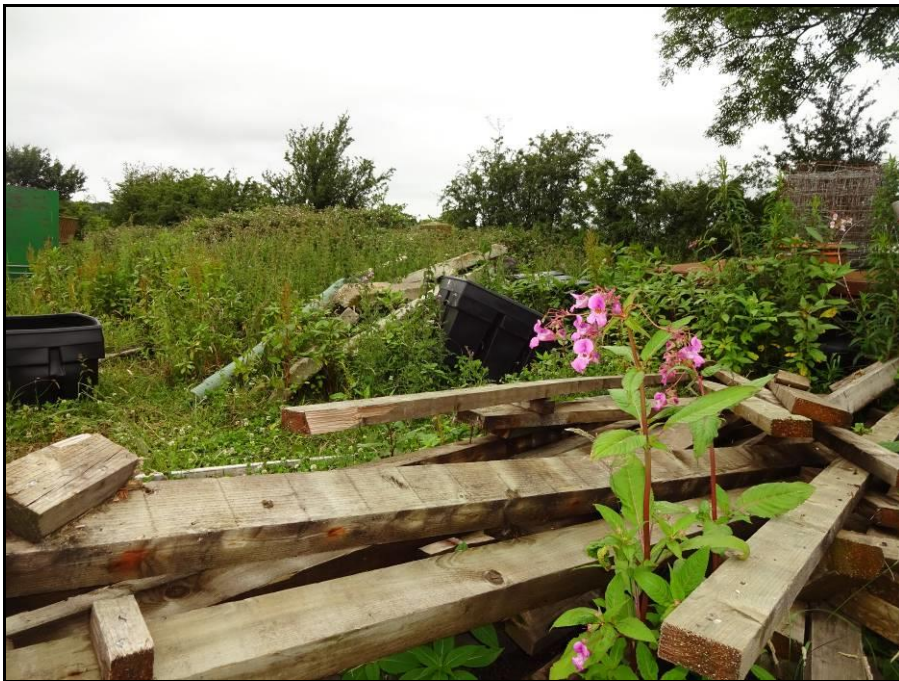
**Photograph 14 showing the ephemeral vegetation**

- 4.6 It is recommended that the Himalayan Balsam is removed prior to work commencing or during construction, using a suitable eradication methodology such as strimming or application of herbicide.
