Tree Condition Report & Management Recommendations

Site Ref: 'Candlemakers Court,
Clitheroe, Lancashire, BB7 1AH

Date of Inspection: 10th October 2018

Arboricultural Report for:
Viridis Ref: Oct 201801
Author: D Rigbye

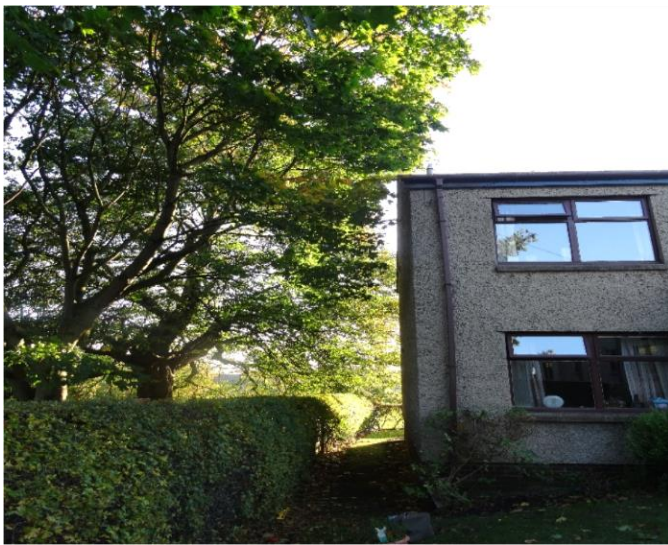
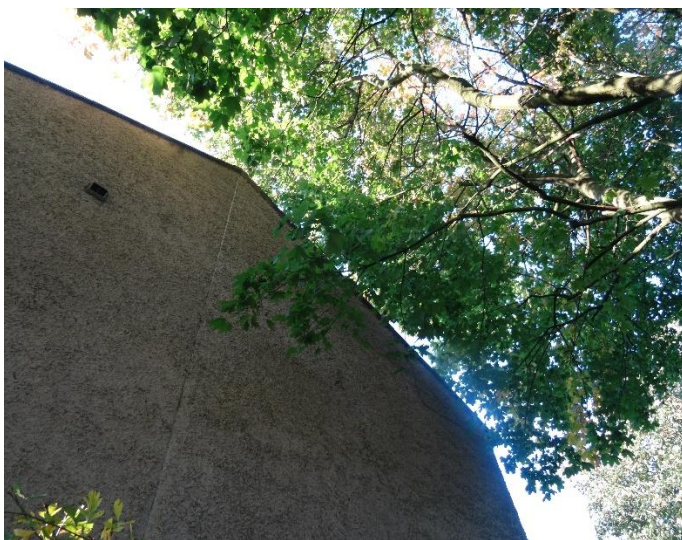
There is a number of branches coming into direct contact with the gable end of the property and roof. From a liability perspective the tree owner is liable for damage proven as a result of tree branches coming into contact with the property.

Image 1 and 2 – T1 contact with property

A 211 Notification should be made to Ribble Valley Borough Council to remove the two limbs on T1 Norway Maple of which branches are coming into contact with the gable end of 7 Candlemakers Court. The removal of these two limbs will abate any nuisance and give enough clearance that further works are not required for the near future as regards clearance from the property. Deadwood should also be removed over the pathway at the side of the property.

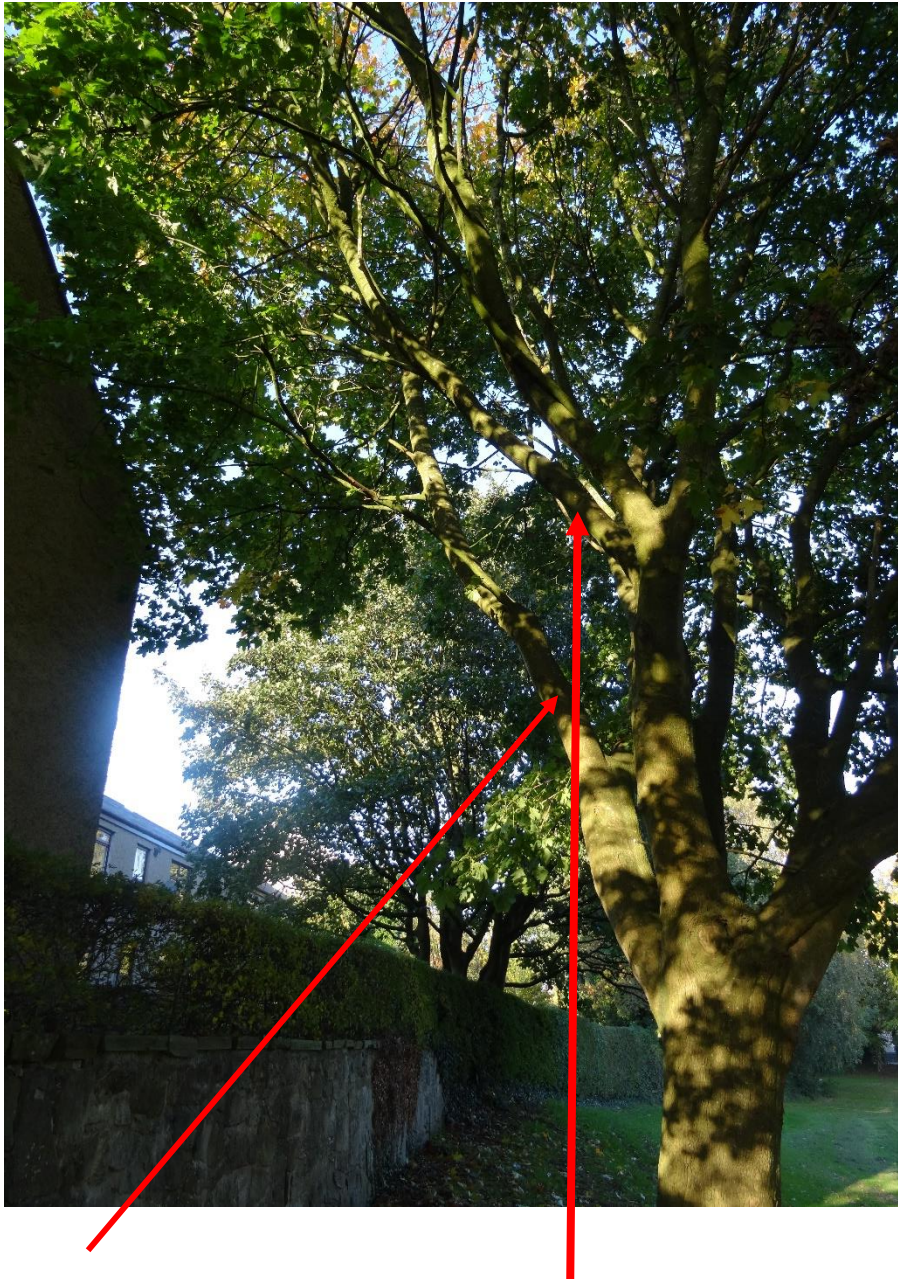
Image 3 Two limbs from T1 to be removed to abate nuisance

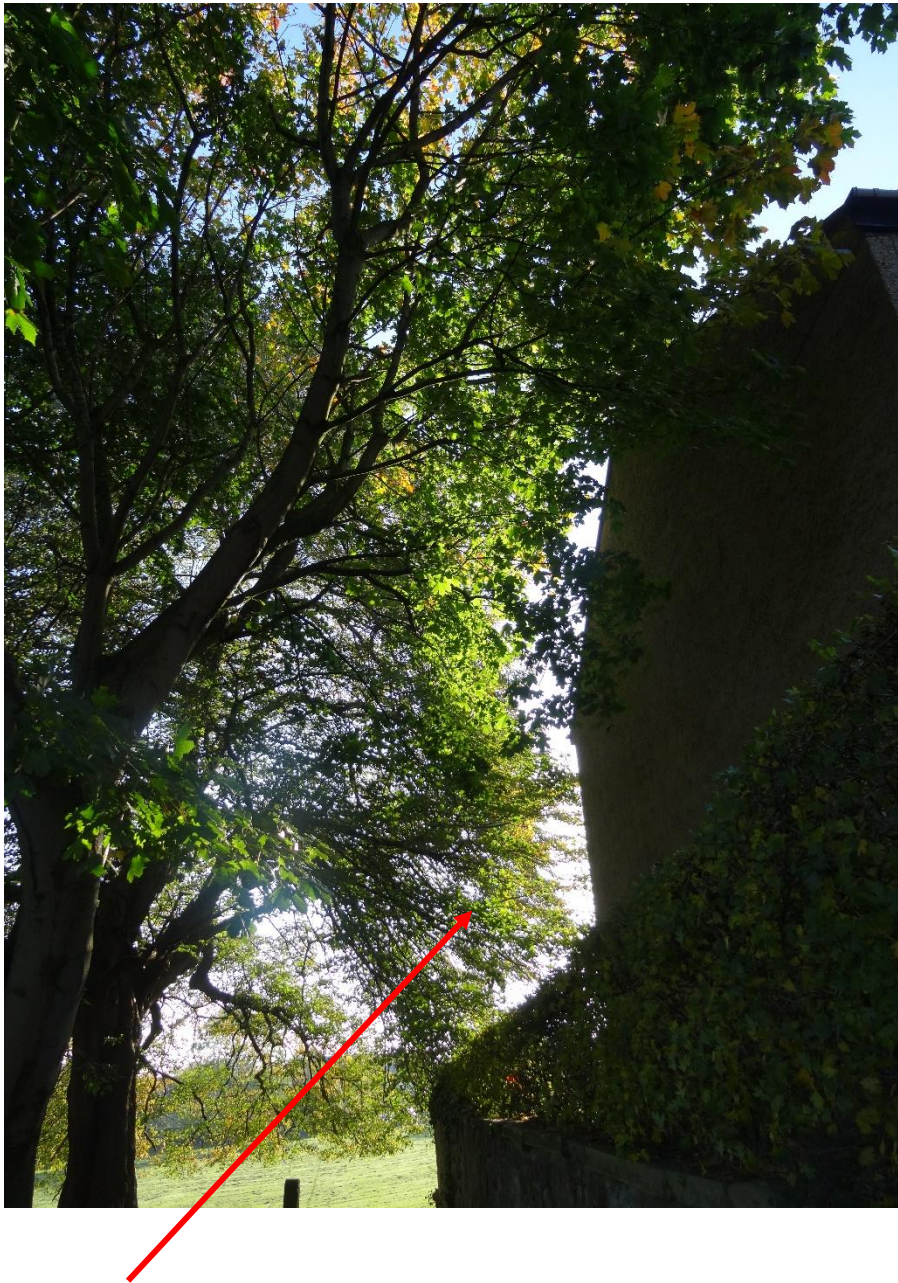
Branches coming toward the property in question should be sympathetically pruned back in accordance with the relevant legislation given the trees age. A tree of this age will take substantially longer to react to pruning wounds and therefore it is recommended that the minimum is pruned off the tree to abate any nuisance in regard to branches coming into contact with the south eastern edge of the property, in this case I recommend up to two meters.

Image 4 General area of branches from T2 to be pruned back from edge of property by up to two meters.

T2 Small Leaved Lime should be sympathetically pruned back up to two meters from the south eastern edge of the property to suitable junctions.
