**Preliminary
Arboricultural Report
for Mortgage and
Insurance Purposes**

20 Mellor Lane
Mellor
Blackburn
BB2 7JR

24/07/2018

GMTC Job Ref: 1200

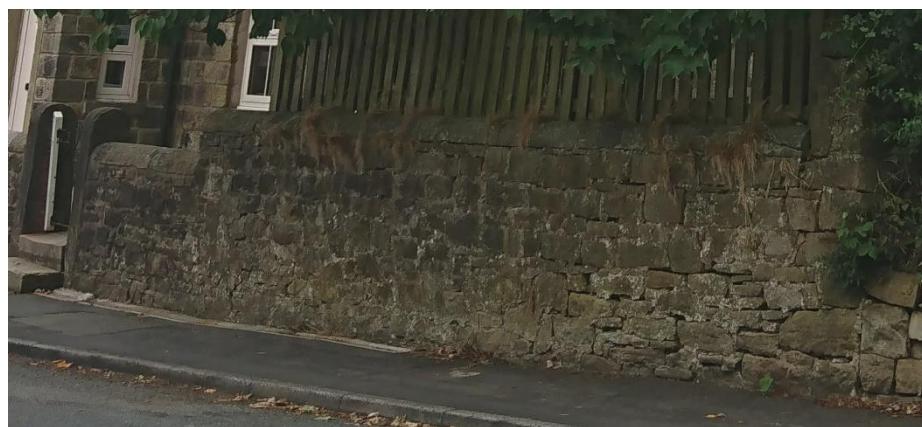
There is a risk that future growth could cause direct damage to light loaded structures such as fences, walls, patios etc due to their less substantial foundations / footings. The boundary retaining wall does have some visual indicators of long term movement, although in my opinion from the visual characteristics of the wall this has occurred over the extensive life of the trees which is in excess of 40 years and I do not foresee the trees continuing to damage the wall in the short term. If additional cracking did occur the trees could be removed.

Inspect the boundary wall annually for signs of additional cracking.

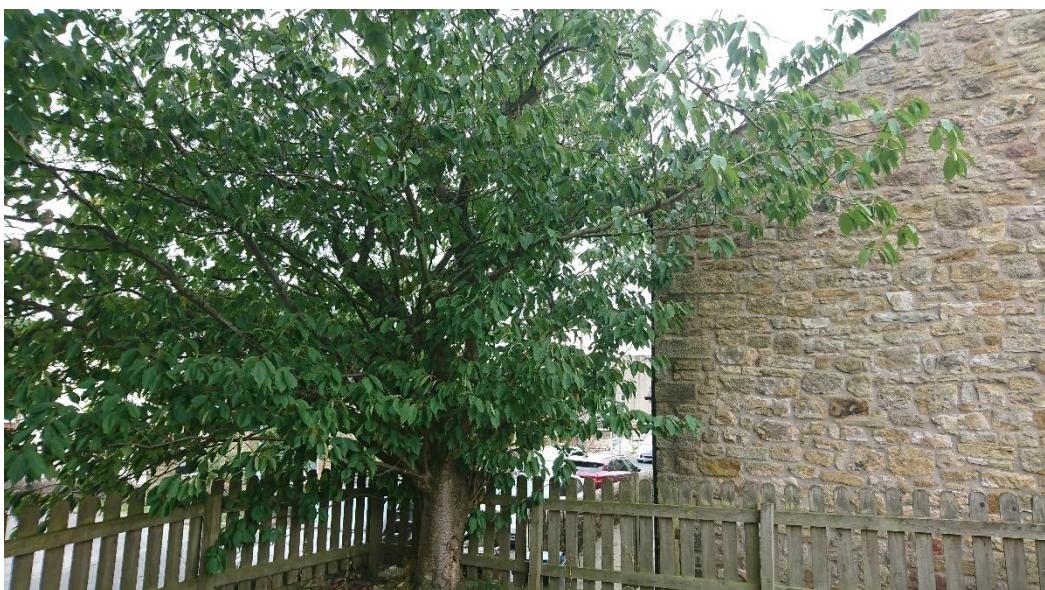
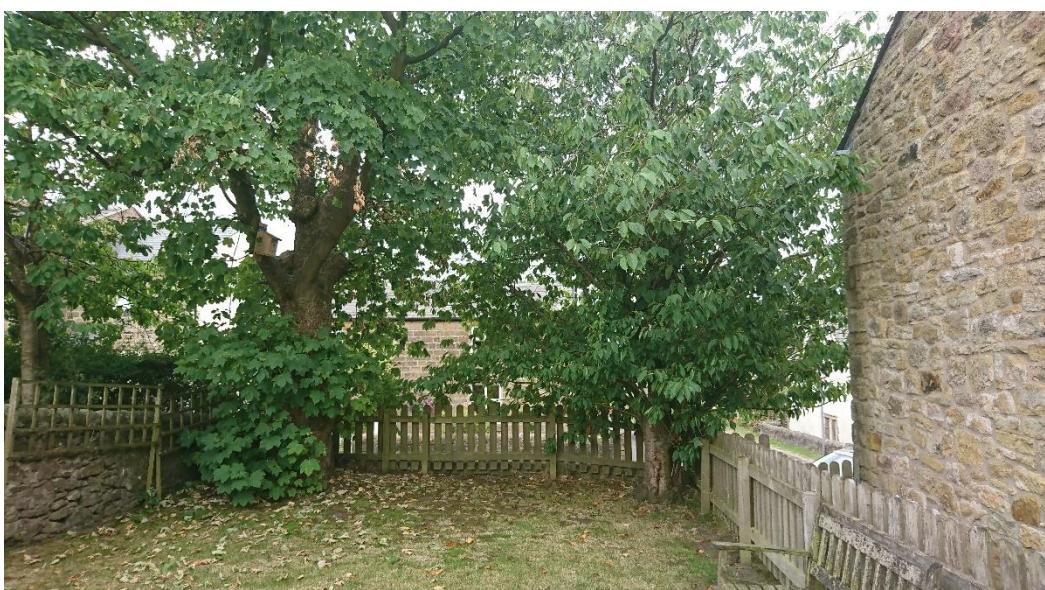
The cherry tree has developed a canopy that is in close proximity to the property, it is recommended that this is pruned back and maintained to give at least 1m clearance from the roof and structure, clearance over the road and footpath must also be maintained. Removal of the tree is optional and would not be detrimental to the landscape if the client so desired.

Carry out pruning works on the 2 trees to give clearance from the property, road and footpath.

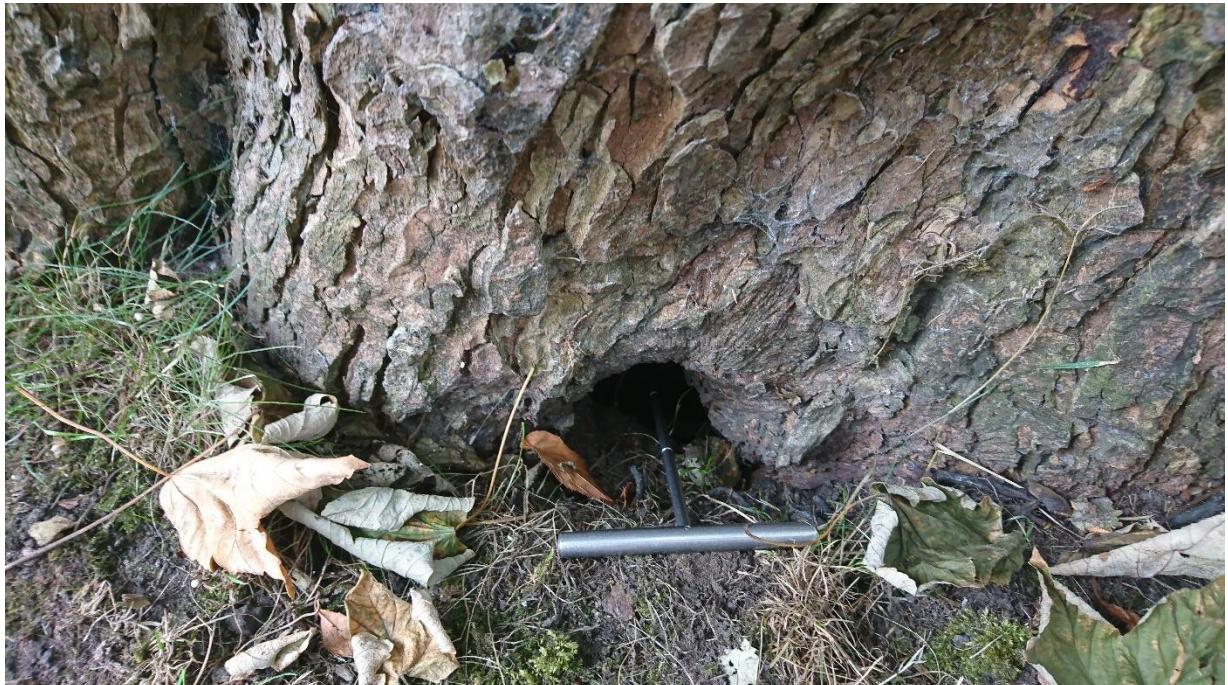
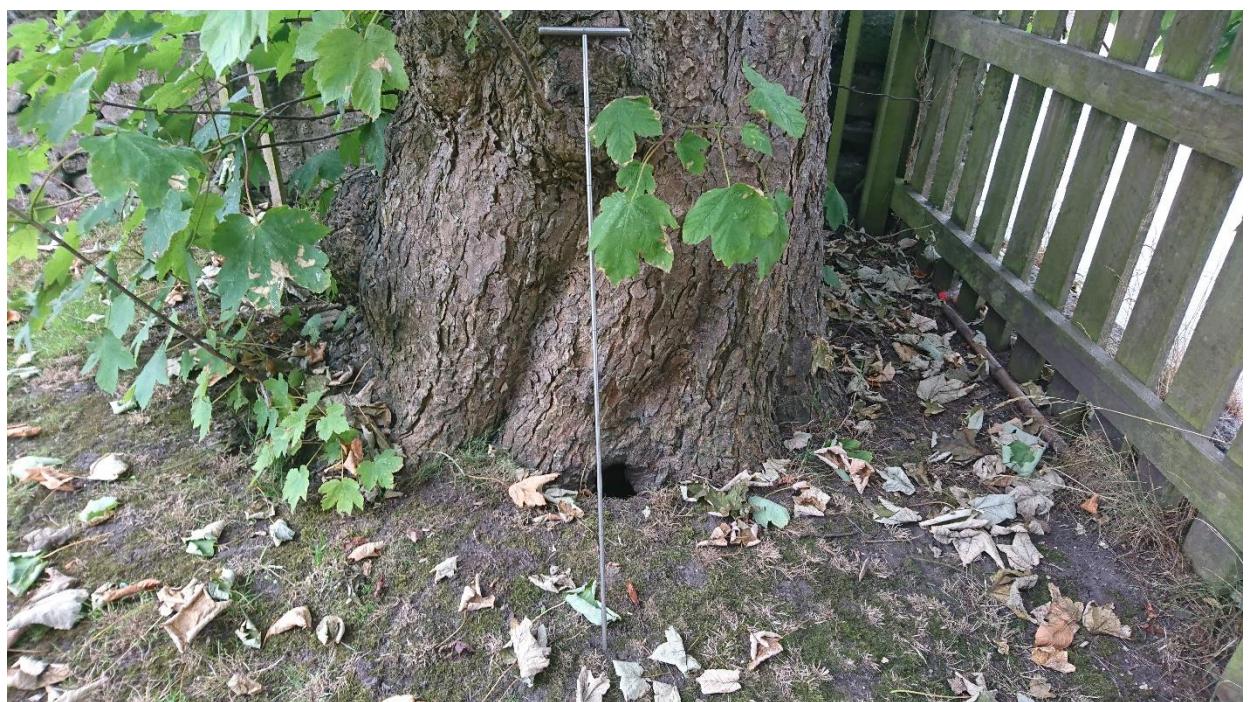
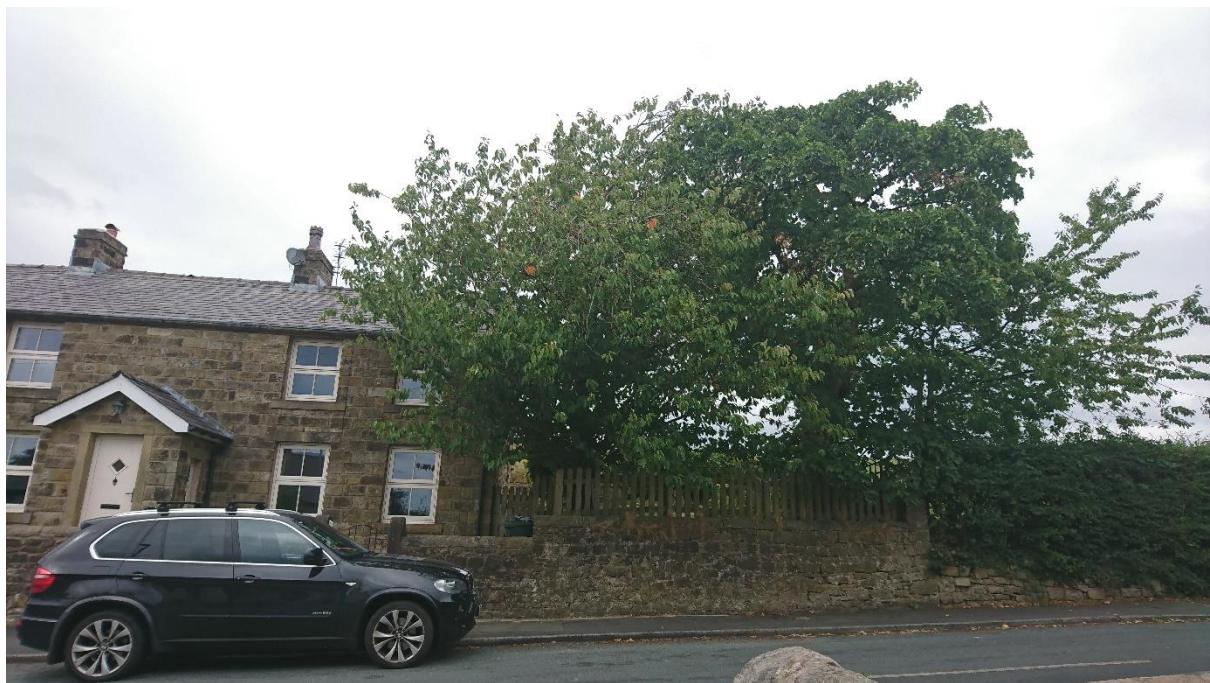
The Sycamore tree has good vitality. There is an internal cavity within the main stem that is accessible through the hole at ground level, as the tree does not have a tall canopy framework there is no imminent visual risk of failure, but ongoing monitoring is recommended to assess the extent of the internal cavity by using a resistograph, at least within every 5-year interval. As with the cherry, clearance over the road and footpath must also be maintained.
