Barn at Lower Stony Bank  
Easington, Lancashire:  
Historic Building Record

October 2018

STEPHEN HAIGH

### Historic Building Record

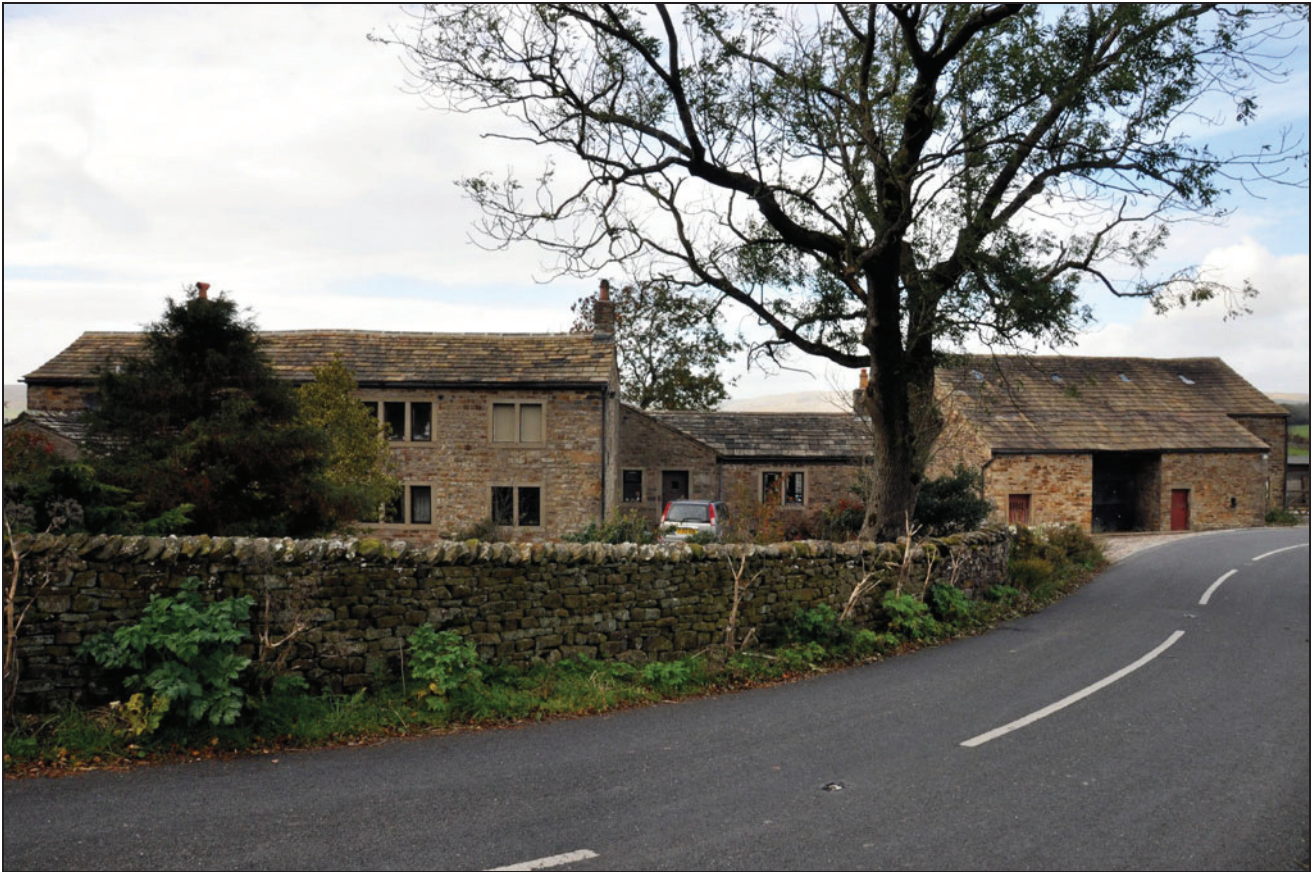
- 8.1 The barn stands to the north-east of the farmhouse, facing onto a modern stone forecourt with the road beyond, and these historic buildings of various dates form a loose cluster, with a common, south-east facing alignment (**1,2**). The barn has walls of local sandstone rubble, roughly squared and partly coursed, and the roof is stone slate, although it has been re-laid in recent years (**3**). The quoins are generally undistinguished from the walling stone, and although some of the doors and windows have finely dressed sandstone surrounds, others have rough flagstone sills and lintels.

Photo 1: General view of the farmstead, from the south-east

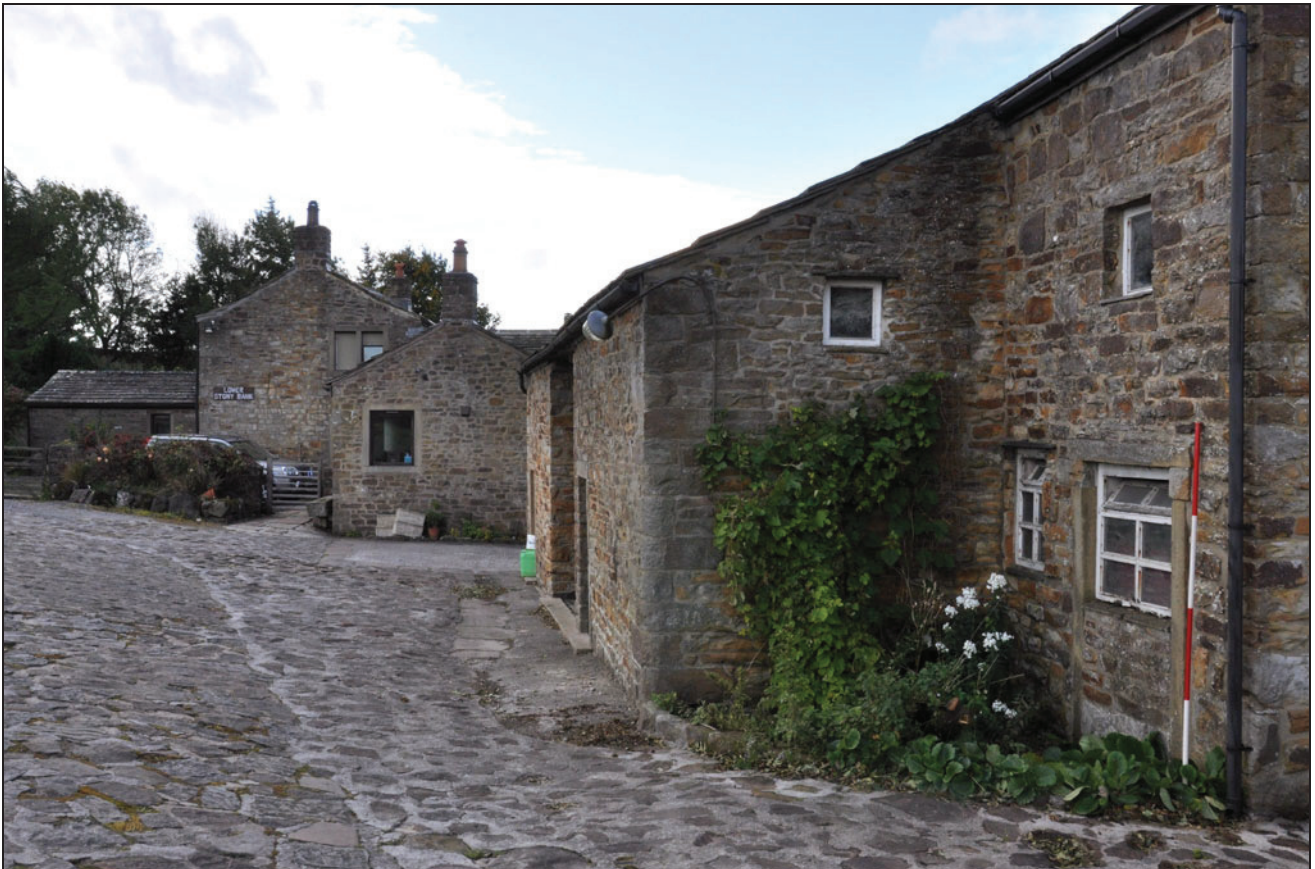
Photo 2: Barn and farmhouse, from the north-east

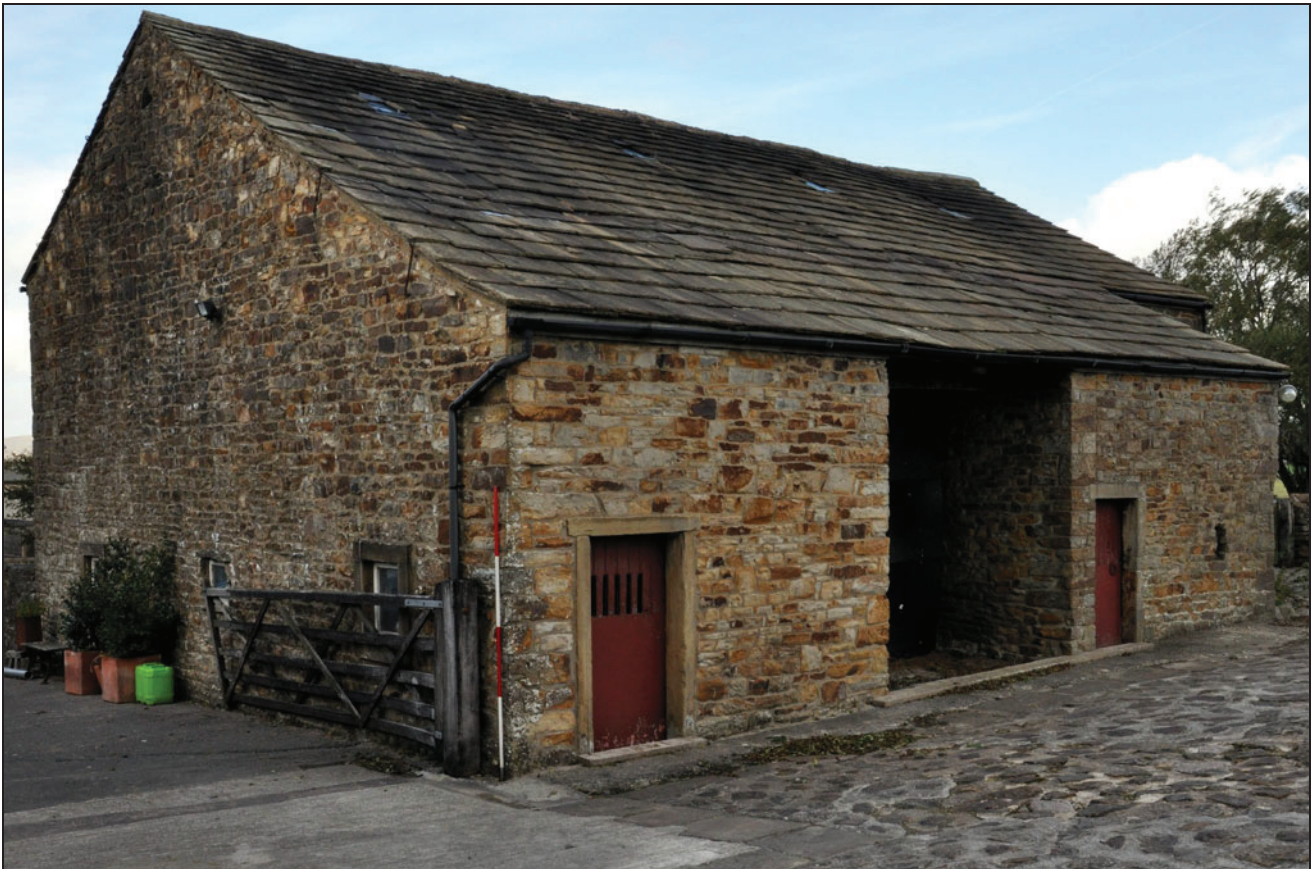
- 8.2 In plan, the building was originally L-shaped, with a wider south-west end incorporating the porch to the front elevation, and this L-shape persists, despite the small historic addition to the right of the porch (**4**). The longer roof slope to the front pitch continues down unbroken over this south-east side of the building.

Photo 4: The barn, looking north

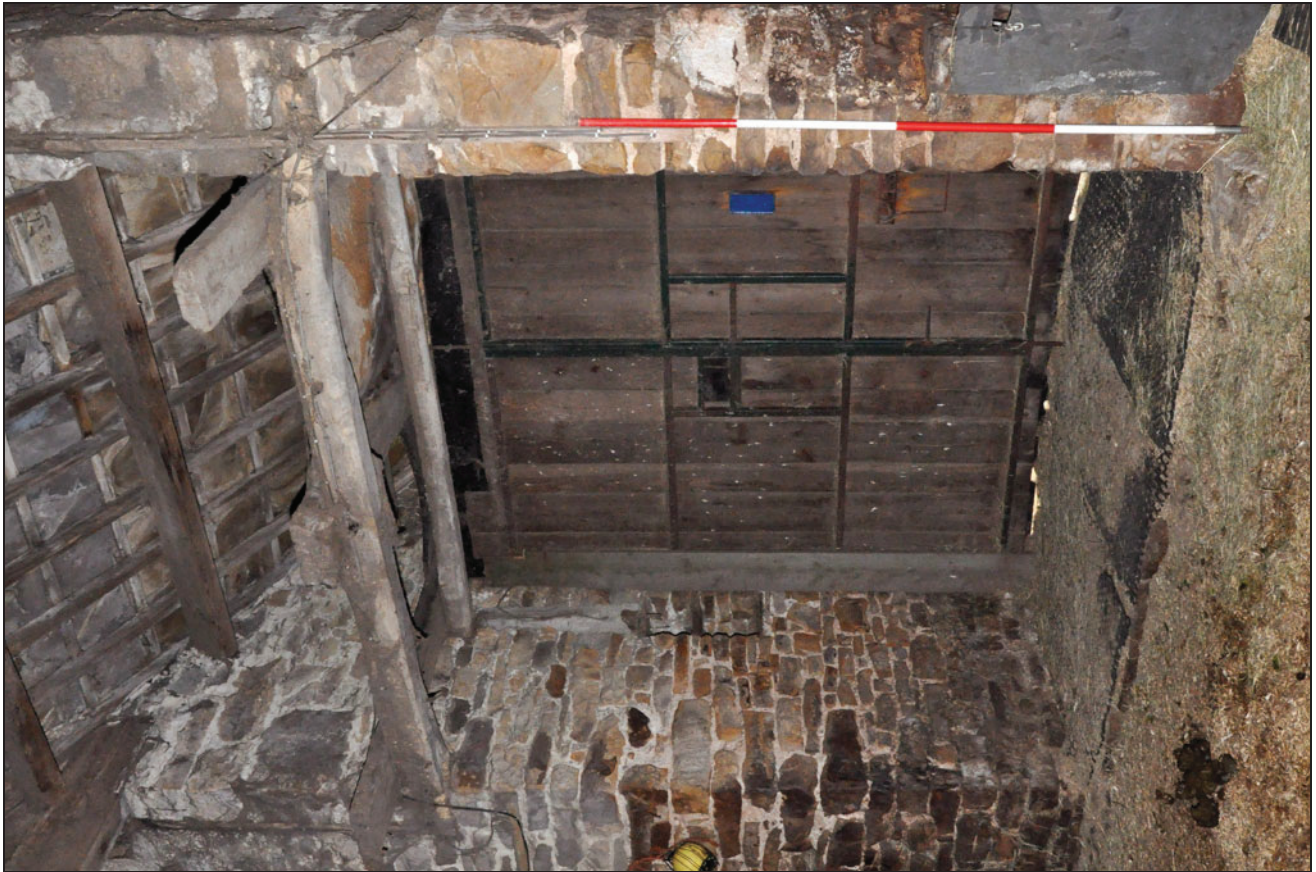
replacements set forward of this (5,6). A shelved recess is set within the right-hand side of the porch, and opposite that is a glazed window, probably created from another recess. Oak beams, including the door lintel, once supported a loft over the entry, but this has been removed, and the outer lintel at the building's eaves is a modern softwood replacement.

Photo 5: Internal view of porch, looking east

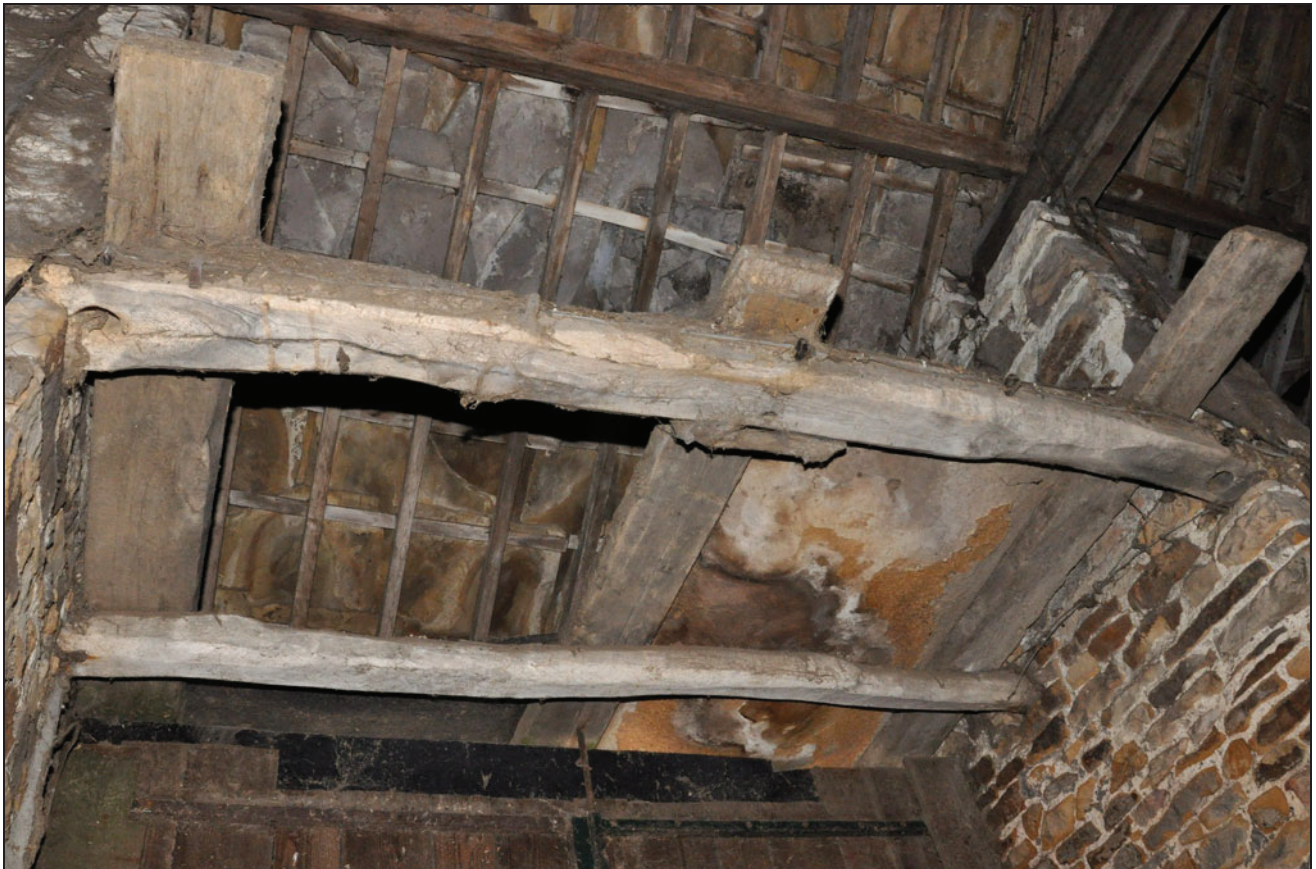
Photo 6: Detail of underside of doorway lintel, within porch

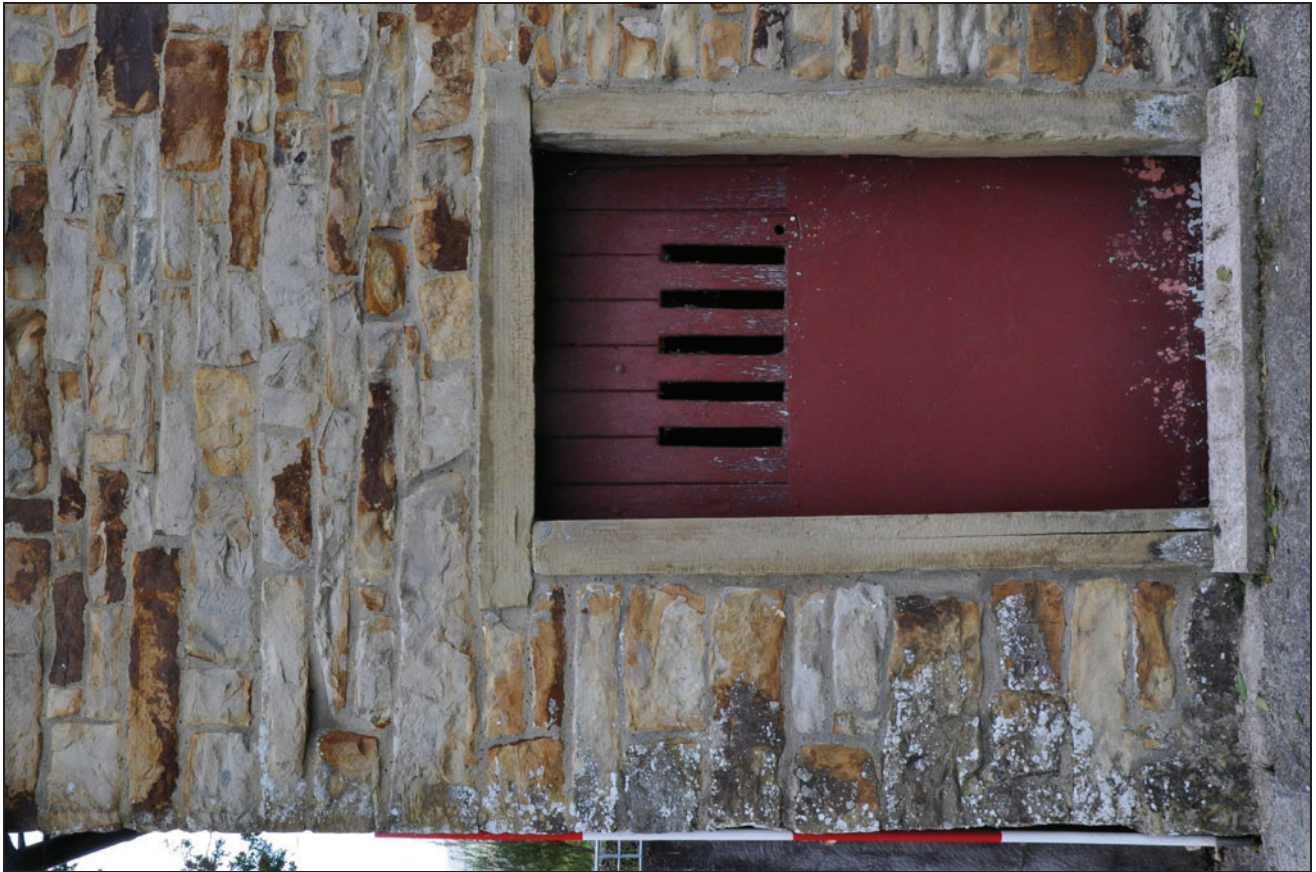
- 8.4 To the left of the porch is a pedestrian doorway into the shippon (7), and its present timber door, with sliding hit-and-miss ventilator, may be an original fixture. To the right of the porch, a second pedestrian doorway of different form has been incorporated within the small extension here; the doorway has a concrete lintel internally. There is a small plain breather beyond this opening (8). Within the extension, two blocked breathers can be identified in what was the barn's original front, as well as a larger opening at first floor level, which lacks dressings and may be an insertion. The outer north-east end of this addition has an unusual recess at ground level, which might have formed an opening at one time, together with an upper level window, inserted or rebuilt in recent years (9).

Photo 7: Doorway to shippon, in south-west end of front elevation

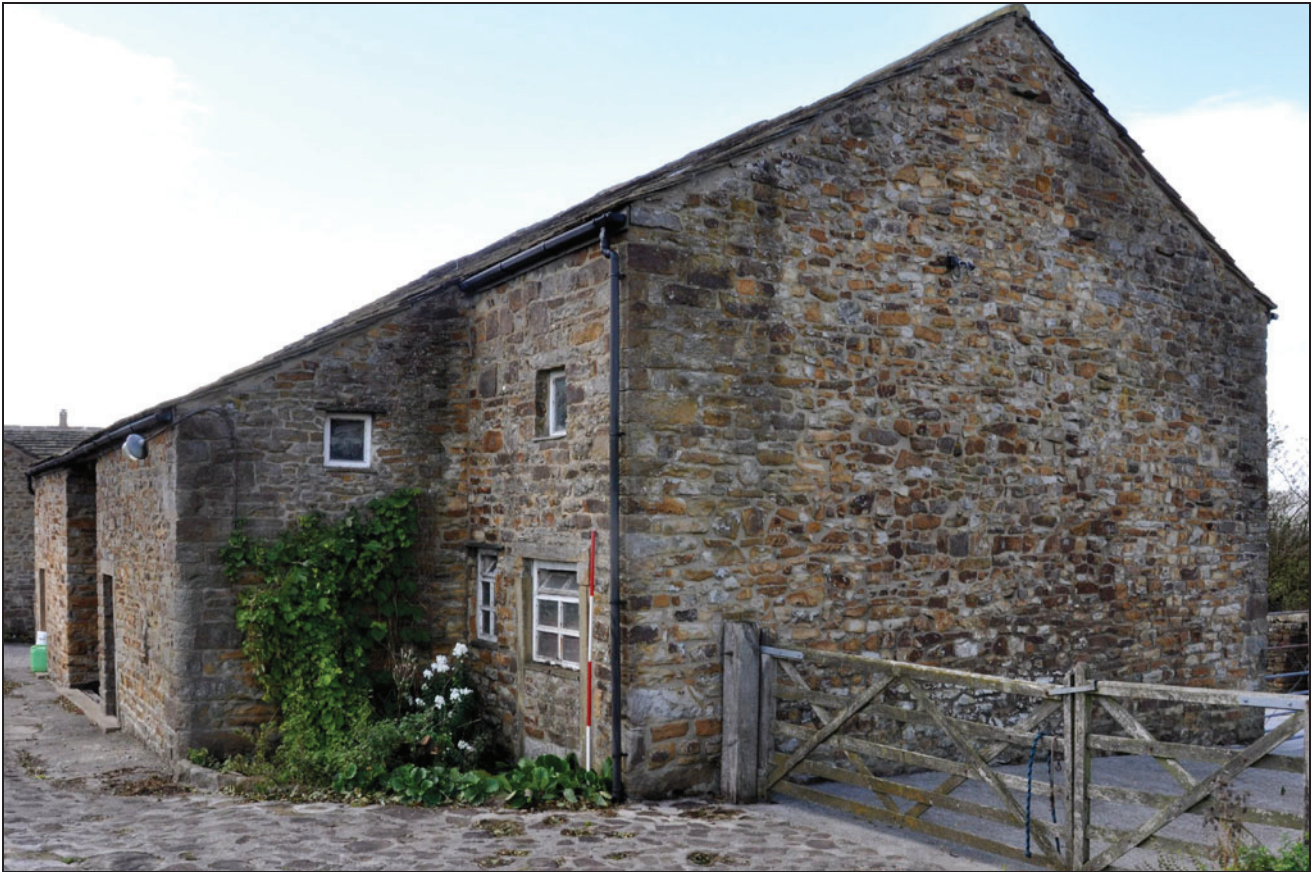
Photo 9: The barn, looking south-west

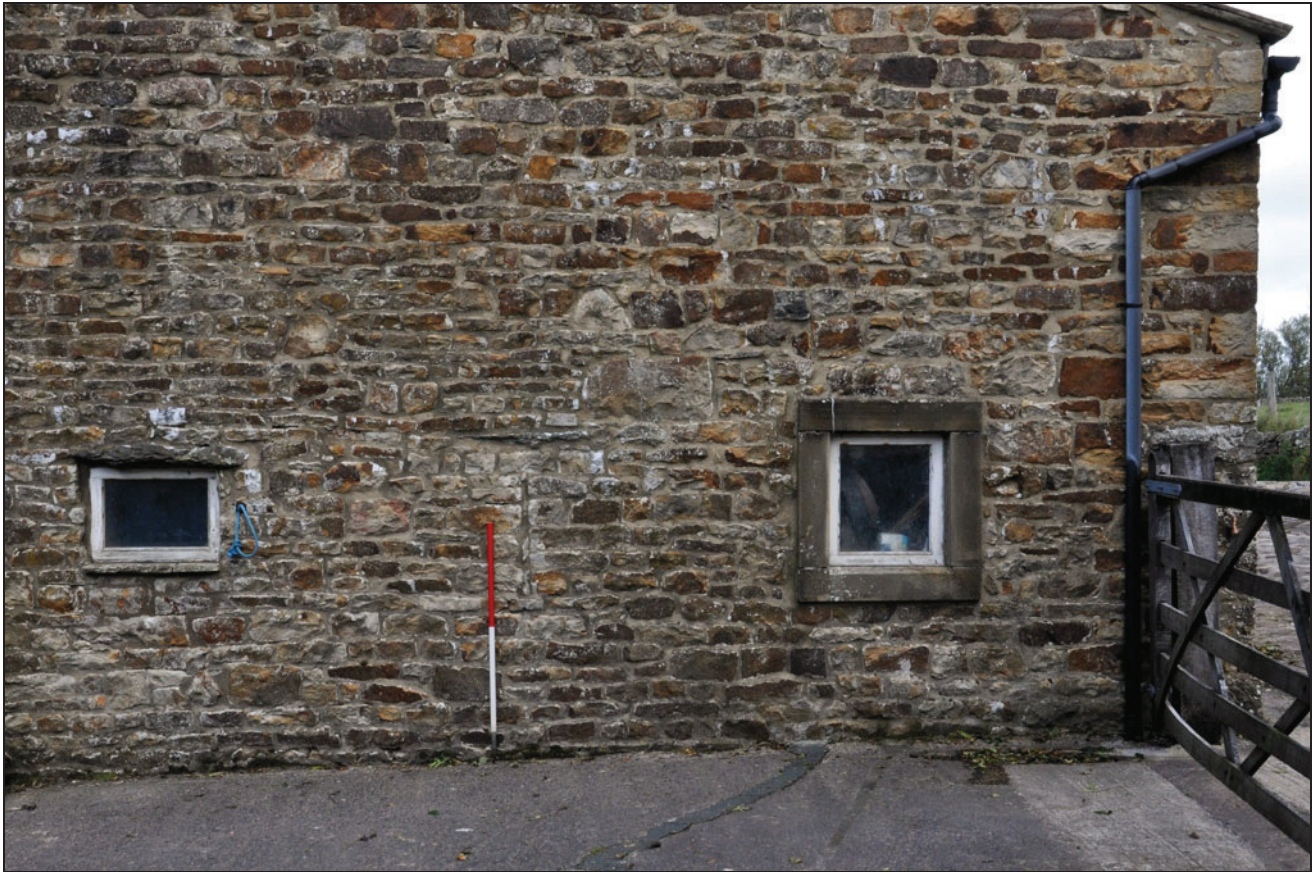
- 8.6 The south-west gable retains some of its original pattern of openings, although here too there has been alteration (12). At ground floor level there seems to have been a characteristic row of four slit breathers, with central mucking-out hole between, but only two of the former survive and they have been blocked. The other two have been enlarged in the early 20th century to square openings with projecting, sawn stone surrounds, and are now glazed (along with the muck hole) (13). There is also a plain, triangular owl hole close to the ridge.

Photo 13: Detail of openings in south-west gable

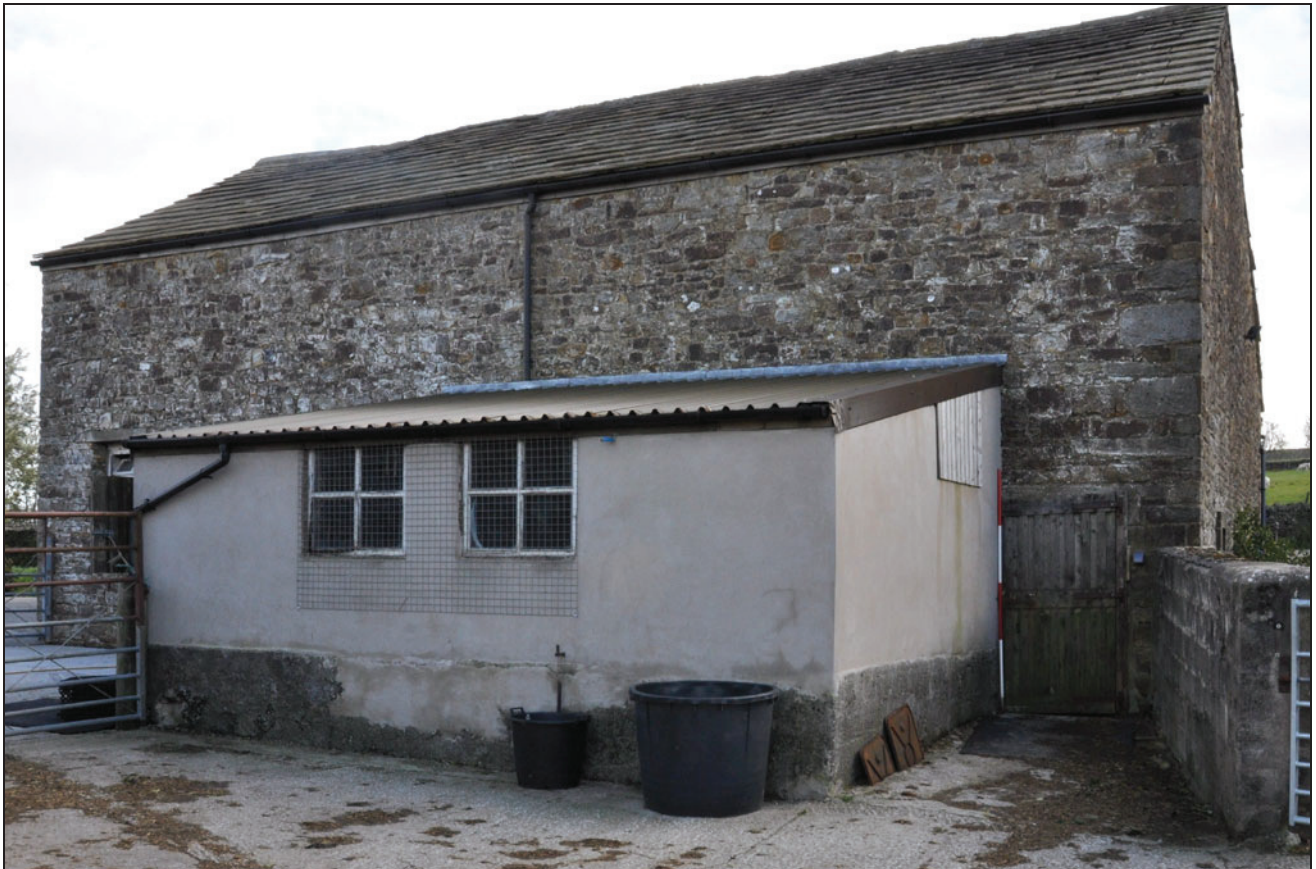
- 8.7 Within the rear elevation, the barn has a doorway opposite the main front entrance, located within the rear lean-to (14,15). This now resembles the other pedestrian doorways, with jambs formed from upright blocks, but it has been reduced to its present width by about 0.7m and may have had an arched head previously. The present internal lintel is of re-used oak, with a pegged halving (16). Other openings to the rear include a doorway to the shippon in the south-

Photo 14: Rear of the barn, looking east, with modern lean-to in foreground

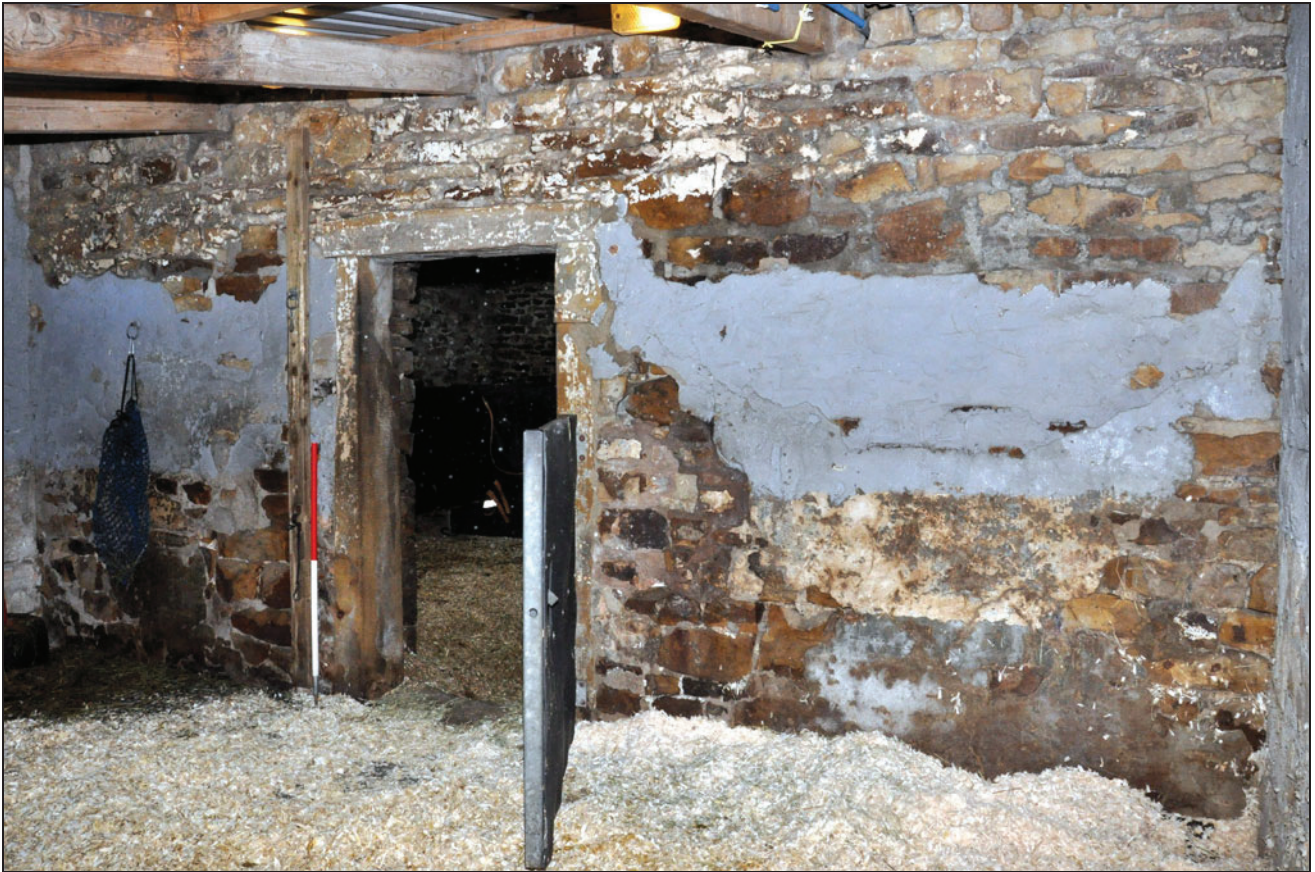
Photo 15: Detail of altered doorway in rear elevation, now within lean-to

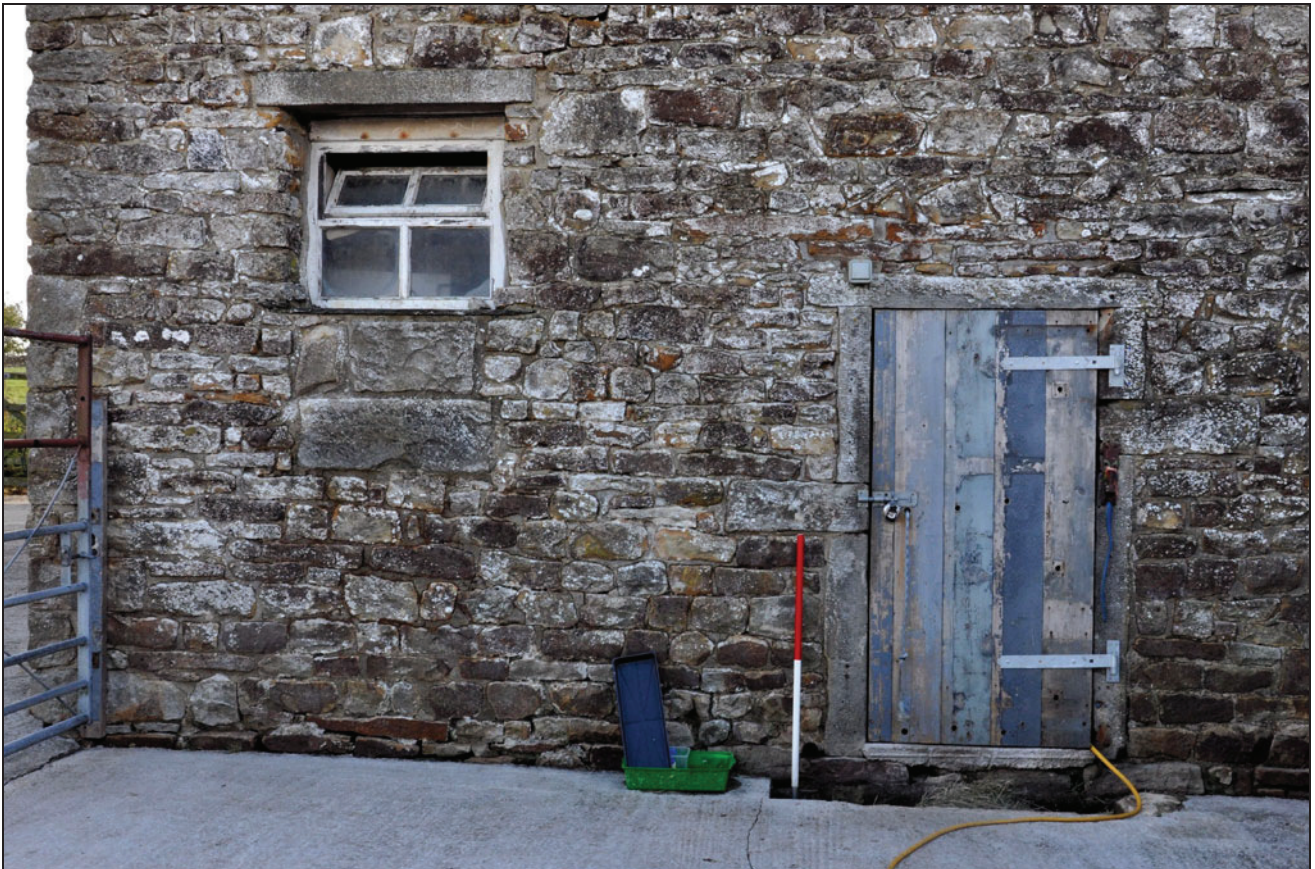
west end of the barn, and a similar doorway at the north-west end (possibly a stable at one time), with an adjacent window which has been raised from its original level (17,18).

Photo 18: Detail of openings, north-east end of rear elevation

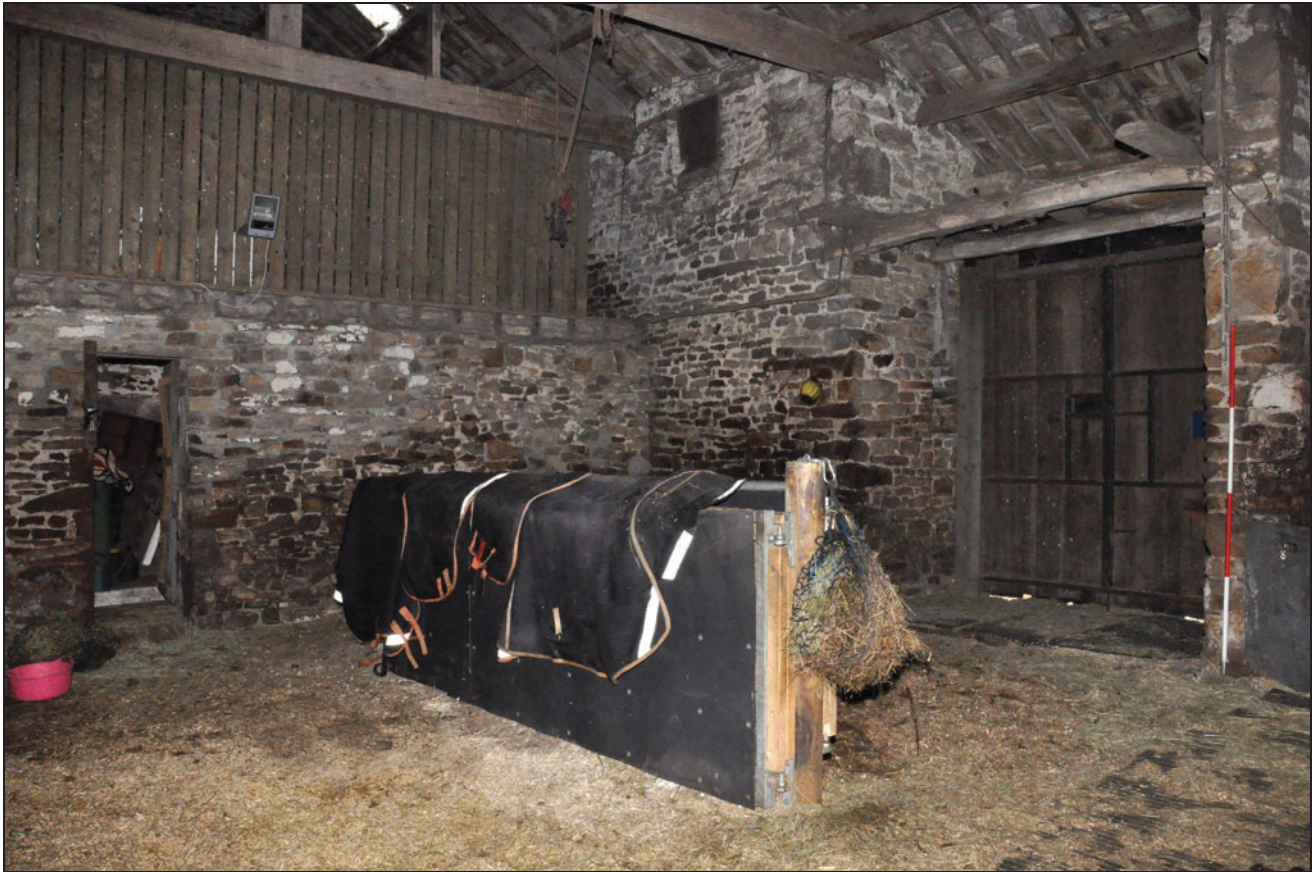
- 8.8 Inside the barn, the main entrance leads into the former threshing bay and mewstead, an area enclosed on the north-east side by a wall of thin rubble, formerly about 1.5m high, but more recently raised to its present 2.5m (19,20). This wall is in any case secondary to the barn, as it slights a breather which can be seen in the front elevation (now within the small extension). The heightened wall supports a modern loft, and also probably had a similar function previously, perhaps with additional timber uprights providing the necessary height. In contrast, the threshing bay and mewstead have always been open to the roof.

Photo 19: Threshing bay and mewstead, looking east

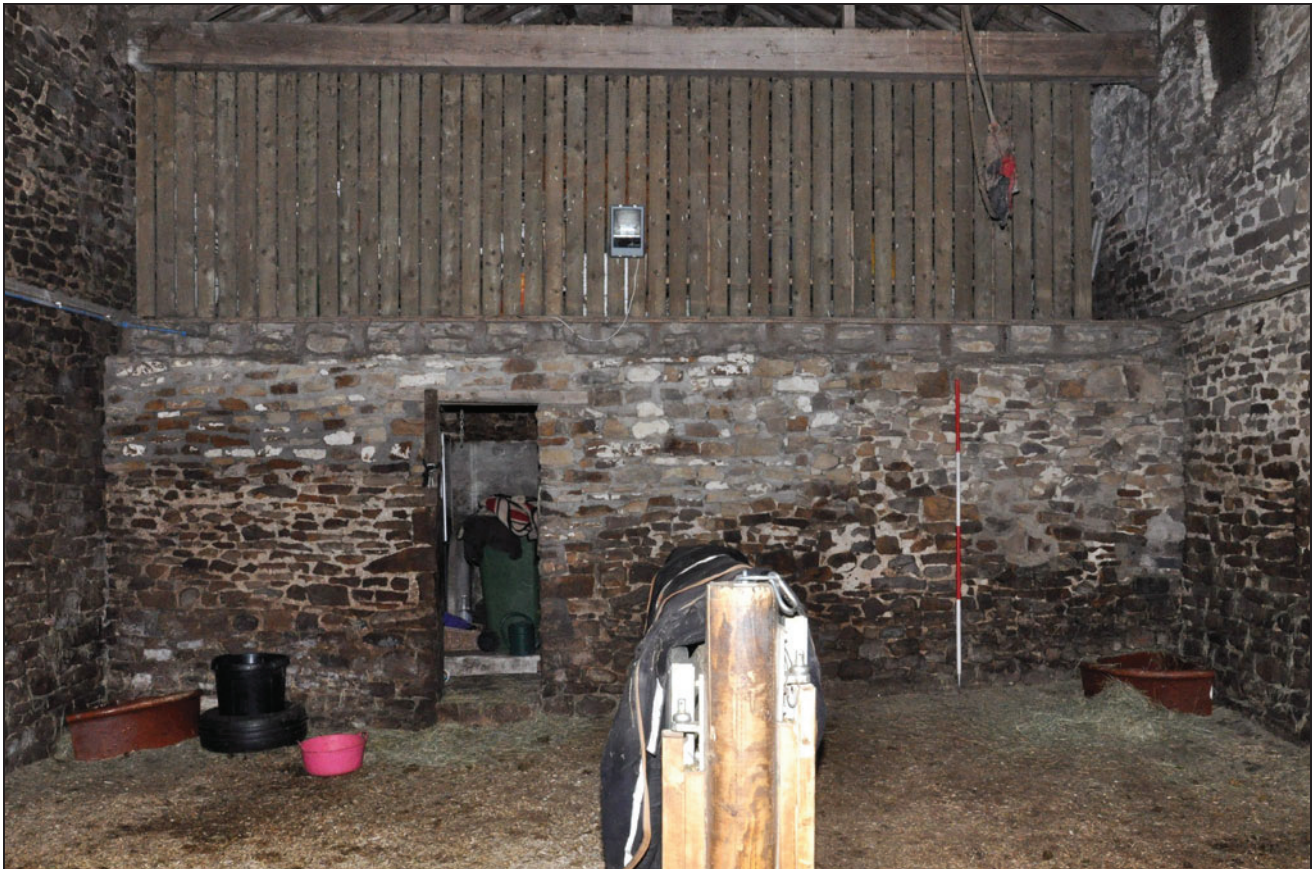
Photo 20: Cross-wall in barn, looking north-east

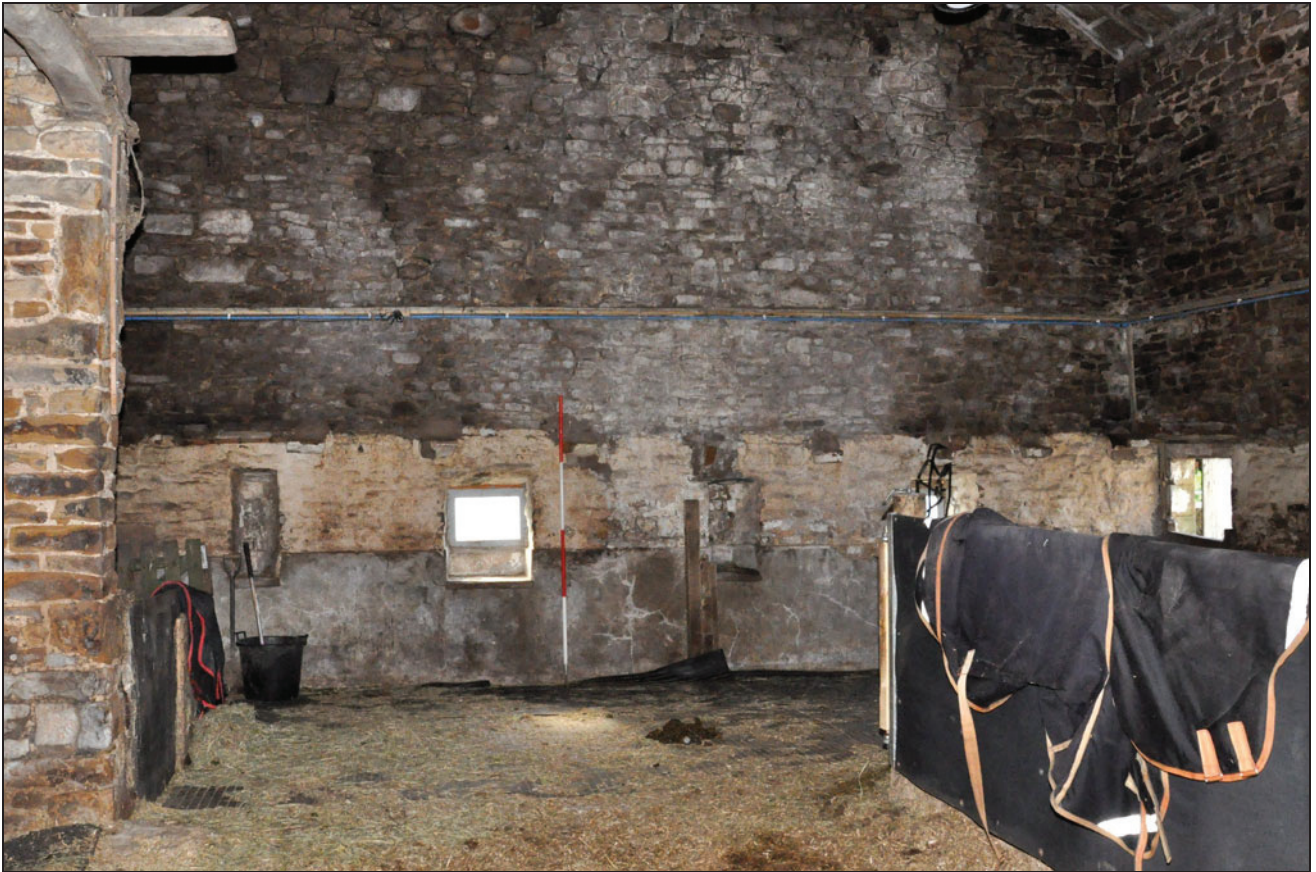
- 8.9 At the south-west end of the barn, the structure of the former shippon and the hay loft which it carried have both been lost (21). Sockets in the gable, with stone corbels beneath, indicate where beams were once located, though one such beam, of oak, does remain against the front wall (22-24), and the spacing of the inferred beams suggests there were stalls for 10 cows. Two large upright slates surviving in the south-east part of the shippon are thought to have been re-sited here from the original timber frame, where they would have formed panels within the boskins. The floor here has been laid in concrete, so the slates were probably re-set at that time.

Photo 22: Former shippon, looking south-west

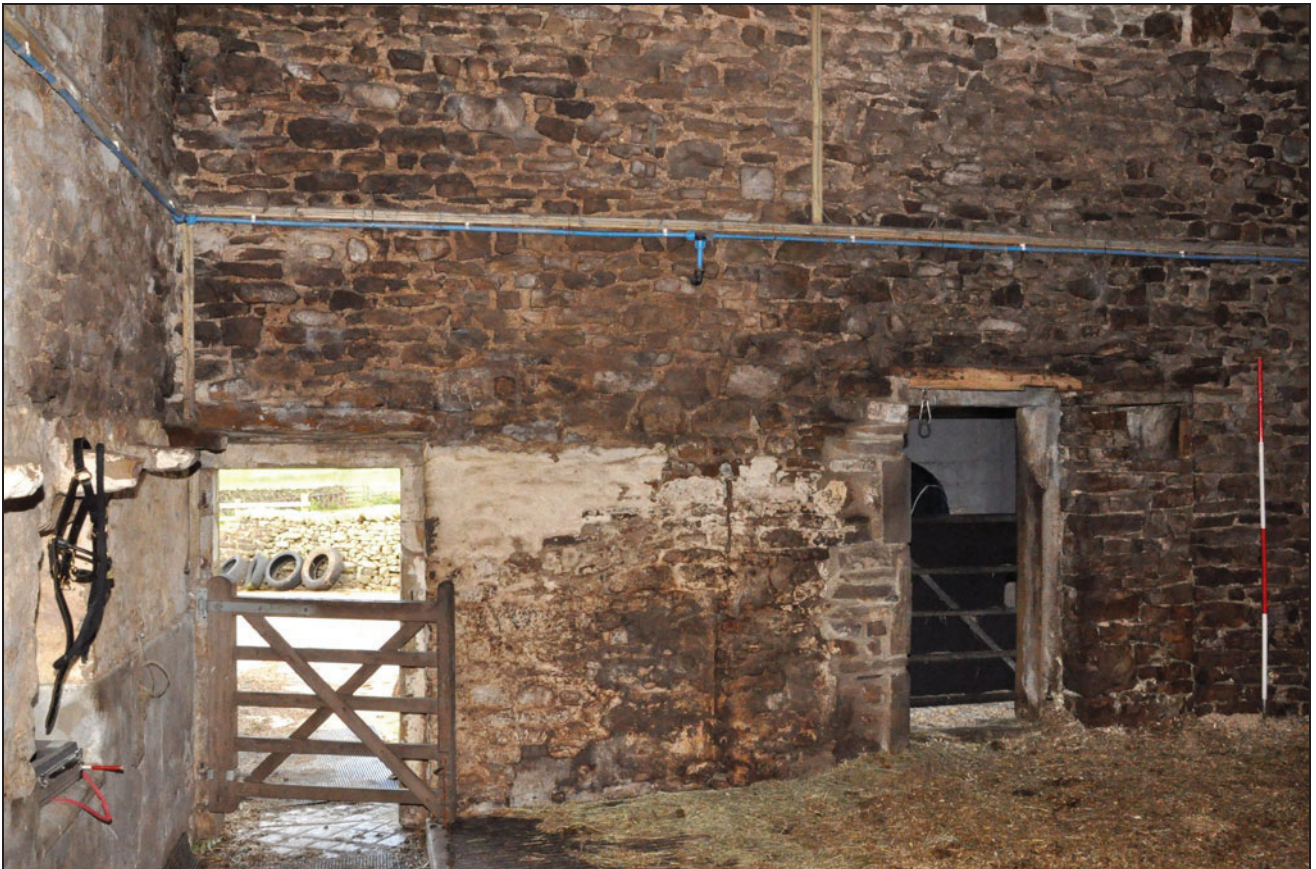
Photo 23: Former shippon, and rear doorways to barn, looking north-west

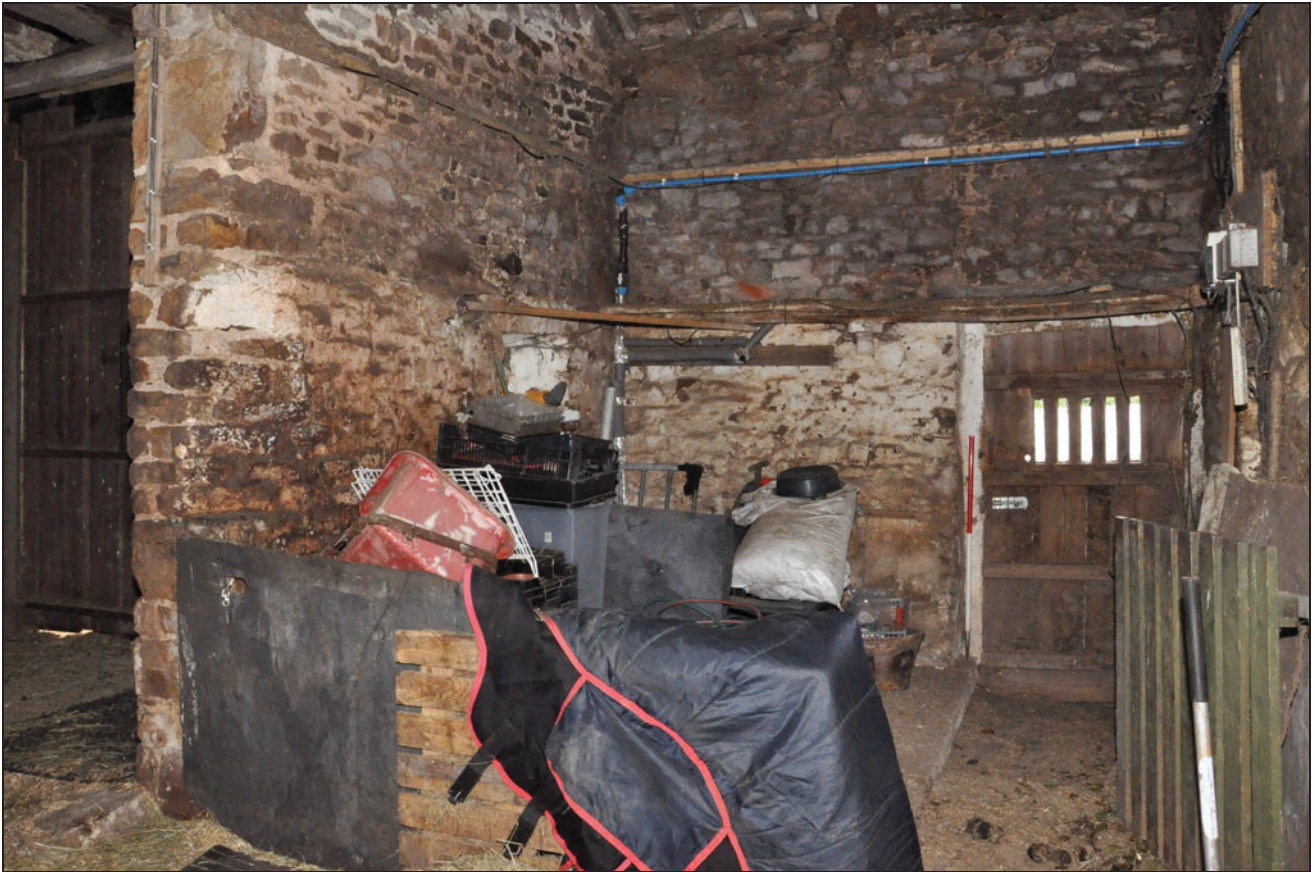
Photo 24: Former shippon, looking south-east, with slate uprights

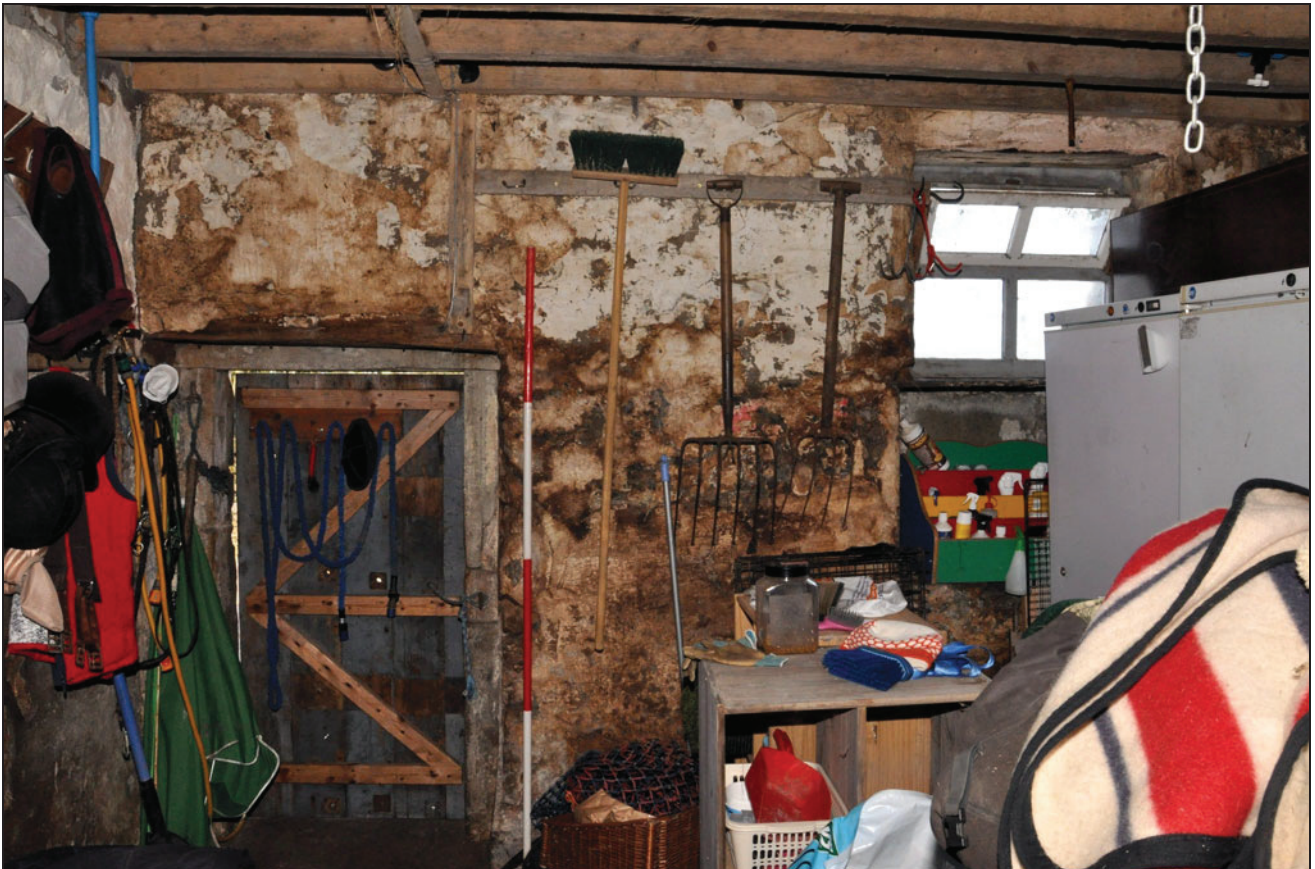
- 8.10 The north-east end of the barn, beyond the dividing wall, now forms a shippon with mid 20th century concrete boskins and concrete floor (25-27), and its original configuration cannot be established, though as noted previously at least part of it may have been a stable at one time. The partial blocking of the front doorway was probably undertaken when the present fixtures were constructed. A very modern staircase leads from here up to the modern loft (28), though an earlier upper floor can clearly be inferred from the presence of the window opening and cross-wall on which the loft is supported.

Photo 25: North-east shippon, looking north-west

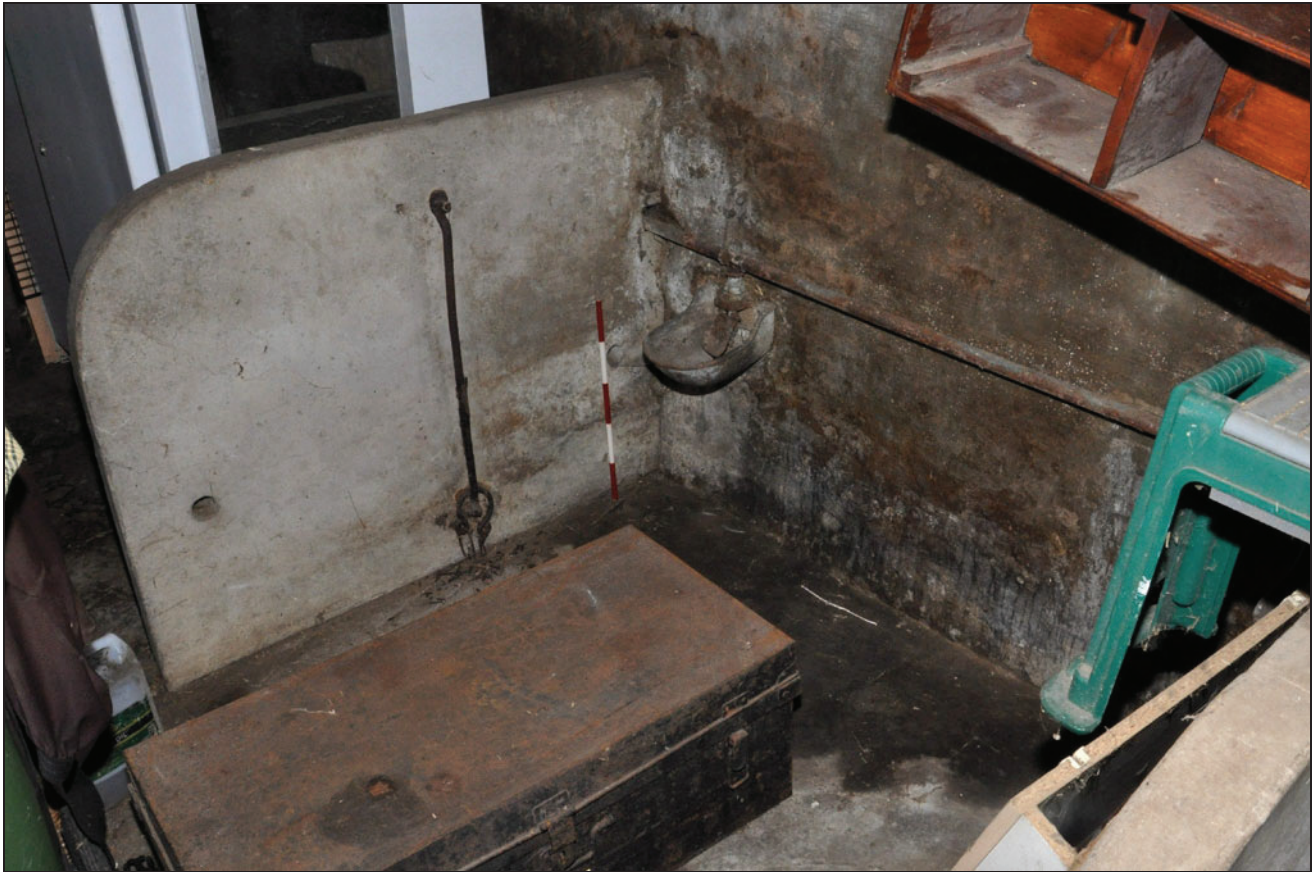
Photo 27: Concrete boskin and floor in north-east shippon
