Barn at Lower Stony Bank  
Easington, Lancashire:  
Historic Building Record

October 2018

STEPHEN HAIGH

### Historic Building Record

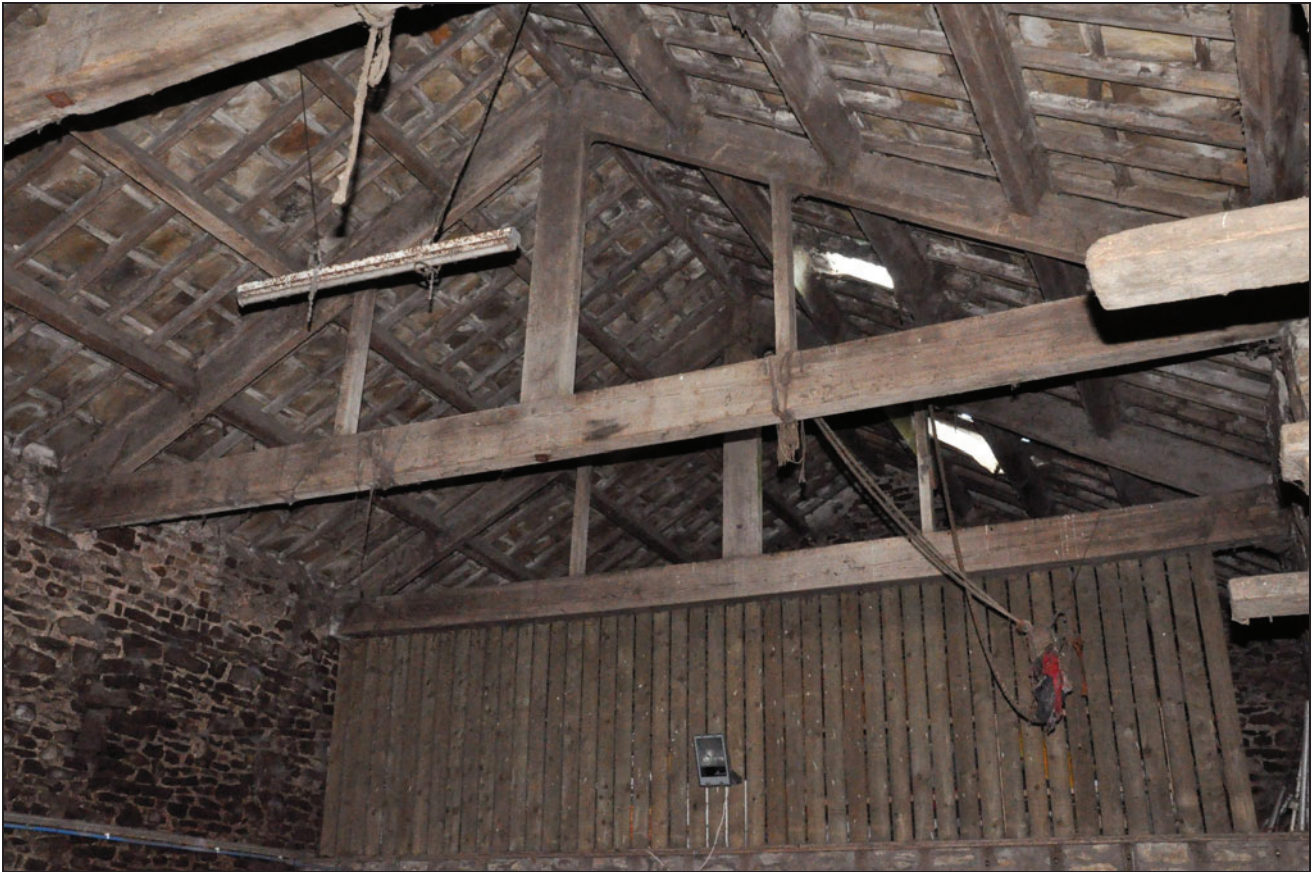
- 8.11 The present roof over the barn is fully constructed from machine-sawn, imported softwood, and has king posts bolted to the tie beams, with vertical struts (29). The trusses may possibly date from the early 19th century, but may instead be replacements from later that century or early in the 20th, although no clear evidence was observed to indicate that they are secondary.

Photo 29: Roof trusses over barn, looking north-east

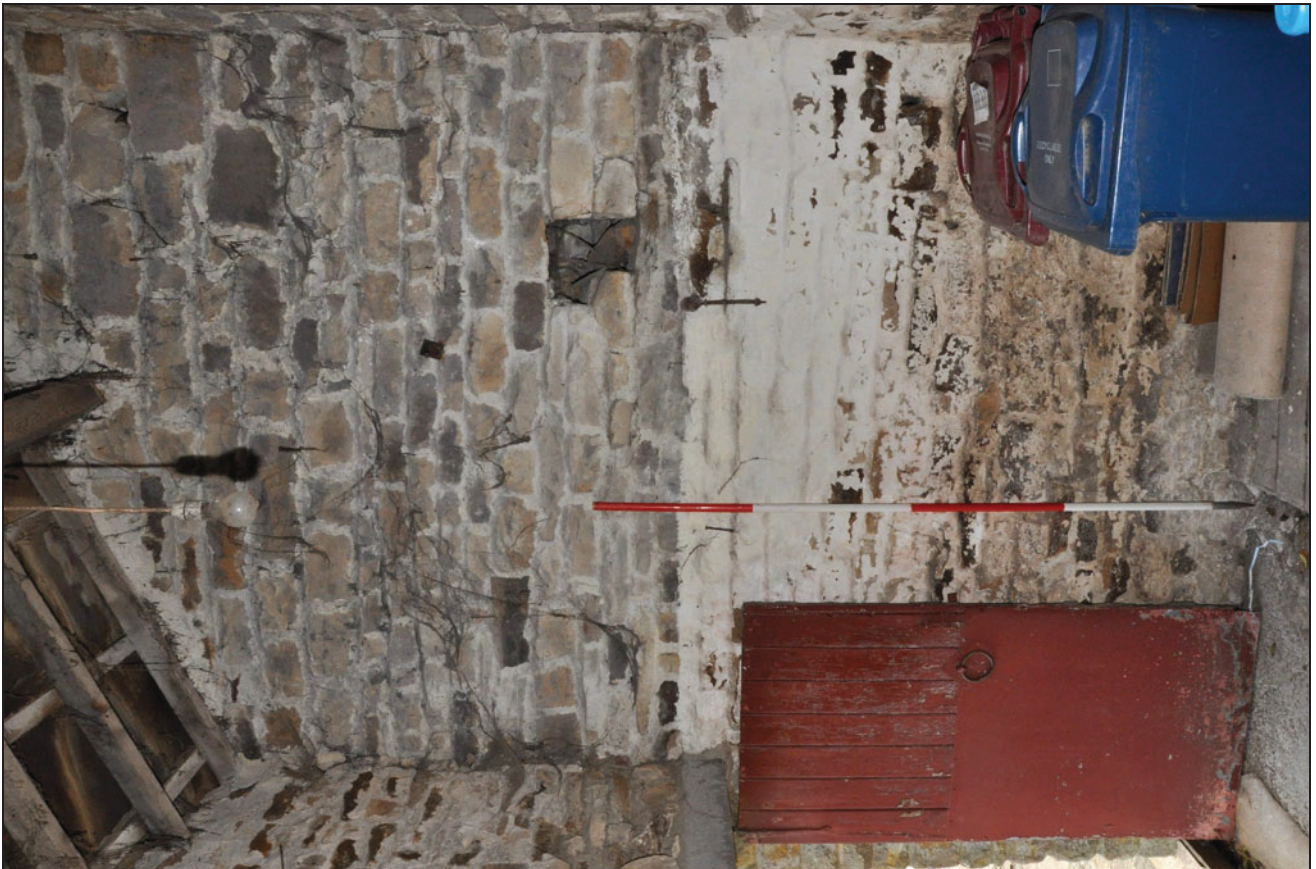
- 8.12 The small front extension (which maps suggest was present by the 1840s) appears to have been added to provide more animal housing, with a loft over. The ground floor is now partly concrete and any stalls, together with the loft, have been entirely removed (30,31).

Photo 30: Interior of front extension, looking south-west
