**STRUCTURAL APPRAISAL**  
**OF**  
**LOWER STONY BANK BARN**  
**SLAIDBURN**  
**BB7 4TR**

| <b>CONTRACT NO. 1357</b> | <b>PHILIP WRIGHT ASSOCIATES LTD</b><br><b>WELLINGTON ST</b><br><b>WESTHOUGHTON</b><br><b>BOLTON BL5 3YW</b> |
| <b>SEPTEMBER 2018</b> | <b>TEL. 01942 811532/ 07939 547865</b><br><b>E-MAIL: <a href="mailto:info@philipwrightassociates.co.uk">info@philipwrightassociates.co.uk</a></b> |

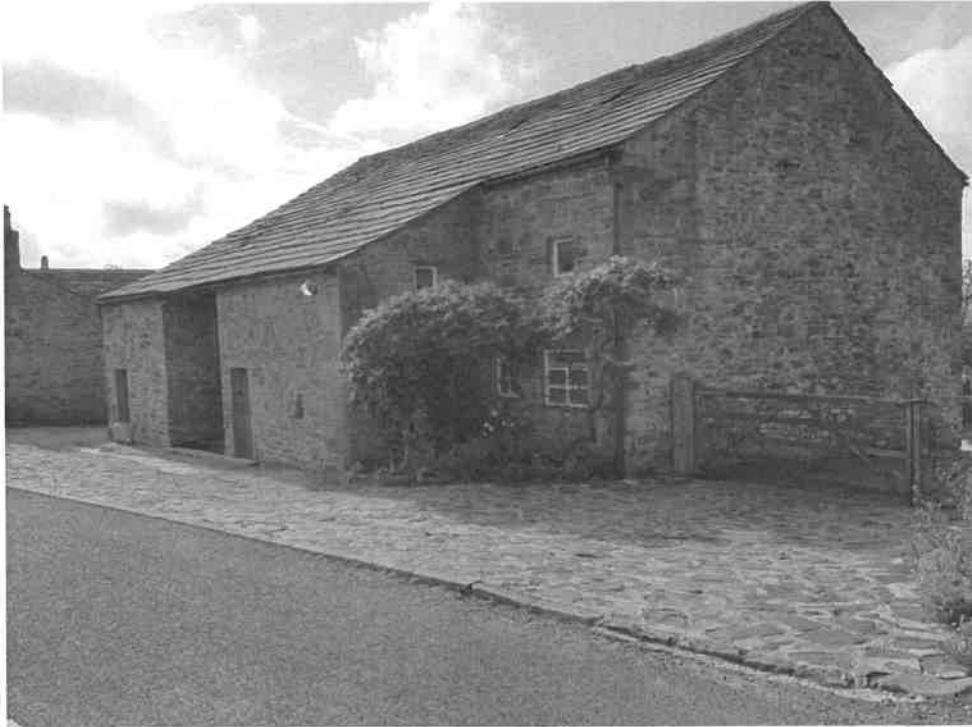
**FRONT/RIGHT HAND ELEVATION**

The front elevation of the barn has a stepped façade with the right hand portion stepping towards the rear with a raised eaves. The elevation incorporates a small door to the left hand corner, a large main full height opening to the middle, a smaller door to the right of the main opening and two windows to the inset wall to the right hand side.

The wall was in general noted to be in a fair and reasonable condition, the heads were noted to be reasonably level and the wall was noted to be reasonably plumb within acceptable tolerance.

To the main arched opening the roof timbers were exposed and some decay and infestation was noted to the supporting timber beam.

Over the main arched opening to the front of the property the exposed timber elements were noted to have insect infestation and localised decay, these are required to be replaced.

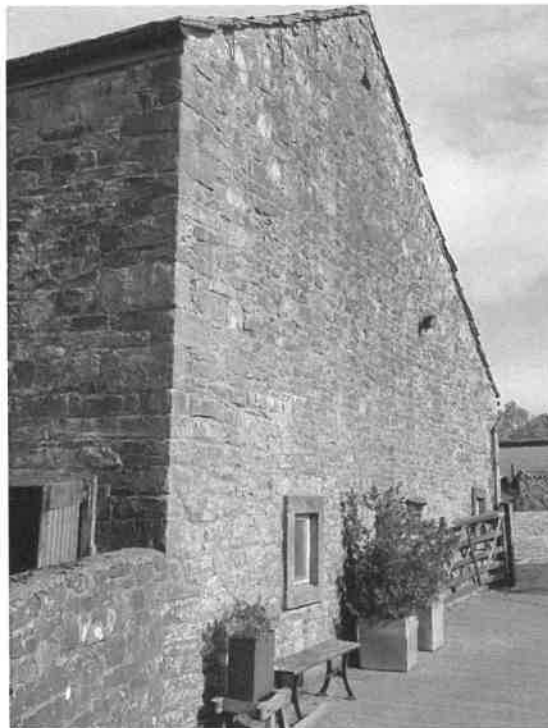
**LEFT HAND ELEVATION**

The wall to the left hand elevation incorporates three small windows to the lower part of the wall, the near and far windows incorporating stone surrounds with the middle incorporating a natural stone head. The wall was in general noted to be in a fair and reasonable condition, the wall was noted to be reasonably plumb although the upper part of the pike was noted to have a slight inward lean. The cills to the windows were noted to be level.

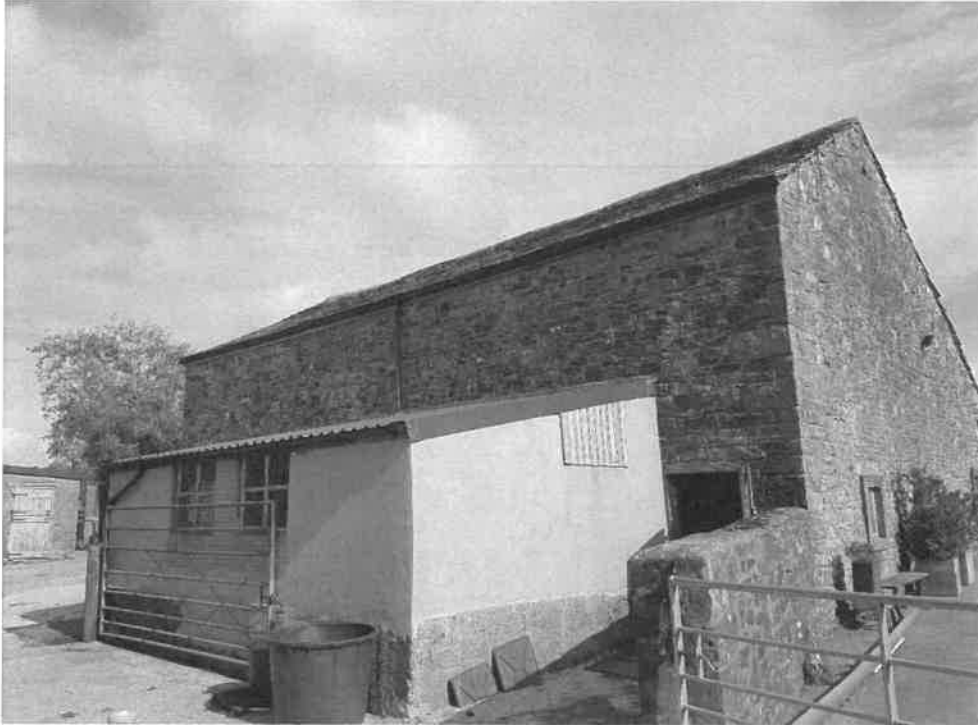
**REAR ELEVATION**

The wall to the rear elevation incorporates the lean to with the roof to the extension extending to approximately half the height of the main barn. The main wall incorporates a door to the left hand corner and another door to the right of the extension and window to the right hand corner. The wall was noted to be in general in a fair and reasonable condition, the alignment of the wall was however noted to undulate but was generally within acceptable tolerance.

The rear wall of the extension incorporates two windows, the wall was noted to be in reasonable condition and the wall was noted to be plumb within acceptable tolerance and the cills level.

The modern extension to the rear of the property incorporates a shallow pitched roof which will be unsuitable to incorporate a stone slab or slated roof and with this regard a complete new roof construction would be required. Considering the construction undertaken it may be prudent that rebuilding of the extension would be required to facilitate the proposed works.

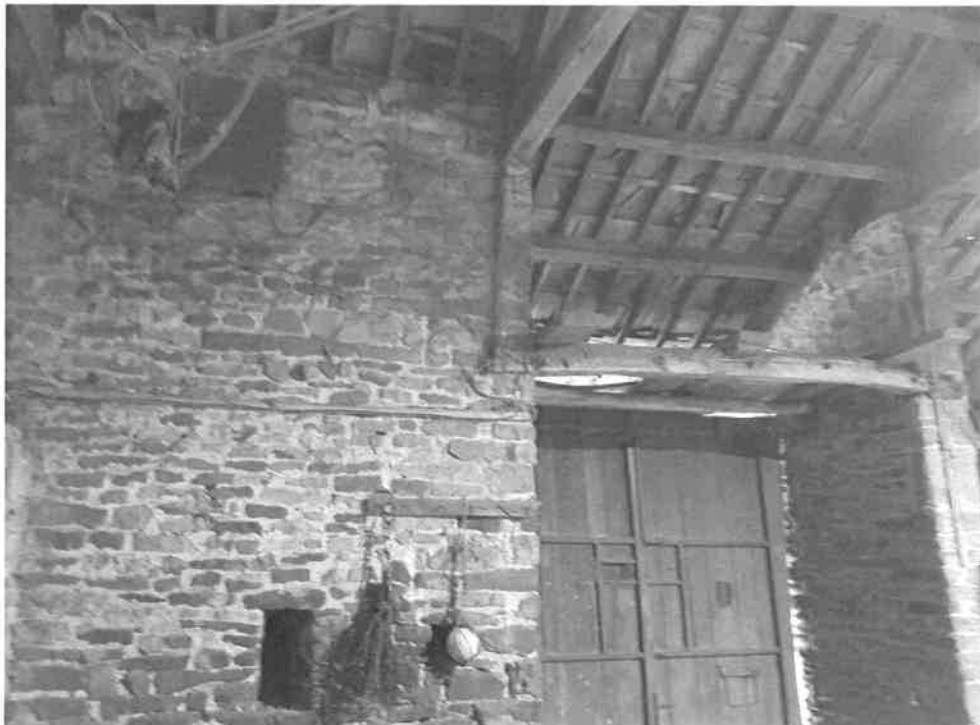
**INTERNAL FRONT WALL**

The right hand side of the barn incorporates a recently constructed first floor with exposed joists. The lintels over the two windows to the front of the property incorporate an exposed timber lintel. Adjacent to the stair to the right hand side of the property a historic crack was evident adjacent to the division wall, the crack being in the region of 50mm wide.

To the right hand side of the front elevation of the property there is a historic crack adjacent to the windows together with the exposed lintel over the windows. The lintel should be replaced and the crack locally repaired and infilled.

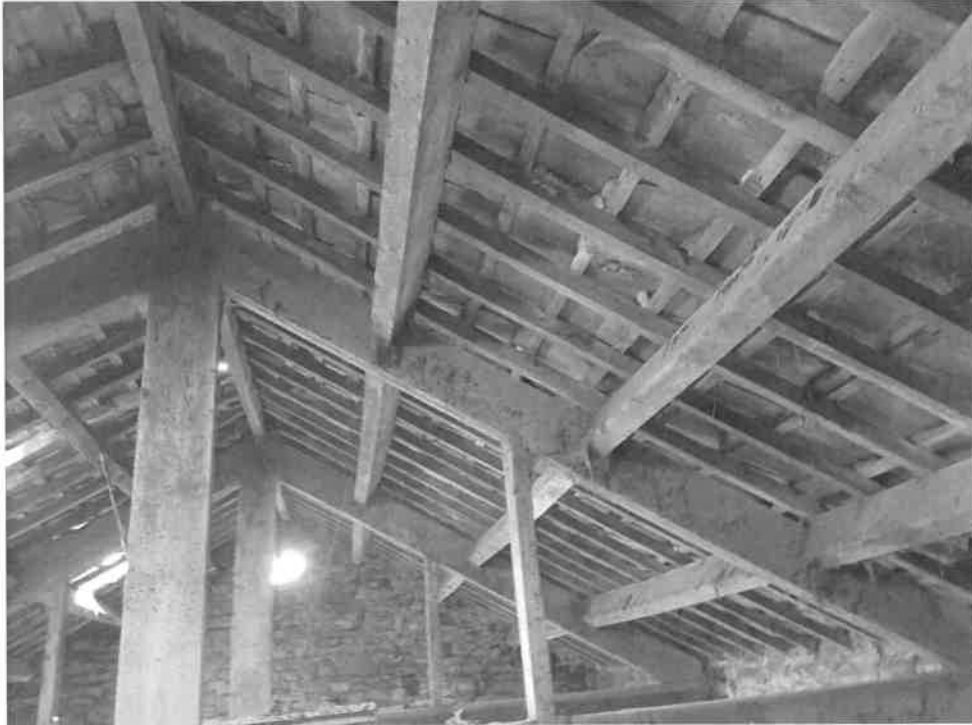
**ROOF**

The roof when inspected from the road to the front of the property was to a fair and reasonable alignment, the stone tiles were noted to be in good order.

The structure to the roof incorporates traditional loose construction incorporating three purlins per slope supported on three substantial timber trusses. The roof continues on the line to the front projection with a further two purlins. From my inspection undertaken from ground floor there was no evidence of any significant distress to the roof structure.

A detailed inspection of the roof elements has not been undertaken, it would be expected that a timber preservation and damp specialist should be appointed to undertake a detailed inspection of these elements.

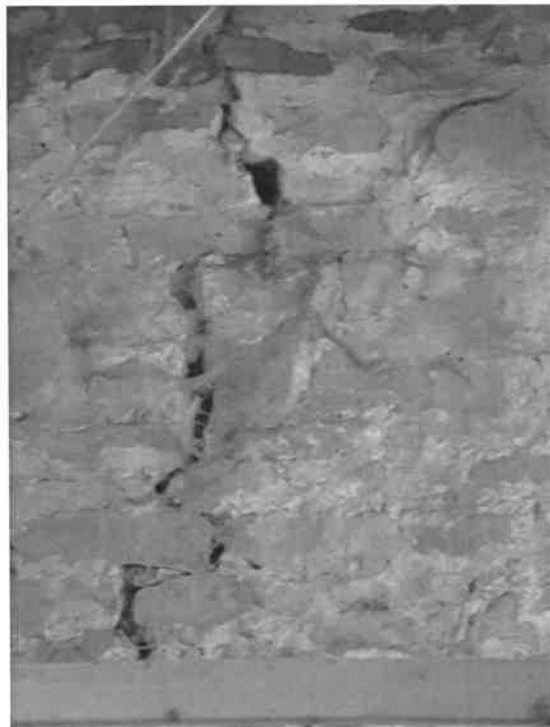
**CRACK TO SIDE OF STAIR**

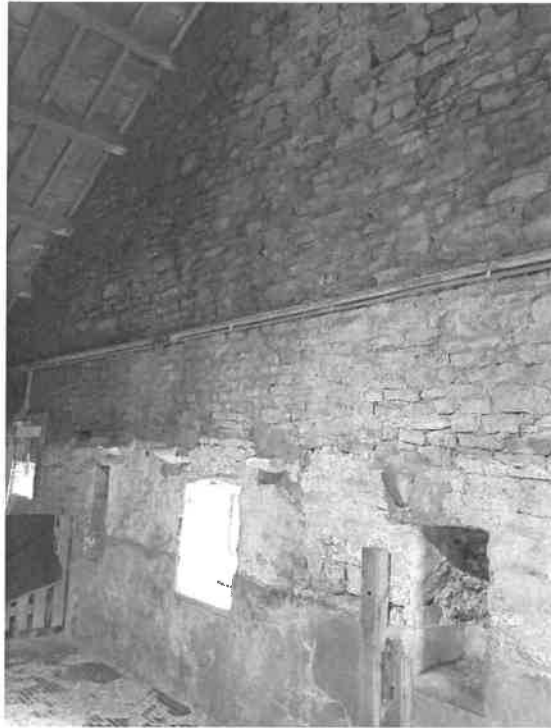
**INTERNAL LEFT HAND WALL**

In general the main external walls of the barn were noted to be in a fair and reasonable condition, there were however a number of open joints and evidence of random cracking particularly to the left hand wall however there was no evidence of any recent disturbance or of structural movement which is associated with foundation movement. The alignment of the walls were reasonable and within acceptable tolerance. There was some slight disturbance above the opening from the original barn into the extension to the rear likely associated with the construction of the extension.

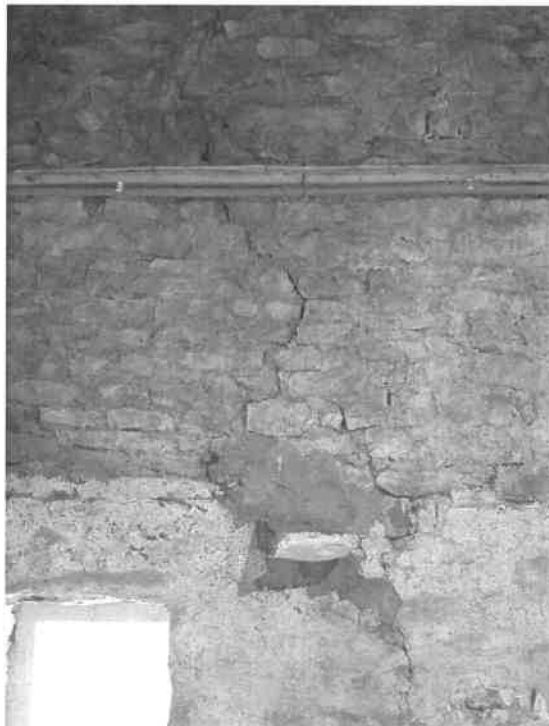
**CRACKING TO INTERNAL FACE OF LEFT HAND WALL**

The alignment of the walls are generally reasonable and with this regard no significant works to the walls are required. Internally there are a number of random cracks particularly to the left hand side which require to be raked out, infilled and pointed. There is also evidence of disturbance over the opening to the rear wall likely as a result of the extension being constructed which require to be repointed or it may be preferable for localised rebuilding to be undertaken.

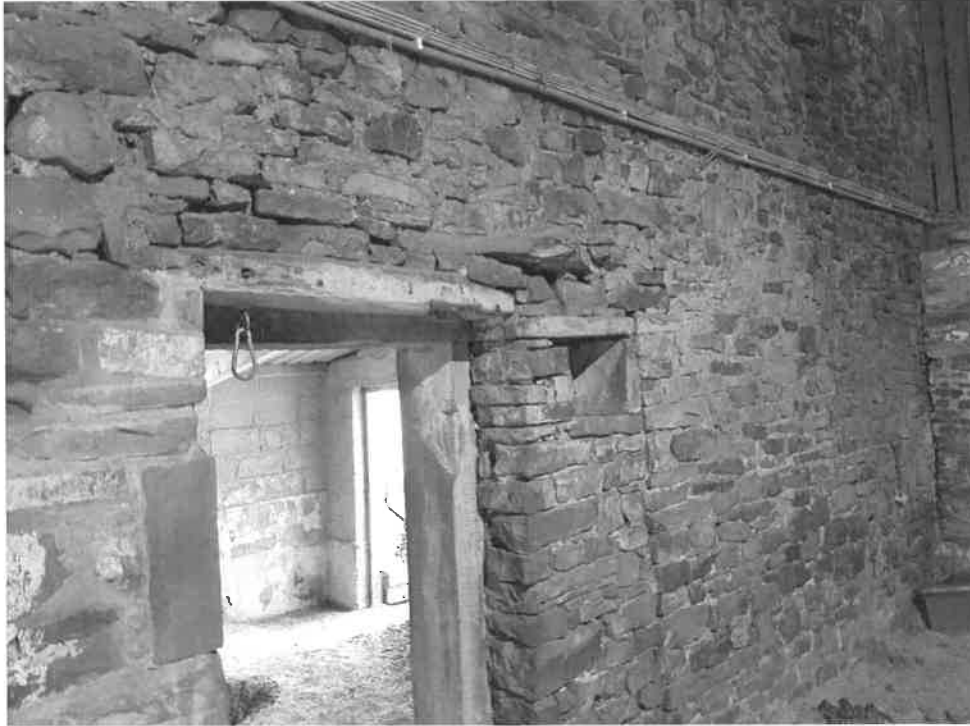
**DISTURBANCE OF STONework OVER OPENING TO EXTENSION**
