**RE: Tree assessment: Punchbowl Inn, Hurst Green.**

As requested, I carried out a site visit to the Punch Bowl at Hurst Green to visually assess the Large copper beech tree located in the North East corner of the site (referred to as T1).

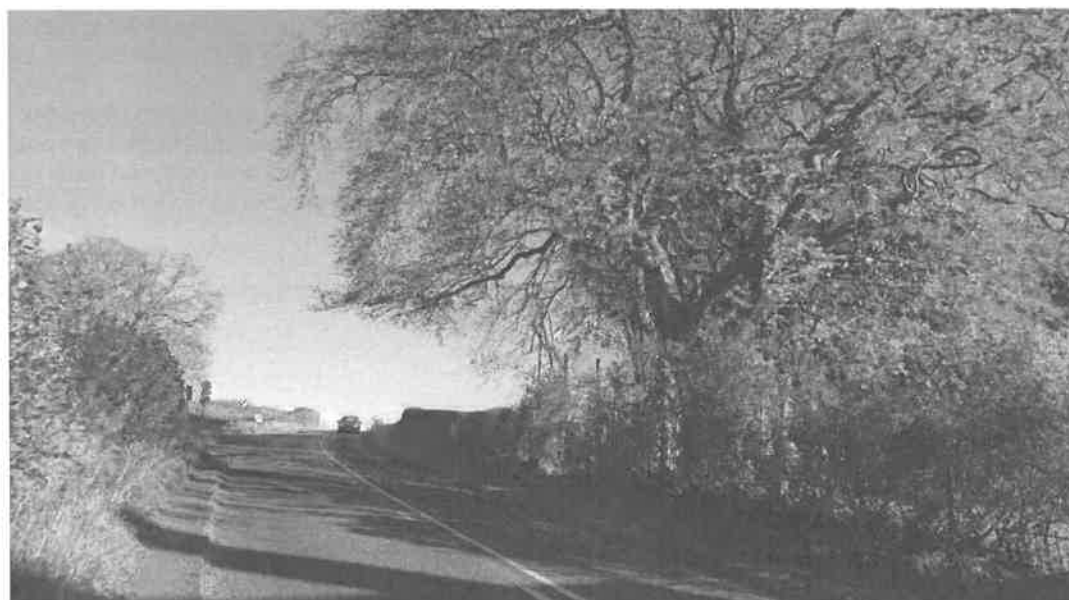
I did note that the overall canopy of the tree that encroaches over Longridge Road does hang lower than what I would recommend with signs of the branches brushing on high sided vehicles, with this, my recommendation is to lift the canopy of the tree so that there is 6m clearance between the road and the canopy, this will allow safe passage of high sided vehicle to pass underneath without the risk of striking the tree and give clearance for any future growth.

Copper Beech – T1 – showing drooping canopy branches over the road

- Crown lift to give 6m of clearance over the road, canopy to be pruned back by removal of 3<sup>rd</sup> order branches or smaller only, no major limbs are to be remove.
- A visual assessment of the tree from within the canopy is recommended by the climbing arborist to assess if there are any significant issues within the tree that can not be seen from ground level (no additional work will be carried out unless agreed in writing by the local authority).
