**Proposed Re - Development at  
Startifant Farm, Longridge Rd,  
Chipping,  
Lancashire.**

**Structural Appraisal.  
of the Stone Barn**

**Mr & Mrs R. Robinson.**

**J HADFIELD ENGINEERING SURVEYING**  
SPRINGS HOUSE, CHIPPING, LANCASHIRE. PR3 2GQ  
Tel: 07740 929096 ~ Fax: 08708 362185

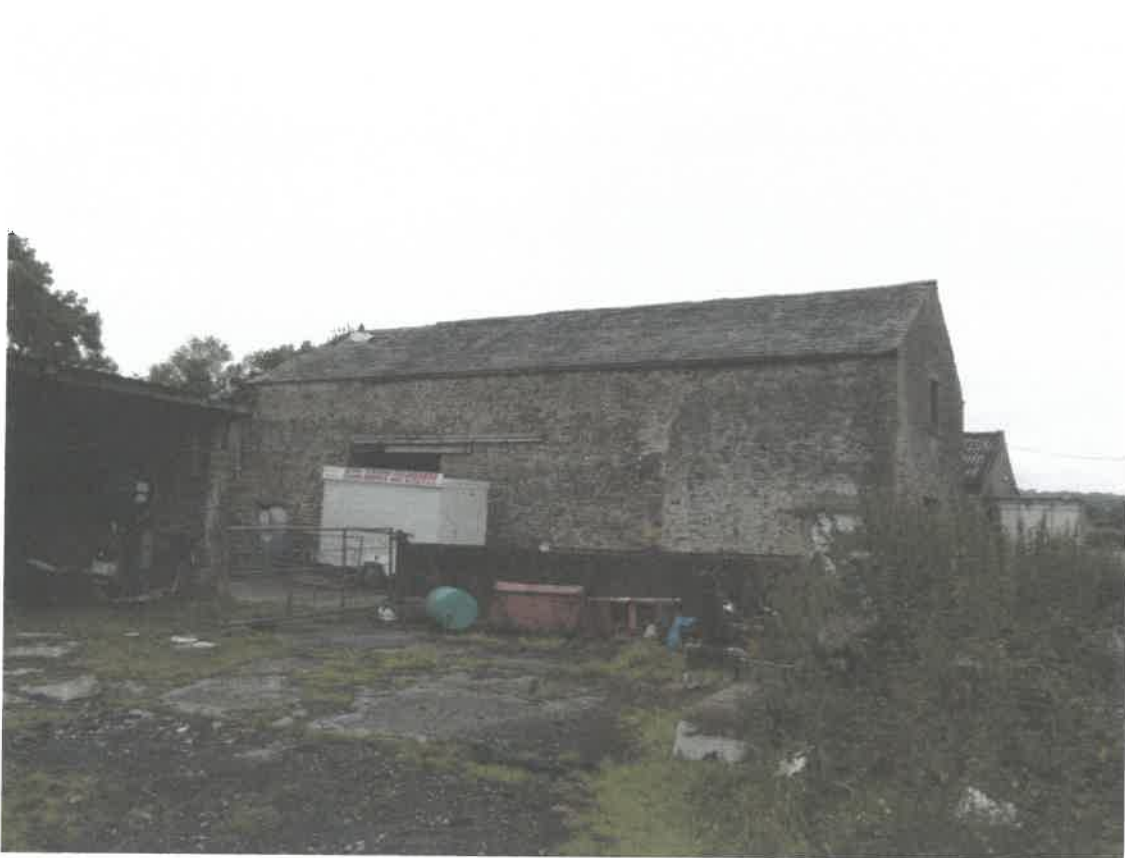
The barn door opening has been formed by a very shallow arch of stone visors, which have a timber lintel below. The low level masonry to the eastern side of the barn door is in much better condition, although between the barn door and the pedestrian door at the eastern end of the elevation, evidence remains of what appears to be the lean to extension to the barn, with a visible step between the two sections of masonry of up to 50mm (see photograph 1).

**1 : Photo of the front elevation.**

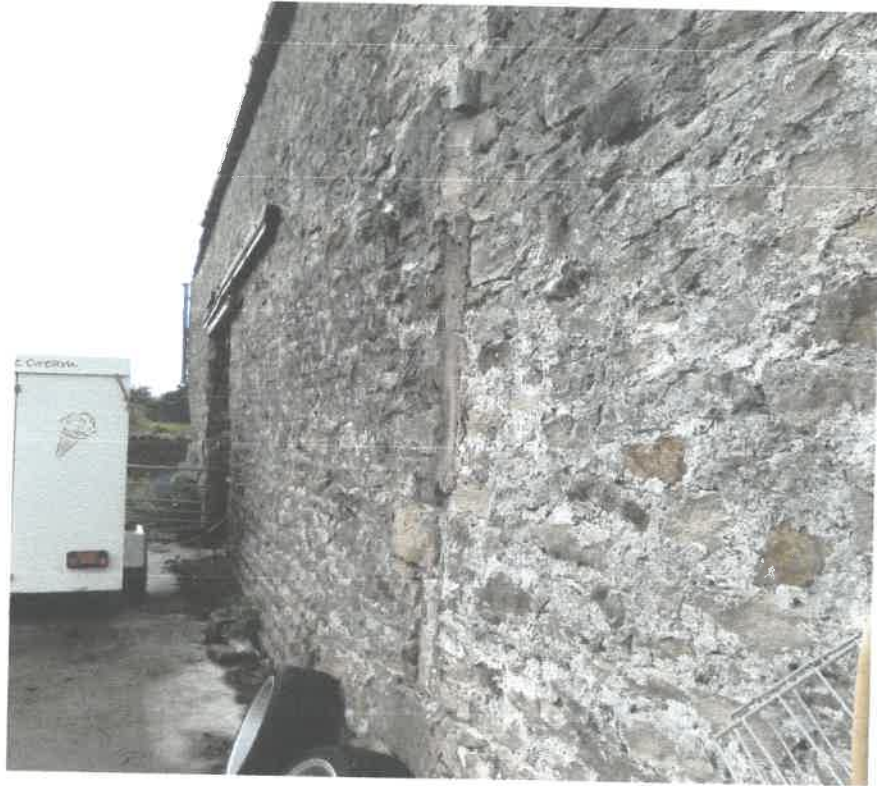
3.12 It is misleading to see the misalignment in the front & rear elevations are a defect as the inward / outward bulges to the rear and front elevations respectively, are considered to be the result of the way in which the barn was extended eastwards. (see appendix B, Photo 2)

The removal of high level quoins, removal of at least part of the roof covering, and the removal of the first floor masonry would have left a very unstable structure, even in the short term. That said, the step in the stonework to the front elevation would suggest that that of the original barn may have moved forwards prior to it being extended.

**2a : Photo of Step in front elevation masonry**

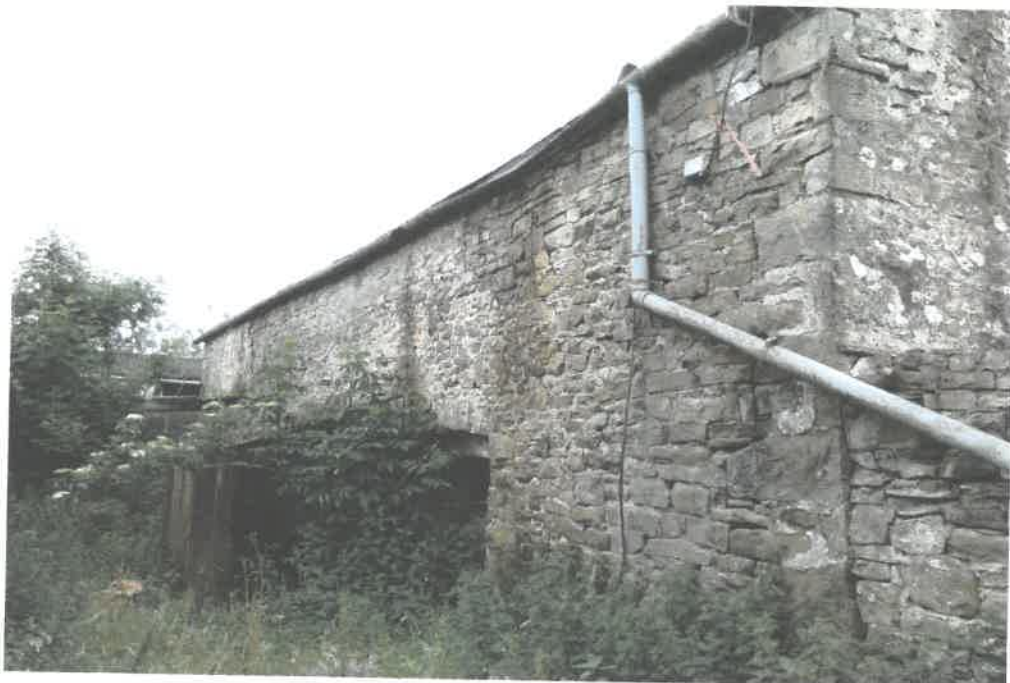
2.2.4 The eastern aspect of the rear elevation is difficult to assess in close detail as there is a dilapidated lean to and numerous semi-mature trees in close proximity to the wall. The centre of the rear elevation has noticeably distorted, with the upper part particularly water ingress due to the erosion of the pointing.

This area coincides with that on the front elevation where the barn was probably extended. The alignment of the front and rear walls is not correct and gives an impression of movement on the rear elevation though there is no sign of movement internally on the walls or roof structure components or where they join.

**2b : Photo of Step in rear elevation masonry**

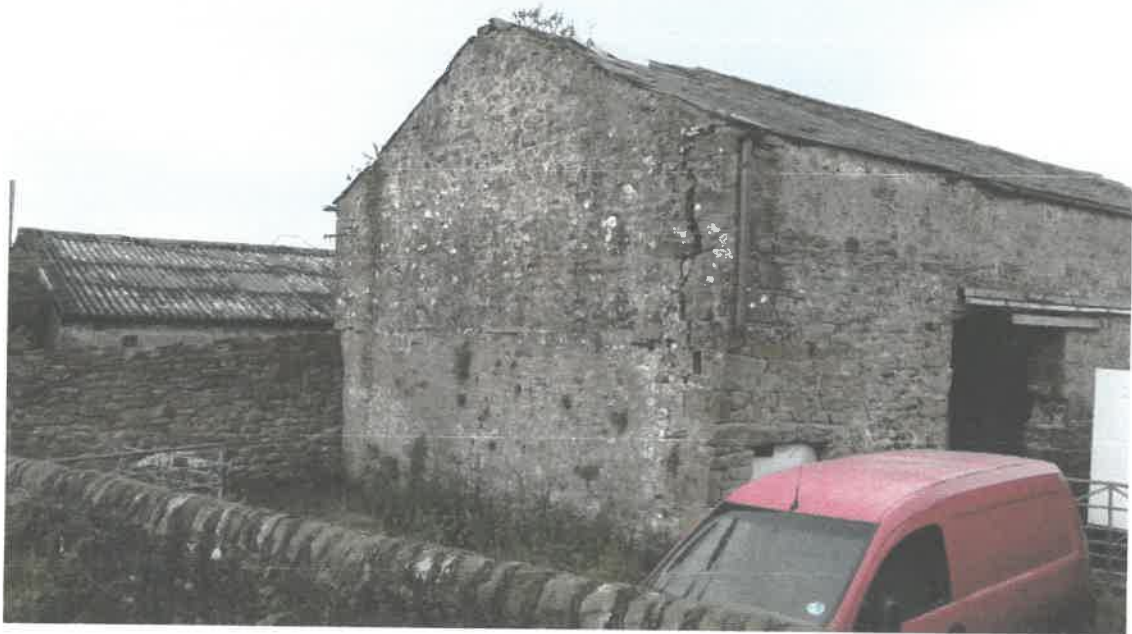
The gable is dominated by a crack where it should join to the front elevation which extends from approximately 1.5m above ground level up the eaves, and is estimated to be, at its most severe, 75mm in magnitude (see photograph 3). The movement has occurred between the quoins and the remaining gable stonework, and even extends over the uppermost quoin suggesting that the movement is entirely limited to the front elevation. Pockets were noted in the stonework at approximately 2m above ground level, where timbers were previously seated to form the lean-to adjacent to the barn. Again, no fascia boards are present along the roof line, and the stonework below the missing slates to the front elevation is particularly uneven.

The position of the crack to the eastern gable is further indication of poor tying between the perpendicular walls, common when this type of rounded rubble stone is used in construction, and the outward movement is clearly limited to just the front elevation. (see appendix B, Photo 3 a, b & c )

**3a : Photo of West gable.**

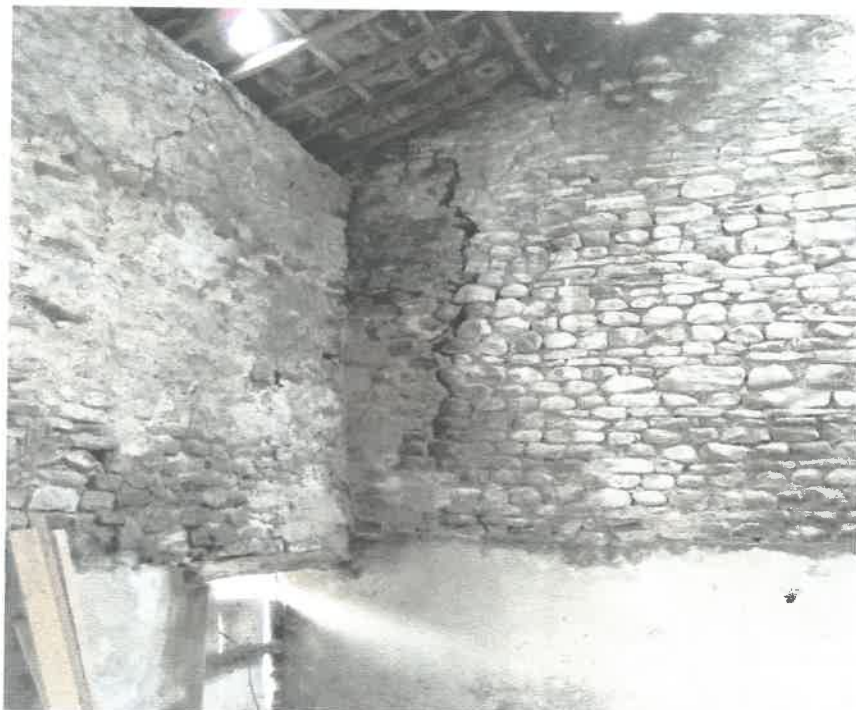
2.3.3 There is poor bonding of the perpendicular walls internally, and much of the internal masonry is formed from rounded cobble-type stones. The movement noted to the western gable is also visible internally, albeit not to the same extent.

**3b : Photo of West gable (Internally)**

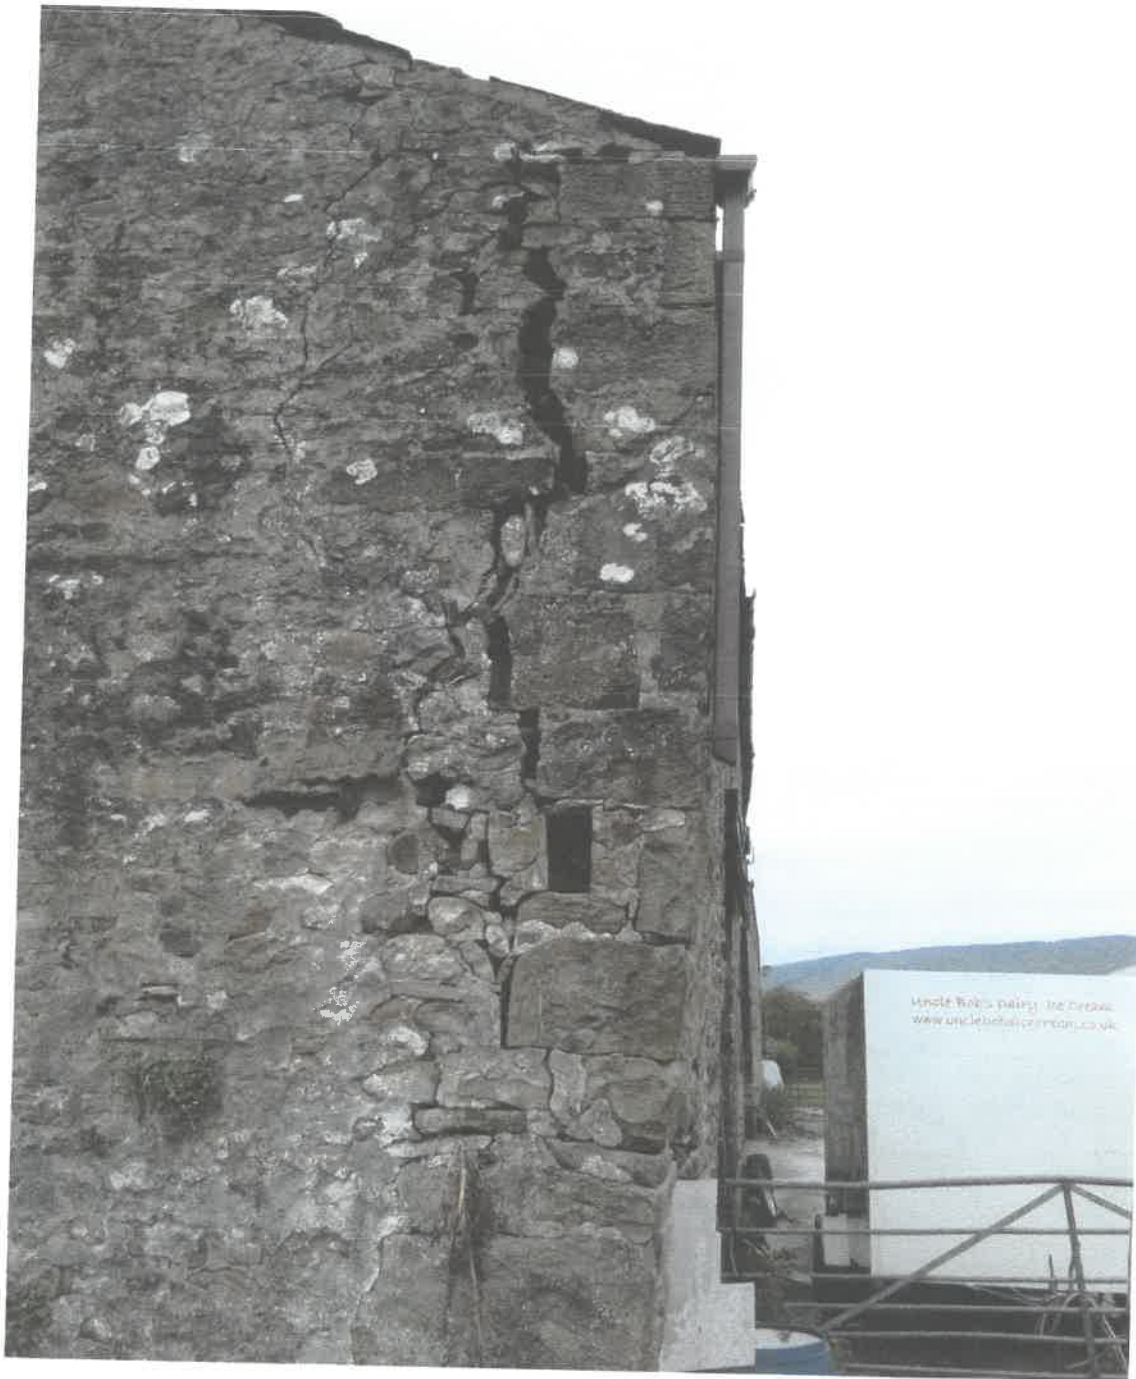
**3c : Photo of West gable.**

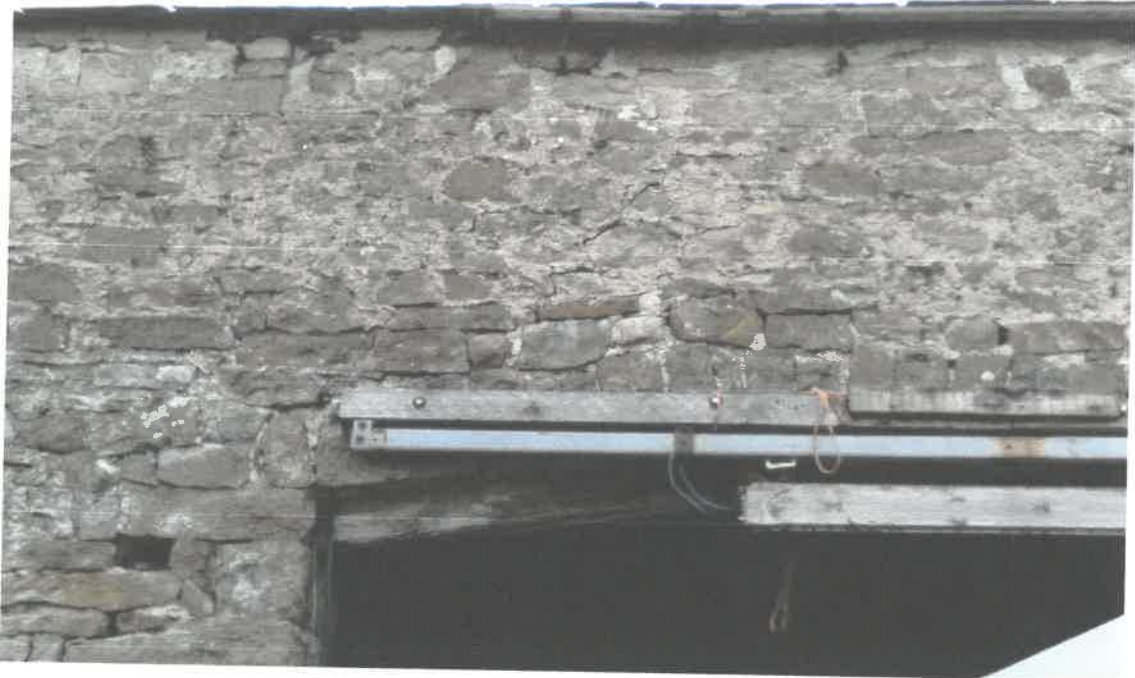
The installation of the timber lintel below the stone arch is an unusual arrangement, however given the shallow nature of the arch, it is unsurprising that an additional support to the opening was required. This lintel was noted to have wood boring insect damage, and diagonal cracking to the masonry above would suggest that some deflection of the lintel has occurred.

Although there is little evidence of the arch having dropped externally, the addition of the timber beam below is an unusual step, but probably a necessary one to support what is inherently a weak structure. The existing stone voussoir's could be reused if required. (see appendix B, Photo 4)

**4 : Photo of Front elevation arched door-way.**

3.15 We would recommend that the nominal arch to the main barn door opening be rebuilt with a galvanised right angled lintel hidden behind to give additional support.

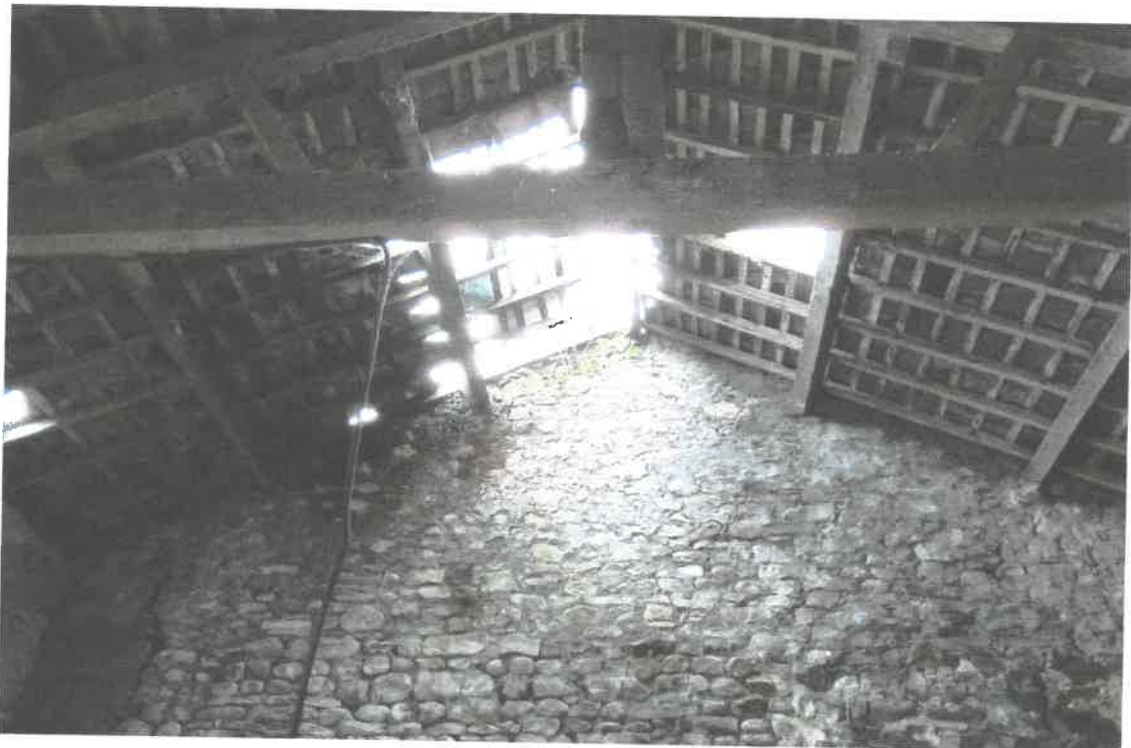
2.3.1 The roof of the barn is of timber rafters bearing onto two lines of timber purlins per pitch and a ridge board. The purlins in turn are supported off the gable walls and three timber kingpost-type trusses. Whilst close inspection of the westerly timbers was not possible, they do not appear to be suffering from wet rot or any noticeable wood boring insect damage as neither is the truss that can be inspected from the first floor loft area.

The purlins are slender, and although they are not noticeably deflecting, despite those below the void in the roof being wet, they are unlikely to be suitable for retention. ( see appendix B, photo 5 a & b )

**5a : Photo of internal roof structure – East gable end**

3.16 Consideration should be given at Building Regulations stage to allow sufficient headroom to accommodate the retention of the existing trusses.

Aside from requiring treatment for wood boring insects, the timbers do appear to be in good condition, and as they are supporting a slated roof now, there will be little increase in load on the structure once it is converted. Given that the purlins are slender (and some affected with wet rot) it is unlikely that these could be retained, and the rafters will require replacement in order to accommodate the necessary insulation.

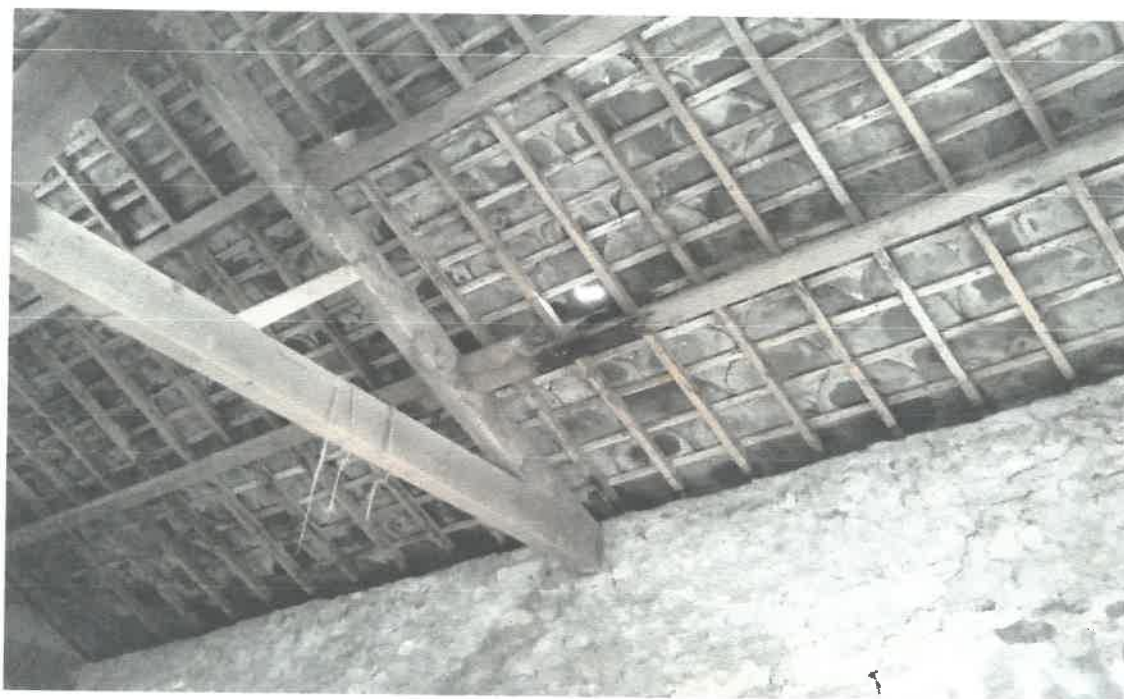
**5b : Photo of internal roof structure – West gable end**
