HERITAGE STATEMENT

PROPOSED REPAIR WORKS

Crabtree Cottage
Back Lane
Wiswell, Clitheroe
BB7 9BU

NOVEMBER 2018

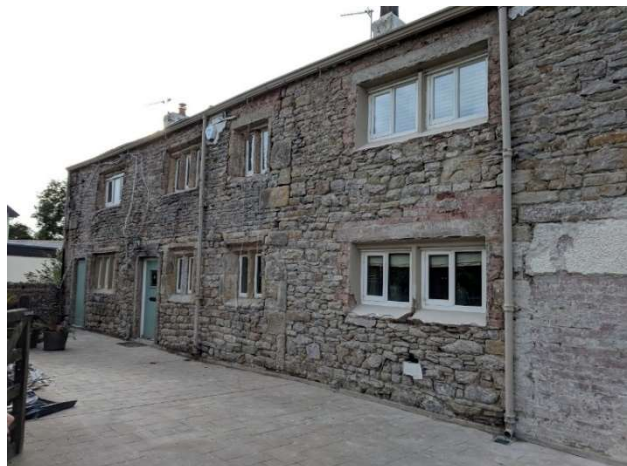
Figure 1 – Front Elevation with the render removed

Looking at the building with the render removed makes it possible to see properties layers of change through years. You can see how the property was altered as and when required. When looking and the front elevation (principle elevation onto Back Lane) you can see that originally the property was probably single storey, based on the stone to the walls and the fact that the window details at ground floor are slightly different to the first floor windows. Also, when looking at the two ground floor doors to the main property it is possible to see that these have been altered, potentially installed at a later date based on the stone and detailing. When looking at the right hand side there is a clear line with some stone quoins showing where the barn has been attached. Within the former barn there have been several windows installed with poor repairs to the surrounding stone, using red brick instead of stone to match.

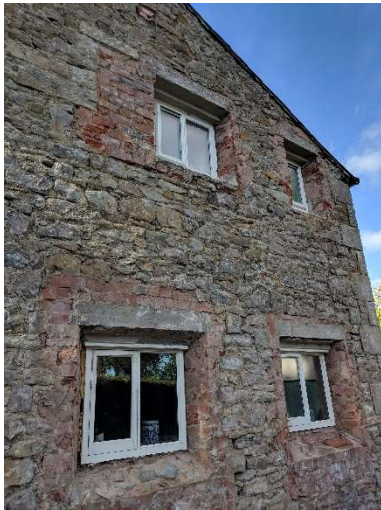
Figure 3 – Photo showing inappropriate/non-original materials to end elevation

The proposed repair of the inappropriate/non-original materials to improve the authenticity and visual appearance of the building. The inappropriate/non-original materials used to repair/alter the building will lead to long-term damage of the historic asset. The proposal is to replace these materials with materials to match in substance, texture, quality and colour. These materials will be installed using traditional techniques appropriate to when the building was constructed. The works will result in an asset that has greater historical integrity and will be visually compatible in its own right and as part of the village of Wiswell.

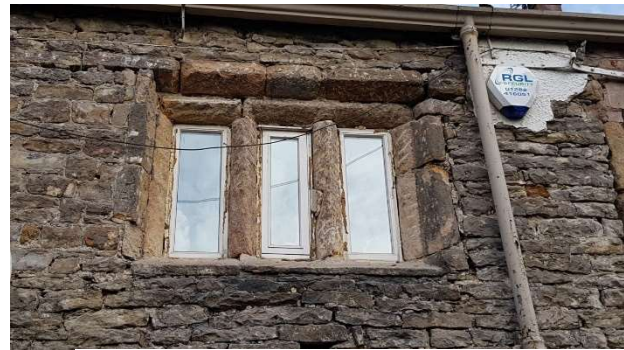
There are areas where the original stone has been damaged/removed and this is resulting in further damage to be caused elsewhere within the building.

Figure 2 – Photo showing damaged stone mullion

The proposed repairs to the original stonework will be done using matching materials. The materials are to match in substance, texture, quality and colour and will be installed using traditional techniques. This is to ensure that the significance of the heritage asset is not affected but the heritage asset is protected for future generations.

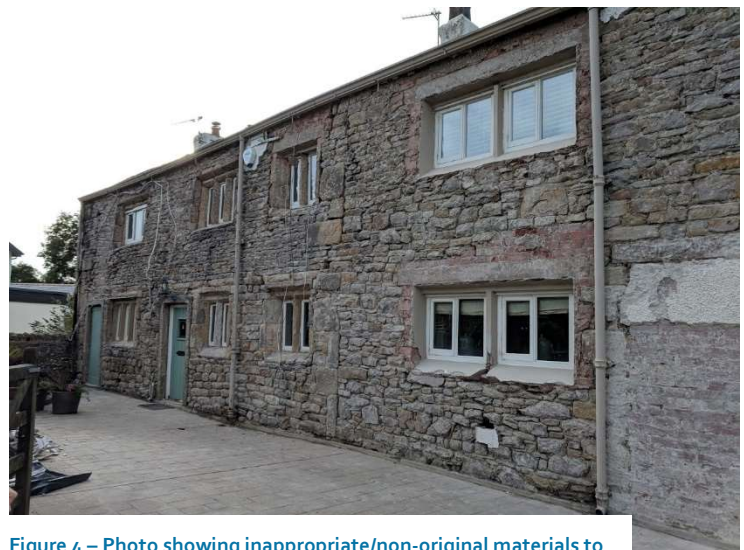
Figure 4 – Photo showing inappropriate/non-original materials to front elevation
