Contaminated Land Phase One Desk Study for Proposed Office Accommodation on Land Opposite Woodfield Garage, Longsight Road, Clayton-le-Dale, Blackburn, BB2 7JA

O'Callaghan Ltd
Civil Engineering Contractors
Showley Fold,
Showley Rd,
Clayton-Le-Dale,
Blackburn,
BB1 9DR

January 2019

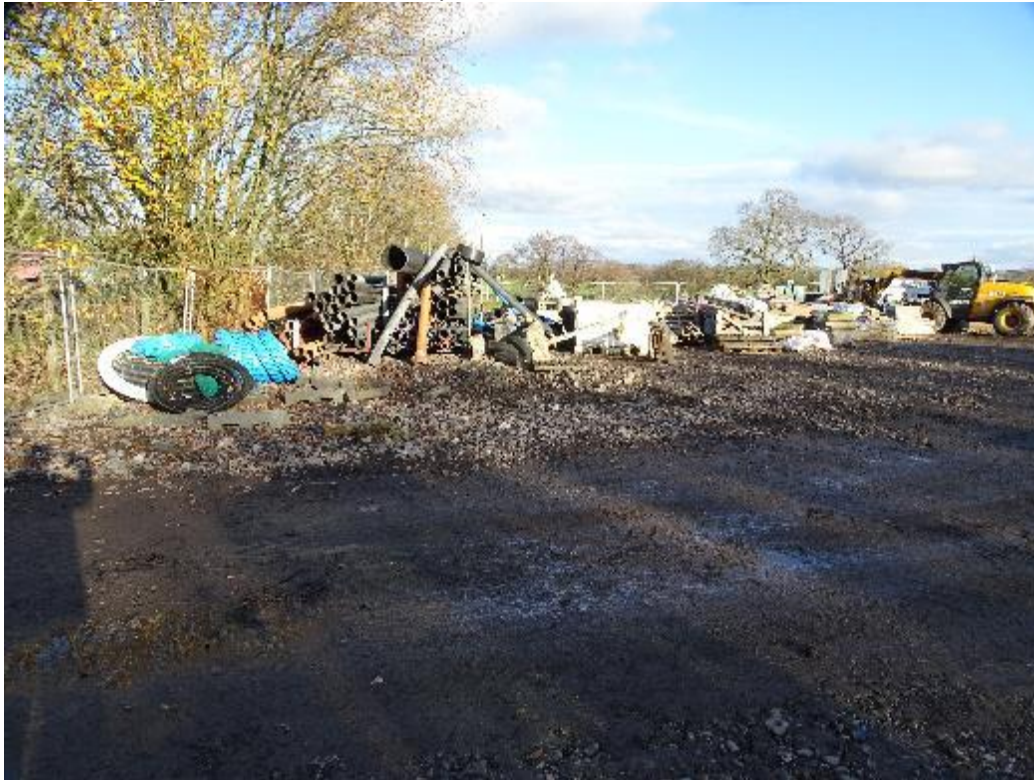
A view of the front of the site from Longsight Road
Looking along the northern boundary eastwards

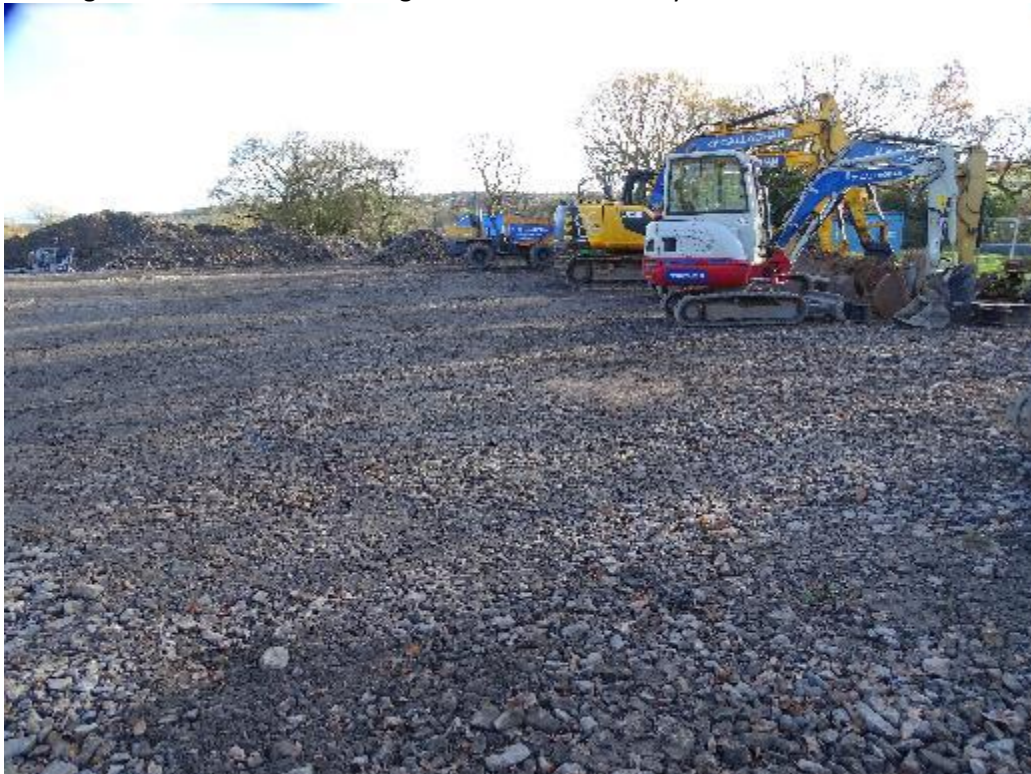
Looking from north to south along the western boundary of the site

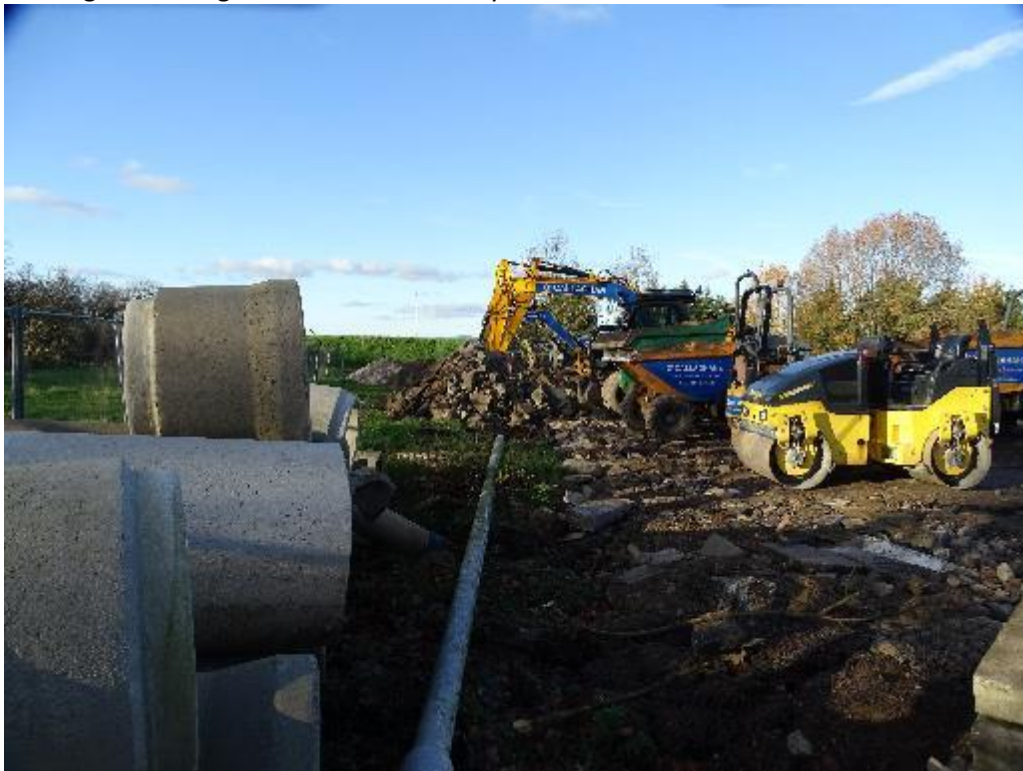
Looking back along the western boundary south to north.

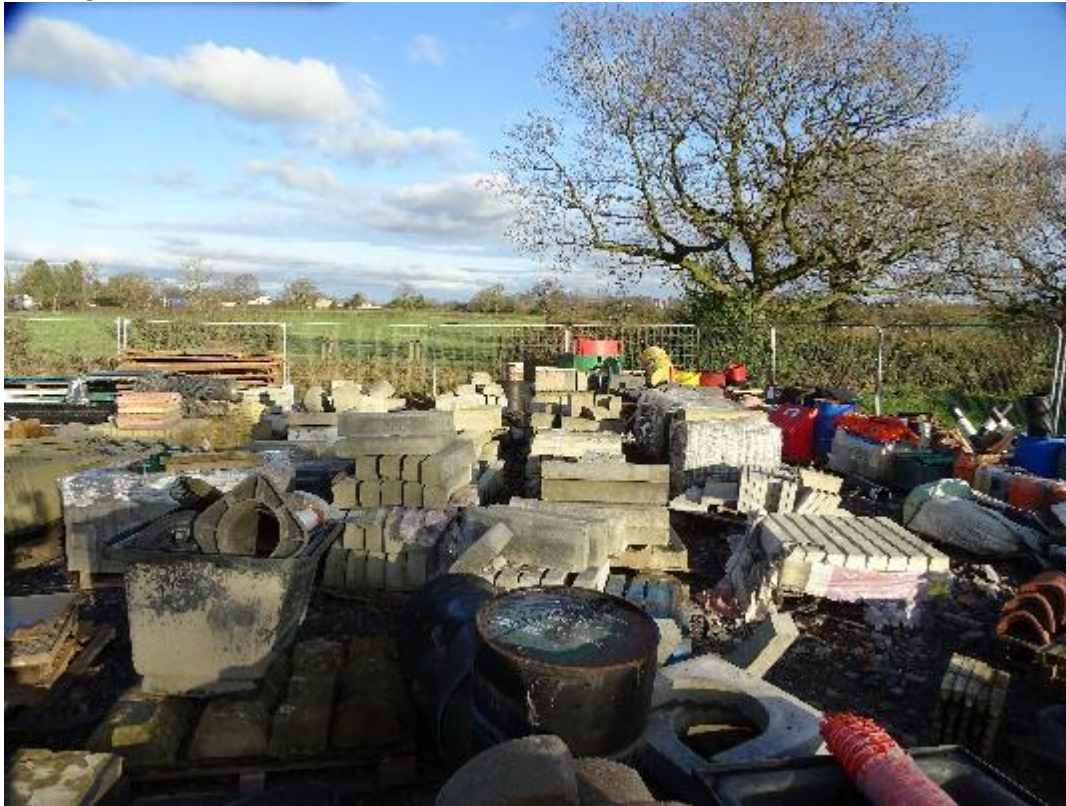
Looking east

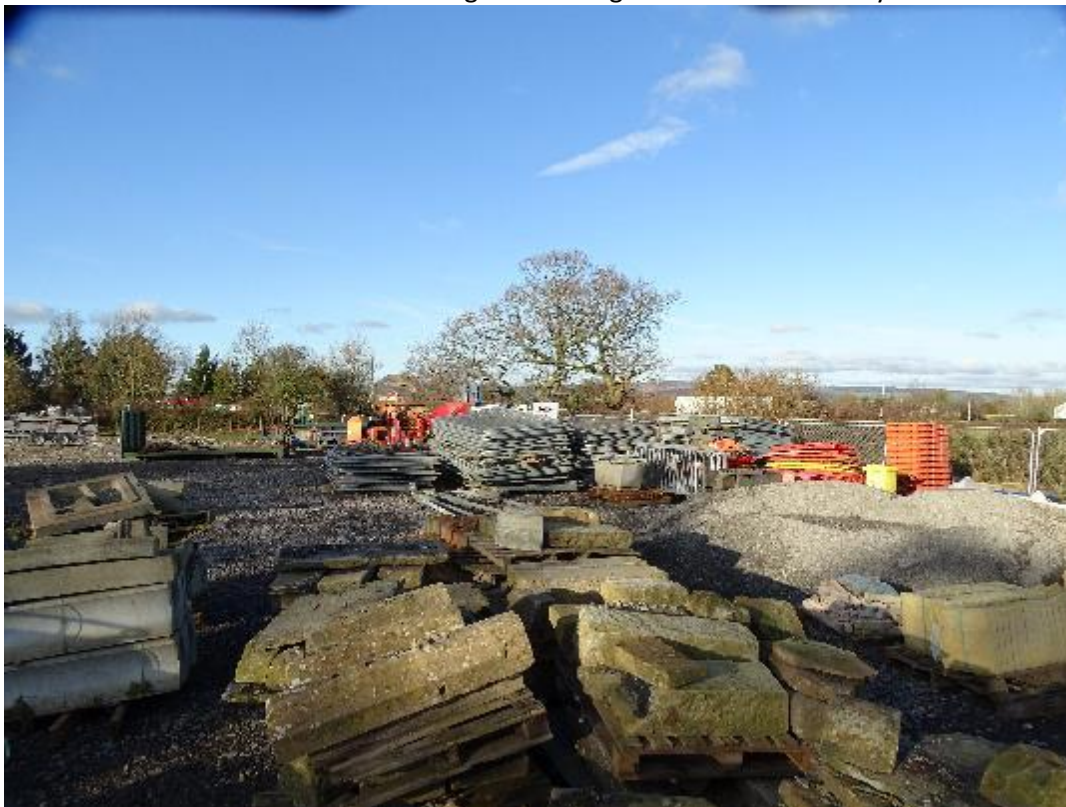
The southeast corner of the site looking north along the eastern boundary

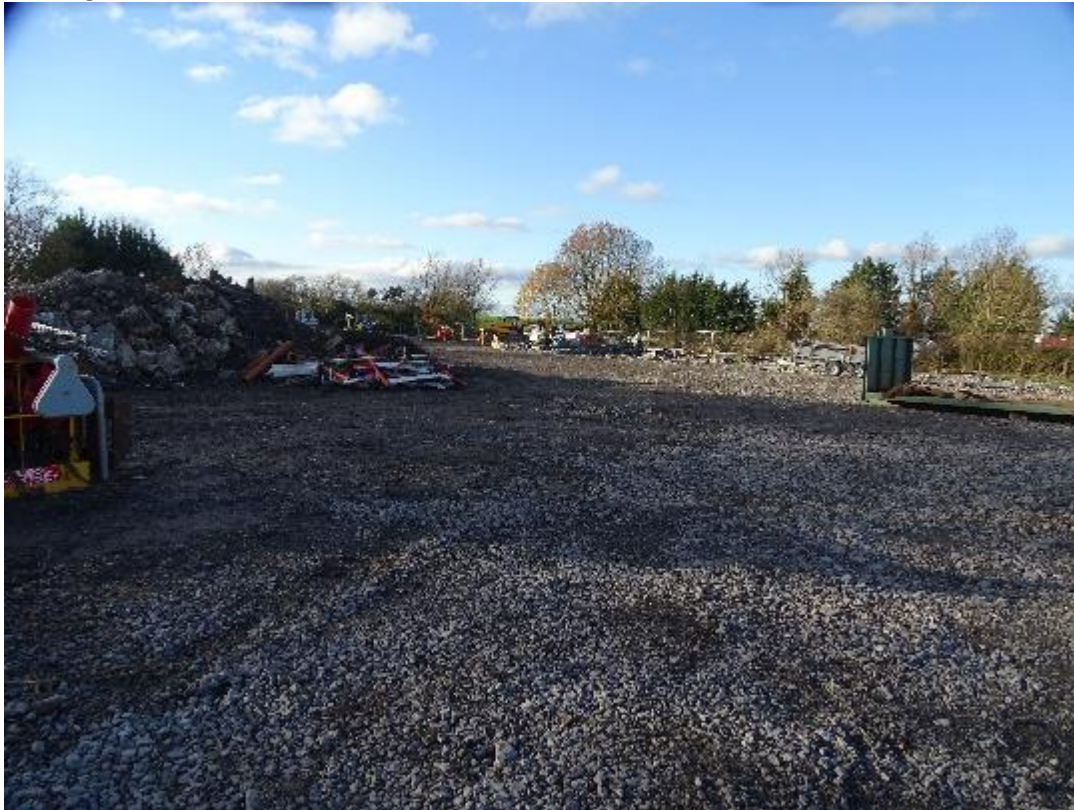
Looking across the site

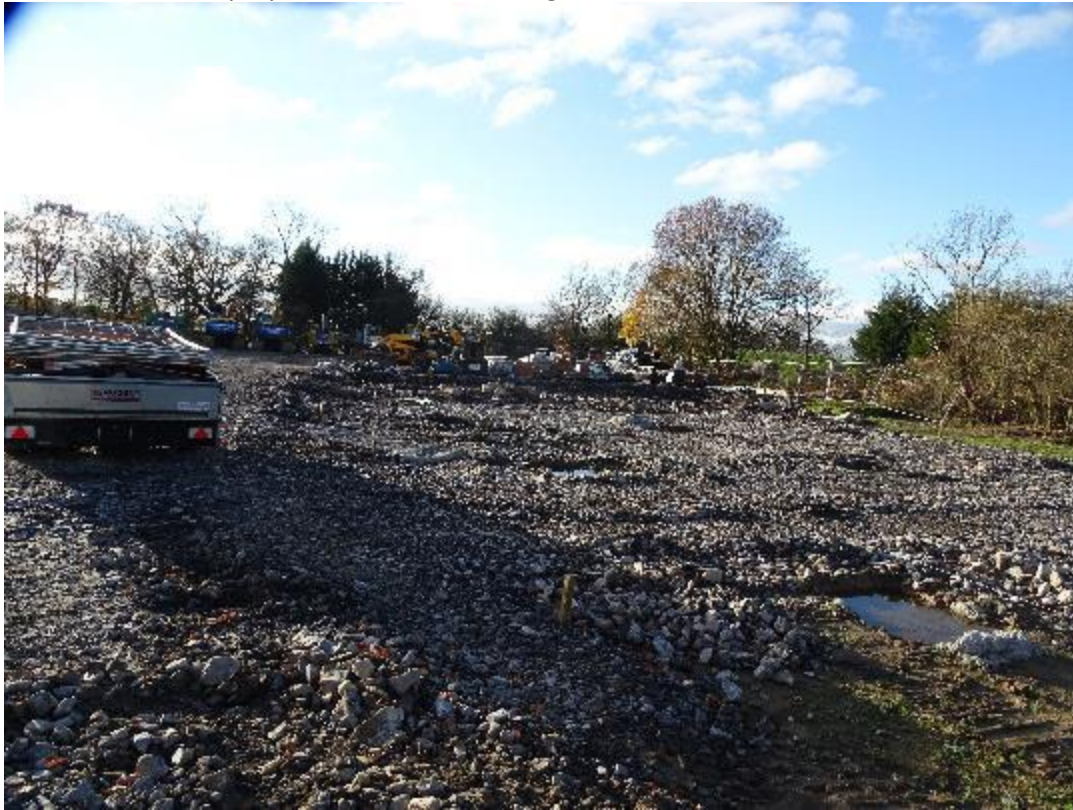
Hardcore based in preparation for the building
