Heritage Statement

Proposed Roof repairs

Keys Cottage, 6 Main Street,
Bolton-by-Bowland, BB7 4NW

February 2019

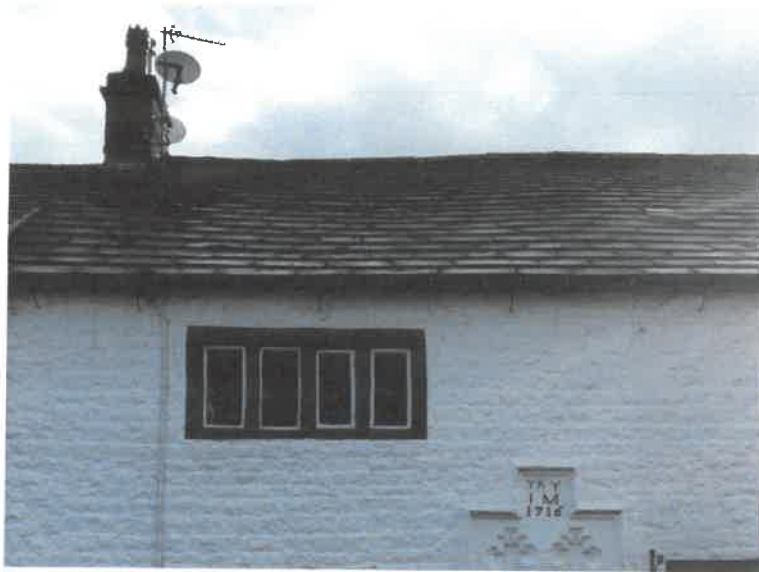
Front elevation of existing roof

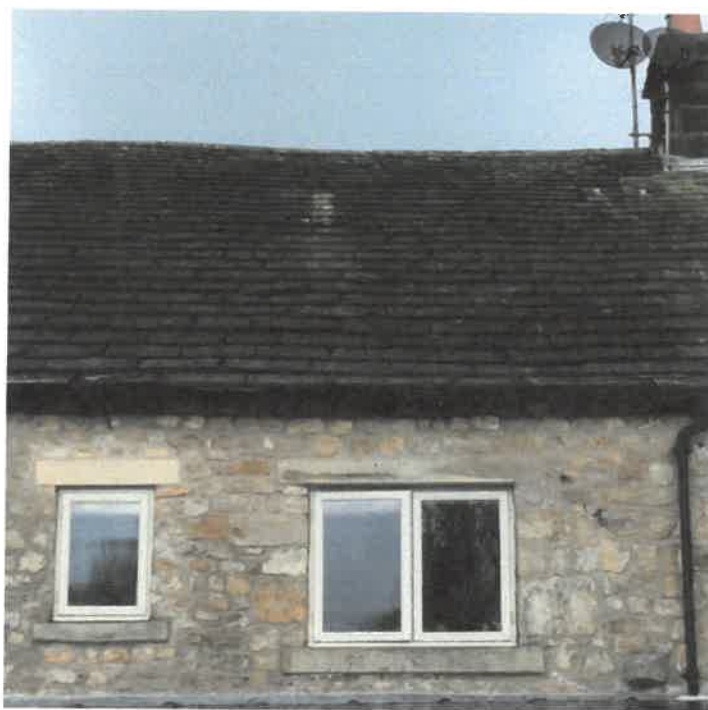
Rear elevation of existing roof

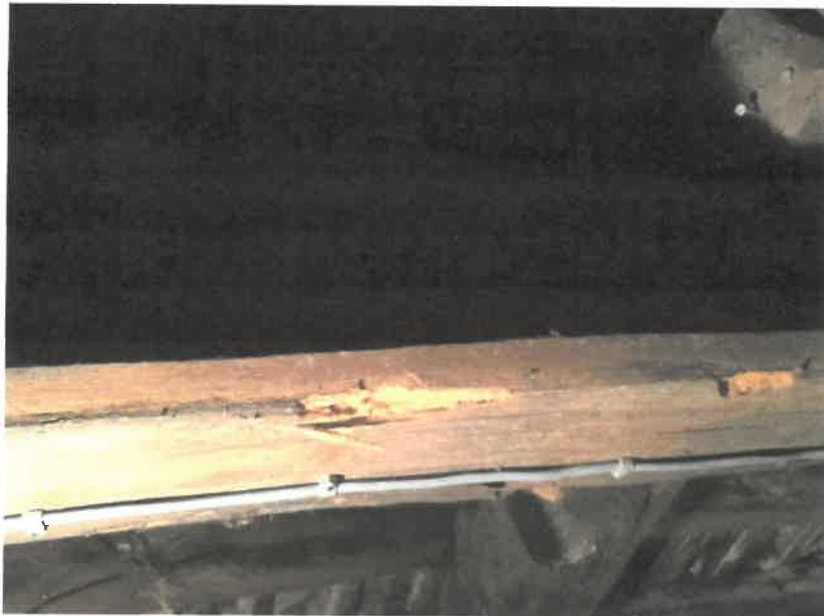
Signs of wet rot on main roof beam

The repairs to the roof will not lead to the loss of any historic features and will respect the heritage asset and retain the existing plan form and fabric as much as possible. Where any existing roof timbers or tiles have to be replaced, this will be done using reclaimed materials which match as closely as possible the existing ones.

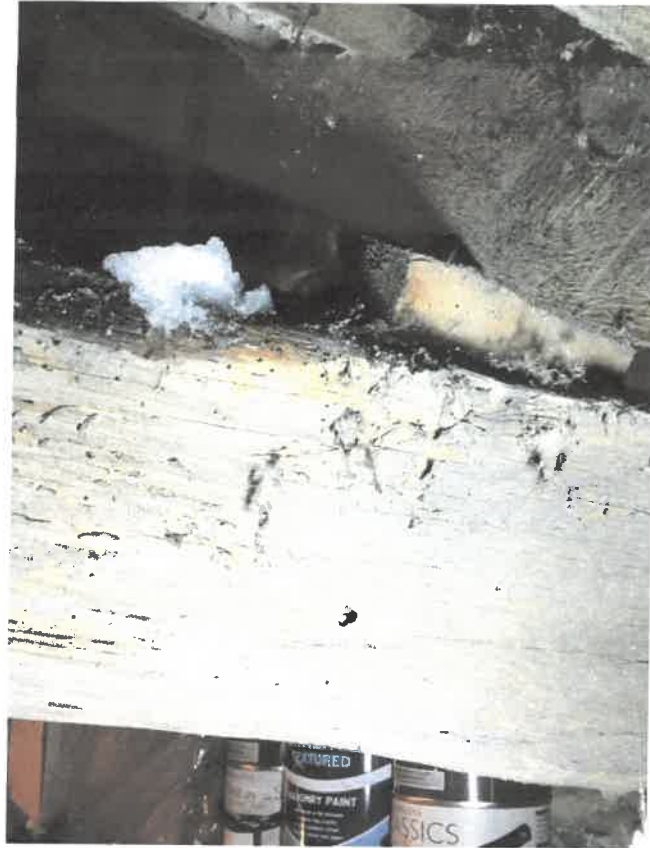
Internal photograph showing snow entering into roof space and settling on beam
