**WADDOW VIEW**  
**CLITHEROE**  
**ARBORICULTURAL IMPACT ASSESSMENT**  
**JANUARY 2019**

| Document Title | Arboricultural Impact Assessment |
| Prepared for | Barratt & David Wilson Homes North West |
| Document Ref | 6896.001 |

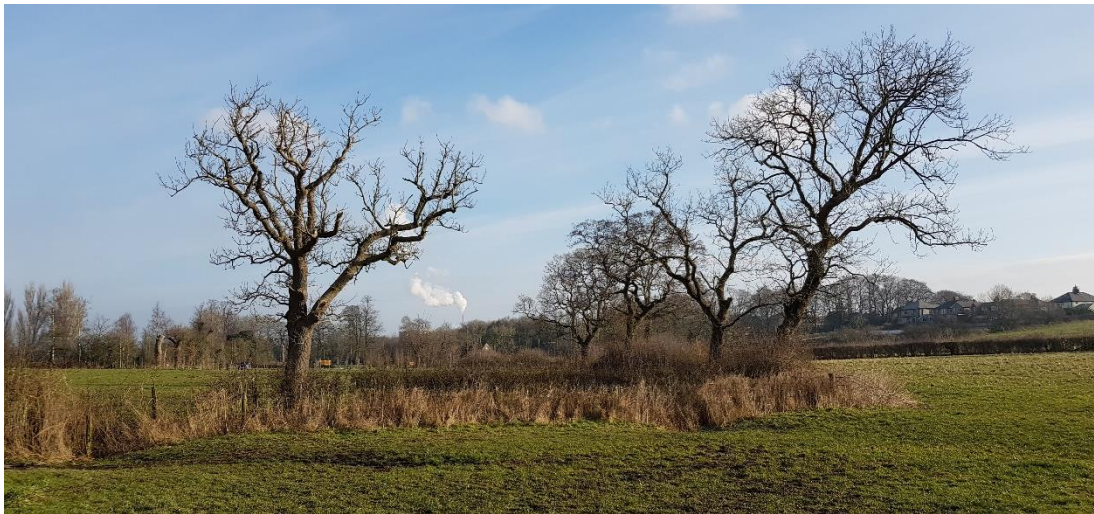
*Figure 2 View north at T14, T15 and T16*

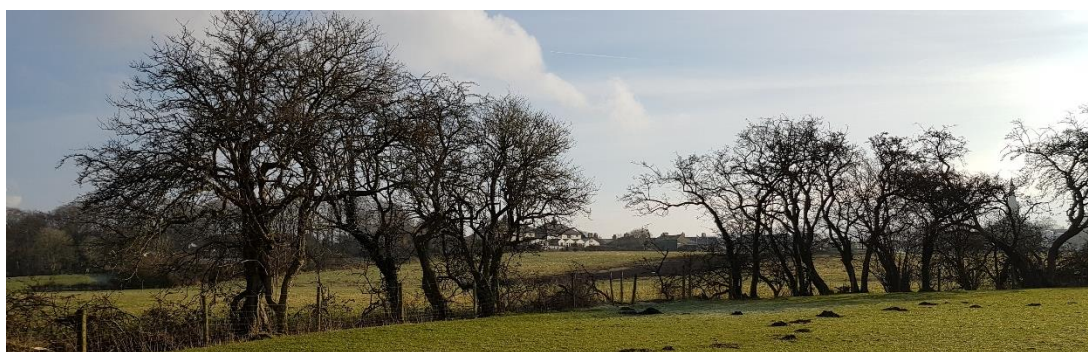
- 4.3 Across the southern half of the site and forming the boundary of one of the fields is a lapsed hedgerow that now forms a linear group of very old hawthorn trees in varying condition. They are all mature trees, some with very large stem diameters for this species. A high proportion of trees in the group are multi-stemmed with a gnarly form and snapped out limbs, have evidence of brown rot decay and dead wood, features typical of veteran trees. However, some of the trees are in decline and some have failed stems with the crowns lying in the adjacent fields. This arboricultural feature no longer functions as hedgerow as it is not stock proof and it would be difficult to bring back into hedgerow management without extensive new planting but it does provide valuable niche habitat and connectivity across the wider site.

*Figure 3 Lapsed hawthorn hedgerow group G1*

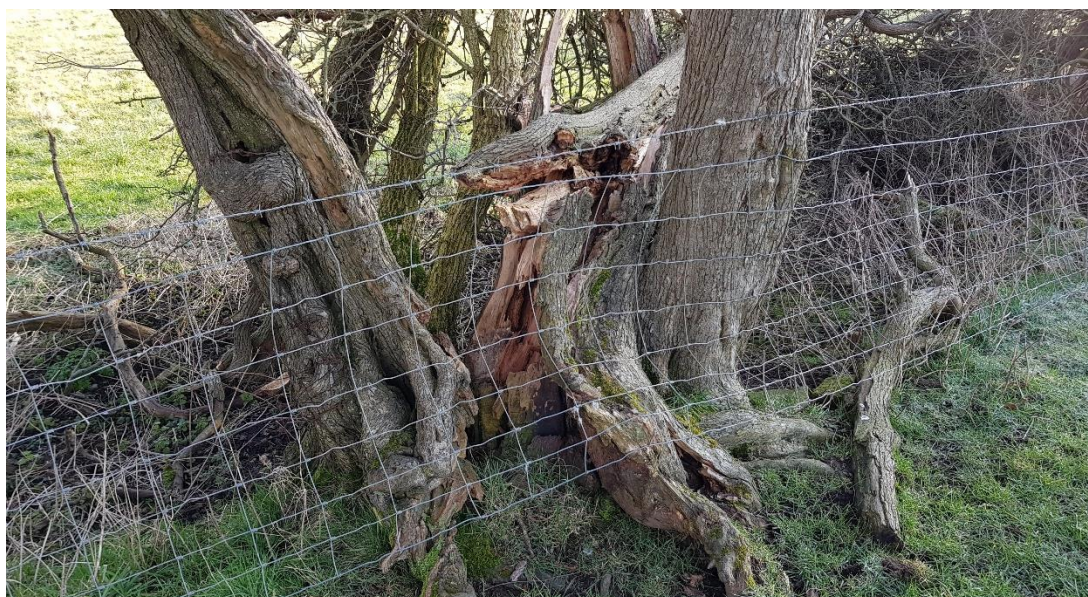
- 3.3 On this site there are no ancient woodland or veteran trees. Hawthorn trees forming group G1 are very old and contain features commonly associated with veteran trees. Based on their overall condition however, they fail to meet the full criteria required to designate them as true veterans, although they do pose increased ecological value due to the niche deadwood habitats they provide.

*Figure 4 Deadwood habitat on failed hawthorn in group G1*

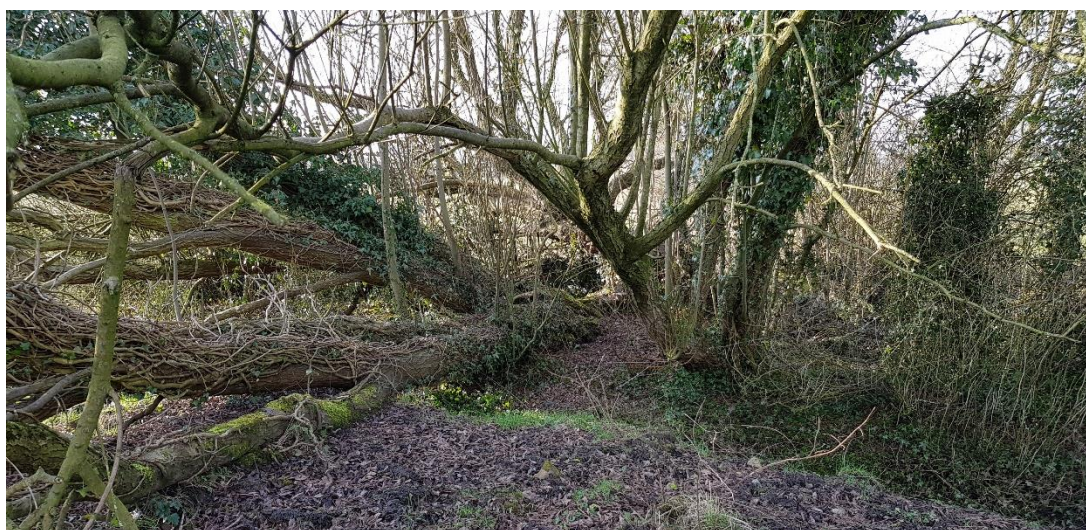
*Figure 5 View south at layered stems of T26*
