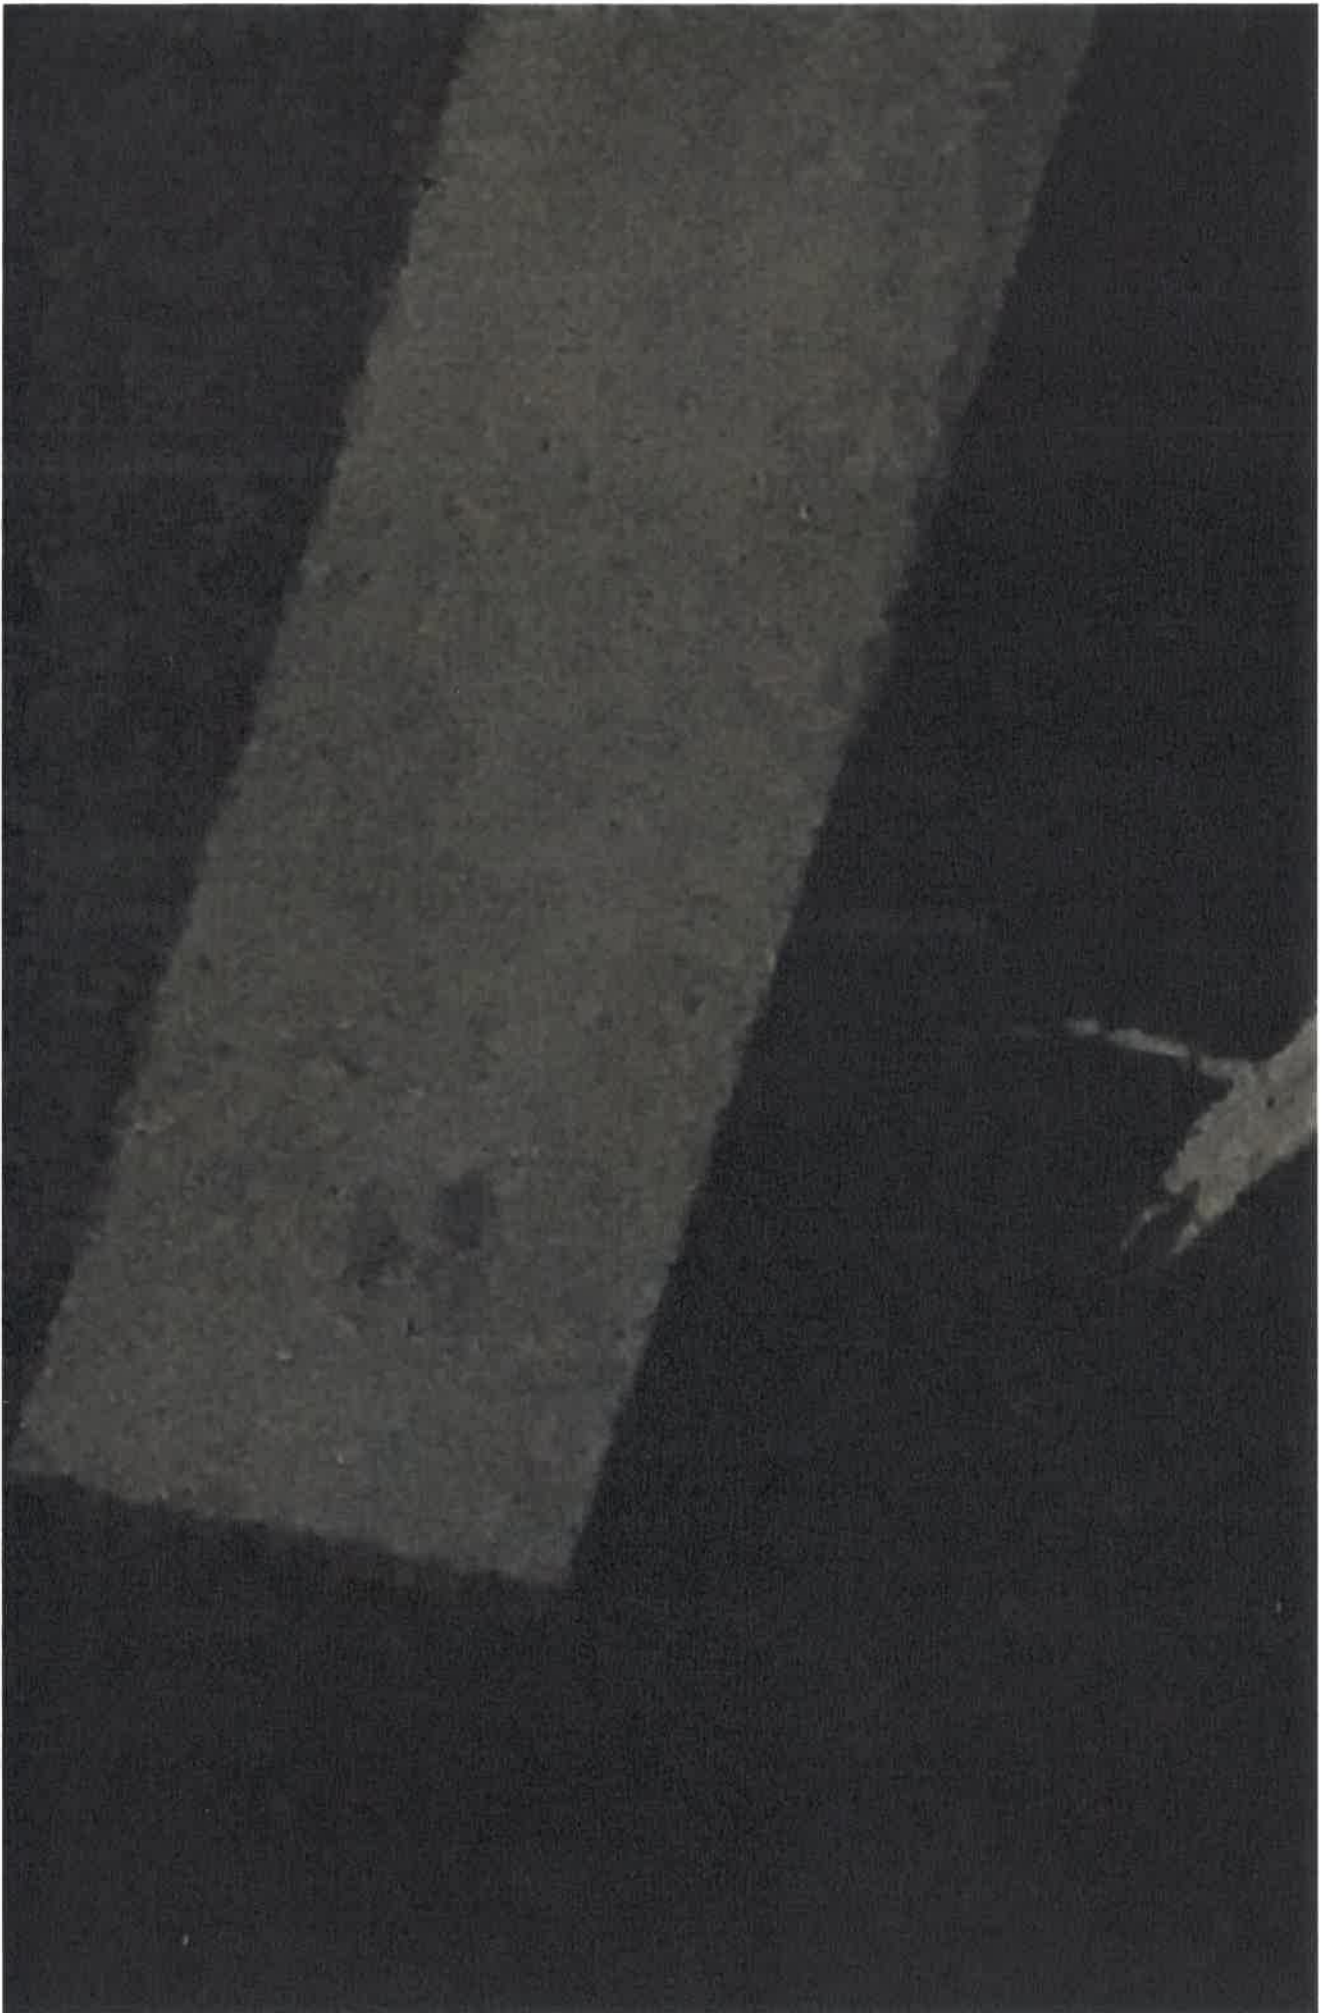
Image above shows damage to roof repaired temporarily with expanding foam filler.

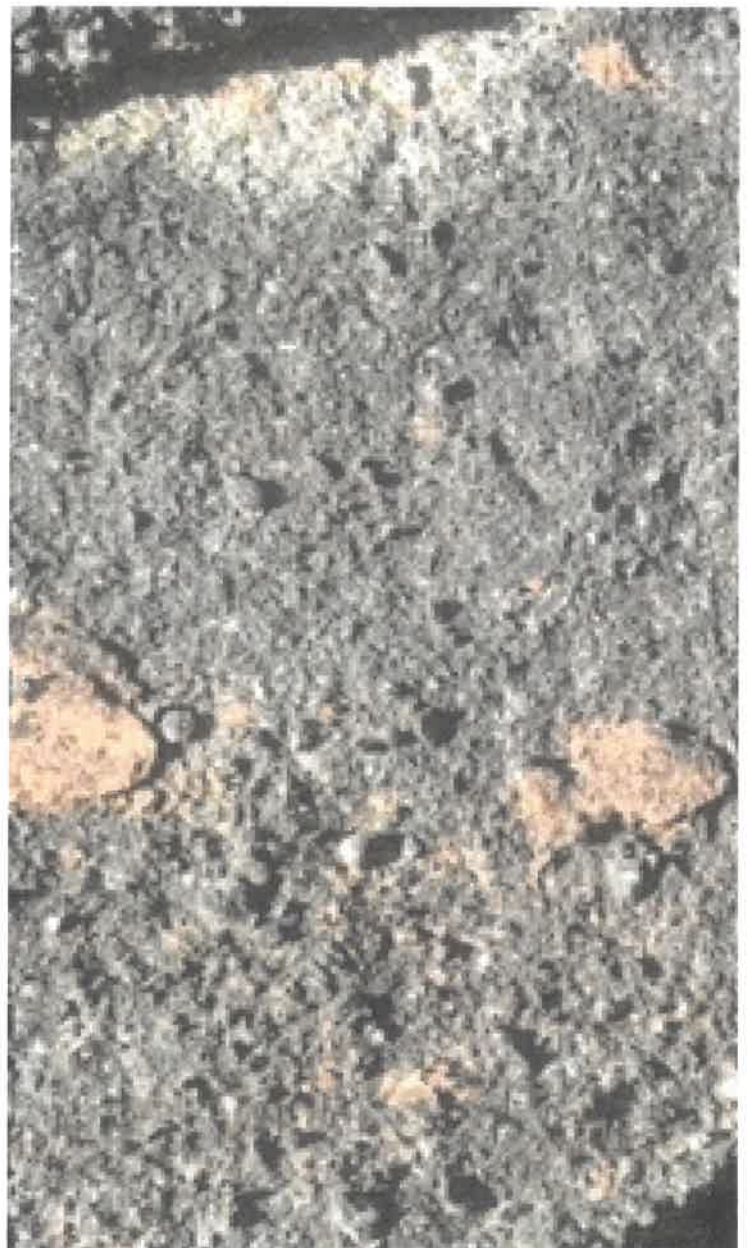
Image above shows corroded tiles which moss has damaged over time(the lighter colour shows the corrosion)

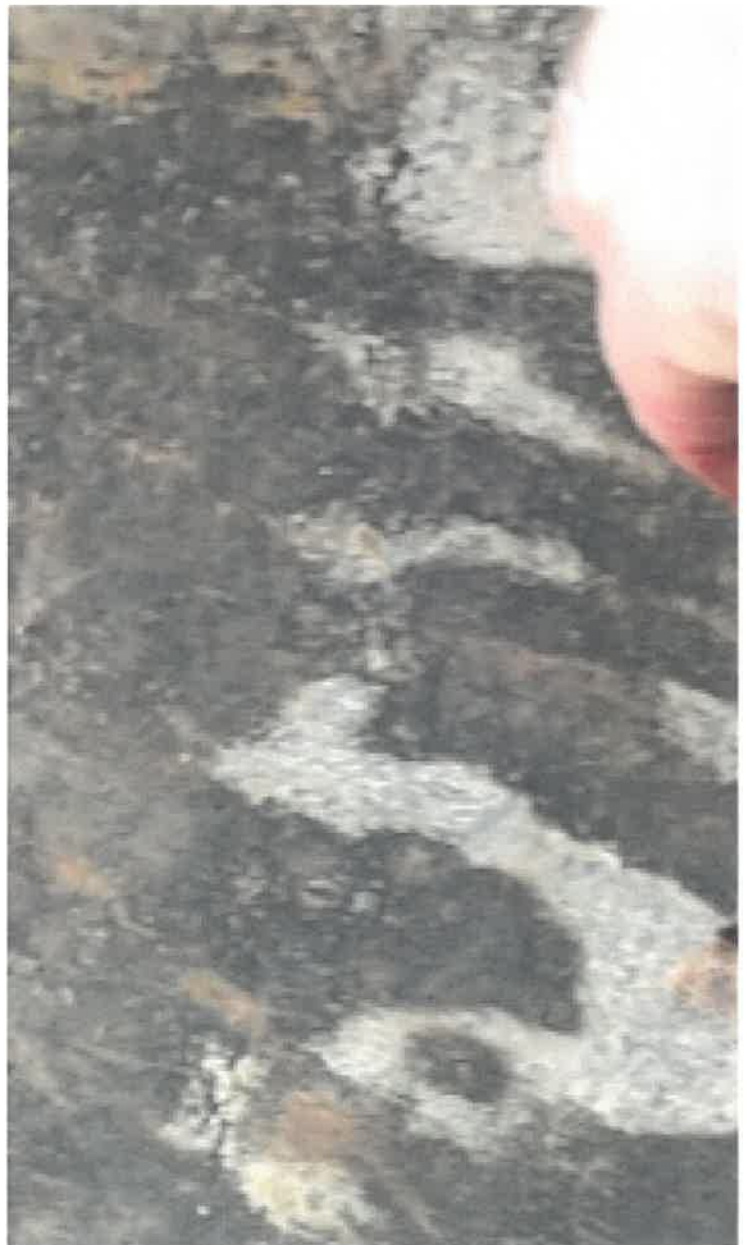
Image above shows how thin the roof tiles have become over time-the tile near my hand is the part that has been shielded from weather-the opposite end which is exposed is less than half the thickness so providing hardly any protection from the rain.

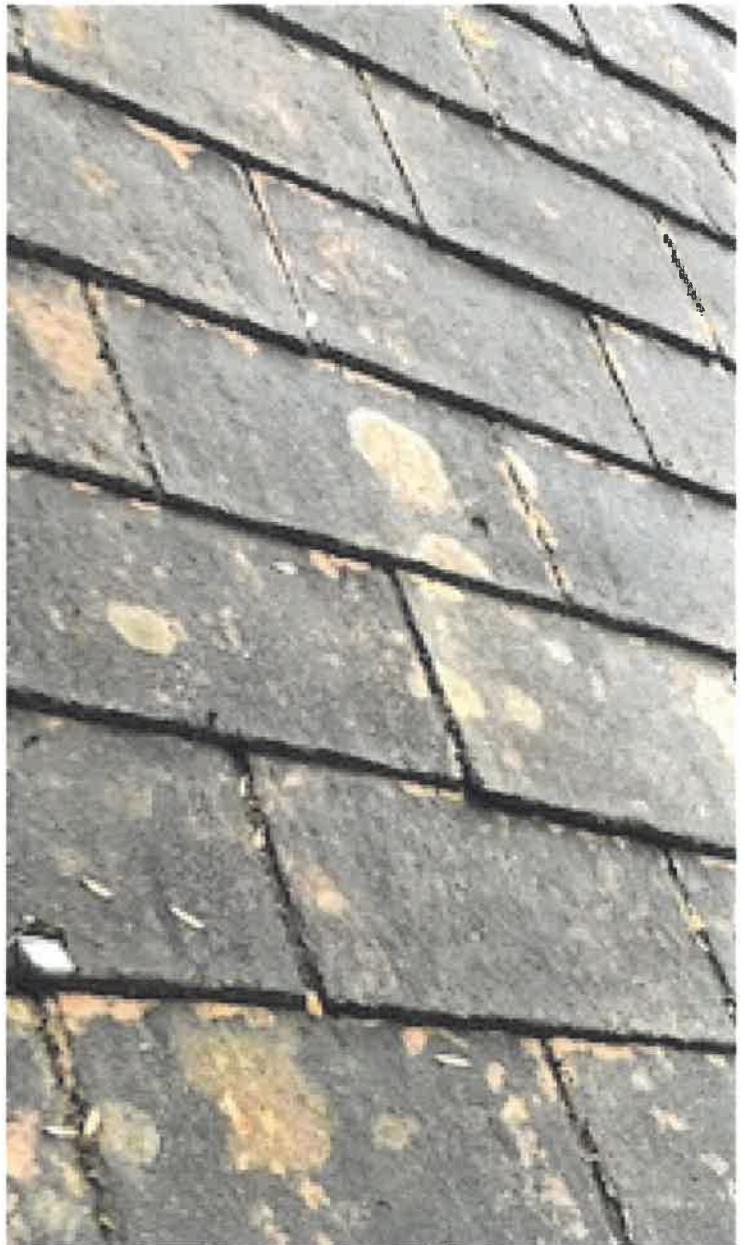
Image above shows cracked tiles and more patchy corroded tiles.

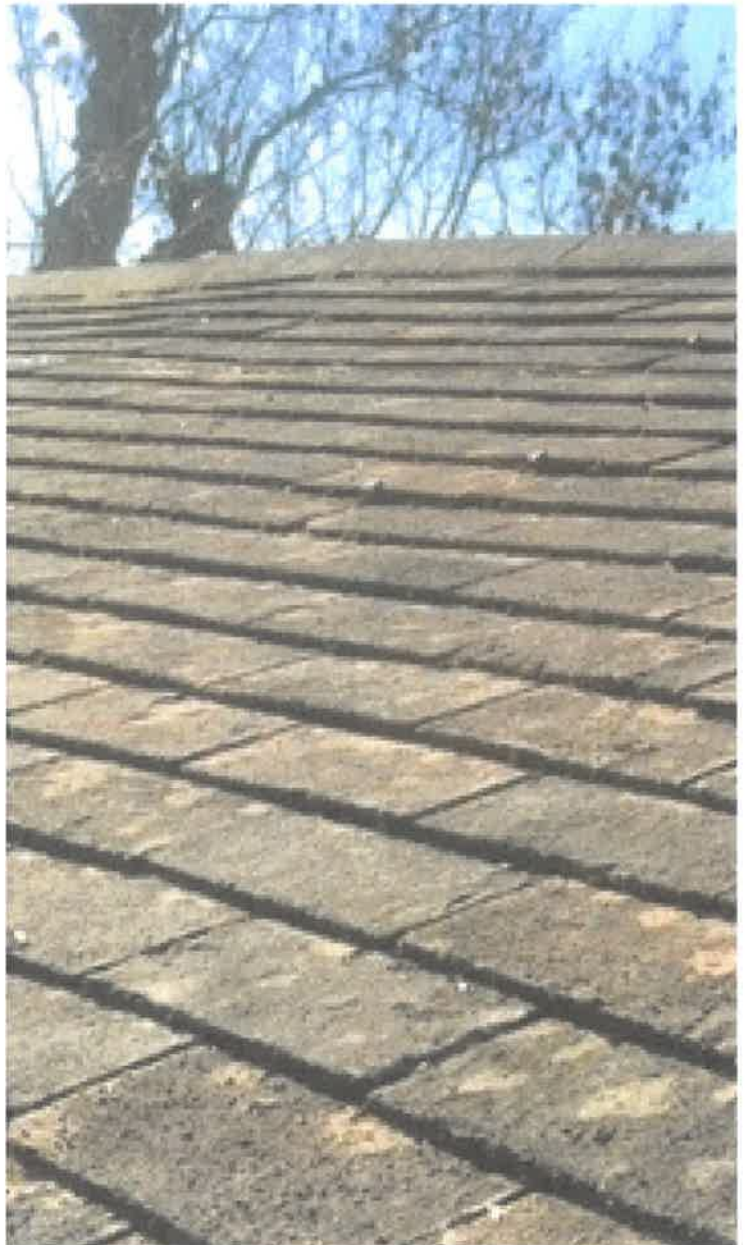
More cracked and corroded tiles
