CONDITION ASSESSMENT OF THREE BEECH TREES AT WHALLEY TENNIS CLUB

Client: Mr H Farrar (acting for Whalley Tennis and Cricket Club)

Date of Tree Inspection: 6.3.19

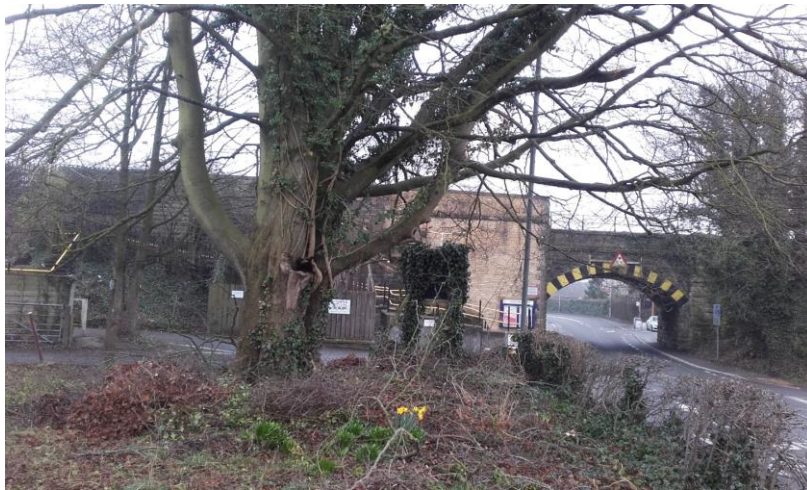
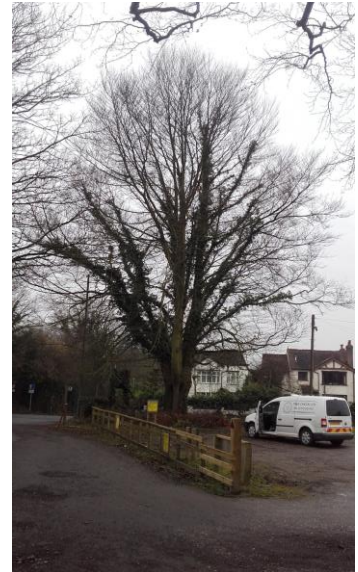
T28 by Road

1. The tree is located 4m from Station Rd and in close proximity to a street lamp post (13) and a BT Pole. The tree lost a large limb from the lower canopy in the last year. The tree has an overall height of 23m and a Dbh of 1220mm. The canopy extends to the middle of the road (9m) and the Club grounds entrance.

2. The root zone of the tree is covered to a radius of 2m with brush prunings from adjacent landscape works to a depth of 400mm. While this debris keeps people away from the immediate under canopy area of the tree the brush cover rules out an inspection of the root zone surface and the presence of any root decay pathogens.

3. Ivy growth covers the main scaffold of the tree to a height of 10m and obliterates branch unions, adds wind drag to the tree in winter and makes inspection difficult.

The tree is within failure range of a busy road with a traffic flow at 30mph of 60-100 vehicles per hour during the day at a location where there are multiply junctions and visibility issues. We would regard the target value as high. The likelihood of further limb failure is medium and in its current state, branch failure over the road pavement and entrance track is likely.

1. Sever the ivy at ground level and at 1.5m
2. Remove the pruning debris from around the tree without creating a ground scrape which will damage surface roots.
3. Canopy lift the tree by removing branches obstructing the Light pole and reducing the light beam spread and remove two lower limbs extending over the pavement and road adjacent to the recent snap out failure
4. The canopy lift over the road should enable road clearance of 5.5m
5. The progress of the *Kretzschmaria deusta* pathogen should be monitored again in November 2020 and any evidence of root decay fungi noted

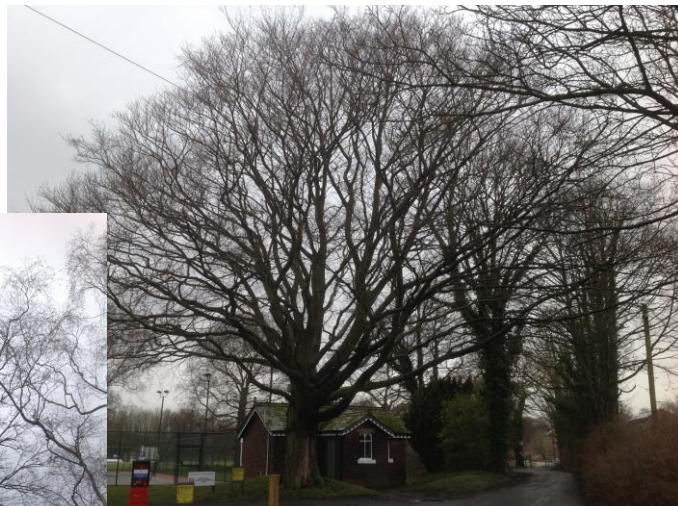
T29 by changing rooms

The tree has a height of 22m and a Dbh of 1180 and a canopy spread ranging from 8 to 14m. Most noticeable is the effect of fire damage of 350mm x2m many years ago on the main stem. The tree has produced significant compensatory growth and the decayed core is a rigid rather than a soft rot.

In the distant past the tree may have suffered a slight root plate lift in high winds and while two roots are visibly dead there is evidence of a secondary rooting system able to sustain the canopy which appears free from dieback.

The canopy growth over the tennis courts presents maintenance issues, debris and slippery moss so a light canopy reduction prune to achieve an effective canopy radius reduction of 2m is recommended.

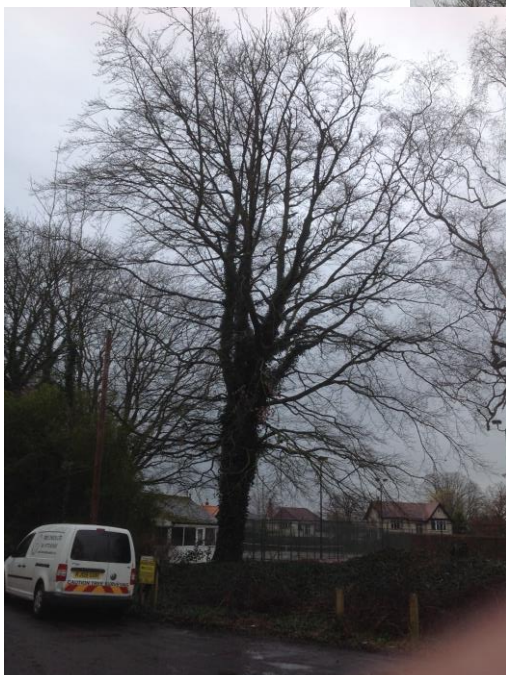
T30

The tree is located on a raised bund behind the Changing rooms. The tree is 17m high with a canopy spread to the access track of 10m and Dbh of 760mm.

There is evidence that the tree may have been root oversoiled in the past and heavy ivy growth obstructs inspection.

The two dominant leaders have both died back and larger deadwood will soon be shed. These leaders are unlikely to recover although some removal of the deadwood might start the process of natural retrenchment and regrowth by the tree. Pruning back of the moribund leaders by 6m is recommended together with the severing of the ivy at ground level and 1.5m.

The progress of the canopy should be reviewed by inspection in November 2020

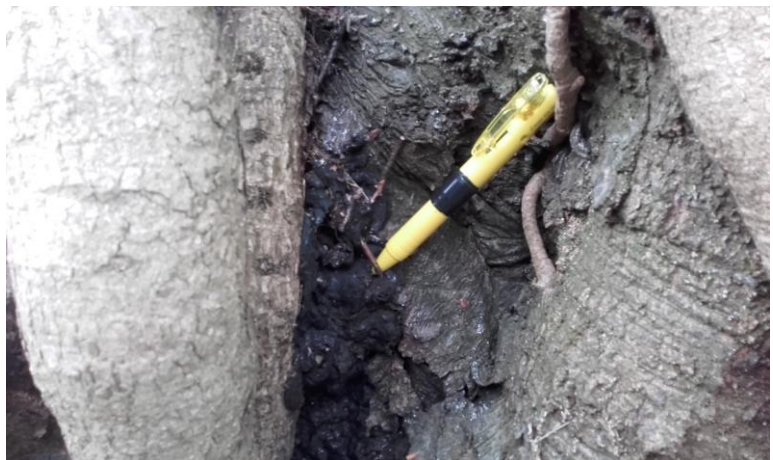
4. The past snap out failure of a large limb is characterised by a typical timber fracture of wood where the cellulose element has been reduced. As shown in the attached photo the older Fruiting bodies of *Kretzschmaria deusta* are visible. The pathogen is present in the outer stem at 1.8m from ground level and in proximity to other unions of branches extending towards the road. Further branch failures can be expected.
