Richard Davis

14th February 2019

DOWNHAM CONCESSIONARY BRIDLEWAY

Tree report to identify tree related issues in relation to new construction, and proposed method statement for construction work

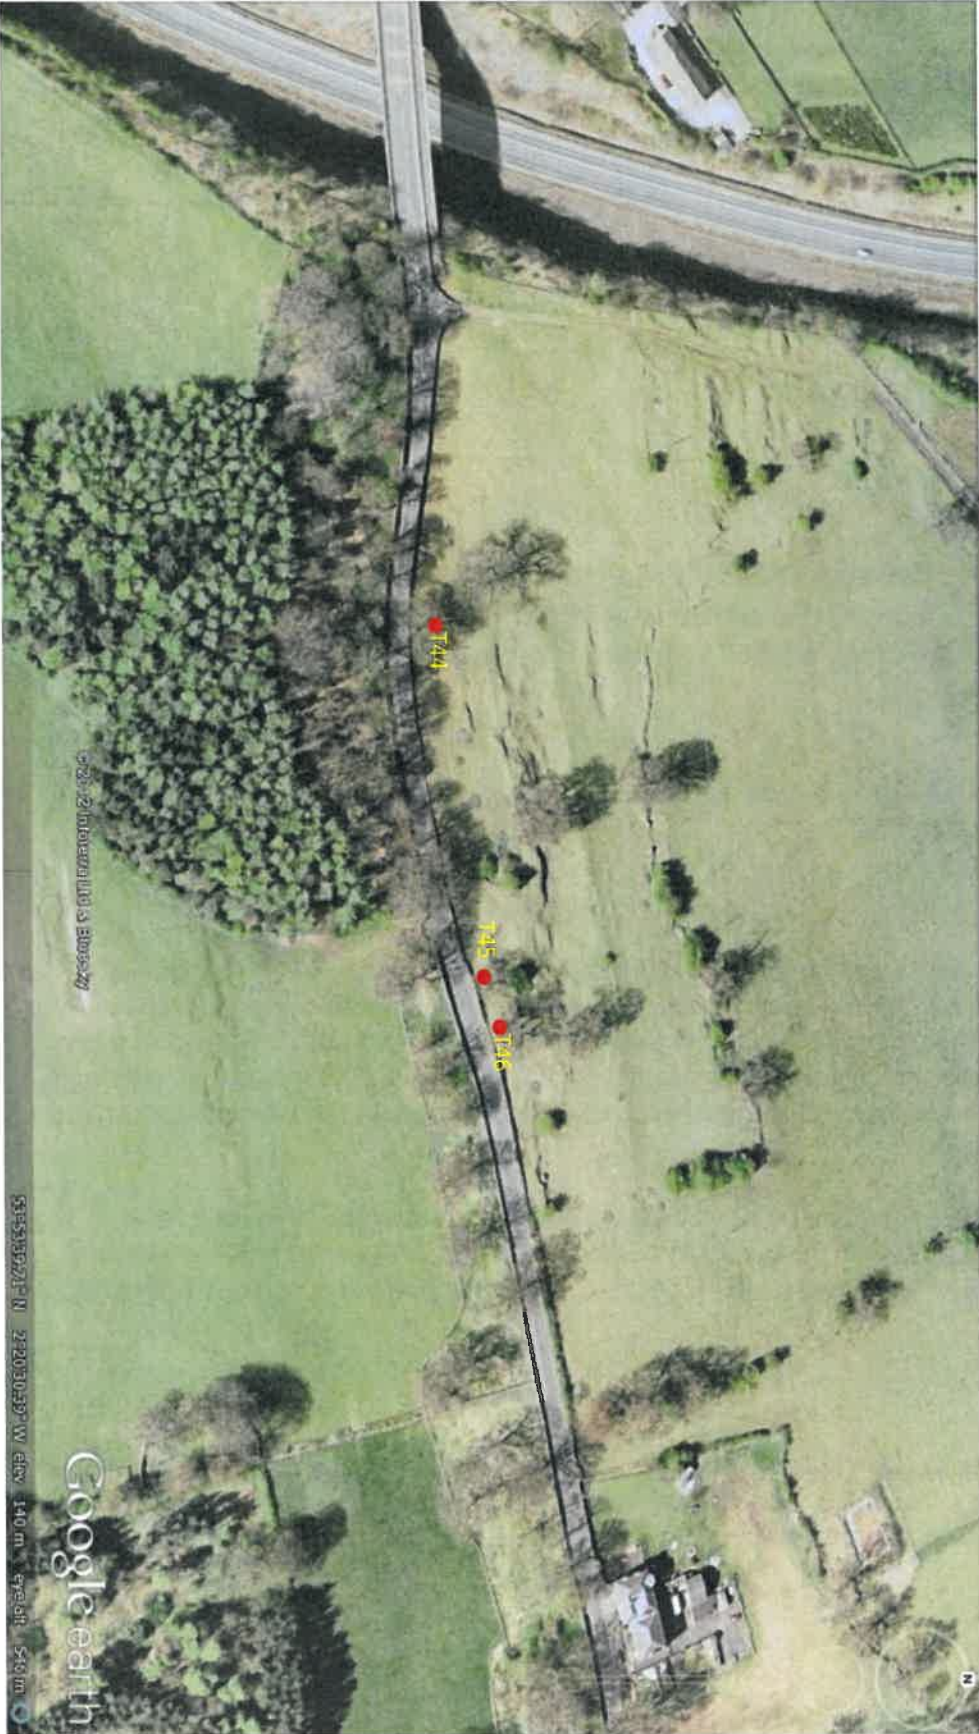
Map 1: Trees on Downham Road, from Chatburn to Greendale

No	Species	Height m	Age class	Category BS5837	Comments
T44	Sycamore	25	Mature	A	Pruned over road 2014.
T45	Ash	18	Mature	A	
T46	Ash	20	Mature	C	Weighted over field.
T47	Lime	26	Over mature	C	Deadwood present in canopy that will fall into field. Low risk.
T50	Sycamore	24	Mature	C	Several dead branches to removed from above road.
T51	Elm	15	Young	B	
G2.4	12x Sycamore 1x Ash 1x Pine	- - -	Semi mature Mature Mature	B B B	1 sycamore has small basal cavity. Low risk. Saplings felled and mature trees pruned.
T52	Oak	16	Mature	B	
T53	Oak	18	Mature	B	Old <i>ganaderma</i> bracket at base. Consider felling.
T54	Oak	12	Mature	B	
T55	Oak	16	Mature	B	Deadwood over field
T56	Oak	16	Mature	B	
T99	Oak	20	Mature	B	
T100	Oak	18	Mature	C	
T101	Sycamore	20	Mature	B	
G10.1	2x Oak 1x Sycamore	- 20	Mature Mature	B B	Sever ivy to permit thorough tree inspection

The trees are generally good quality mature oak, ash and sycamore. They have received pruning in the last 5 years to maintain roadside safety. Most will required deadwood removal and some might require crown-lifting to allow the bridleway to access the desired route.

I recommend that T46 (poor quality Ash) is felled prior to construction, which will allow the route to be kept close to the wall. The lower section of bridleway from Chatburn to Greendale could then be constructed using conventional methods, with only 3 trees on the route requiring Geocells to be used over there RPA's.
