Bowling Green Café

Appendix A

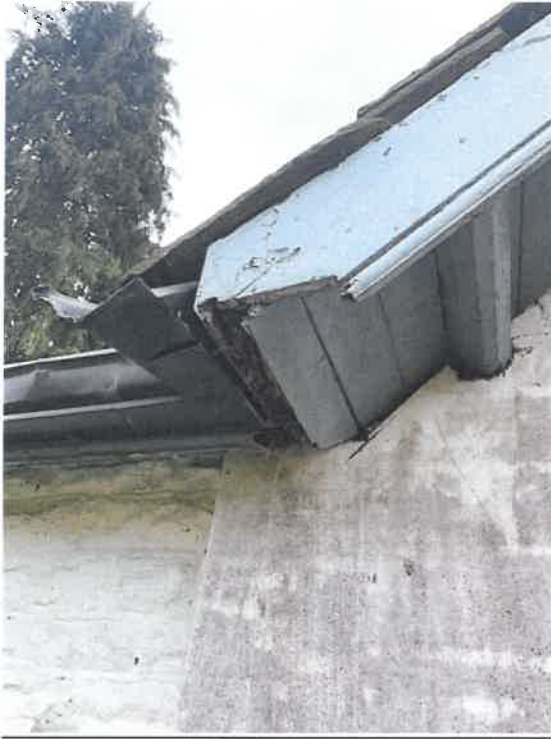
Image 1 shows defective soffits and fascia and the damaged rainwater drain

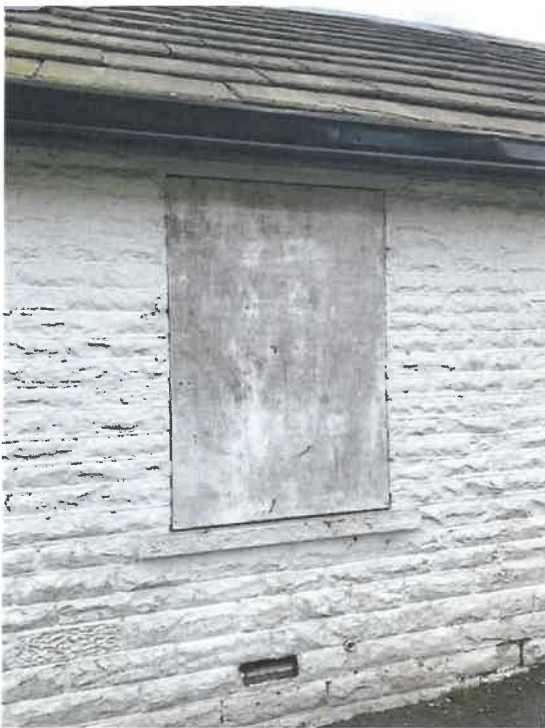
Image 2 shows the windows that are currently boarded up, it is proposed to protect the windows with roller shutters

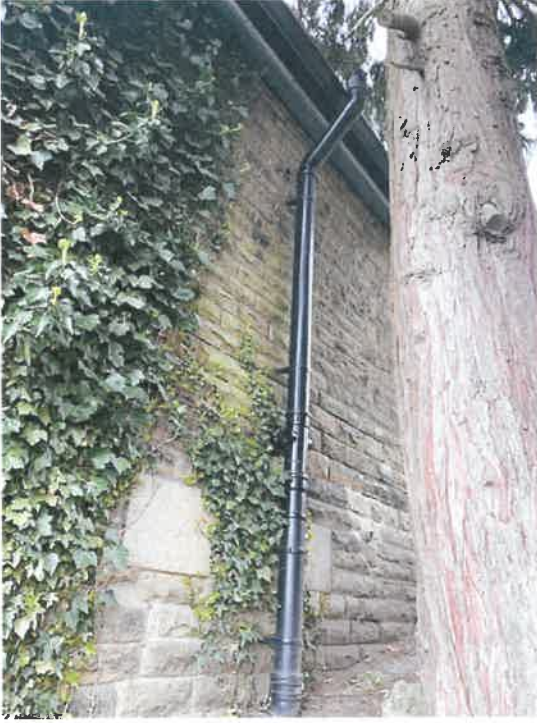
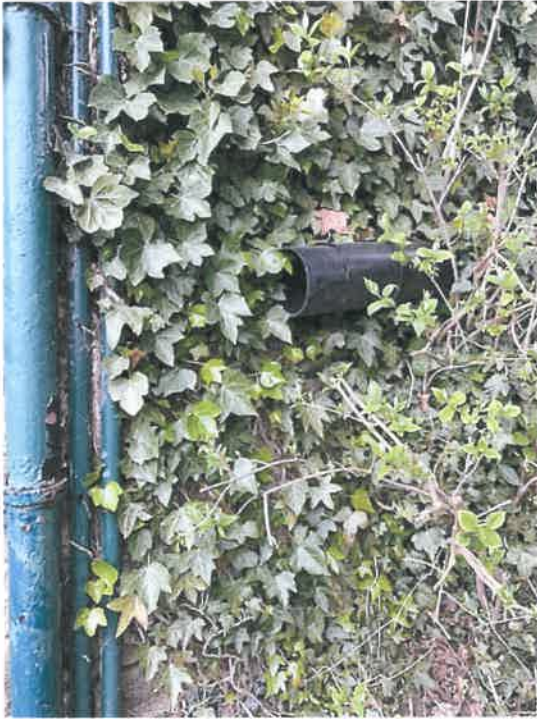
Image 3 and 4 show the damaged existing uPVC soil stack

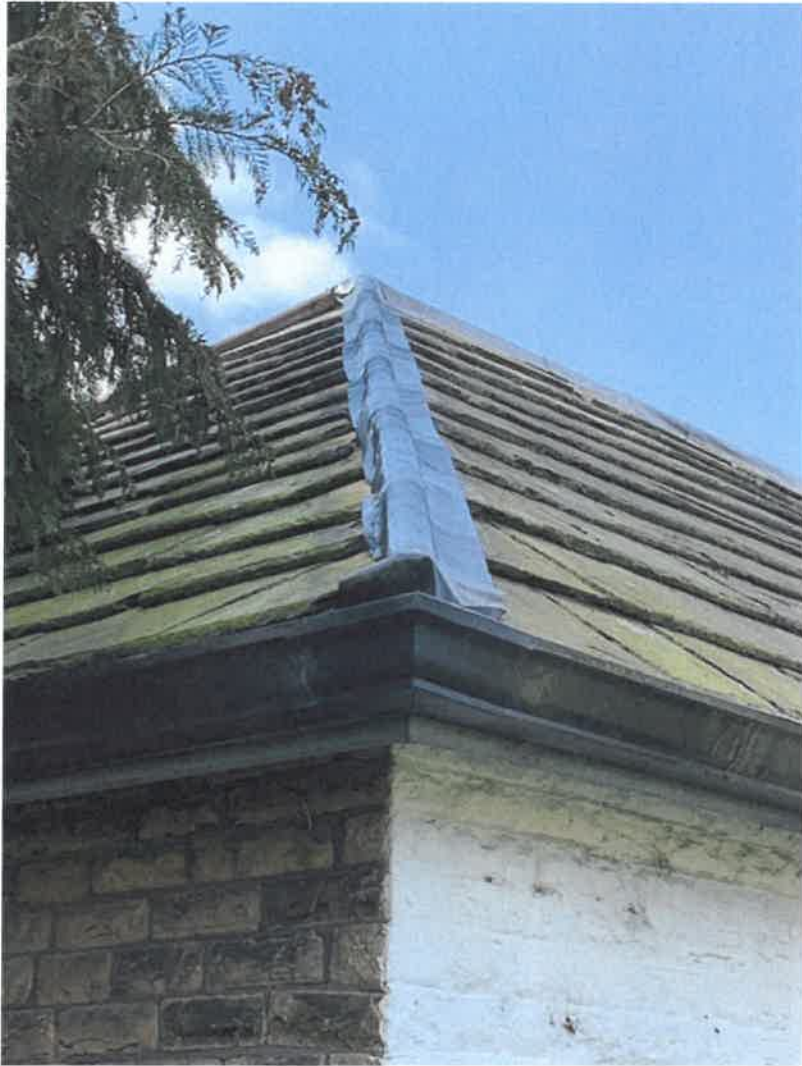
Image 5 shows the existing temporary flashing over the wood core rolls on the hips and ridge. It is proposed to replace this with zinc flashing.

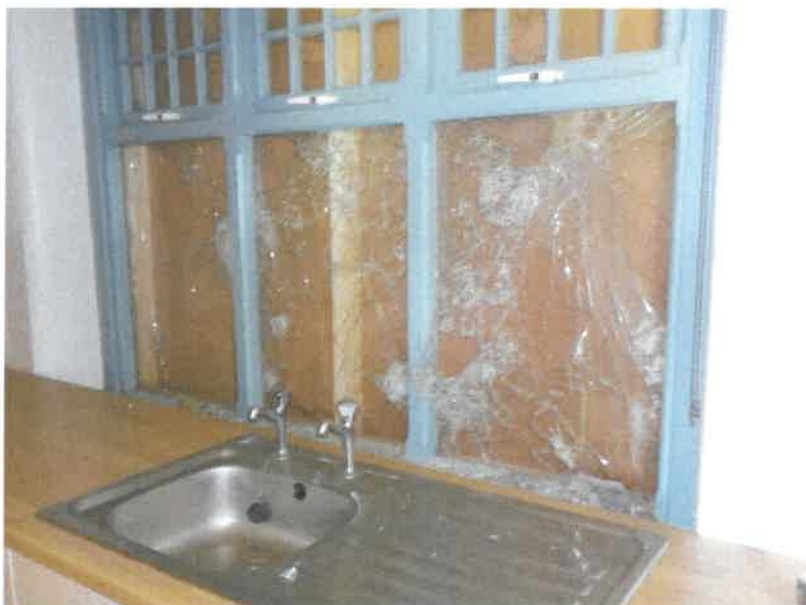
Image 6 shows the existing glazing smashed and boarded up, its proposed to be replaced by bullet proof glass.
