**Proposed Re - Development at
Startifant Farm, Longridge Rd,
Chipping,
Lancashire.**

**Structural Appraisal.
of the Stone Barn
(Amended Mar/19)**

Mr & Mrs R. Robinson.

J HADFIELD ENGINEERING SURVEYING
SPRINGS HOUSE, CHIPPING, LANCASHIRE. PR3 2GQ
Tel: 07740 929096 ~ Fax: 08708 362185

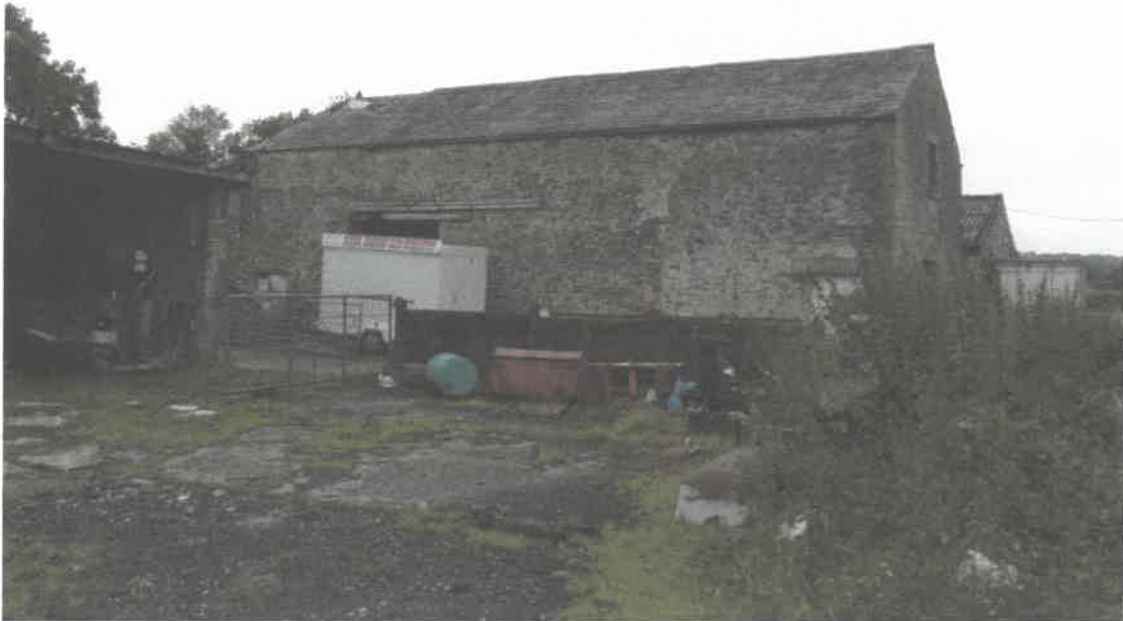
2.2.2 The barn is constructed of random rubble stonework, which although now weathered would originally have been flush pointed. The masonry to the west of the large barn door opening to the front elevation is very poor, having been badly weathered to the point of voids having developed across the stonework.

An outward lean of this section of masonry can also be detected, although being at its worst at high level, it is difficult to quantify accurately. It was estimated to be a maximum movement of 35mm in 1m, with the outward movement commencing at ground level.

The barn door opening has been formed by a very shallow arch of stone visors, which have a timber lintel below. The low level masonry to the eastern side of the barn door is in much better condition, although between the barn door and the pedestrian door at the eastern end of the elevation, evidence remains of what appears to be the lean to extension to the barn, with a visible step between the two sections of masonry of up to 50mm (see photograph 1).

1 : Photo of the front elevation.

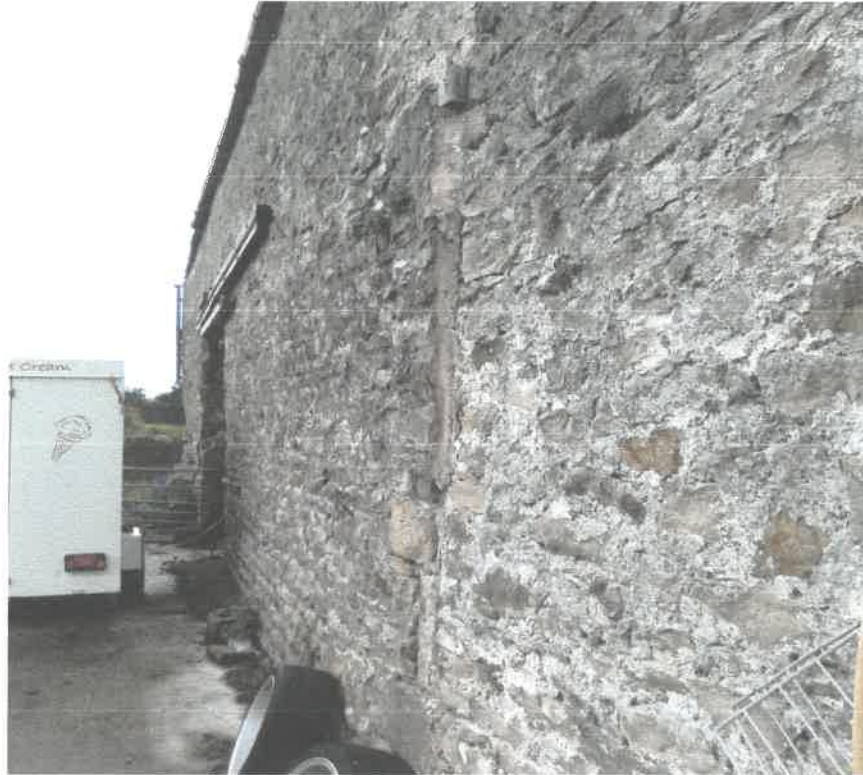
3.12 It is misleading to see the misalignment in the front & rear elevations are a defect as the inward / outward bulges to the rear and front elevations respectively, are considered to be the result of the way in which the barn was extended eastwards. (see appendix B, Photo 2)

The removal of high level quoins, removal of at least part of the roof covering, and the removal of the first floor masonry would have left a very unstable structure, even in the short term. That said, the step in the stonework to the front elevation would suggest that that of the original barn may have moved forwards prior to it being extended.

2a : Photo of Step in front elevation masonry

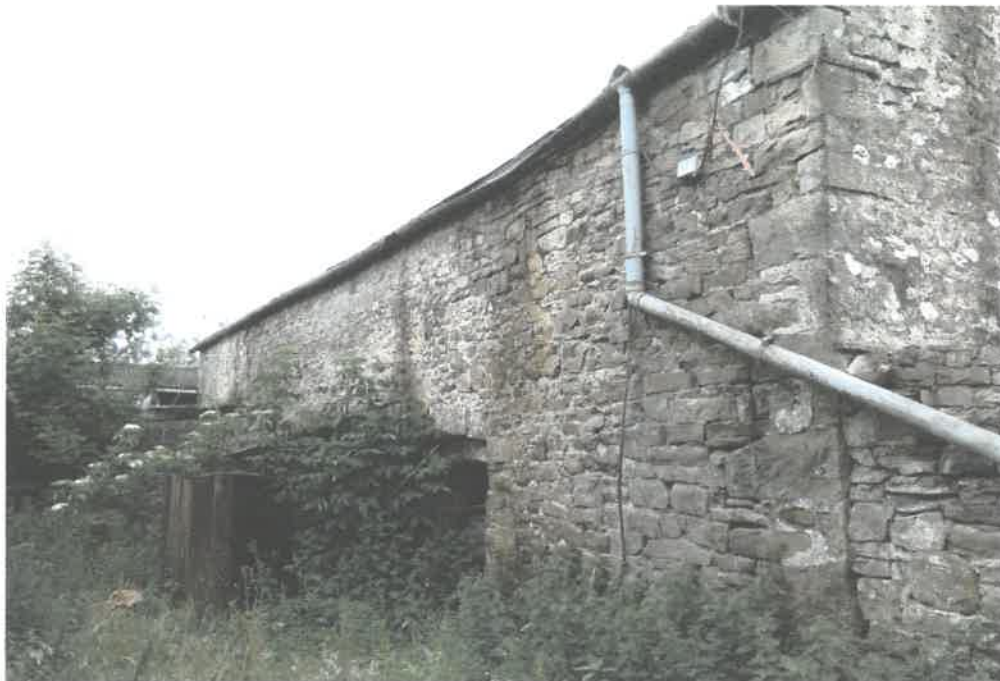
2.2.4 The eastern aspect of the rear elevation is difficult to assess in close detail as there is a dilapidated lean to and numerous semi-mature trees in close proximity to the wall. The centre of the rear elevation has noticeably distorted, with the upper part particularly water ingress due to the erosion of the pointing.

This area coincides with that on the front elevation where the barn was probably extended. The alignment of the front and rear walls is not correct and gives an impression of movement on the rear elevation though there is no sign of movement internally on the walls or roof structure components or where they join.

2b : Photo of Step in rear elevation masonry

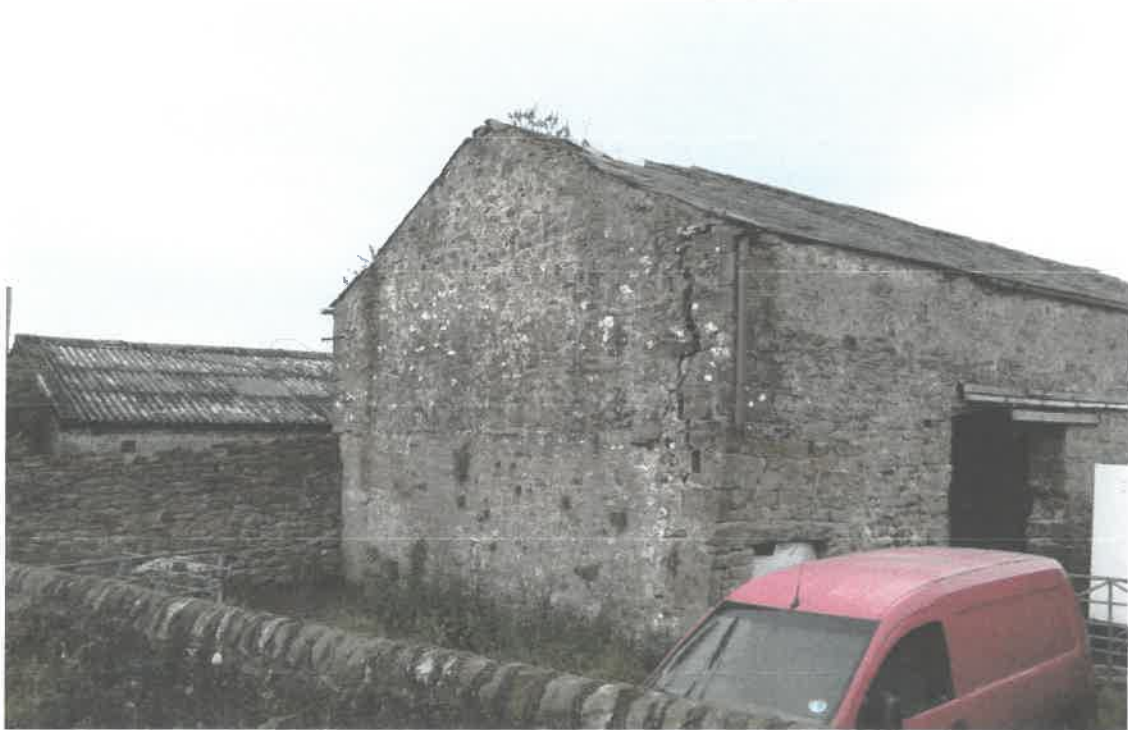
The gable is dominated by a crack where it should join to the front elevation which extends from approximately 1.5m above ground level up the eaves, and is estimated to be, at its most severe, 75mm in magnitude (see photograph 3). The movement has occurred between the quoins and the remaining gable stonework, and even extends over the uppermost quoin suggesting that the movement is entirely limited to the front elevation. Pockets were noted in the stonework at approximately 2m above ground level, where timbers were previously seated to form the lean-to adjacent to the barn. Again, no fascia boards are present along the roof line, and the stonework below the missing slates to the front elevation is particularly uneven.

The position of the crack to the eastern gable is further indication of poor tying between the perpendicular walls, common when this type of rounded rubble stone is used in construction, and the outward movement is clearly limited to just the front elevation. (see appendix B, Photo 3 a, b & c)

3a : Photo of West gable.

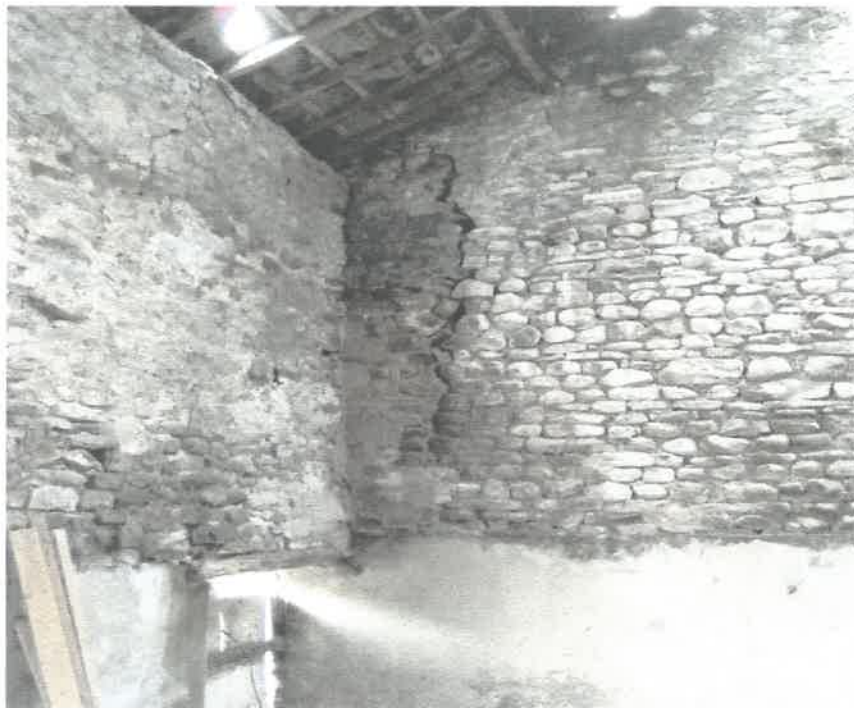
2.3.3 There is poor bonding of the perpendicular walls internally, and much of the internal masonry is formed from rounded cobble-type stones. The movement noted to the western gable is also visible internally, albeit not to the same extent.

3b : Photo of West gable (Internally)

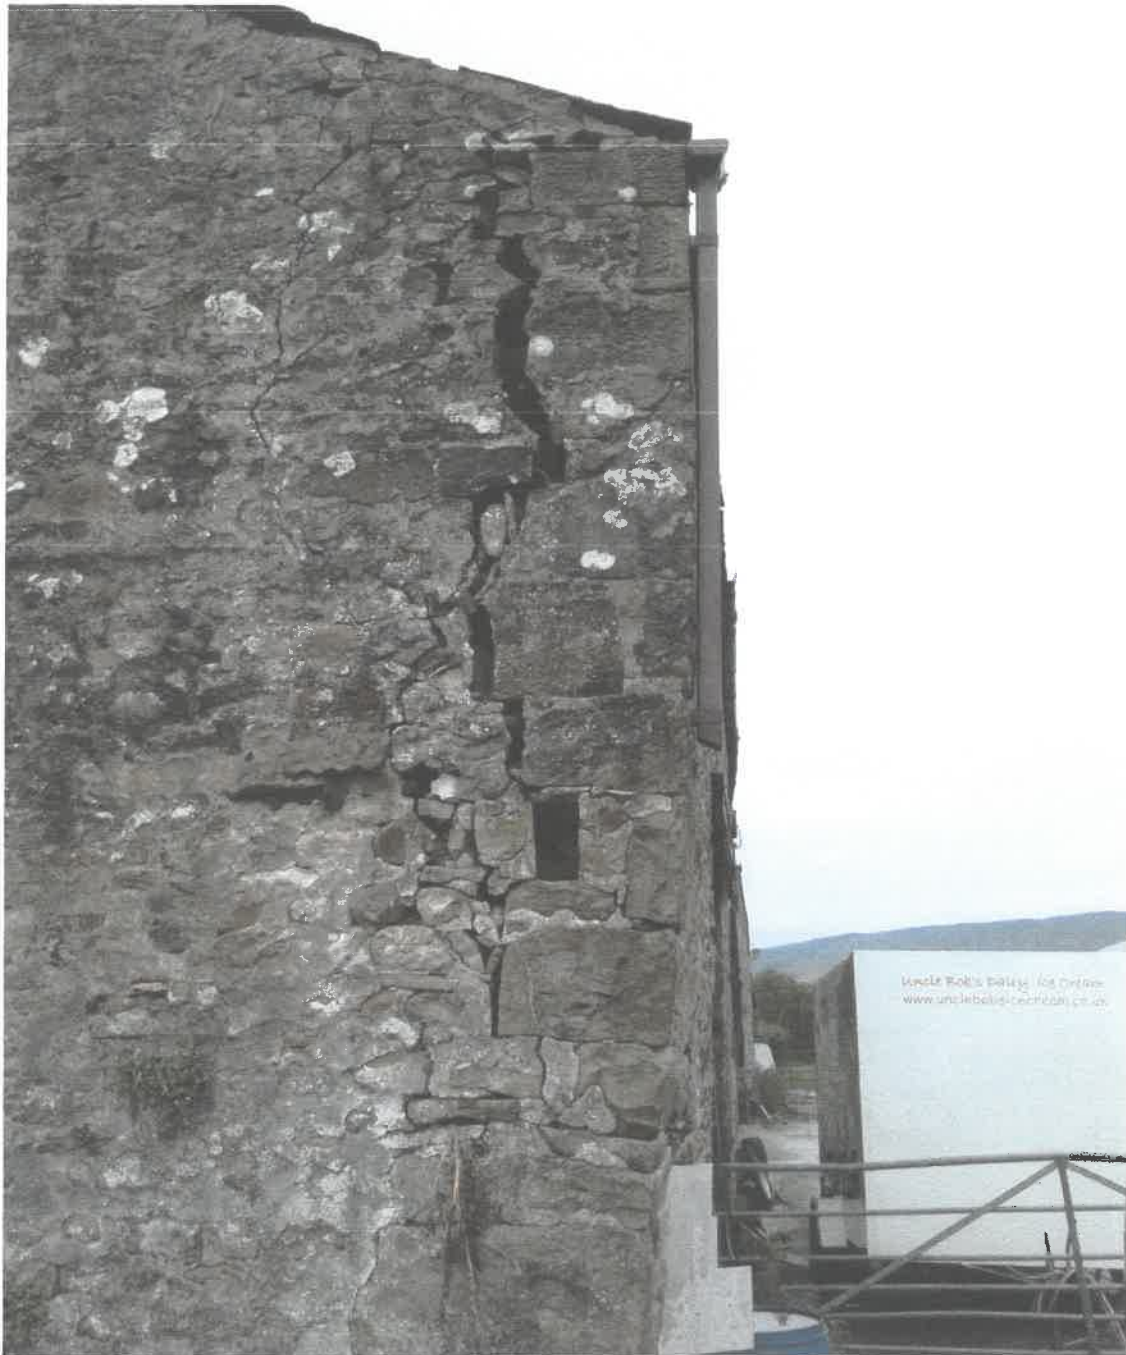
3c : Photo of West gable.

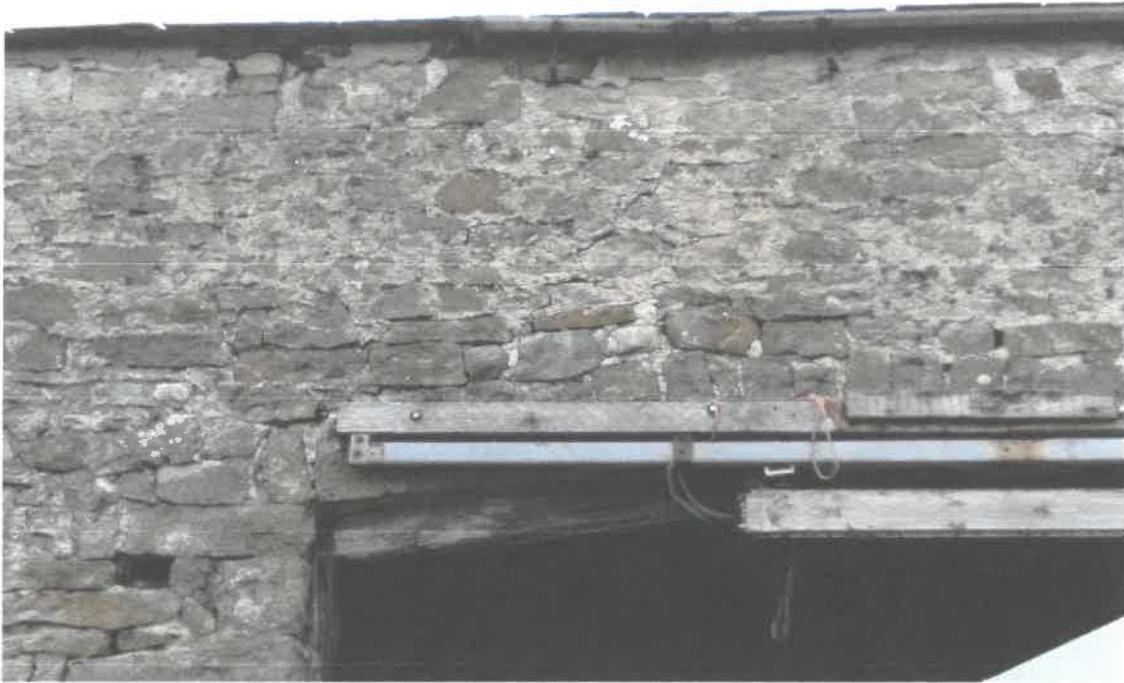
The installation of the timber lintel below the stone arch is an unusual arrangement, however given the shallow nature of the arch, it is unsurprising that an additional support to the opening was required. This lintel was noted to have wood boring insect damage, and diagonal cracking to the masonry above would suggest that some deflection of the lintel has occurred.

Although there is little evidence of the arch having dropped externally, the addition of the timber beam below is an unusual step, but probably a necessary one to support what is inherently a weak structure. The existing stone voussoir's could be reused if required. (see appendix B, Photo 4)

4 : Photo of Front elevation arched door-way.

3.15 We would recommend that the nominal arch to the main barn door opening be rebuilt with a galvanised right angled lintel hidden behind to give additional support.

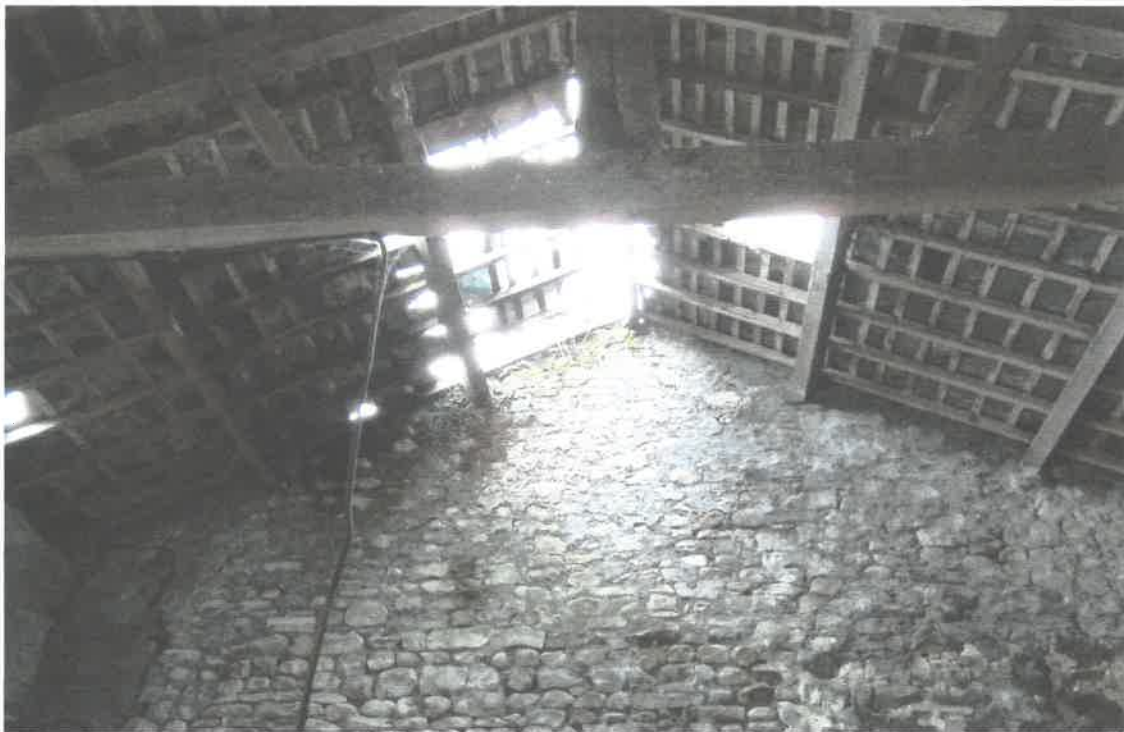
2.3.1 The roof of the barn is of timber rafters bearing onto two lines of timber purlins per pitch and a ridge board. The purlins in turn are supported off the gable walls and three timber kingpost-type trusses. Whilst close inspection of the westerly timbers was not possible, they do not appear to be suffering from wet rot or any noticeable wood boring insect damage as neither is the truss that can be inspected from the first floor loft area.

The purlins are slender, and although they are not noticeably deflecting, despite those below the void in the roof being wet, they are unlikely to be suitable for retention. (see appendix B, photo 5 a & b)

5a : Photo of internal roof structure -- East gable end

3.16 Consideration should be given at Building Regulations stage to allow sufficient headroom to accommodate the retention of the existing trusses.

Aside from requiring treatment for wood boring insects, the timbers do appear to be in good condition, and as they are supporting a slated roof now, there will be little increase in load on the structure once it is converted. Given that the purlins are slender (and some affected with wet rot) it is unlikely that these could be retained, and the rafters will require replacement in order to accommodate the necessary insulation.

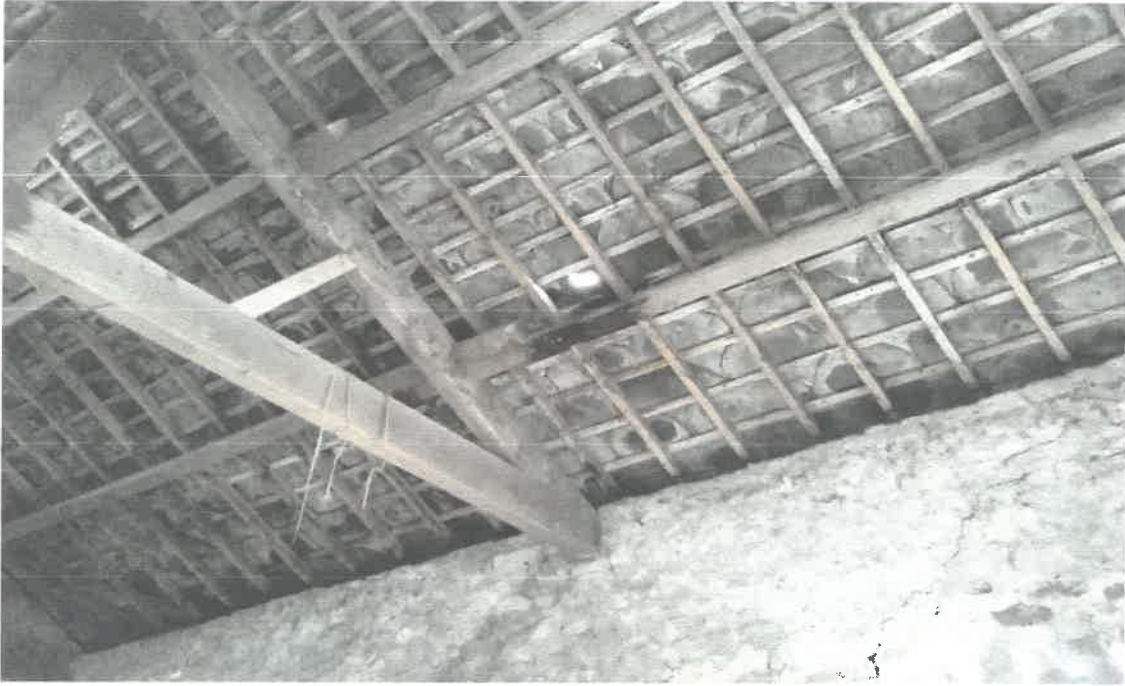
5b : Photo of internal roof structure – West gable end

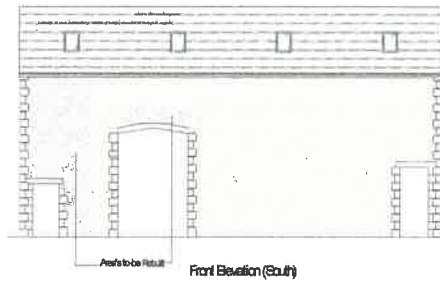
Appendix C – Drawing showing area's to be rebuilt.

Appendix C, shows the area's needing to be re-built that equate 23 m² of random stone work to the two elevations, with an overall exterior area of 240.4 m². This equates to 09.6% or the overall area that is well within the 30 – 40 % allowance.

- Excavate the internal floor area and construct a structurally re-enforced raft for the floor.
- Build internal blockwork skin and internal load bearing walls to eaves level.
- Demolish external wall (area's shown in appendix C)
- Rebuild external walls, tying in to new block inner skin.
