Stonyhurst College – Old Infirmary

Addendum to Preliminary Structural
Appraisal

15 March 2019

Civic Job No. 1093-02

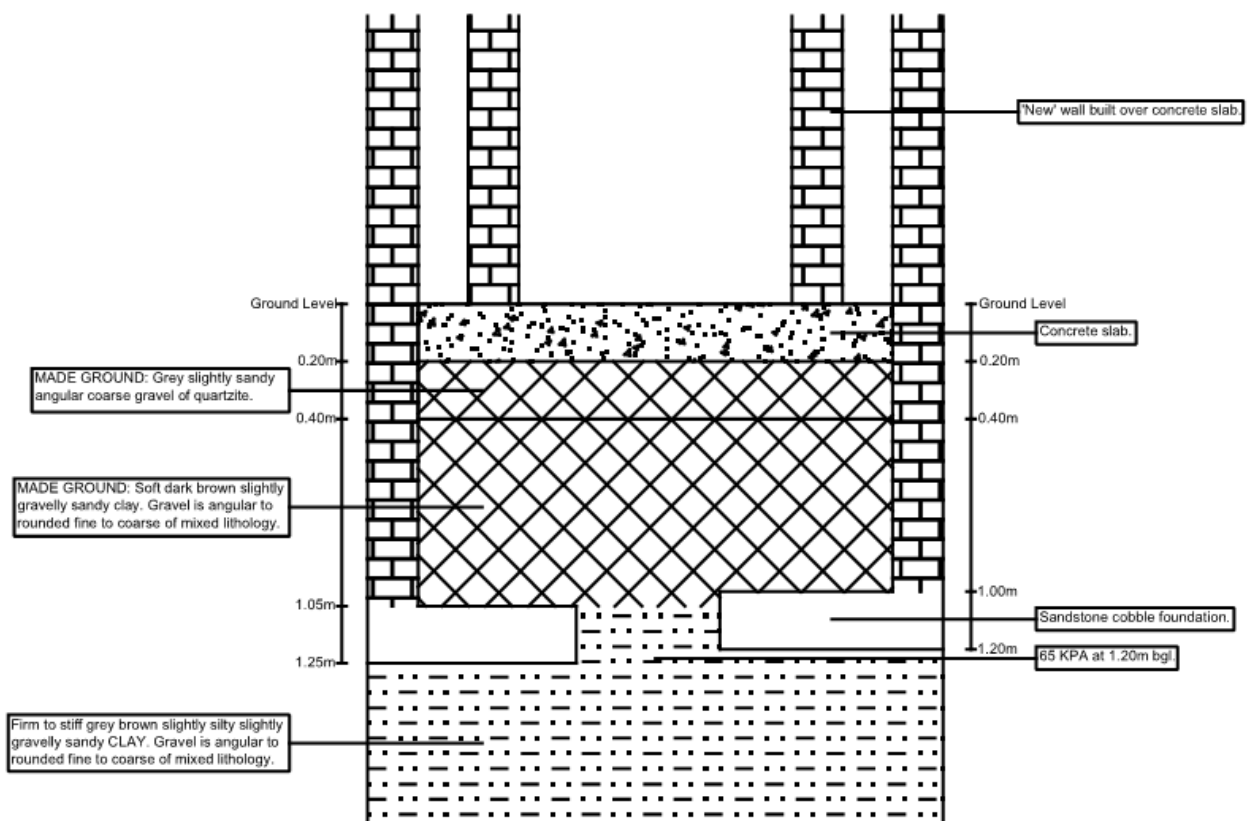
Figure 1: Internal Corridor Foundations (Groundtech sketch)

Two trial pits were carried out to the perimeter walls on the south-west side of the building, to expose the foundations. These confirmed that the walls were founded on sandstone block foundations with a base depth of 1.0 – 1.3m BGL, founded in the sand. An internal trial pit in the basement corridor identified that the original stone walls are founded on a sandstone cobble foundation in clay, with a further wall lining built on a concrete slab; refer to Figure 1.

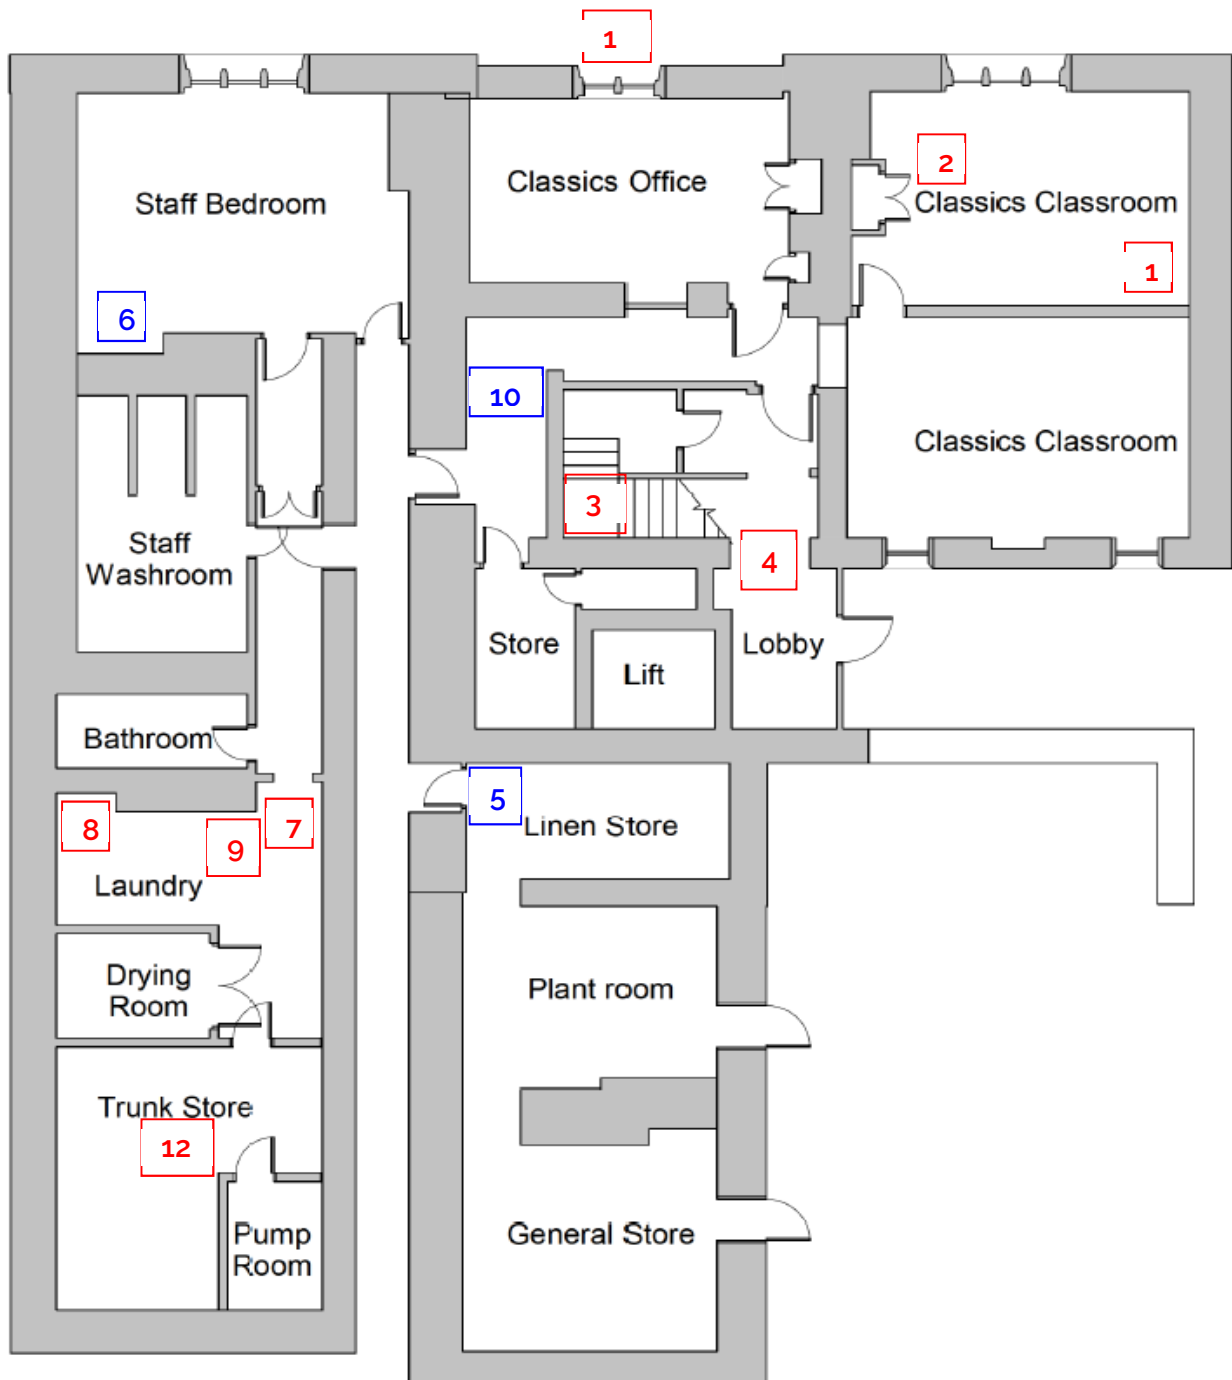
Figure 2: Site Observations - Basement Key Plan

Item	Description	Photo References
5	Plaster stripped out around crack; severe crack in stone wall with maximum 50mm horizontal crack and maximum 20mm vertical crack. Wall above crack is stepped into the room by maximum 25mm.	21-02-19, 14.18.34 21-02-19, 14.18.38
6	Plaster stripped out around crack, blockwork liner wall identified below. Crack identified in blockwork wall below corbel beam support. Beam above identified as timber.	21-02-19, 13.59.36 21-02-19, 14.04.48 21-02-19, 14.05.14
10	Plaster stripped out around crack; wall covering is new lathe and plaster over blockwork lining wall. No structural cracking evident in substrate.	21-02-19, 14.12.44

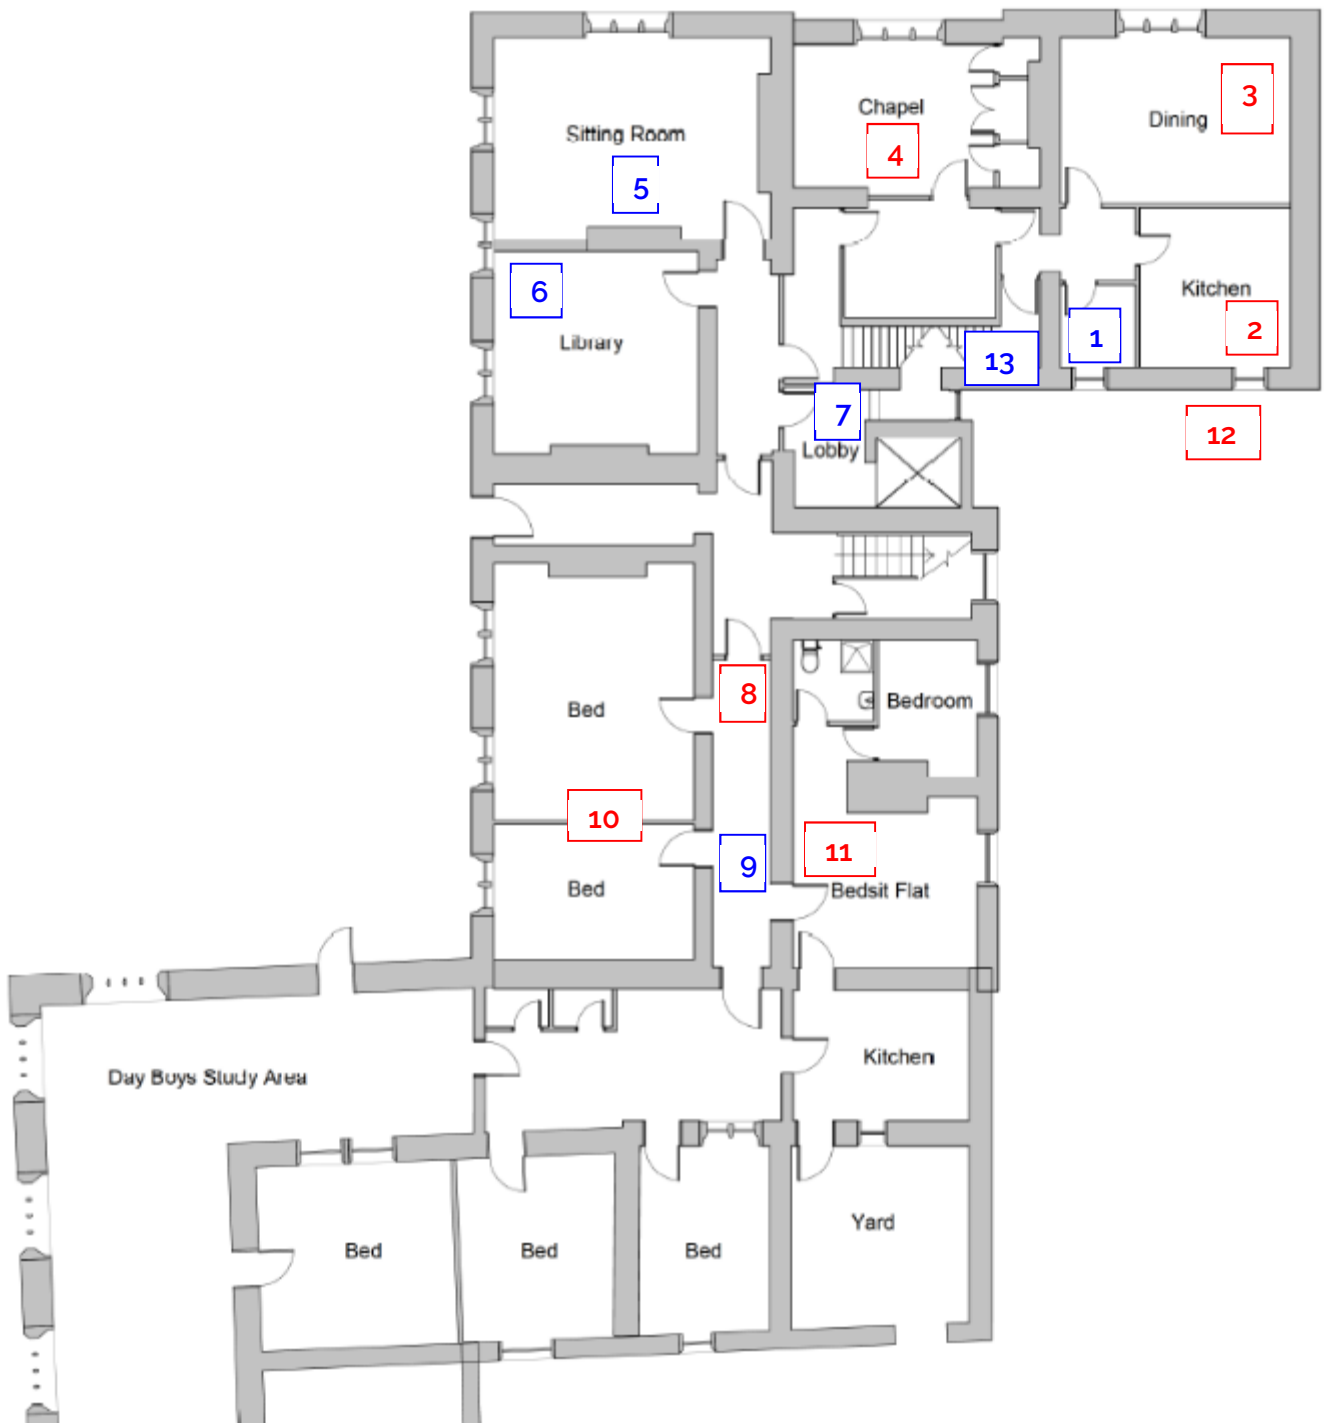
Figure 3: Site Observations - Ground Floor Key Plan

Item	Description	Photo References
1	Plaster stripped back over cracking; timber beam identified in wall in the area of cracking. No structural cracks noted in wall.	21-02-19, 11.22.16
5	Crack to the RHS of fireplace has been stripped out below plaster. Long crack in stone wall below, with maximum 20mm vertical crack width and minimal horizontal crack width. Plaster over crack on LHS of fireplace (above door has been stripped back). No structural cracking noted in the stone wall. A precast lintel is identified over the door.	21-02-19, 11.15.23 21-02-19, 11.17.36 21-02-19, 11.17.21
6	Wallpaper and plaster have been stripped off over crack. Long diagonal crack noted in stone wall, maximum 20mm wide.	21-02-19, 13.47.54 21-02-19, 13.48.08
7	Steel beam lintels identified over timber panelling (305mm deep longer beam and 180mm deep shorter beam). Plaster stripped back around crack above door; no structural cracking noted in the stone wall.	21-02-19, 11.18.38 21-02-19, 11.20.20

9	Plaster stripped back around crack extending from lintel. Crack identified in stone wall, around 25mm width. Timber lintel over door.	21-02-19, 13.46.28
13	Wall adjacent to staircase bows inward between basement and ground floor.	N/A

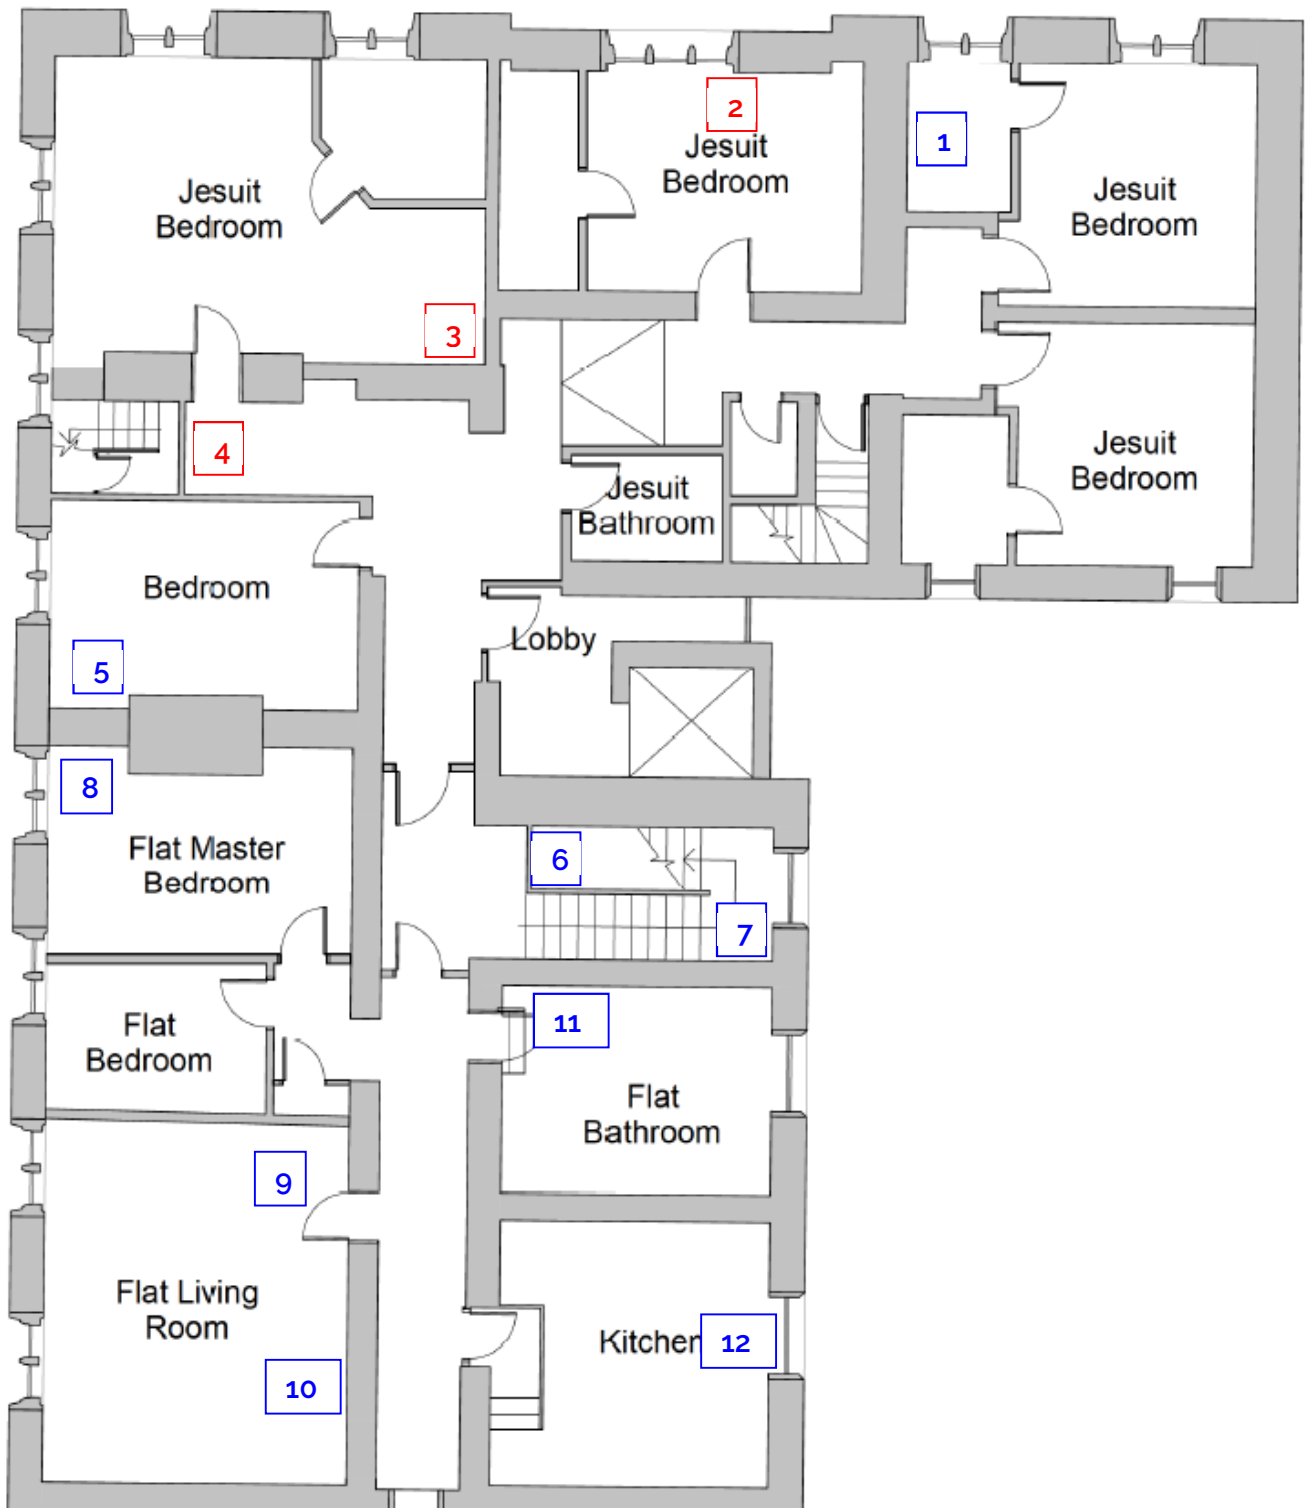
Figure 4: Site Observations - First Floor Key Plan

Item	Description	Photo References
1	Plaster stripped back around crack. The stone substrate general contains loose material, with maximum 15mm crack width.	21-02-19, 11.55.39
5	Plaster stripped back over crack; crack in stone wall below. Maximum 20mm wide vertical crack and minimal width horizontal crack.	21-02-19, 11.48.19
6	Plaster stripped back over crack; crack in wall does not appear to be structural.	21-02-19, 11.40.06
7	Plaster stripped back over crack; crack in stone wall below, maximum 10mm crack width.	21-02-19, 11.39.40
8	Bumps in plaster suggest crack below, following the same line as crack on the other side of the wall (plaster has not yet been stripped back to expose crack).	15-01-19, 13.13.43
9	Crack in plaster above door (appears minor at surface, but plaster has not yet been stripped out to expose full extent of crack).	15-01-19, 13.21.14
10	Cracks in coving between wall and ceiling, appear to be superficial.	15-01-19, 13.19.14

11	Bumps in plaster indicate diagonal crack below in stone wall. Plaster has not yet been stripped back to identify the extent of cracking.	15-01-19, 13.17.15
12	Cracks in plaster above window; plaster has not yet been stripped back to identify extent of cracking.	15-01-19, 13.23.28

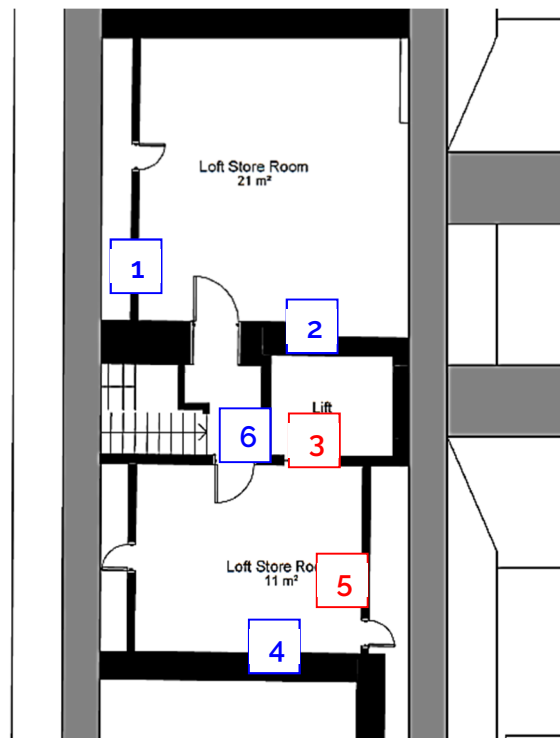
Figure 5: Site Observations - Second Floor

Item	Description	Photo References
1	Plaster stripped back over crack in corner of door; stone lintel identified. No structural cracks noted in this area, however there may be further cracking lower down wall (cracks in plaster noted).	21-02-19, 13.31.47
2	Plaster stripped back over crack. The wall is stone to mid-level and a timber stud wall above (timbers have warped). The line of the stone wall may follow an old pitched roof line, which reflects the line of the crack. Structural crack carries on around step in wall, maximum around 30mm crack width.	21-02-19, 13.29.53 21-02-19, 13.29.55 21-02-19, 13.30.05 21-02-19, 13.30.11
4	Plaster stripped back over crack. Long diagonal crack noted, maximum around 40mm width.	21-02-19, 13.26.14 21-02-19, 13.26.58

Item	Description	Photo References
6	Cracks noted in plaster on wall. Plaster has not yet been stripped back to inspect extend of cracks, however pattern suggests that they follow line of cracks on other side of wall.	21-02-19, 13.36.05

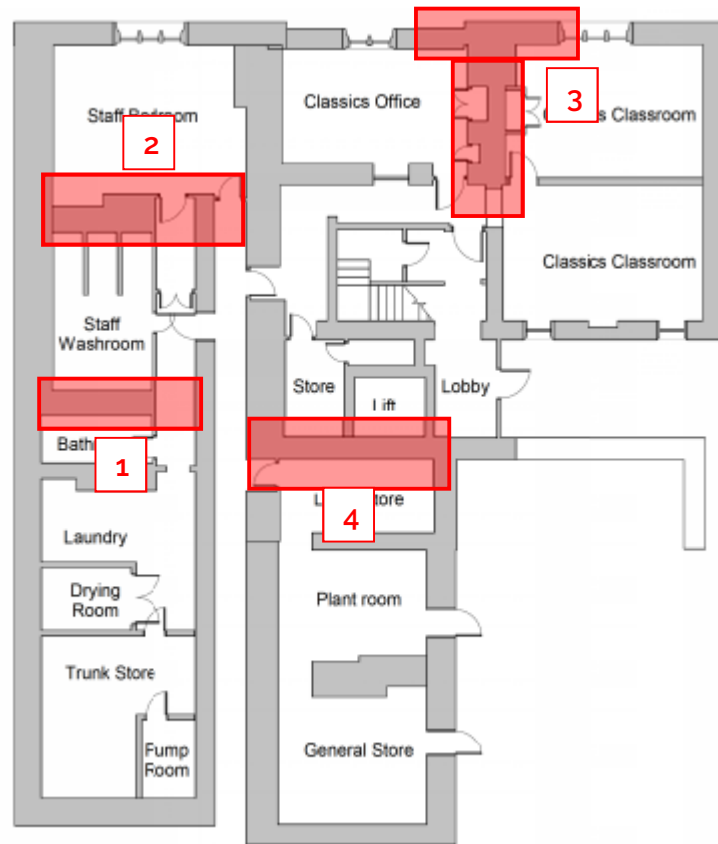
Figure 6: Areas of highest settlement

The pattern of structural cracking in the building shows that differential settlement has occurred; refer to Figure 6 for specific areas. This may be due to a combination of weaker spots in the ground and concentrated areas of the building loads. For example, the walls to either side of the staff washroom (locations 1 and 2 shown in Figure 6) include heavy chimney stacks, and are below the second floor (attic) area which is likely to have been a later conversion so has added to the building weight.

The highlighted walls around the classics office and classics classroom (location 3) appear to support relatively high line loads as the internal wall between the classics classrooms is not load bearing, therefore the supported area is relatively high compared to the rest of the building. An estimated load check at the base of the perimeter wall to the classics classroom found that approximately 225 KPA ground capacity would be required to support this wall load, based on existing foundation geometry exposed by ground investigation.

The pattern of cracking in the wall to the linen store (location 4) suggests that the building has dropped towards the corner with the lift. The lift appears to be a later addition due to the different stone, and the stairs above the linen store appear to have been reconfigured as they do not coordinate with the window level. These renovations may be resulting in the ground in this area having become overloaded.

To arrest any further settlement of the Old Infirmary building, Civic Engineers propose to use ground stabilisation to improve the bearing capacity of the ground below the critical

areas highlighted in Figure 6. The technique proposed is a geopolymer injection below the affected walls, to a depth of 4.0m BGL. The geopolymer expands to fill any voids in the subsoil and binds with the soil to improve the bearing capacity of the ground. This method has the benefit that it can be injected without any temporary propping or restraint of the existing structure over, and only requires small holes to be drilled for the injections rather than large excavations. There is documentary evidence that this technique may have already been carried out along the main internal corridor wall foundations and appears to have stopped previous settlement in these locations as previous cracks have not continued to widen or propagate through the reinstated plaster finishes over them. The geopolymer injection is proposed to a depth of 4.0m BGL because the draft window sample logs received from the ground investigation suggest that the bearing capacity of the ground improves at this level to a suitable capacity.
