Job Title
Stonyhurst College – Old Infirmary

Prepared for
Stonyhurst College

Report Type
Preliminary Structural Appraisal

Date
7 January 2019

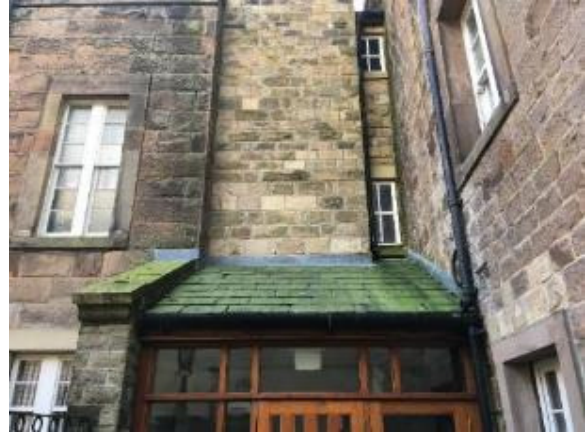
Figure 7: Site photo of lift tower

The lift tower on the north side of the building appears to be a later addition as the stonework is a different size and colour to the surrounding building.

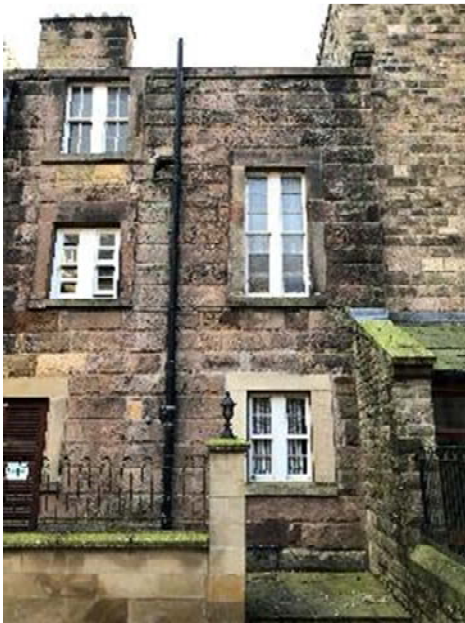
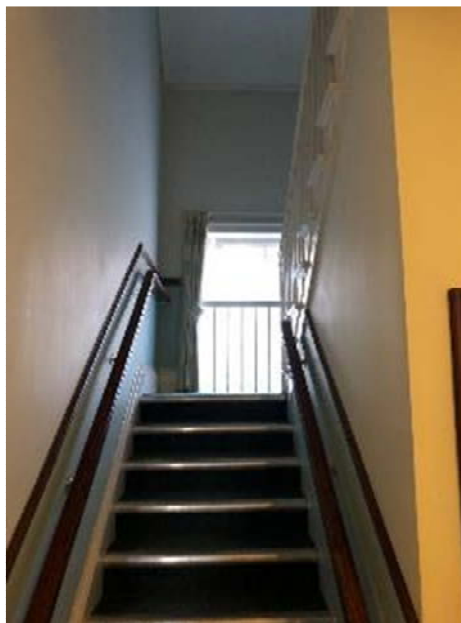
Figure 8: Site photo of stair - from outside and inside

The stair on the north side of the building adjacent to the lift tower appears to have been added or reconfigured during the building's history, as the alignment of the original window is not consistent with the stair landing.

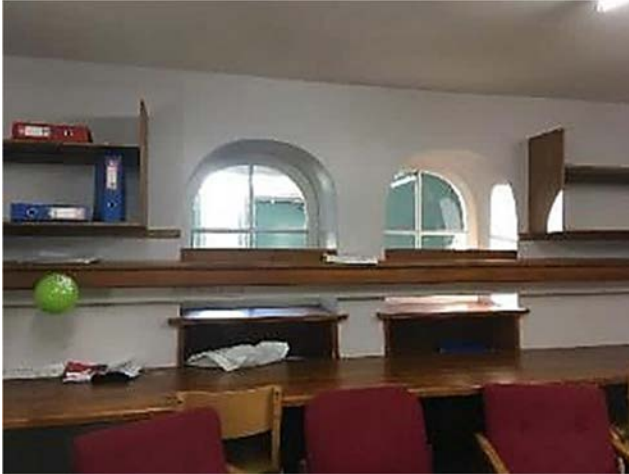
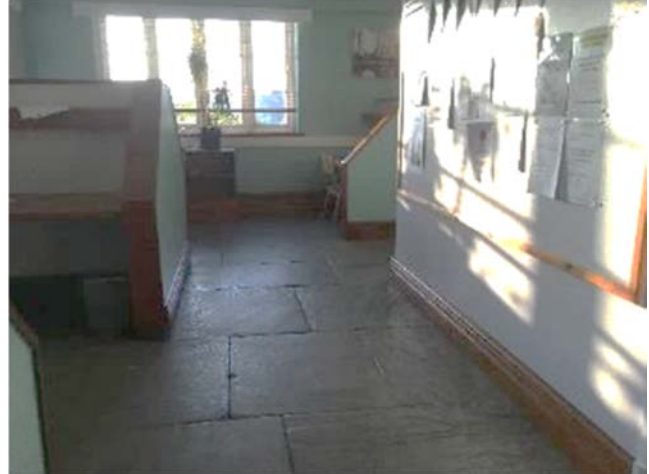
Figure 9: Site photos of current Day Boys Study Area

The existing Day Boys Study Area is situated to the south-east of the Old Infirmary and provides the link to the main College buildings. The flagstone floor and the arched windows suggest that this area may previously have been an open-sided covered walkway which has been converted into an internal space. The area to the north of this space may be a later extension as the arched windows (refer to Figure 9, left photo) suggest that this was previously an external wall.

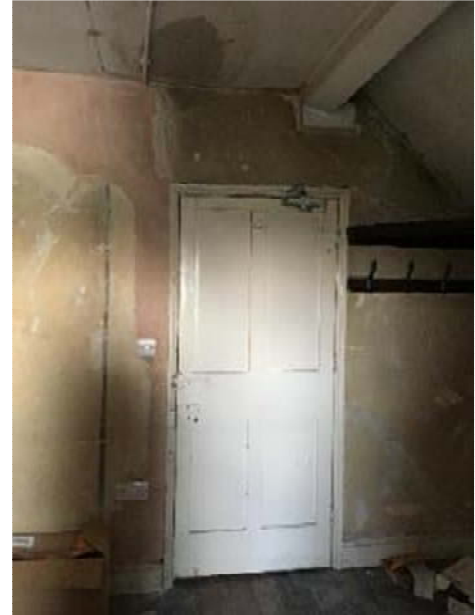
Figure 11: Site photo of Second Floor storage room

A small area of the roof space is accessible (referred to as the second floor). This is likely to be a later conversion and includes the possible addition of a 1m³ water tank. The rooms are currently used for storage, although appeared to be unused at the time of Civic Engineers' site visit. From inspection into the roof space, it appears that an original chimney on the north side of the roof pitch has been removed and a lightwell has been installed.

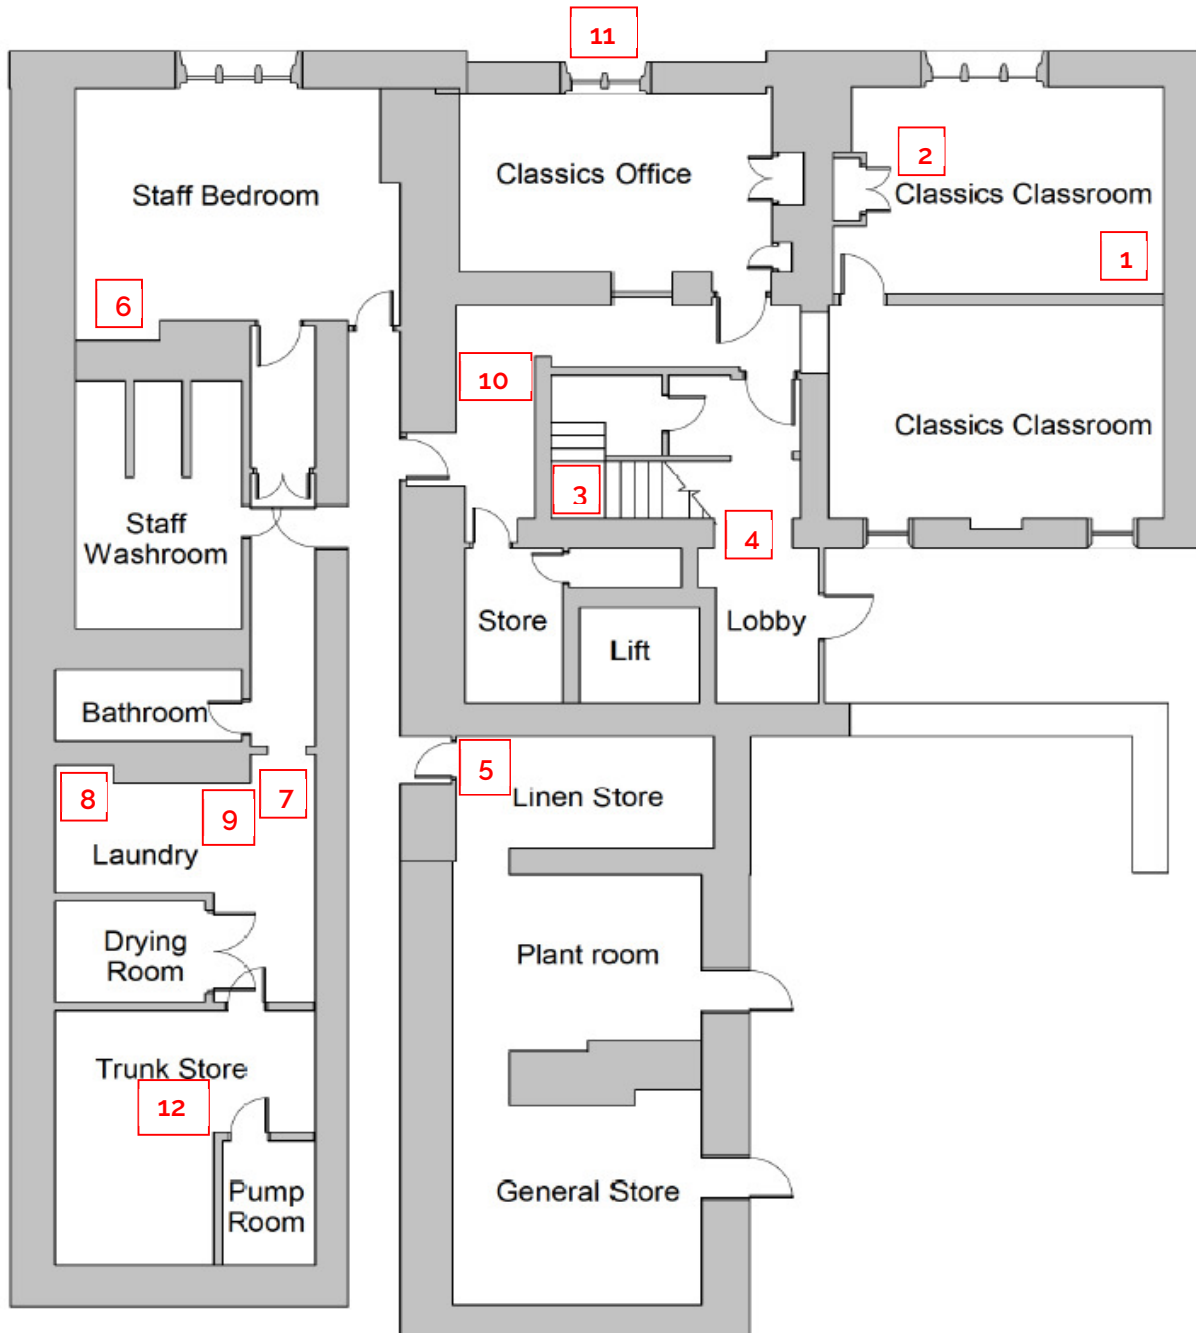
Figure 13: Basement – Site Observations Key Plan

Item	Description	Photo References
1	Minor diagonal crack between external wall and ceiling.	5826
2	Distance between ceiling and top of cupboard door frame is greater on the right-hand side of the cupboard door, suggesting that the basement floor and ground floor are not level with respect to each other.	5821
3	Damp noted on staircase walls.	5865
4	Noted that current internal opening between staircase and lobby was likely part of the original external wall as a stone archway is visible.	5819
5	Long minor diagonal crack (=1mm width) on wall from doorframe to ceiling.	5861
6	Diagonal crack from top corner of wall towards centre of wall. Crack is wider at the top. Crack starts below a bulkhead assumed to be covering a timber beam.	5839
7	Basement floor slopes up from the bathroom towards the drying room.	N/A
8	Minor diagonal crack on wall between external retaining wall and ceiling.	5853
9	Minor cracks just above floor level next to doorframe.	5850

10	Long horizontal crack along wall between door and adjacent wall, approximately mid-height on wall. Vertical crack on wall from plug socket.	5828, 5831
11	Diagonal stepped crack in external stone wall, below and to the right of the basement window. Crack widens from 10-20mm over 300mm. Diagonal stepped crack between basement and ground floor windows in centre of windows.	5785, 5790, 5792
12	Crack in basement floor.	1051

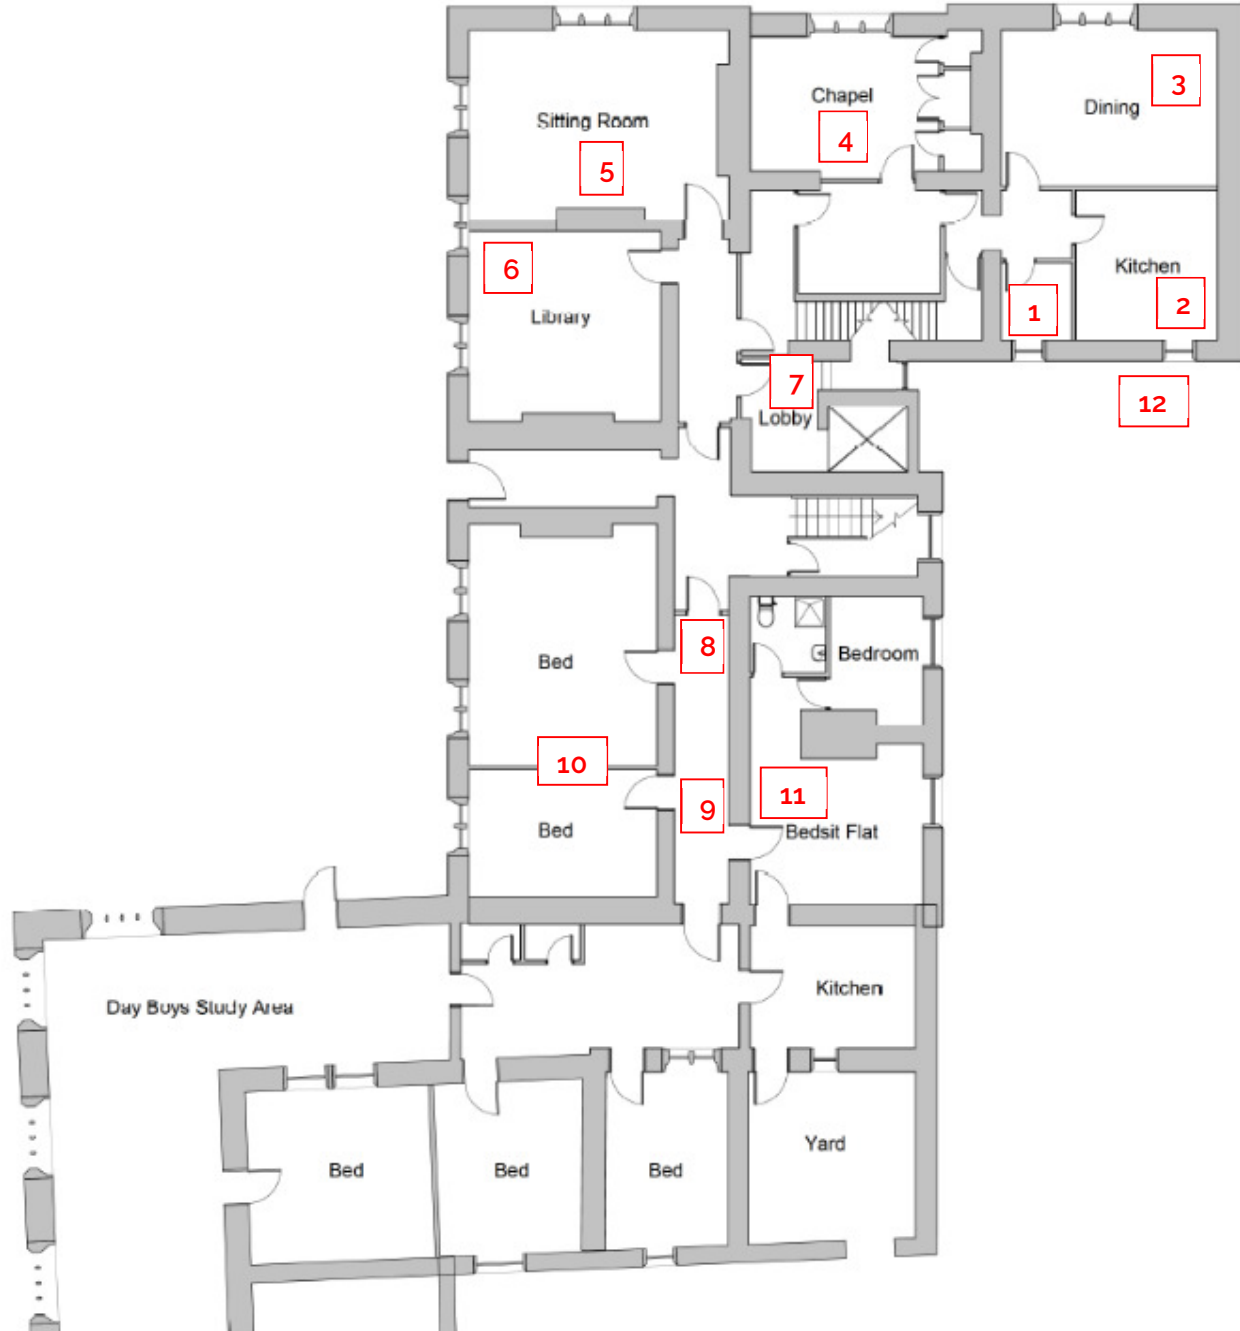
Figure 14: Ground Floor - Site Observations Key Plan

Item	Description	Photo References
1	Horizontal crack from window onto side bathroom wall. Evidence of damp below window suggests window seal has failed.	1059, 5872, 5877
2	Minor vertical crack from ceiling on right-hand side of window. Varying widths of plinths below kitchen units suggest that floor slopes upwards away from door and window.	5880, 5878, 5879
3	Noted that the floor in the dining room slopes downwards towards the door from the other three corners of the room.	N/A
4	Noted that the floor in the Chapel slopes downwards by approximately 30mm across the room, with the lowest point at the cupboards. 60mm difference noted across the lobby outside the Chapel, in the same direction. Damp noted on ceiling.	5887, 5889
5	Diagonal cracking either side of fireplace suggests that fireplace has settled.	5890, 5893
6	Diagonal cracks on wall from plug socket.	5894
7	Diagonal crack from corner of opening in stone wall, above timber frame. Extends from top corner of door frame to ceiling, appears widest at the door frame. Minor vertical crack above the door between the lobby and the corridor.	5898, 5899

8	Noted that the ceiling above slopes 80mm downwards above the door.	5960
9	Noted that the top of the doorframe slopes 40mm downwards (to the right of the doorframe when viewed from the corridor). Historic cracks have been plastered over on left of doorframe (when viewed from corridor). This is apparent on both sides of the wall.	5961, 5962, 5964
10	Noted that the floors in both bedrooms slope downwards from the external wall to the corridor wall.	N/A
11	Archway noted adjacent to back-to-back fireplaces; may have been added at a later date	5955

Item	Description	Photo References
12	<p>Minor crack above right-hand side window; possibly due to thermal expansion.</p> <p>Noted that the centre of this elevation appears consist of different (smaller) stone to the majority of the building.</p> <p>Noted that wall has been repointed.</p> <p>Noted that lintels have been replaced.</p> <p>Noted that previous plant growth on walls has been removed.</p> <p>Noted that windows have been fixed in with cementitious mortar.</p>	5812, 5815

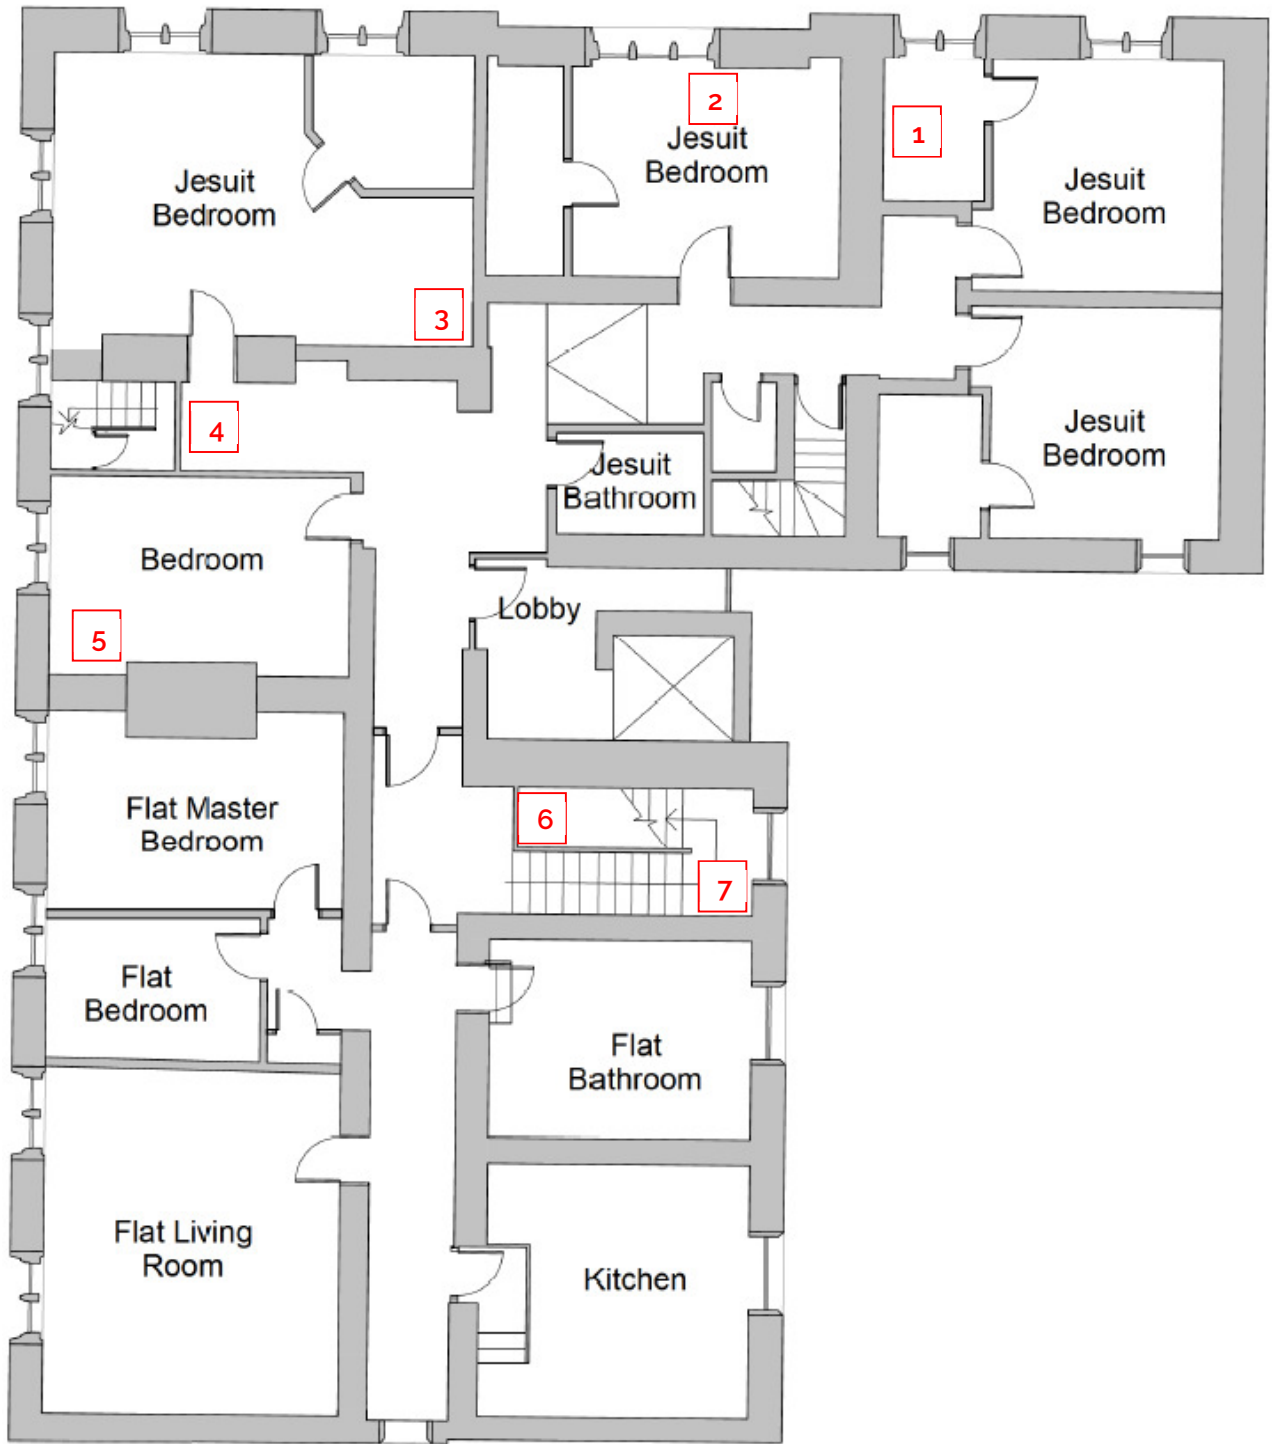
Figure 15: First Floor - Site Observations Key Plan

Item	Description	Photo References
1	Diagonal crack in bathroom wall from top corner of wall falling towards window.	5907
2	Damp noted below window on the right-hand side. Noted that the floor of the bedroom slopes downwards away from the bathroom.	5905
3	Minor crack in ceiling across corner between two walls.	5910
4	Cracks and damp noted to wall under staircase to second floor (right-hand side wall when viewed from door to staircase). Wall to left-hand side is damp and bows out into the staircase area.	5914, 5917
5	Diagonal cracks near bottom of wall, next to fireplace. Damp noted on ceiling.	5935, 5938
6	Crack in wall between archway and pitched roof over staircase.	5943
7	Diagonal crack in external wall to staircase, between ceiling and adjacent wall.	5946

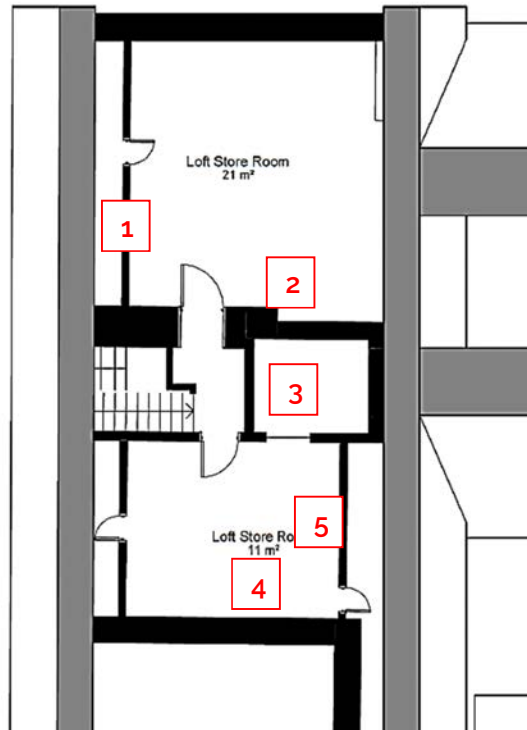
Figure 16: Second Floor - Site Observations Key Plan

Item	Description	Photo References
1	Long diagonal cracking noted across chimney breast to left of door, and on wall to right of door. Direction of cracks 'arch' towards door, suggesting that the door has dropped. Cracking noted above door around roof beam.	5923, 5924, 5927, 5926
2	Long diagonal crack (plastered over) from bottom corner of wall up to top of wall.	5919
3	Hot water tank noted (assumed 1m ³). Note that label on plan shows 'Lift'; not present on site.	N/A
4	Long crack in wall (has previously been plastered over) from cupboard door.	5933
5	Noted that original chimney has been removed and a lightwell has been installed.	N/A

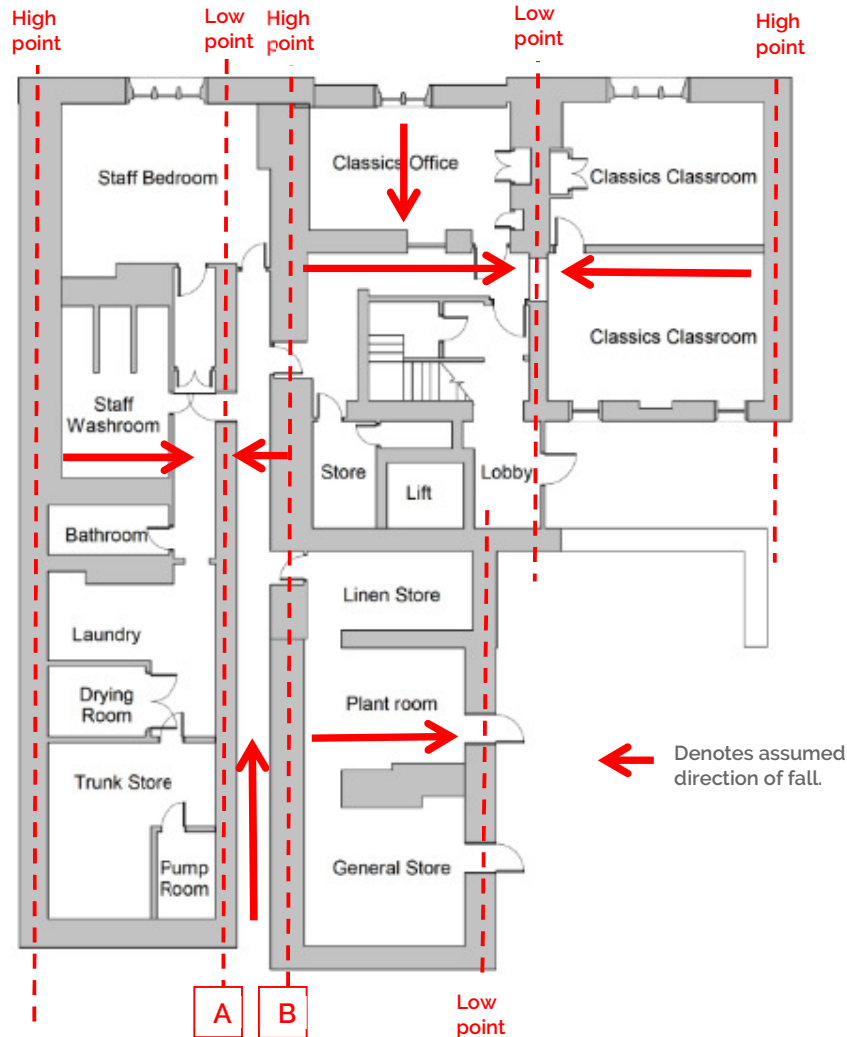
Figure 17: Summary of assumed building movement

Figure 17 shows a summary of the evident location and direction of overall movement across the building, based on the patterns of cracking, floor slopes and distortion identified. The figure shows that generally the external walls are a high point and the internal walls appear to have dropped in relation; excluding the north-facing external wall to the plant room at basement level which is a low point. The only internal high point is the northern wall to the main corridor, labelled as 'B' on Figure 17.

The quote by Urettek discussed in Section 2 states that the ground stabilisation system that was proposed is "suited to granular soils and cohesive soils with a low plasticity...unable to treat ground where subsidence has been caused by clay shrinkage.". The quote also describes the ground conditions as

poor brick fill over weak clay. As this system is not suited to clay, it is likely that the stabilisation was carried out to the overlying brick fill. As a full ground investigation is not available, there is a possibility that the ground conditions vary across the site, causing differential settlement.

- Review of any further available archive drawings or information in order to understand the structure and any alterations that have been made.
- Intrusive ground investigation in order to confirm the ground conditions across the site and the existing foundations. As there is a possibility that ground conditions vary across the site, investigation locations should be spread to give information across the site.
- CCTV survey to identify the condition of the existing drainage, locate the existing culvert and confirm suitability of the existing network for the proposed scheme.
- Opening-up works to further investigate cracking; this is likely to include the removal of plaster to walls and ceilings. Crack monitoring may also be required to determine if cracks are stable or worsening.

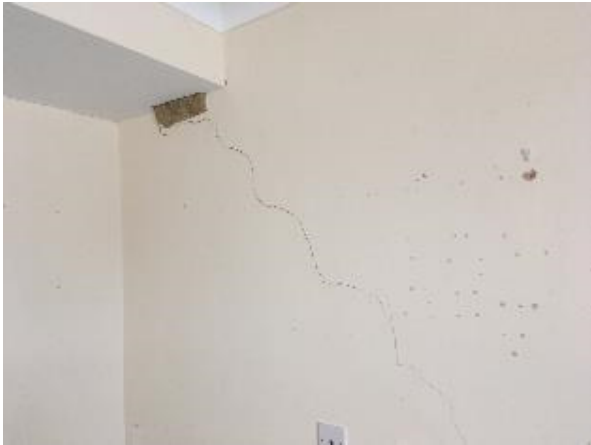
Figure 19: Beam below fireplace

In addition to the overall building movements, there are two areas of the building where localised cracking has occurred. These are potentially due to alterations to the original building. The bedroom in the south corner of the building (Staff Bedroom at basement as shown in Figure 17) has a fireplace at ground floor. At basement level, there is a doorway below the fireplace which appears to be a later addition so there is likely a lintel across this doorway. There is also a boxed-out beam below the fireplace, below the ground floor. Cracking at ground floor shows that the fireplace has dropped in relation to the adjacent walls, possibly due to deflection or undersizing of the lintel or beam. A crack at the end of the beam shows that there may have been a change in the load path by introducing a point load into the wall.

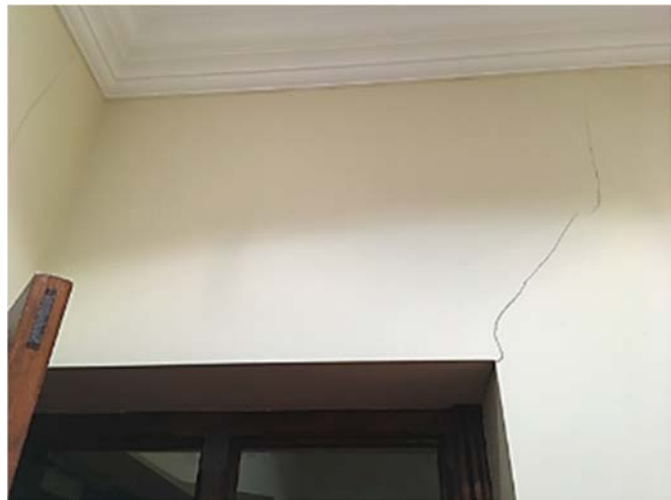
At ground floor, the original stone walls around the lobby appear to have been replaced by timber panelling and glazing. Therefore, new beams or lintels will have been installed over the timber panels, changing the load path from a linear load to a substantial point load at the end of the new beams. The longest beam is approximately 4.1m in length. There is evidence of cracking at basement level below this location, suggesting that the original wall and foundations are not sufficient to support the point loads. There is also a crack at ground floor at the end of one of the assumed lintels, suggesting that a change in load path has caused movement in the wall (refer to Figure 20).

Figure 20: Photo of crack at end of assumed lintel
