Bat Advice Note: 6 Downham Road, Chatburn

6 Downham Road, Chatburn

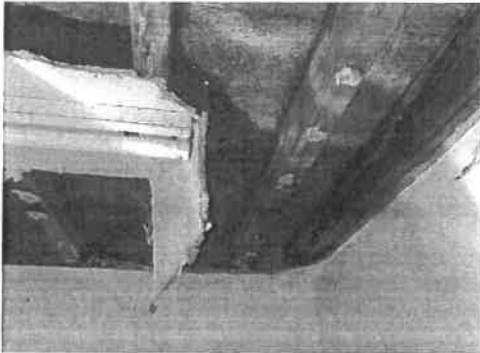
Internally, the building is in slight disrepair. The plasterboard ceiling in all three rooms is partially collapsed; allowing visibility of the plywood panelling which is suspended by six wooden beams (photos 1, 2 and 3). Behind the partly exposed outer layer wall are breeze blocks which extend throughout the whole building (photos 1 and 2). There is also a plastic membrane which lies between the brickwork and plastered walls. No natural light appears through the brickwork and there are no gaps around the interior of the whole building. Access for bats into room 1 is possible through a broken window in the door frame. Room 2 and 3 have the same internal material composition as room 1, however they are in a better state of repair, and less of the ceiling/ walls are exposed (photo 4).

Photo 1: Damaged ceiling with wooden beams, plywood and breeze blocks exposed

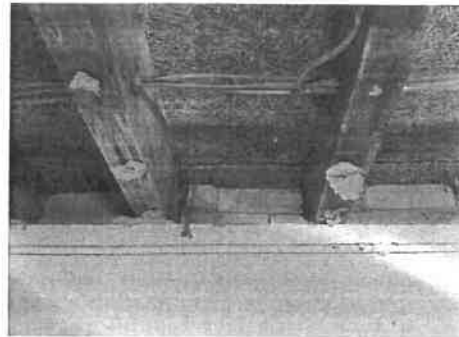
Photo 2: Wooden beams with concrete breeze blocks, plywood and electrical wiring exposed

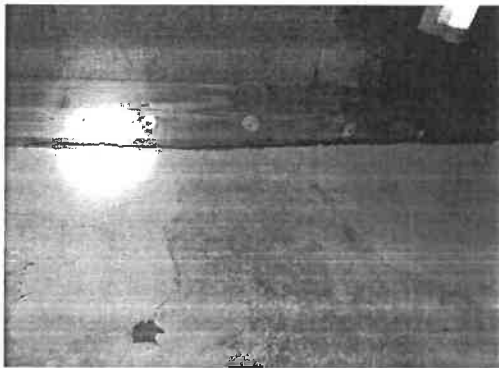
Internally a number of gaps and crevices in the walls were found during the inspection (photos 3 and 6). However, no evidence could be found that these crevices are accessible from the exterior of the building. No natural lighting was observed in any of the three rooms through gaps or crevices in the walls. The only access for bats to the interior was via the broken window in room 1, and two gaps were found in that said room; one in the north east corner of the ceiling and the other on the eastern wall by a beam. Rooms were generally well sealed and the only possibility of roosting areas which were found internally are between the wooden beams and brickwork structure at ceiling height of the side walls to the north (photo 3), though after further inspection these were later categorised as negligible features, due to the lack of access opportunities and width of gaps. This area in each room was extensively checked for signs of bats; and no droppings, urine stains or feeding remains were visible, while the gaps were concluded to be too open and vulnerable to fluctuating conditions for bat inhabitation. An abundance of old cobwebs present in most of the gaps also suggest they have not been utilised by bats.

Photo 3: Plywood ceiling and wooden beam with outer layer of interior wall

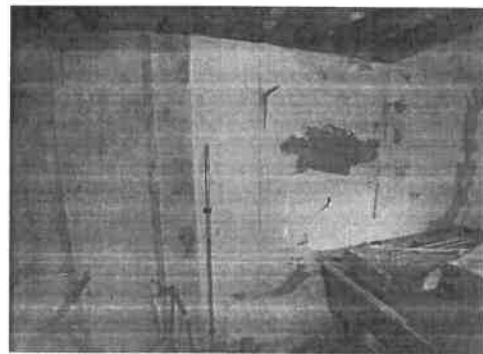
Photo 4: Room 3 interior wall

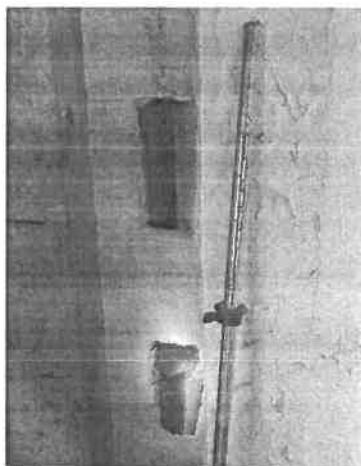
Photo 5: Cavities in concrete brickwork structure (not visible from exterior of building)

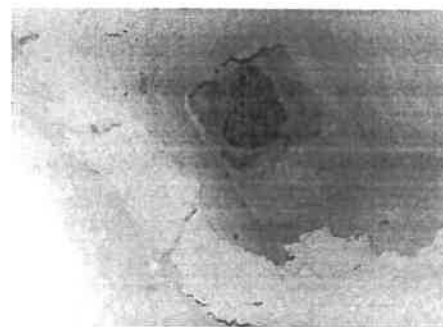
Photo 6: Interior of cavity

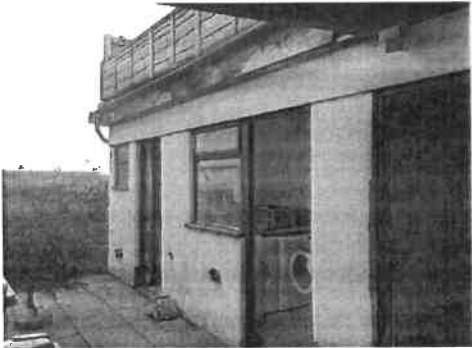
Externally, on ground level, the building comprises a concrete breeze block structure with a layer of plaster and white paint (heavy flaking) (photo 7). A timber soffit and soffit box are present, which runs along the perimeter of the side wall (photos 8 and 9). Attached to the soffit is a gutter and subsequent downpipe on both sides of the building (photo 10). Immediately above the soffit is a traditional bitumastic roof lining with lead flashing underneath. Gaps were present between the soffit and soffit box (photo 9). These were more prevalent at the two ends of the soffit (west and eastern sides of the building), the diameter of these openings was sufficient enough for bat access into the soffit box, however due to an absence of droppings it was concluded that bats have not used the soffit box recently. One small rodent dropping was found inside the gap on the eastern side. Therefore, the soffit box was categorised as a low potential roosting feature.

Photo 7: Ground level view of building exterior

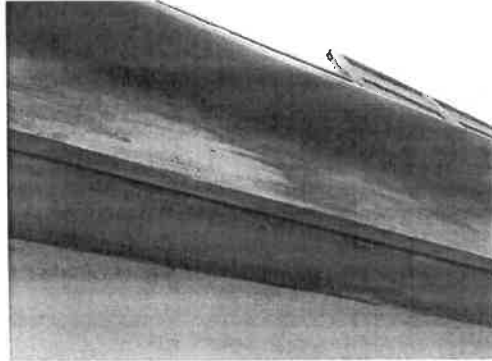
- Low PRF- The soffit box located on the southern elevation of the property provides a large enough access space for bats and protection from weather conditions. The feature only extends a maximum of 10cm on each end of the box (which is a larger diameter on the eastern side).

Photo 8: Soffit and soffit box which extends along the front (south) of the outbuilding

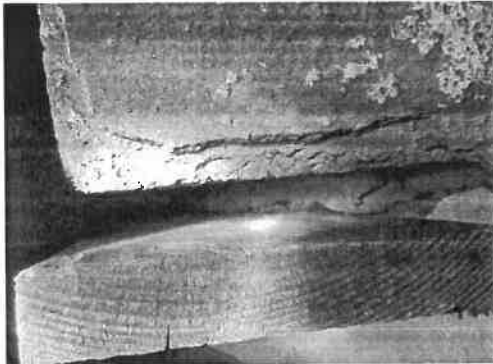
Photo 9: 'V' shaped gap between the soffit and soffit box

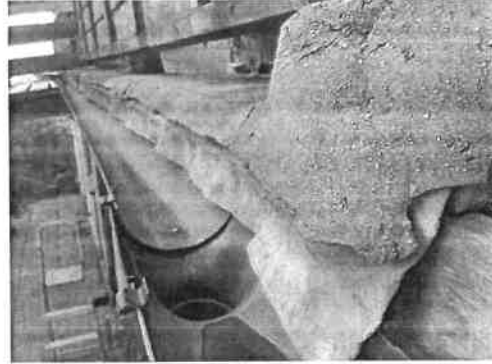
Photo 10: Layers of roofing materials, beam and gutter.

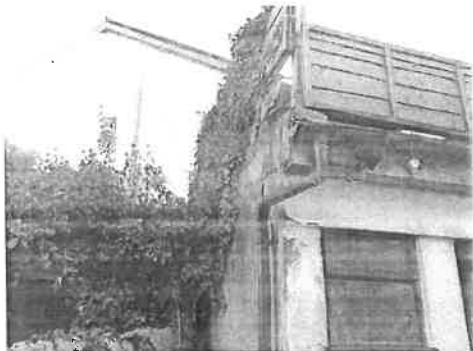
The wall on the western end of the building is partially covered in ivy (*Hedera helix*) cladding (photos 11 and 12) (70% cover) which extends onto the other side of the wall reaching ground level. This ivy cladding provides a low potential roosting feature because of the density of the vegetation and latticing. Furthermore, the stem diameter of the ivy reaches 50mm or more in places; and is partially detached. BCT (Bat Conservation Trust) guidelines list this habitat as a potential roosting feature (PRF). However, the ivy is close to ground level and is vulnerable to predation by animals such as domestic cats who can easily move between the outbuilding roof and neighbouring property, therefore reducing its suitability for roosting bats. In addition to the ivy, there is an under-layer of perimeter stone wall where gaps are present within the pointing. This could potentially provide safe harbour for roosting bats..

- Low PRF- The ivy cladding (photos 11 and 12) located on the western elevation of the outbuilding, which stretches over the neighbouring shed to the west and timber fencing on the roof terrace to the east. The ivy was indicated to be of some potential because of its maturity (where some stem diameters reached 50mm), and dense covering of stonework. The progressive narrowing of the outbuilding wall to the adjoining boundary wall (photo 11) provides some cover from harsh weather conditions, and is not intruded harshly by artificial light. The feature could not be fully explored due to the ivy being too dense to observe any

roosting bats, combined with the narrowing of the adjoining wall creating a difficult area to reach by hand. This feature was identified to be of low potential.

Photo 11: Overhanging ivy cladding on the western side of the building which densely covers the neighbouring shed. The outbuilding wall narrows against the neighbouring wall.

Although a low PRF, the ivy cladding should still be inspected by the contractor prior to removal for possible bat presence (see Appendix C for information on identifying bats); it will then be removed carefully by hand, using loppers or a pruning saw; still remaining vigilant in the case of bats which were missed by the initial inspection. If works do not require the removal or modification of the ivy cladding feature then careful attention should still be adhered to impacting potential roosting bats.

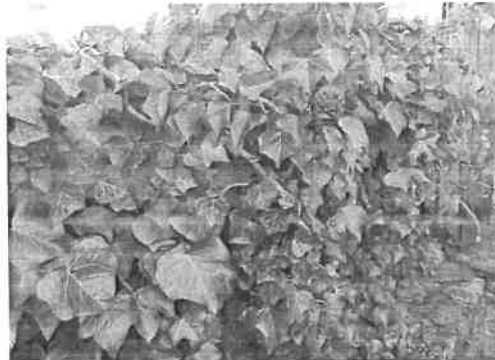
Photo 12: Dense ivy cladding on the western boundary of roof terrace.

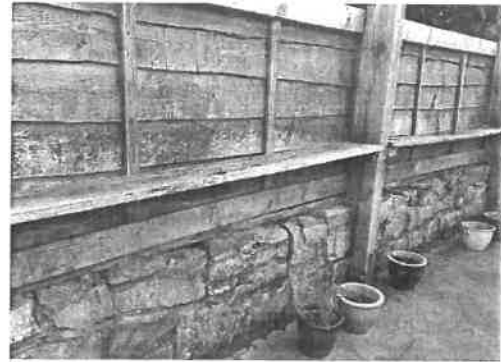
Photo 14: Timber fencing and stone wall boundary (height extended on the northern boundary)
