REPORT ON A STRUCTURAL INSPECTION

Little Woodfield Farm

Project No. 1716

REV B

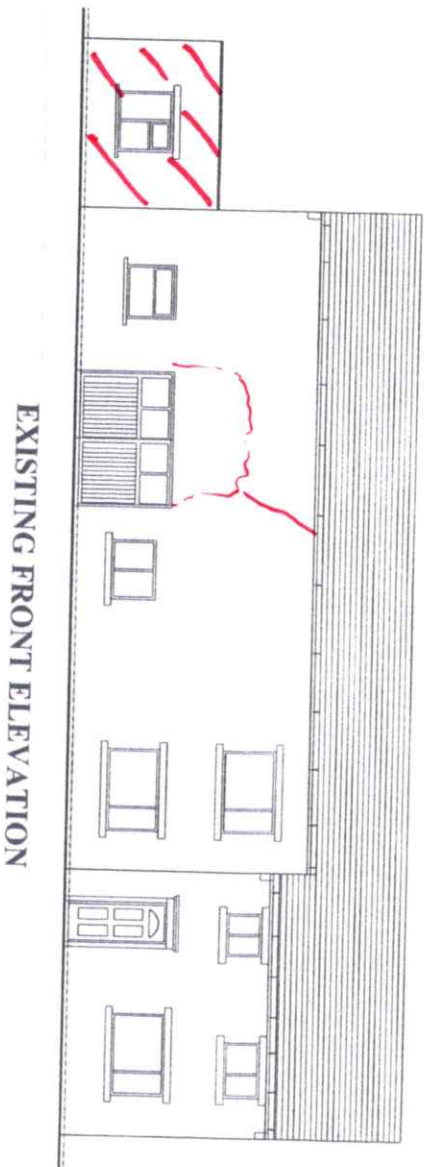
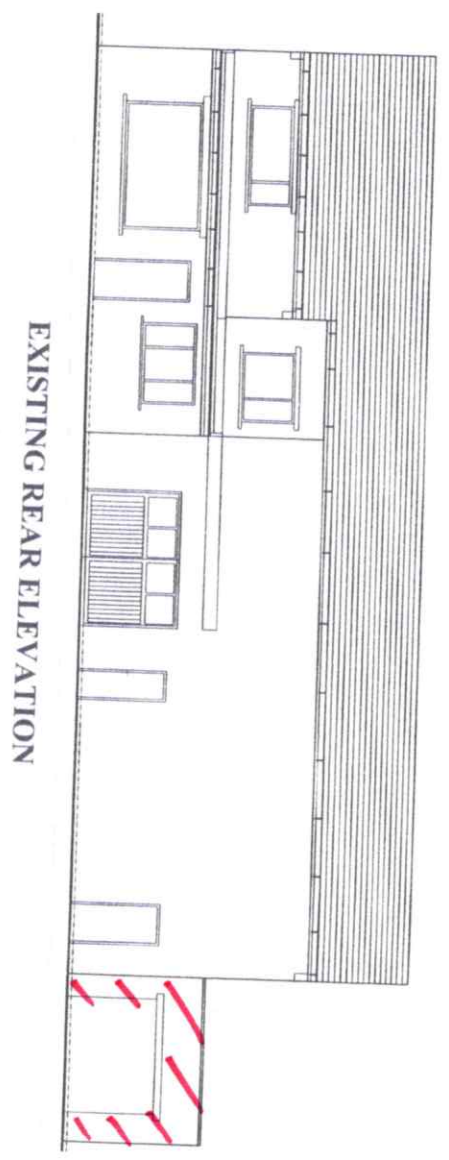
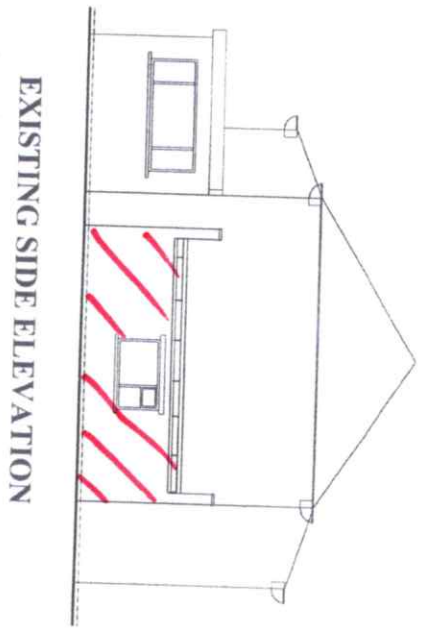
FIG. 1

Reporting from the left gable wall there is a ground floor window. This has a stone cill, lintel and jambs. Then there is a panel of wall to a large double doorway. As seen internally this was a much larger doorway but this has been blocked in. There is cracking around the profile of the original opening. There is a 1mm. wide vertical crack running up from the top right corner of the arch to the eaves.

The side wall is leaning out at the top by 30mm. There is a crack running down the butt joint of both the front and rear walls where they abut the gable wall of the barn.

The single storey extension has suffered from differential settlement. The building should be demolished and if needed to be re-built.

There are some cracks to the internal walls and these need raking out and pointing.

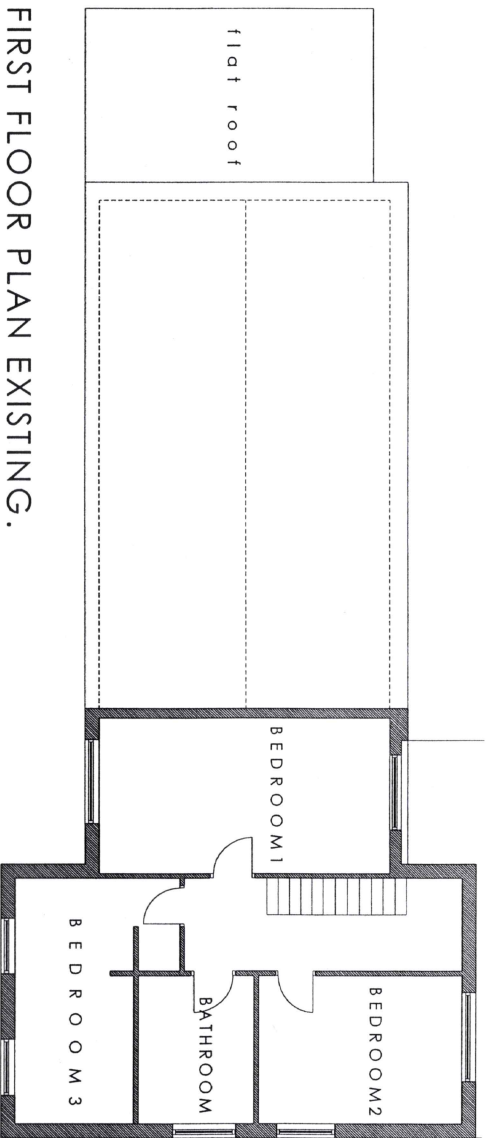
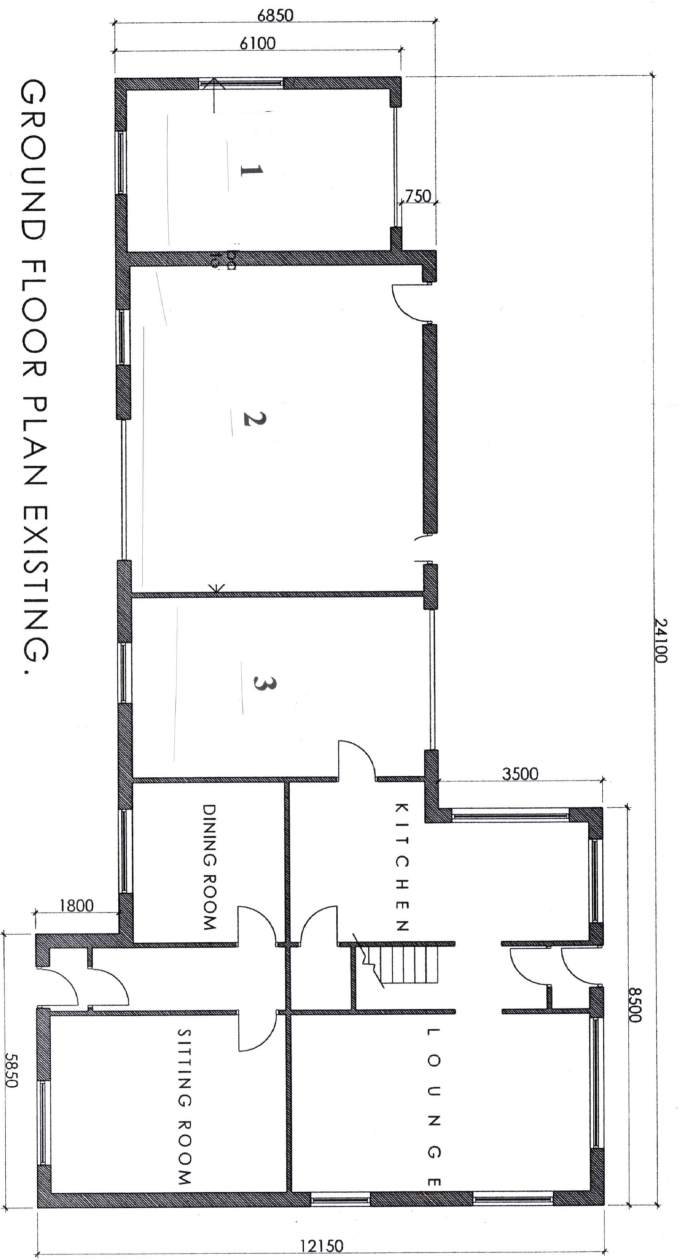
FIG. 2

This area is to the left of the main barn. This is shown on Fig. 2 and designated area 1. This room is the single storey extension to the side of the main barn.

This area is to the left side of the main barn. This is shown on Fig. 2 and designated area 2.

This area is to the right side of the main barn. This is shown on Fig. 2 and designated area 3.
