WALKERS TREE SERVICES

Tree Survey & Report

For the protection of two trees
during a proposed development at:

12 Ribchester Road
Wilpshire
BLACKBURN
BB1 9JH

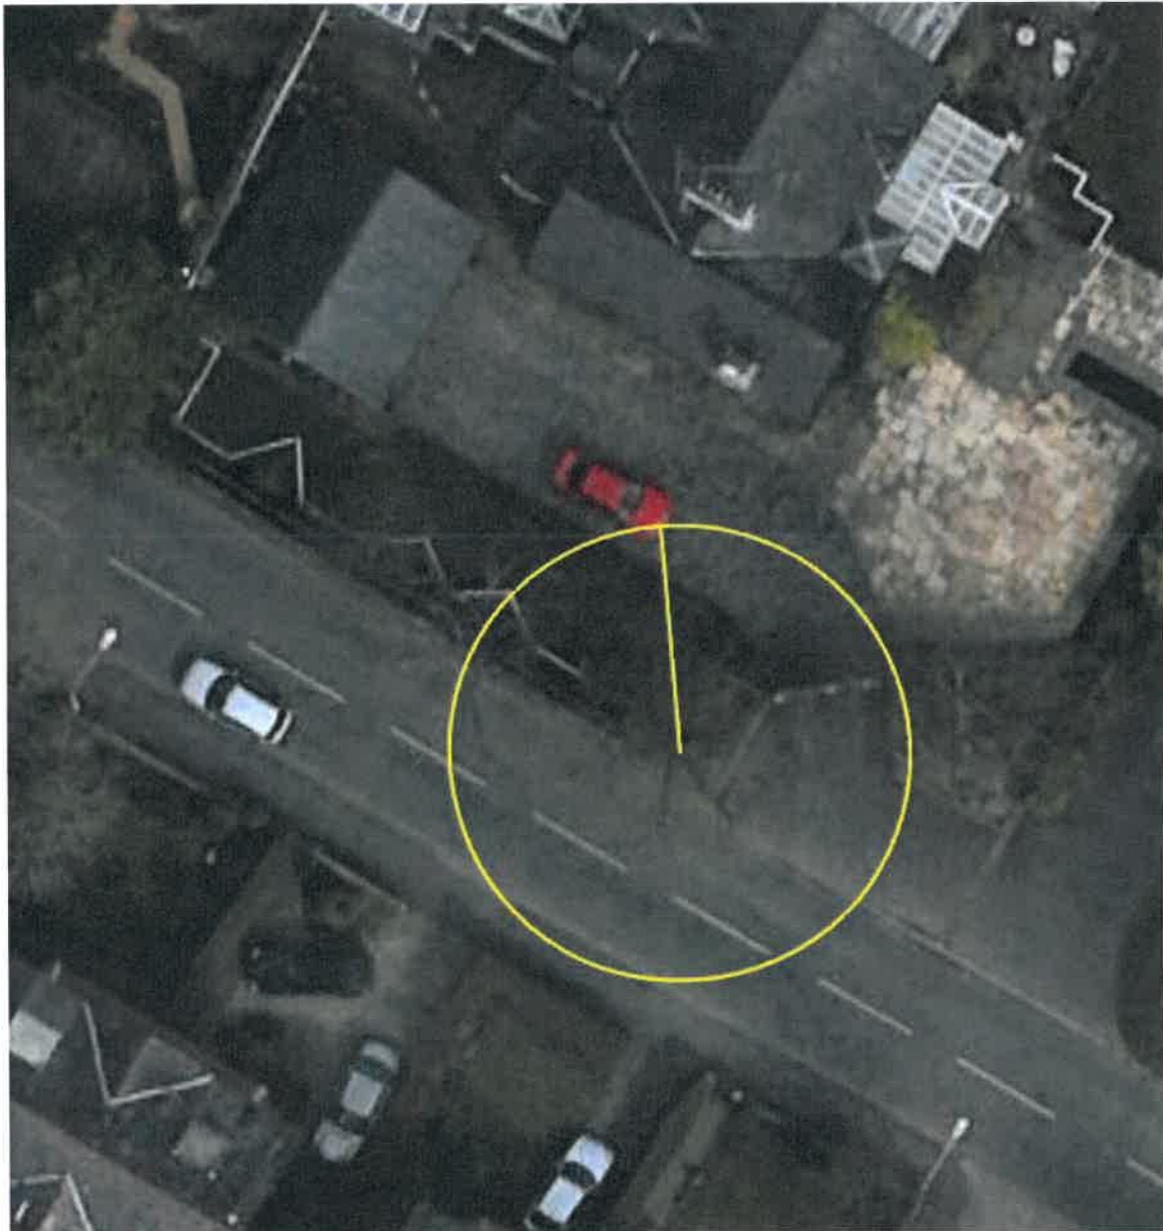
Appendix E: Root Protection Area (RPA) of T.1 Horse chestnut

The Root Protection Area (RPA) of each tree has been determined using the calculation methods detailed in BS5837:2012 and plotted as a circle which is centred on the base of the stem. The RPA's of each tree can be found in [Appendices E & F](#).

- The storage of building materials to be made outside of the Root Protection Areas of both trees. The RPA's are to be marked on the ground in visible red spray paint. And to be maintained both in being clear of stored building materials and in being visible throughout the proposed development works.
