**Project:** Witcher Well structural survey  
**Client:** Mr. J. Ibison  
**Description:** First issue  
**Date:** 26 March 2019

**Noriker  
Civils Ltd.**

## **Structural survey with respect to proposed development at Witcher Well Fish Hatchery, Dunsop Bridge.**

**Version:** 1.0      **Description:** First issue for client approval / planning submission

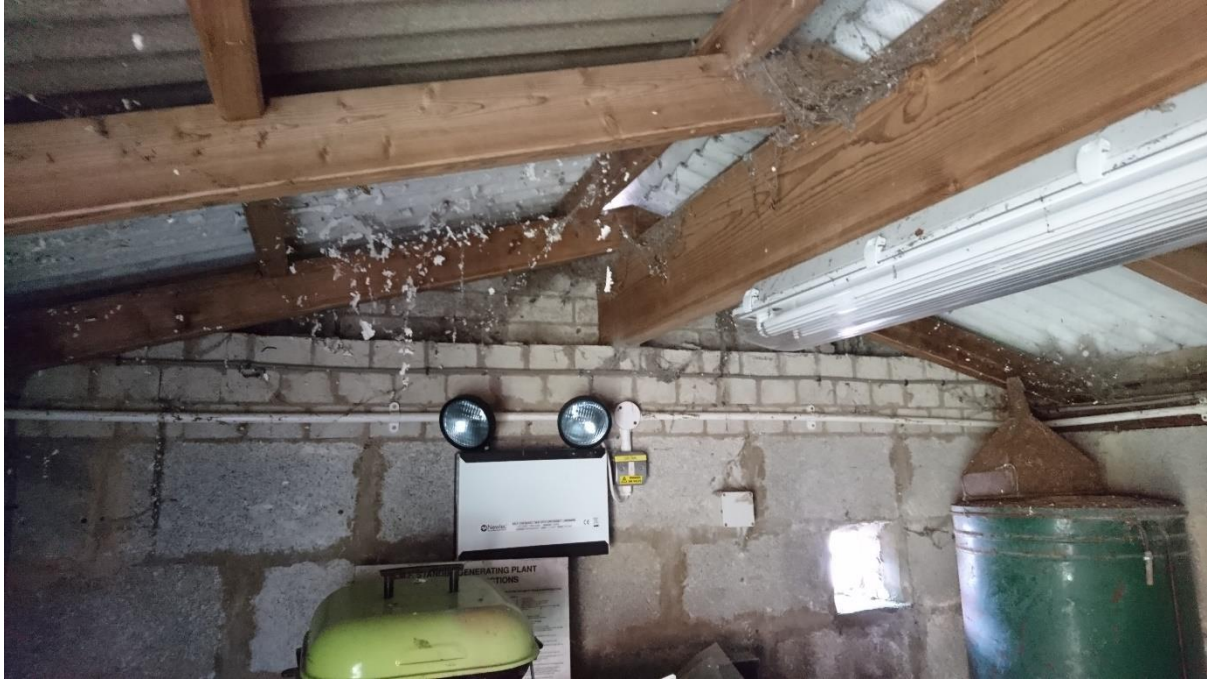
The plant room roof is a simple timber structure with a 47 x 225 softwood ridge beam supporting 47 x 100 softwood rafters at approximately 700mm centres. The roof covering is corrugated sheets on 3 No. purlins per slope. The roof sheets should be checked by a competent person for asbestos content.

*Figure 6: Plant room roof layout*

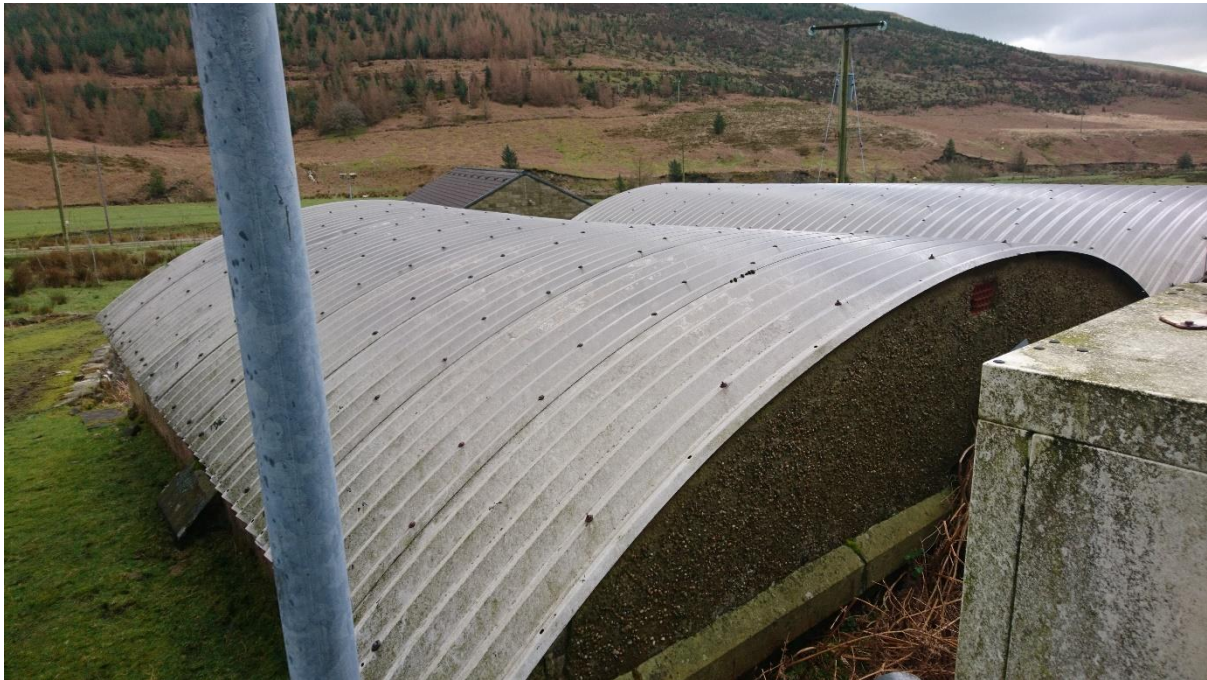
The tank house roof is a later addition, constructed from a single ply of uninsulated corrugated galvanised steel sheets, supported at the external walls by a rotting timber wall plate, and down the central spine of the structure by a steel girder system, with a masonry pier mid span. The gables have been built up to match the arched profile using aggregate concrete bricks in cement mortar and with exception of the archway directly above the entrance, are well sealed.

*Figure 7: External view of tank room steel roof*

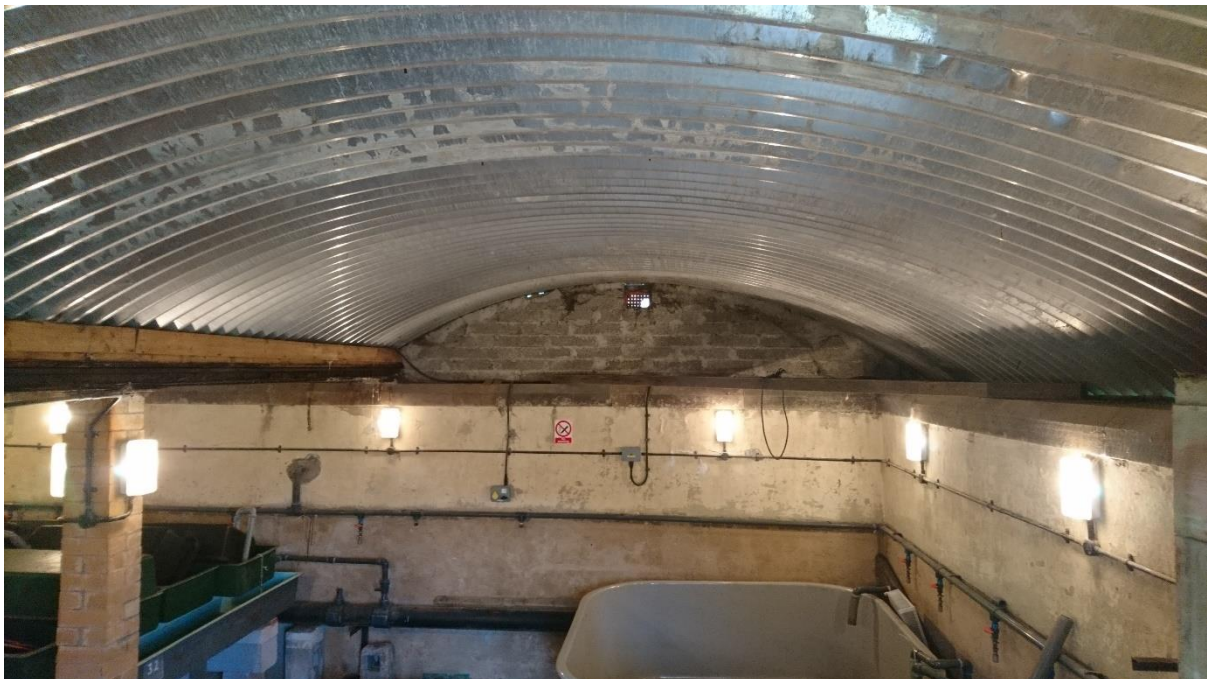
*Figure 8: Internal view of tank room steel roof*

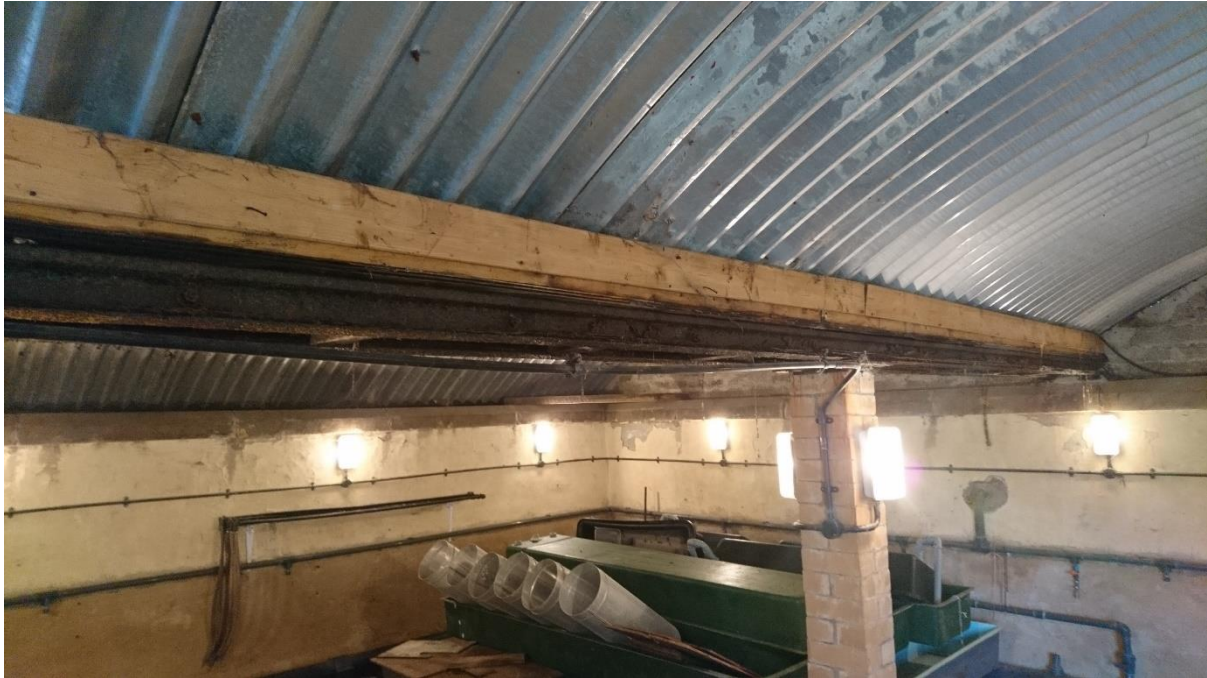
The central supporting steel girder is a composite unit, which appears to be constructed from two light railway rails bolted together at the required spacing through the rail web with timber packing at regular intervals. A plywood deck is fitted between the foot of the rails which supports the central gutter. The guttering may have failed, or some other means of water ingress developed since the plywood deck,

timber packing and steel rails are in very poor condition and showing signs of extensive rot, decay and corrosion.

*Figure 9: Central girder and supporting pillar*

The masonry pillar which props the girder at mid span is created by laying two clay bricks side by side in cement mortar to make a 215 x 215mm pillar. The pillar is sat on a 600 x 600 x 100mm concrete thickening/pad directly on the floor slab which is showing no signs of distress

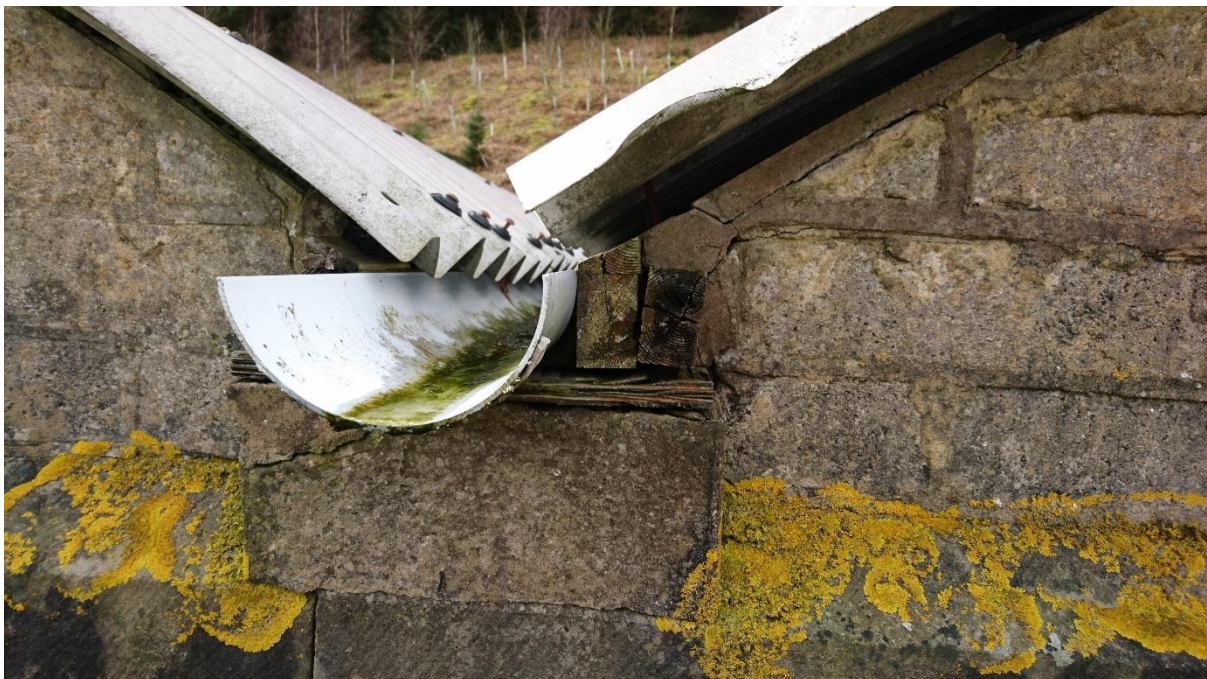
*Figure 10: Decaying plywood and timber packing in central gutter*

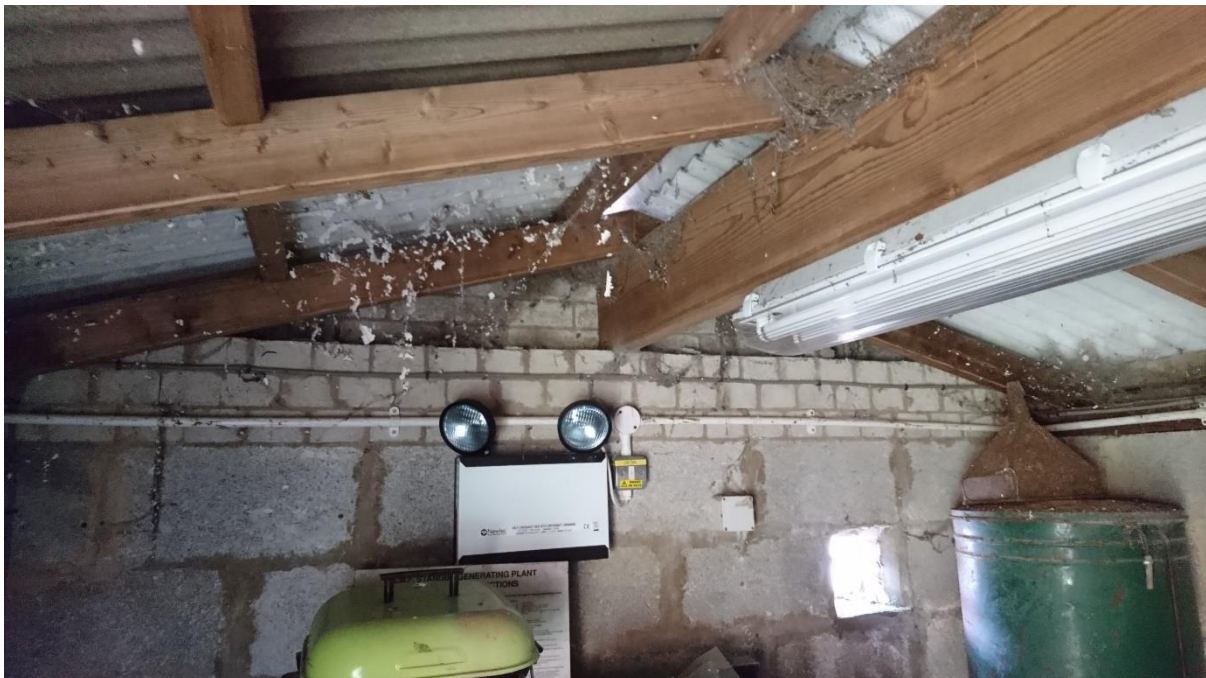
The walls are a simple construction of 215mm thick hollow concrete blocks laid in cement mortar. The upper parts of the gables are built from concrete bricks, initially laid one brick thick for three courses above the hollow blocks, and then half a brick thick to the ridge to provide a shelf to support the ridge beam. No damp proof course was visible.

*Figure 11: Masonry shelf for ridge beam bearing*

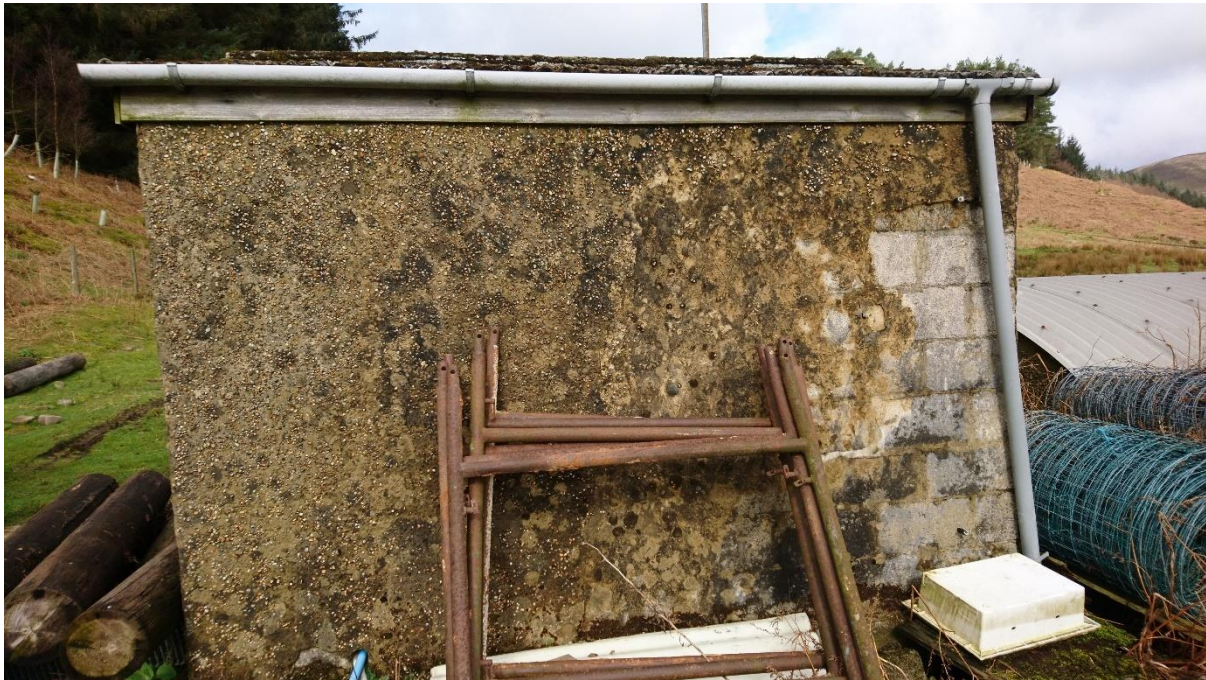
The blockwork has a cement and pebble render applied on all external elevations, which needs replacement.

Figure 12: External render

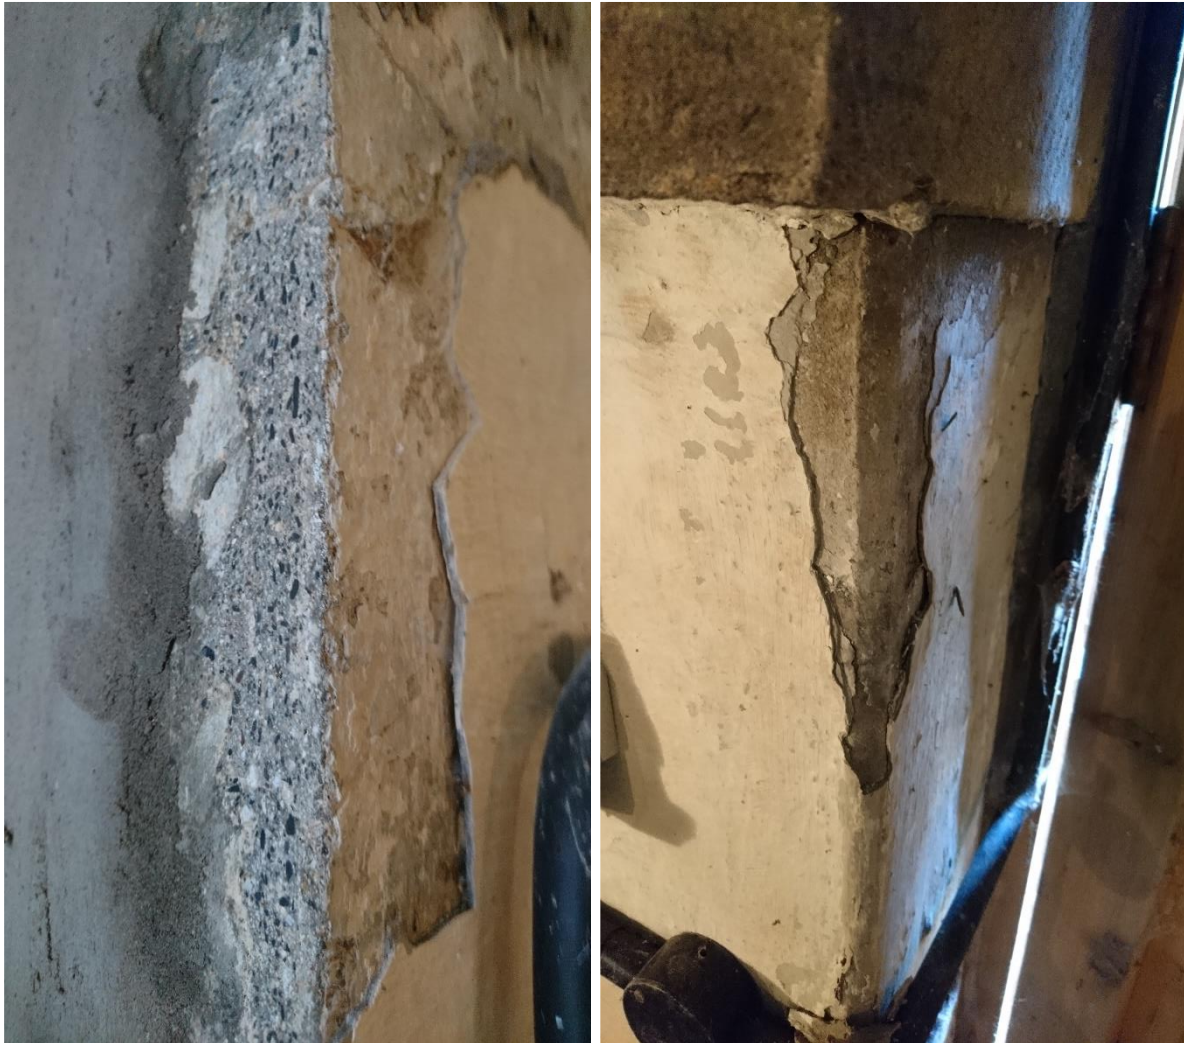
The doorway opening both supports and contradicts the idea of an open-air pool. The doorway has a sawn cut on the south eastern most edge, which supports the idea that the walls were an enclosed pool, however on the opposite side, a chamfered corner is present, which appears to have been cast in place, indicating that the walls may have had an opening as part of the original design. The masonry above the doorway is supported on a 100 x 125mm concrete lintel, assumed to be of modern construction. This lintel appears to be functioning well under current loading, but should be checked during structural design for future loading.

*Figure 13: LEFT: Sawn concrete at edge of door opening, RIGHT: Chamfered corner on opposite edge of door opening*

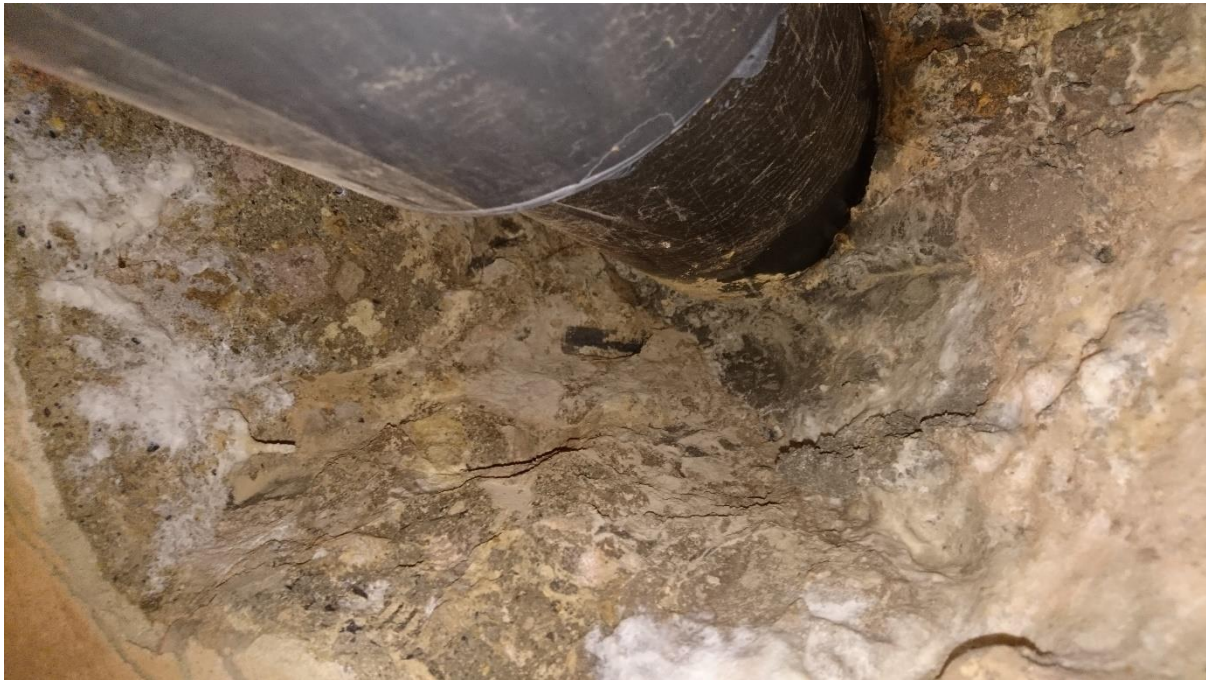
There are no visible cracks in the walls (noting that there is a layer of plaster over a large proportion of the wall surface). Several openings have been made in the walls, for water drainage and services from the plant room and the nearby water storage tank. The largest hole is approx. 400mm in diameter and no evidence of reinforcing steel or the thickness of the wall at this location can be seen in this cutaway section.

*Figure 14: Closeup of opening in rear wall for water supply pipe*

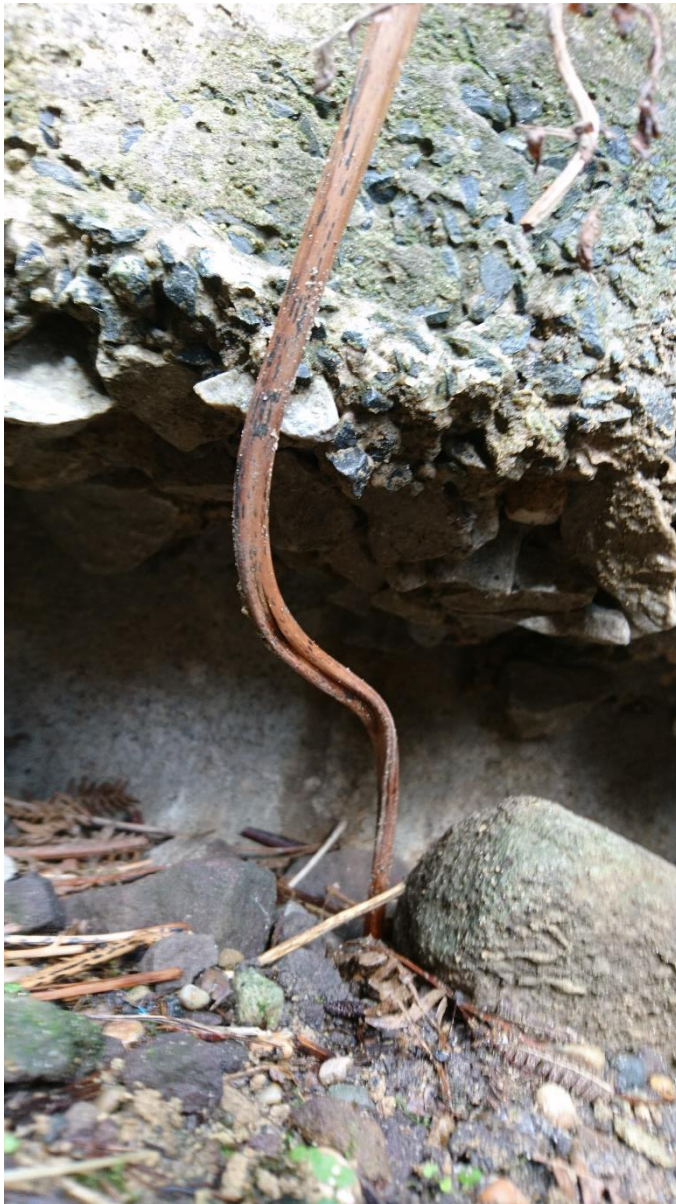
The plant room had a solid cast concrete floor slab. The presence of any reinforcement is unknown. The floor shows no signs of distress and is currently performing well. The north western elevation has become undermined, it is not clear how this has occurred. However, the depth of the slab is visible and what appears to be concrete blocks below are also visible. This may indicate that a strip footing has been taken to a depth sufficient to avoid loading the retaining walls with the foundation surcharge. The floor slab and foundations appear to be functioning well, although are not understood to be in the proposed development plans.

*Figure 15: Closeup view of exposed slab with concrete blocks underneath*

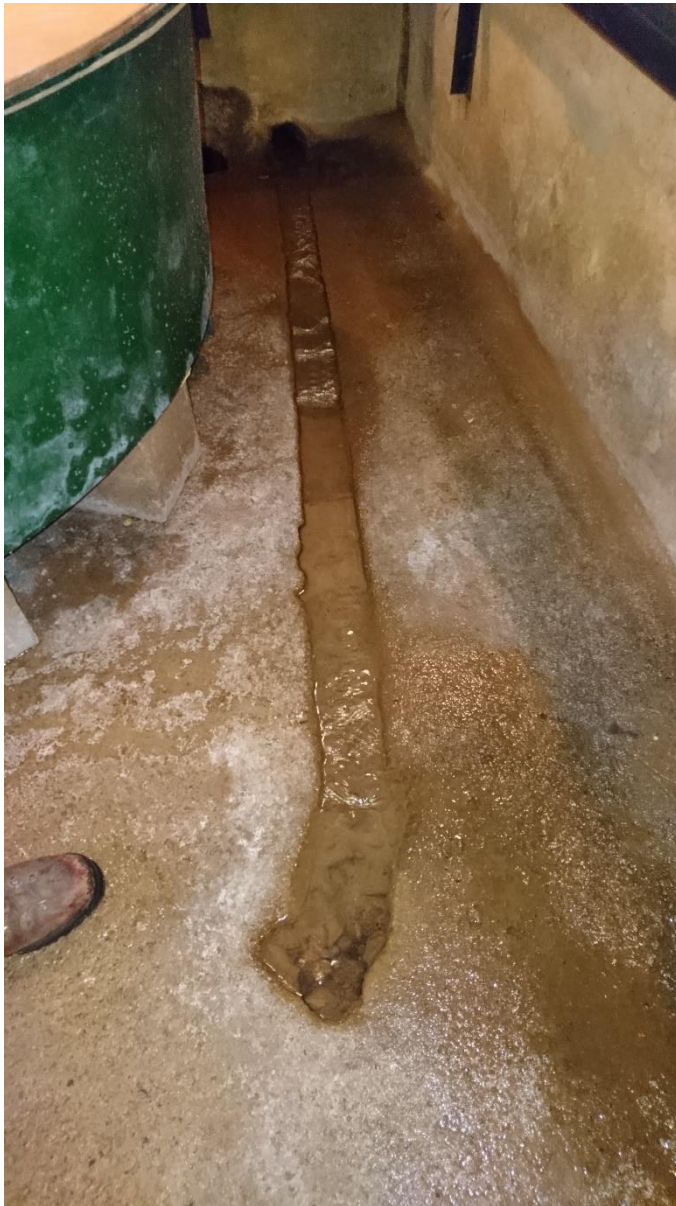
There is a small opening in the floor structure, which is believed but not confirmed to be the source of a spring. A drainage channel has been formed in the floor slab and an exit drain(s) provided in the front (north eastern) wall. The presence of this spring is not a structural problem in its current function, although should the floor slab crack and the soil below become saturated, structural problems may arise. It is acknowledged that the soils may already be saturated if the spring is issuing immediately under the slab. Careful architectural detailing is also required to mitigate any damp issues.

*Figure 16: Spring / water issue with cast in channel leading to drain in front wall*

A test core should be cut from the slab directly above the issuing point, to understand the source of the water flow (i.e. is it a spring, or has it been intentionally piped?) and the condition of the soil immediately below.

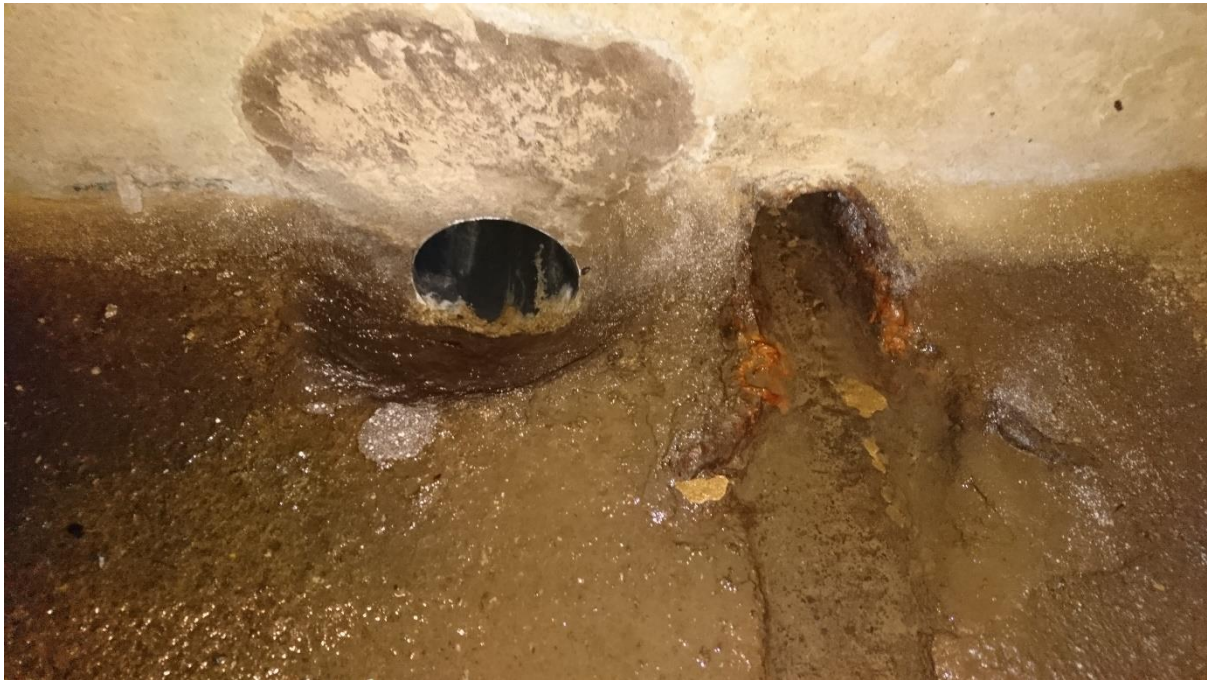
*Figure 17: Closeup of drain in front wall*
