ARBORICULTURAL CONSULTANT

## **Section 7**

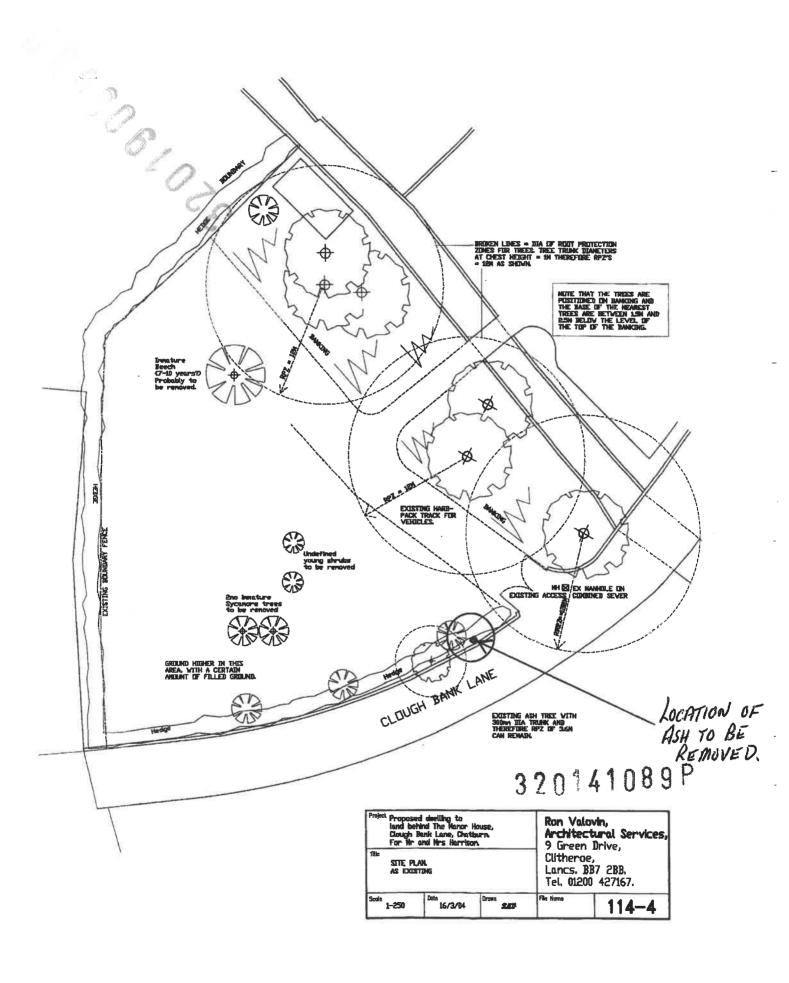
The tree has been infected with Ash dieback (Hymenoscyphus fraxineus) and has been totally defoliated and appears at present to be effectively destroyed. Some level of recovery could take place in the spring but the tree is considered to have been effectively destroyed.

Ash tree to be removed is item to left of the two defoliated trees – without ivy extending up into the crown.

Removal of the Ash tree identified in the attached photographs and as indicated on the included plan is to be undertaken.

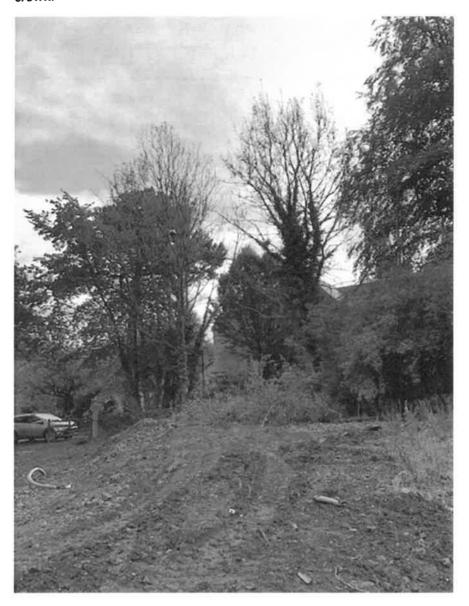
It is also in very close proximity to the boundary wall in an elevated position where it would be expected to cause displacement of the structure by incremental growth of roots and stems. Such action may already be occurring but due to the presence of ivy and other items access and visibility is also restricted.

Base of Ash to be removed – multi stemmed from ground level indicating coppice type habit. Very close to / touching wall.
