**Proposed Change of Use of Camping Barn.
Clark House Farm.
Chipping,
Lancashire.**

**Structural Appraisal.
of the Stone Camping Barn**

On Behalf Of

Messr's P. Stott & Son.

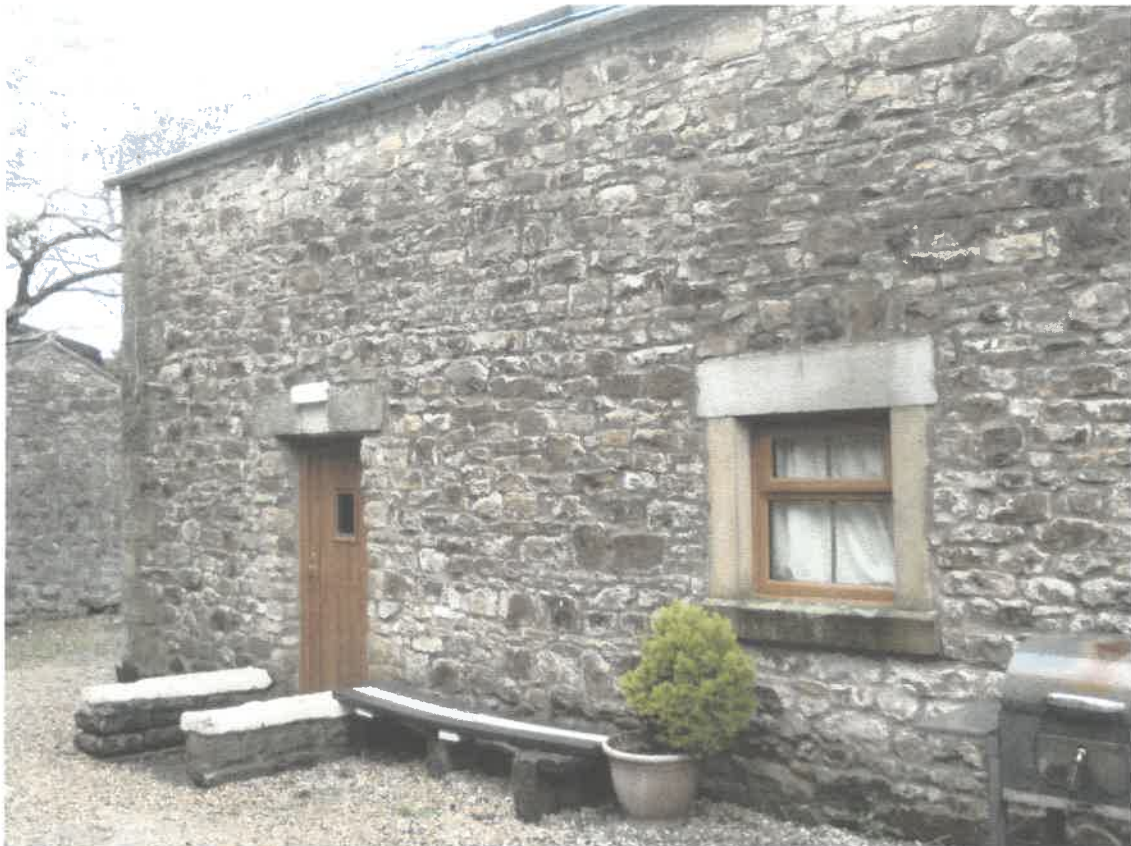
1 : Photo of the Rear elevation.

More recently the windows & rear door have been replaced and are in excellent condition. (see appendix B, photo 1)

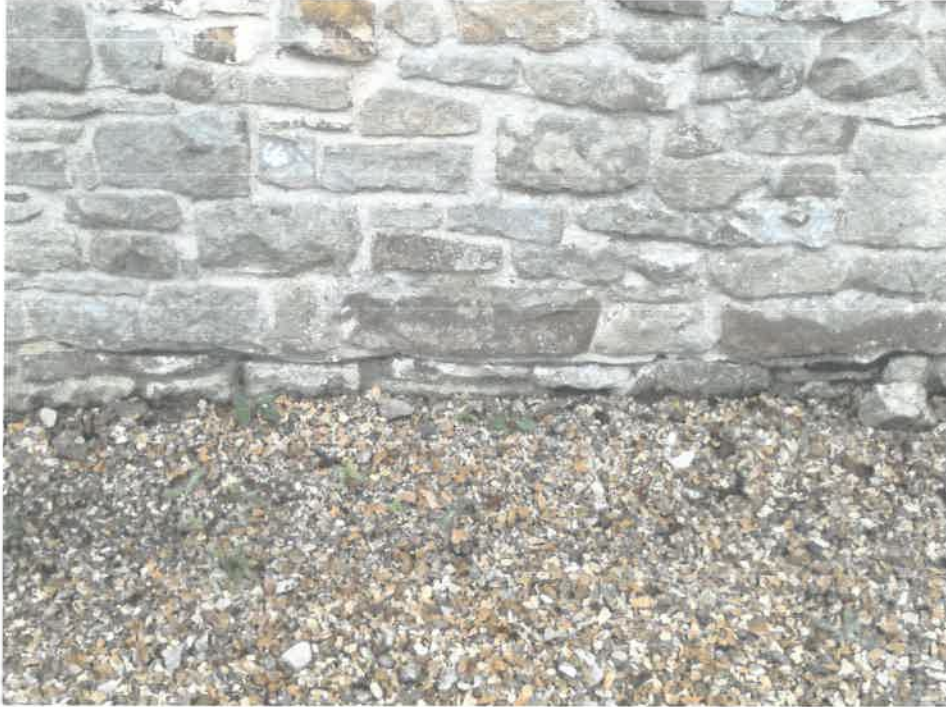
2 : Photo of Dpc in front elevation masonry

Where the barn door opening has been filled in on the front elevation, there is evidence of a Dpc being used. (see photograph 1).

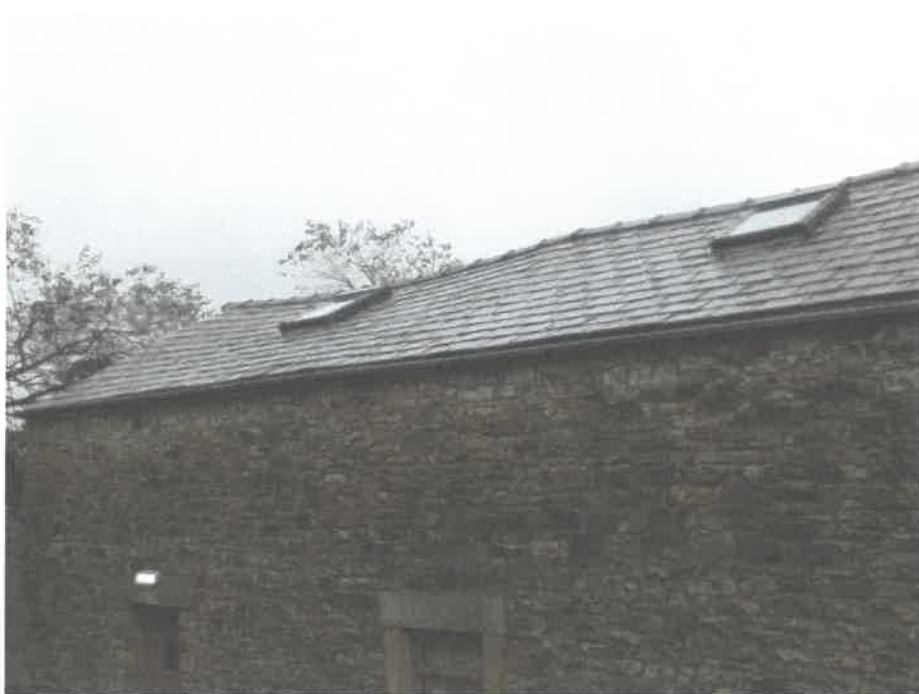
3 : Photo of North End of Roof.

2.2.1 The slated roof of the barn pitches from front to back, with the ridge and eaves lines being noted as level with the exception of the Northern half of the ridge having a bow due to the weight of the roof. This appears to be historic and little or no evidence of recent movement.

The purlins are slender, and are showing signs of deflecting due to them being two timbers side by side and movement has occurred due to them not being sufficiently fastened together and are unlikely to be suitable for retention. (see appendix B, photo 3 & 4)

3.10 From the findings summarized previously it is apparent that there are some structural weaknesses in part of the roof, as the structure would need to be covered with a breathable membrane, insulated and the ridge & purlin timbers needing replacement, this would be considered an expected remedial repair to a roof.
