Statement of Significance And Condition Report

Teewood Farm
Slaidburn Road
Waddington

for
Mr Michael and Dr George Fisher
December 2018

Ref. 18103/HS
RevA 07/02/19

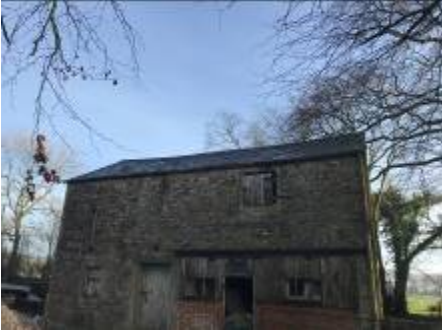
Element	Construction	Condition
BARN A		
Roof, west pitch

Slate laid in random widths and diminishing courses. Sandstone ridges Four glazed panes of glass built into roof act as rooflights.	There are several slipped and broken slates across the roof. Slates do not line through particularly well at the south verge, this may be associated with movement to the wall below. The bedding mortar to the ridge tile is lost for about 30% of the overall ridge.
Roof, east pitch

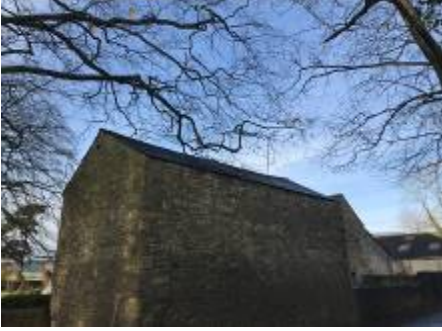
Slate laid in random widths and diminishing courses. Sandstone ridges Glazed panes of glass built into roof act as rooflights.	Generally, in better condition than the west pitch. There are however several slates loose along the eaves and some are also missing close to the ridge at the south end.
Rainwater goods

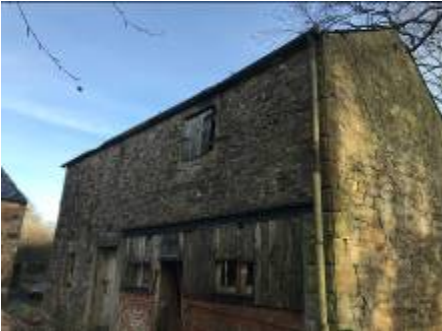
There are only rainwater goods on the west side of the barn. The gutter and downpipe are a fibrous material (potentially containing asbestos). Gutters and downpipe fixed via metal brackets. The downpipe discharges over the ground and not to a gully.	The gutter and downpipe are full of debris and the gutter is broken.

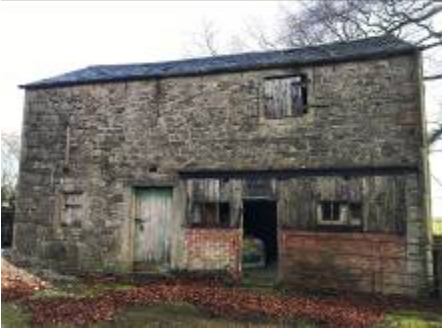
Walls, west

Sandstone rubble walls with dressed quoins. Walls are pointed in a hard mortar. A former large opening is built up in brick and timber boarding with a large steel lintel over. To the left of this is a doorway and window. At first floor level is an additional opening with timber door.	Walls generally have open joints. The softer build mortar can be seen behind the harder cement mortar in places. On the south west corner the quoins are unstable. The brickwork infill has many open joints and the timber boarding is very decayed with the decoration having completely failed.

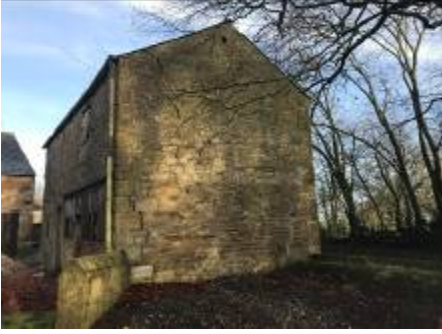
<p>Walls, south</p>

<p>Sandstone rubble walls with dressed quoins. Walls are pointed in a hard mortar. External ground levels here are higher than internal and there is a tree growing close to the gable wall.</p>	<p>Significant movement throughout gable. This is evidently a longstanding problem as there have been previous attempts to repoint the large open joints caused by the spread of the wall. The wall is however reasonably plumb. There is algae growth to the wall at high level.</p>
<p>Walls, east</p>

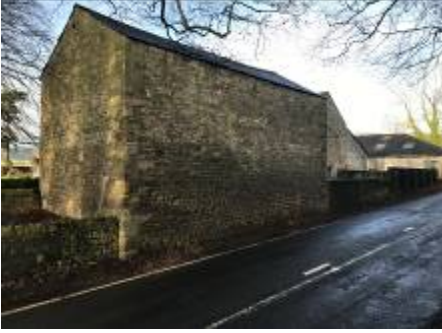
<p>Sandstone rubble walls with dressed quoins. There is a bench mark visible at low level towards the north end of the wall. Walls are pointed in a hard mortar. There is a metal sign bracket fixed to the wall at the north end and this appears to have been hit by a passing vehicle.</p>	<p>Wall is generally sound. It is very dirty up to a height of approximately 2m and this is from vehicles on the main road. There is a slight bow in the wall towards the south end.</p>

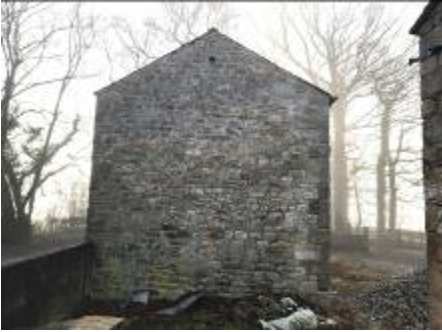
<p>Walls, north</p>

<p>Sandstone rubble walls with dressed quoins. Walls are pointed in a hard mortar. There is evidence of a whitewash finish on many stones across elevation.</p>	<p>Wall is plumb and appears sound. There is some minor cracking at the base of the wall. Pointing mortar is quite coarse but is in reasonable condition except at the verge close to the roof apex where the mortar is loose.</p>
<p>Window, ground floor, west elevation</p>

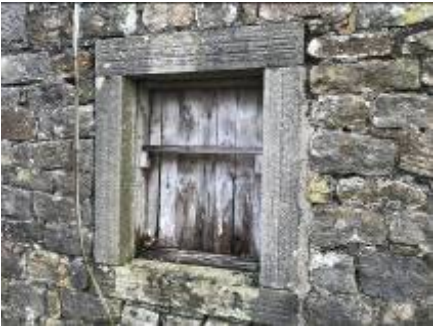
<p>Sandstone surround. Timber frame and timber boarding inserted into opening. The frame and boarding is all machine cut.</p>	<p>Sandstone surround in good condition. The frame and boarding is rotten and wormy.</p>

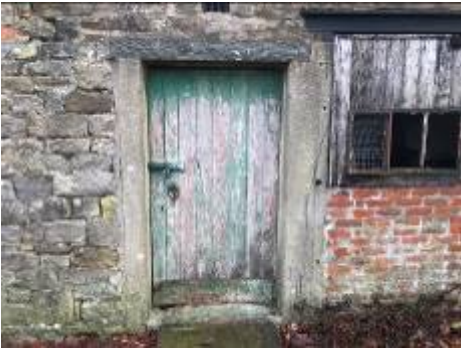
<p>Door, ground floor, west elevation</p>

<p>Sandstone surround and lintel to door. Door is timber boards with a metal kickplate.</p>	<p>Surround and lintel in good order. Decoration on the door is poor and the door is quite rotten at its base.</p>
<p>Infilled panel, ground floor, west elevation</p>

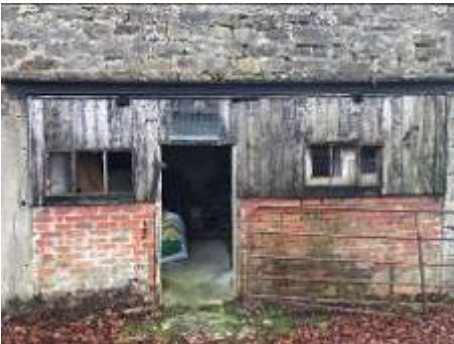
<p>Opening infilled with brickwork and timber frame and boarding. The windows are metal. Behind the screen is a steel post and lintel.</p>	<p>Window are very corroded and no longer functional. There is no door and the door frame is completely rotten at its base. Boarding is generally saturated and quite decayed. The steel lintel and post internally are corroded.</p>
<p>Window, first floor, west elevation</p>

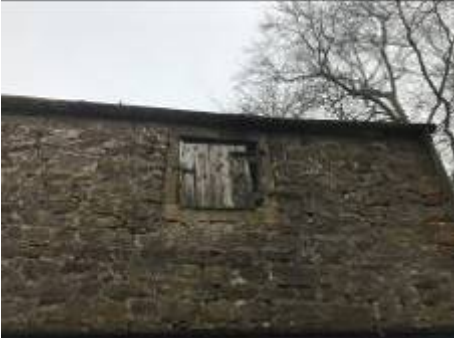
<p>Dressed sandstone surround with hinged timber boarded door.</p>	<p>The right-hand sandstone jamb is shattered and cracked at hinge position. Hinges are likely corroded and causing damage to the stone. Timber boarded door is in poor condition.</p>

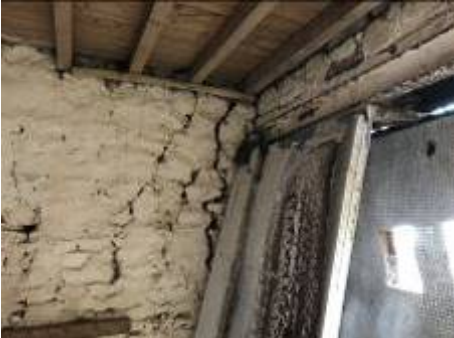
<p>Ceiling is exposed joists and timber boards which, one assumes, are the floor finish above. All are machine cut. External walls are rubble and the dividing (north) wall is brickwork. All walls are whitewashed. The stalls within the room are reinforced concrete. There are water pipes linking to troughs in each stall.</p>	<p>Cracking on the south wall corresponds with the external cracking walls are otherwise in reasonable condition considering building's use. The reinforcement within the concrete stalls as corroded and caused the concrete to fracture.</p>

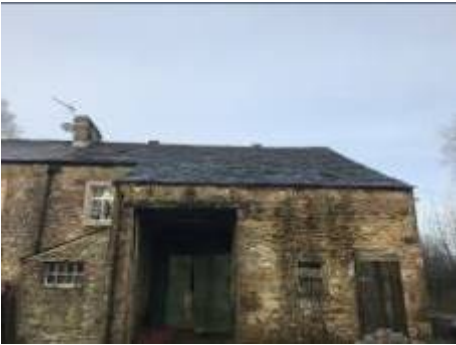
<p>Sandstone tiles and ridge. The ridge incorporates two vents. Five glazed panes of glass built into roof act as rooflights.</p>	<p>Tiles appear in reasonable condition but there is a lot of undulation across the roof plane, particularly over the large barn doors. The perp ends of the tiles are mossy.</p>
<p>Roof, north side</p>

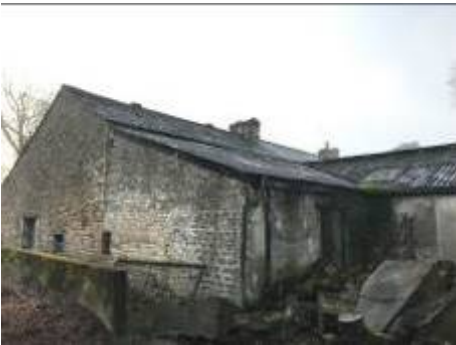
<p>Sandstone tiles and ridge form the upper section of the roof. The ridge incorporates two vents. Three glazed panes of glass built into roof act as rooflights. The lower roof is a later addition and is roofed in profiled metal sheeting with plastic sheeting forming rooflights.</p>	<p>The condition of the upper sandstone section of roof is much the same as the south side. The lower profiled metal sheeting section of the roof is in poor condition. Moss growth is prevalent across the roof covering. The valley gutter is completely blocked and internally there are significant signs of water ingress (discussed in more detail later on in report).</p>

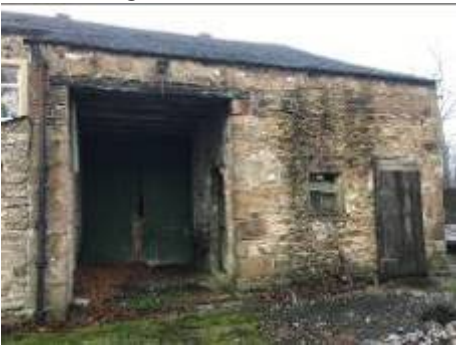
<p>Rainwater goods, south side</p>

<p>There is no longer a gutter, remnants of rise and fall brackets are still present. A cast iron downpipe remains but this does not discharge to a gully.</p>	<p>The cast pipe is in very poor condition and quite unsecure.</p>

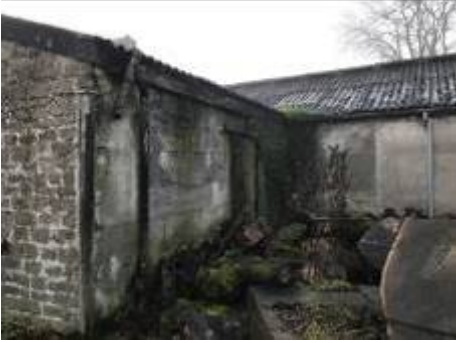
<p>Rainwater goods, north side</p>

<p>The gutter and downpipe are a fibrous material (potentially containing asbestos). Gutters and downpipe fixed via metal brackets. The downpipe discharges over the ground and not to a gulley. There is no gutter at the eaves of the sandstone tiled roof.</p>	<p>The gutter has completely fallen off and only a small section is left hanging. The brackets are still there but fixed into a large timber eaves beam which is rotten. The downpipe is in poor condition.</p>
<p>Walls, south</p>  	<p>Sandstone rubble walling with dressed quoins. The building pattern changes with the top 500mm (approximately) being more coursed walling, indicating a later phase of construction.</p>	<p>Walls are generally plumb. Joints are very washed out and the surface of stone is very friable, unsurprising given the lack of rainwater goods. There is some movement in the wall at high level to the right of the large cart opening, the wall here is also stained indicating water has been washing down over this area which could be a cause of the instability. The large lintel over the cart opening is saturated on the face, but quite dry behind and again this is due to the lack of rainwater goods. The lintel does, at least visually, still appear to maintain its structural integrity.</p>

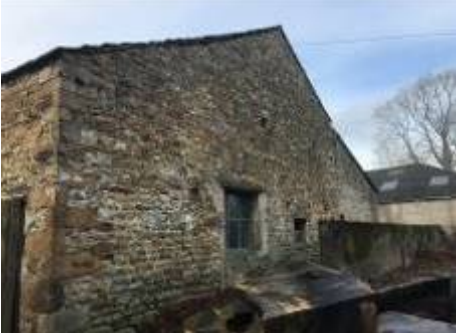
<p>Walls, east</p>

<p>Sandstone rubble walling with dressed quoins. The building pattern changes with the top 700mm (approximately) being more coursed walling, indicating a later phase of construction. From this elevation it is very clear that the roof of the barn has been raised. The wall has evidence of being whitewashed in the past.</p>	<p>Walls are generally plumb and the pointing is in much better condition here than on the south wall. A former personnel door has been built up and the upper section made wider to form a large window. A series of vents have been put through the wall quite crudely at a height of approximately 2m.</p>

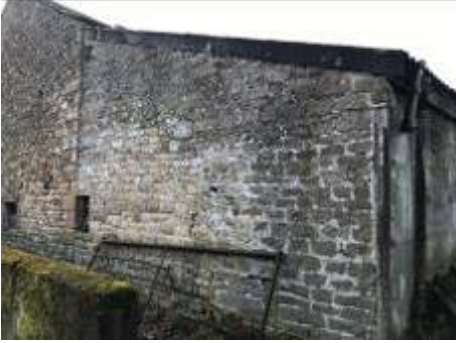
<p>Walls, east lean to</p>

<p>The lean to at the north end of the east wall is clearly a later addition and within this wall there are at least two phases of construction. The building pattern indicates a smaller and lower lean-to which has then been extended to the north and up to the eaves of the main barn. This correlates with what is shown on the map regression.</p>	<p>The condition of the wall is reasonable. There is cracking between the two phases of construction. The wall also exhibits a variety of pointing mortars and again there is evidence that the wall was whitewashed.</p>
<p>Walls, north</p>

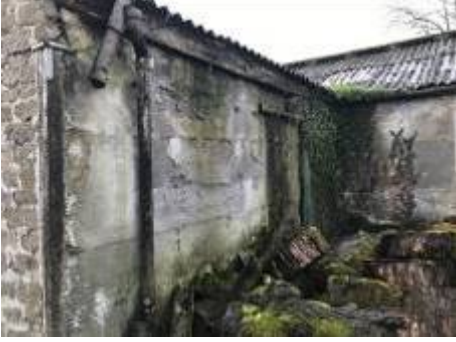
<p>The north wall of the lean-to is in shuttered concrete.</p>	<p>The condition of this wall is very poor and the surface of the concrete has been lost in many places. This concrete wall is linked into the stone wall of the east but it is an unsightly detail.</p>
<p>Entrance area, east wall</p>

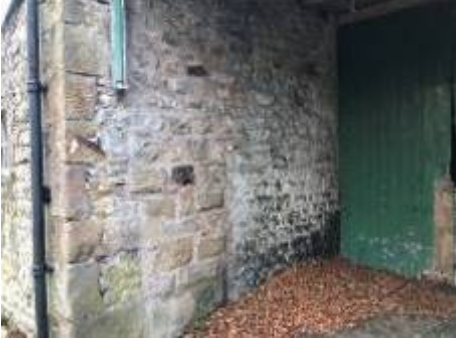
<p>Rubble sandstone walls. A former doorway has been built up in sandstone. The room beyond forms part of the farmhouse accommodation. Several thick layers of limewash remain in the walls here, presumably intact due to the more sheltered location.</p>	<p>In reasonable condition.</p>

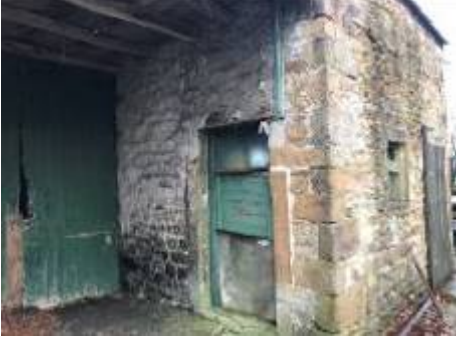
<p>Entrance area, west wall</p>

<p>Rubble sandstone walls. A doorway leads into the stable room. Several thick layers of limewash remain in the walls here, presumably intact due to the more sheltered location.</p>	<p>There is vertical cracking to the left of the door which runs from ground level right up to the underside of the timber soffit.</p>

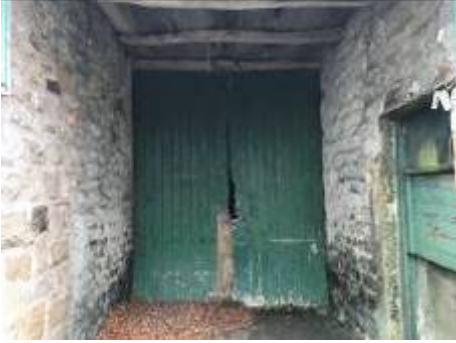
<p>Main barn doors</p>

<p>Timber batten doors held on floor mounted pivot hinges.</p>	<p>The doors are in poor condition with failing decoration and several areas lost to decay.</p>
<p>Personnel door to west of main barn doors</p>

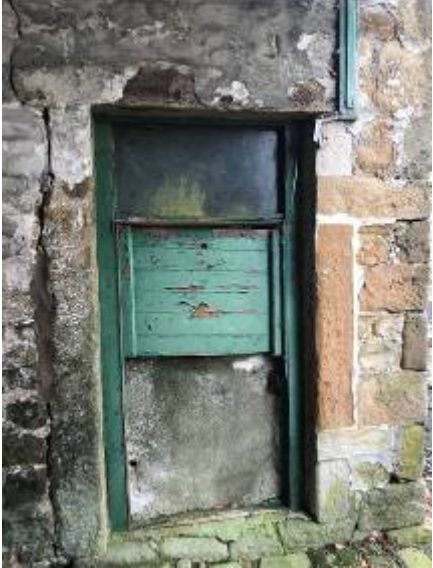
<p>Sandstone surround. Timber frame to opening with a patched-up infill.</p>	<p>Surround and frame in reasonable order.</p>
<p>Window, south elevation</p>

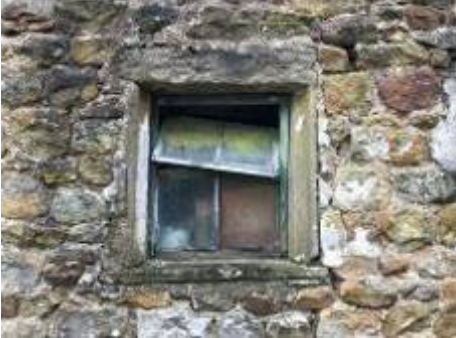
<p>Sandstone surround. The jambs have a convex profile and appear to have been reused from elsewhere. The window is two over two with hinged upper casement.</p>	<p>Sandstone surround in reasonable condition. Timber window is very decayed and the opening casement is loose.</p>

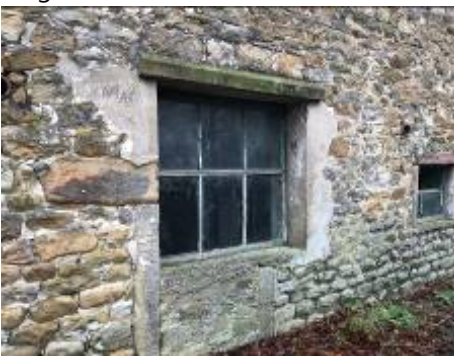
<p>Former door with sandstone surround that has been partially built up and partially enlarged to form window. Where width has been extended to the right the jamb is formed in brickwork which has been rendered in cement. The lintel is sandstone and stands proud of the wall. The sill is concrete. Window is a timber three over three.</p>	<p>Window is in poor condition and decoration is failing. The enlargement of the opening has not been executed well with no proper sill and unsightly jambs.</p>
<p>Small window, east elevation</p>

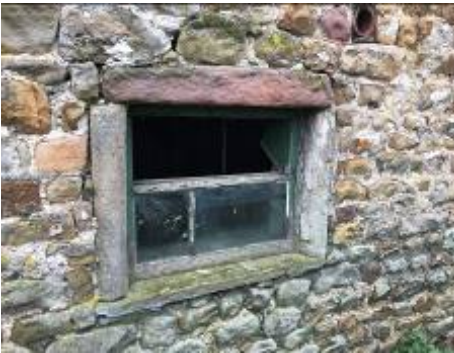
<p>Sandstone surround with timber window with a hinged upper opening casement.</p>	<p>The sandstone sill and right-hand jamb are delaminating and in poor condition. The window is also in poor condition and is missing its opening casement.</p>

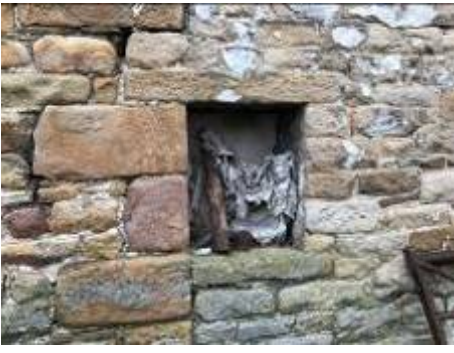
<p>Small window, east lean-to</p>

<p>Window opening with sandstone lintel and sill. There is no window in the opening and it is blocked up on the inside.</p>	<p>Surround in reasonable condition.</p>
<p>Main barn, roof structure</p>	<p>Timber rafters supported off purlins, two to each side, supported off two trusses. All timbers, with the exception of the purlins that extend over cart</p>	<p>Visually the timbers all appear sound. Condition of bearing ends into walls cannot be ascertained from visual ground inspection. Several of the battens are lost or</p>

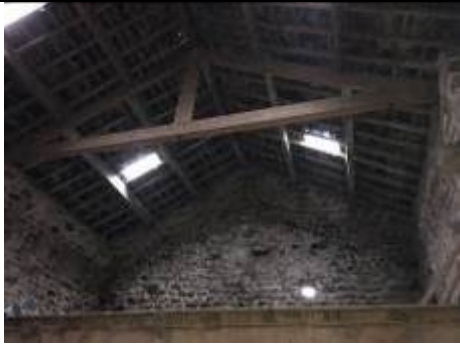
door opening are sawn. Roofing battens are quite large. Roof is not felted.

displaces, likely due to water ingress through the roof covering.

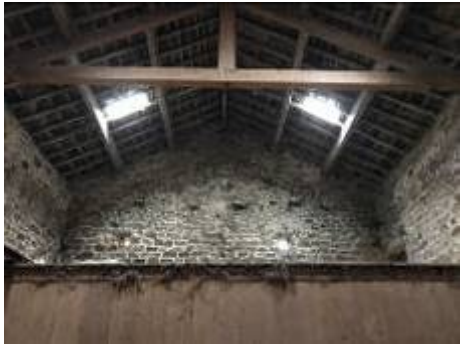
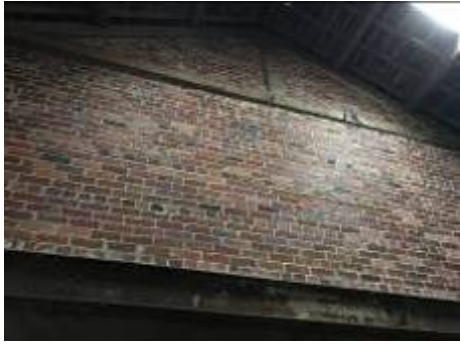
Main barn, walls

Rubble sandstone walls, slobber pointed. Internally it is possible to see where the barn roof has been raised and the walls built up. The most westerly bay of the barn at high level is part of the farmhouse. Here a wall has been formed in engineering bricks built up off a steel beam.

Walls generally appear sound, there are some open joints. The brick wall is also sound but the steel beam it is built up off has surface corrosion.

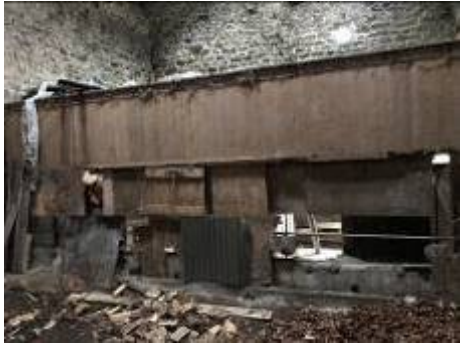
Main barn, partition

Timber partition between main barn space and stable.

The partition is in poor condition and has been significantly altered and adapted. None of the partition appears particularly old or of interest.

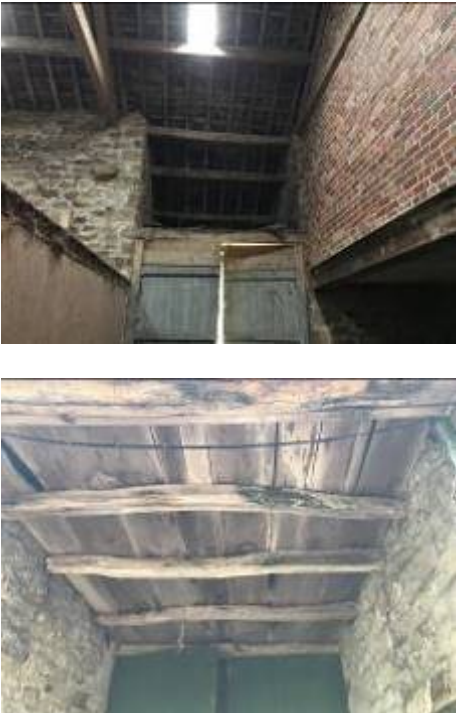
<p>Main barn, loft area over main doors</p>

<p>Riven purlins supported off sandstone walls. Wide timber boards supported of riven beams form the floor.</p>	<p>All in reasonable order. This area appears to contain the oldest timber in the building.</p>
<p>Main barn, floor</p>

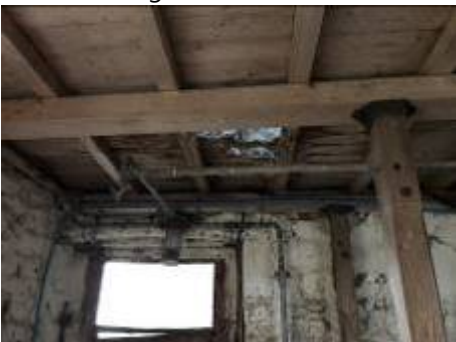
<p>Timber boards on timber joists supported off timber and steel beams. All are sawn timber and modern.</p>	<p>The boards are completely rotten in places and have fallen in. The floor over is covered in hay and this will be holding moisture against the boards, especially in areas where the roof covering is failing. The steel beams supporting the floor over have surface corrosion.</p>

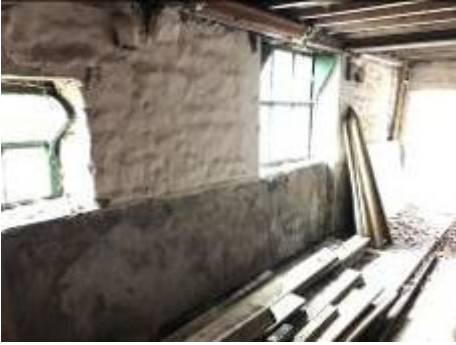
<p>Stable, walls</p>

<p>Walls are slobber pointed and coated in several coats of whitewash. The lower part of the wall to a height of approximately 1m is rendered in a hard cementitious render.</p>	<p>In reasonable condition.</p>
<p>Stable, floor</p>

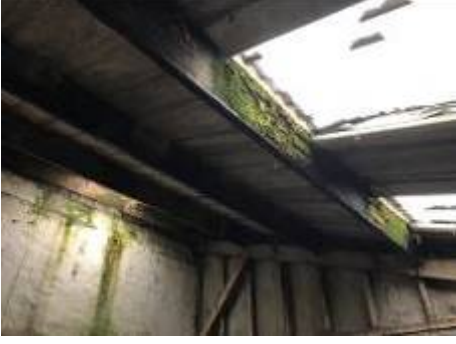
<p>Timber purlins support profiled sheeting.</p>	<p>The roof is in poor condition and badly leaking. Purlins are very wet and have significant vegetation growth.</p>
<p>Lean-to, walls</p>

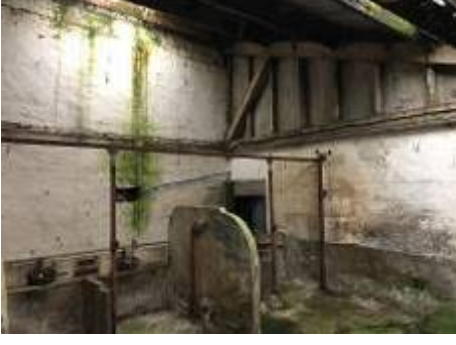
<p>North and west walls are shuttered concrete. East and south walls are sandstone rubble with slobber pointing and whitewash.</p>	<p>All walls are suffering as a result of the water ingress, the concrete walls in particular.</p>

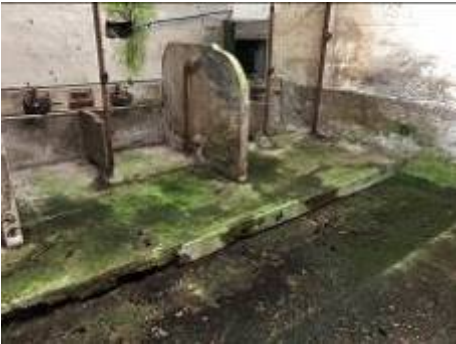
<p>Lean-to, floor</p>

<p>Concrete floor. The floor level here steps up from the main barn.</p>	<p>Floor is very wet and slippery as a result of water ingress from failing roof coverings.</p>
<p>Covered entrance area, floor</p>

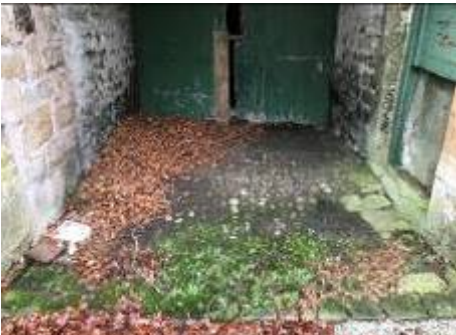
<p>Cobbled setts form ground covering into barn.</p>	<p>Cobble setts are uneven in places but the ground covering is largely intact and an attractive historical feature.</p>
<p>South yard</p>

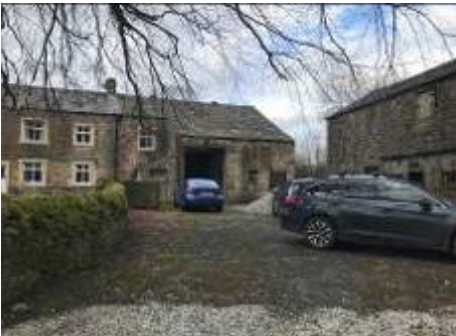
<p>Tarmac yard with some older cobbles to the north of barn A.</p>	<p>Tarmac is well worn and broken up in places. Cobbles are attractive and it may be more are hidden below later layers of hardstanding.</p>
<p>East yard</p>

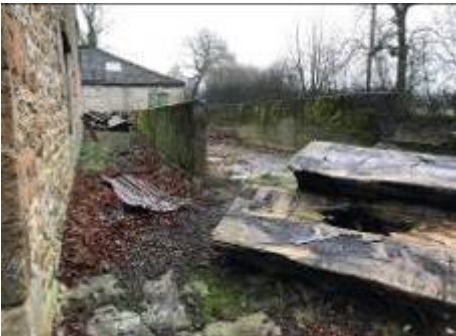
<p>Largely concreted area with concrete structures.</p>	<p>Untidy and unsightly. No longer in working use.</p>
<p>North Yard</p>	<p>Concreted area, covered in timber logs.</p>	<p>No comment.</p>

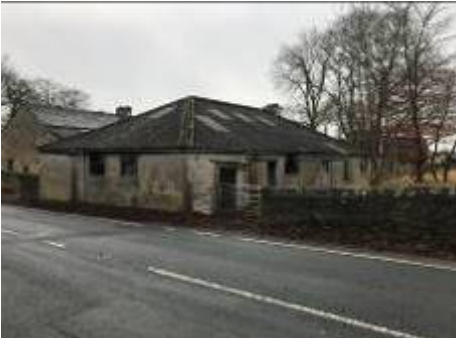
<p>Barn C</p>

<p>Barn C is a modern concrete construction with profiled sheet roofing (likely containing asbestos).</p>	<p>The building is dilapidated and in very poor condition. There is significant water ingress through the roof and in places the building is unsafe. There is also a potential health and safety hazard as the roof covering may contain asbestos and it is deteriorating).</p>
