**STRUCTURAL REPORT  
BARN 1  
TEEWOOD FARM  
WADDINGTON**

Our ref: K35392/DH/SF

March 2019

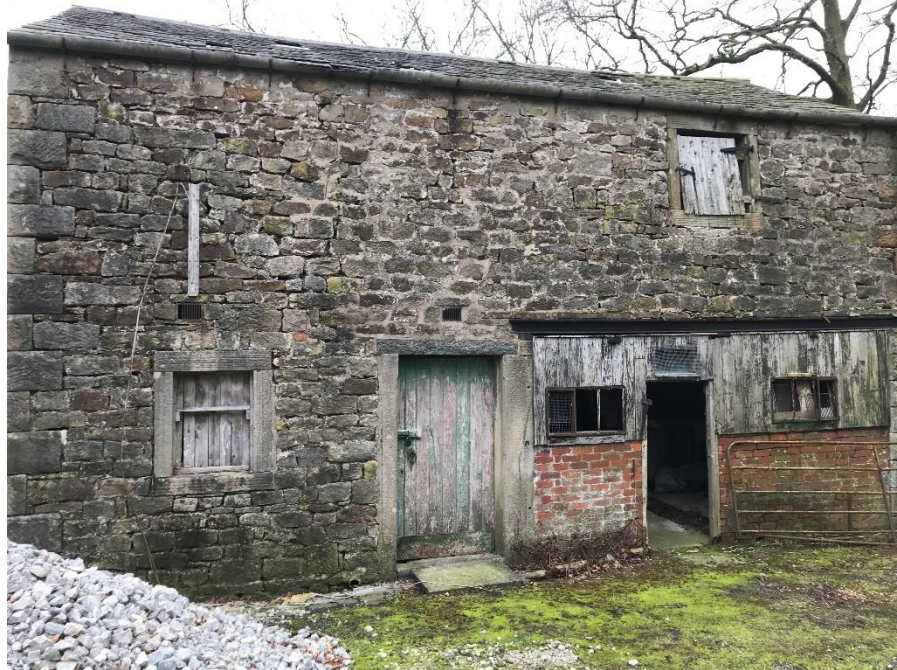
**1) Front elevation**

- 2.2 The west (front) elevation has at ground floor level, a brick and timber infill panel on its north side, with a shallow steel beam over. This has deflected somewhat.

The masonry above the personell door and the ground floor window is open jointed in places but the wall panel itself is reasonably straight

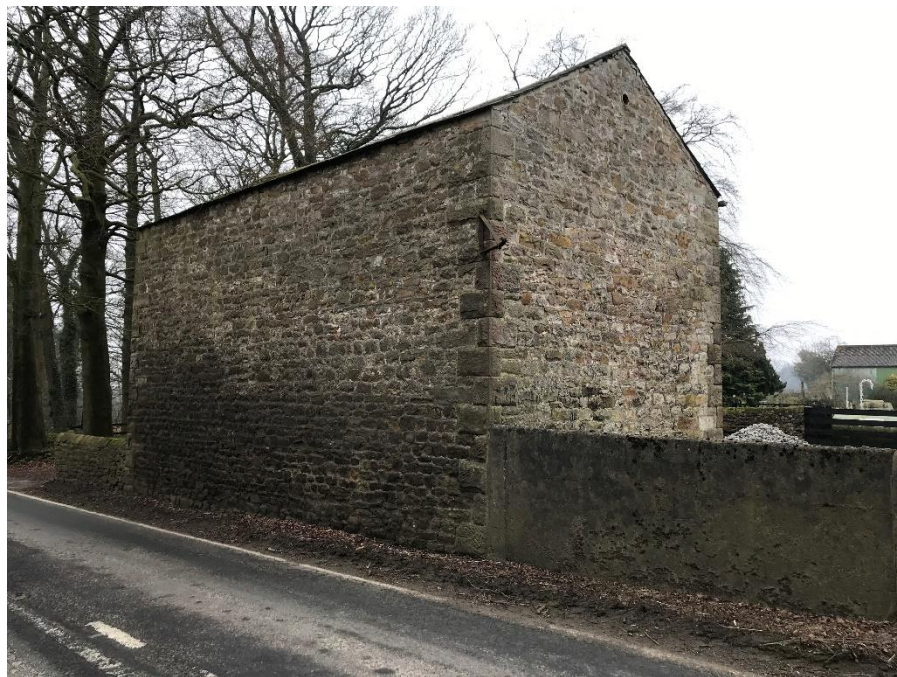
**2) North and east elevations**

2.5 The north gable elevation has no openings within it. The wall panel is straight with well formed corners. A crack extends from ground level upwards for about 1.5m. It is vertical in orientation and approximately 10 – 15mm in width.

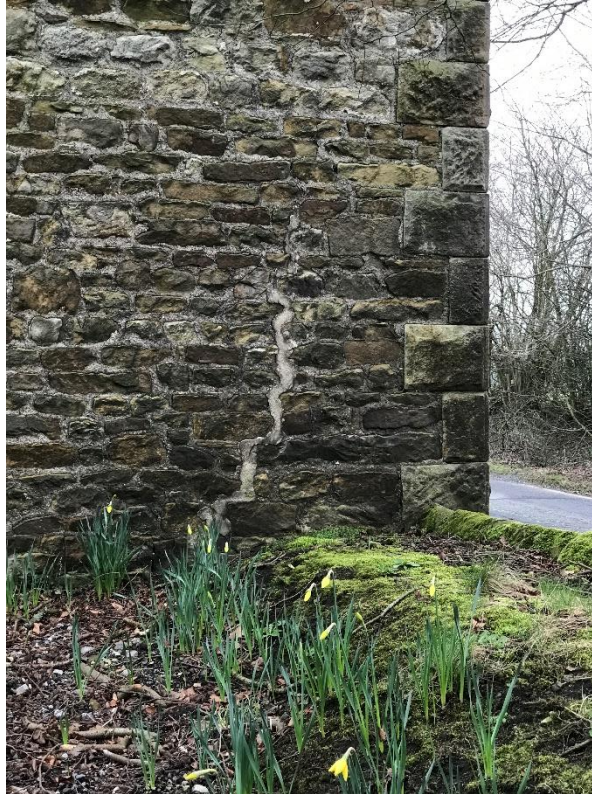
- 2.3 The south gable elevation is a stone panel with no openings within it. There are vertical cracks adjacent to the west corner, extending from ground level to the roof verge. The maximum width of these is estimated at 20 – 30mm from ground level. It very much looks like these cracks have been previously repaired and re-opened. On the corner adjacent to Slaidburn Road there is a crack extending from ground level vertically upwards. It has previously been re-pointed and has not significantly re-opened. There is a rainwater down pipe on the corner of the building which discharges onto the ground. Apart from the cracking, the wall panel is reasonably straight.
- 2.4 The east elevation is immediately adjacent to Slaidburn Road and sits approximately 1m behind the channel line. The wall panel has no openings, is straight and generally intact.

**3) Previous crack on south gable, road side**

- Rake out and re-point the existing walls.
- Investigate by trial holes, the state of the foundation to the south west corner where the cracking has occurred. Depending on findings the corner may need to be re-built as part of the conversion.

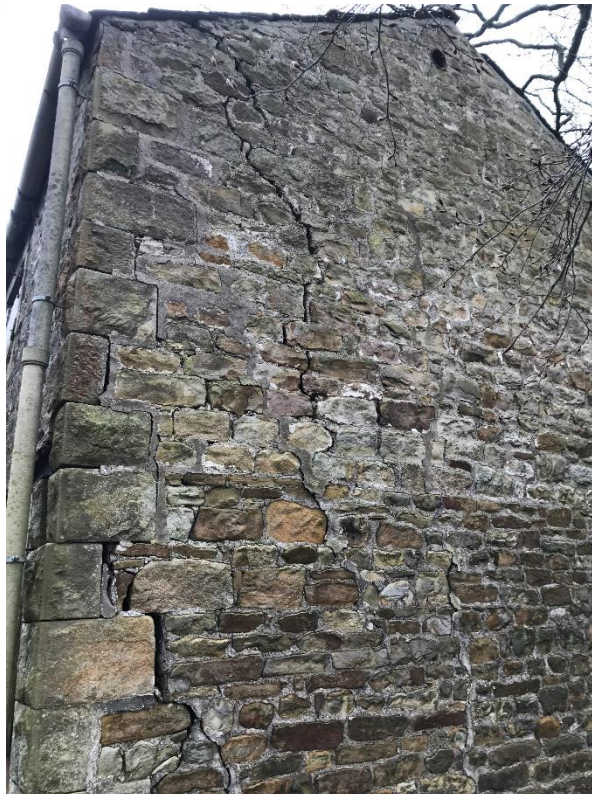
4.1 The stone walls forming the barn are generally in reasonably good condition, the exception being the south gable wall which exhibits cracking. It is likely that this is as a result of outward movement of the front elevation, which is supported by beams together with a little settlement. The rainwater pipe discharging onto the ground may have weakened the ground in this respect.

**4) Cracking to south gable**

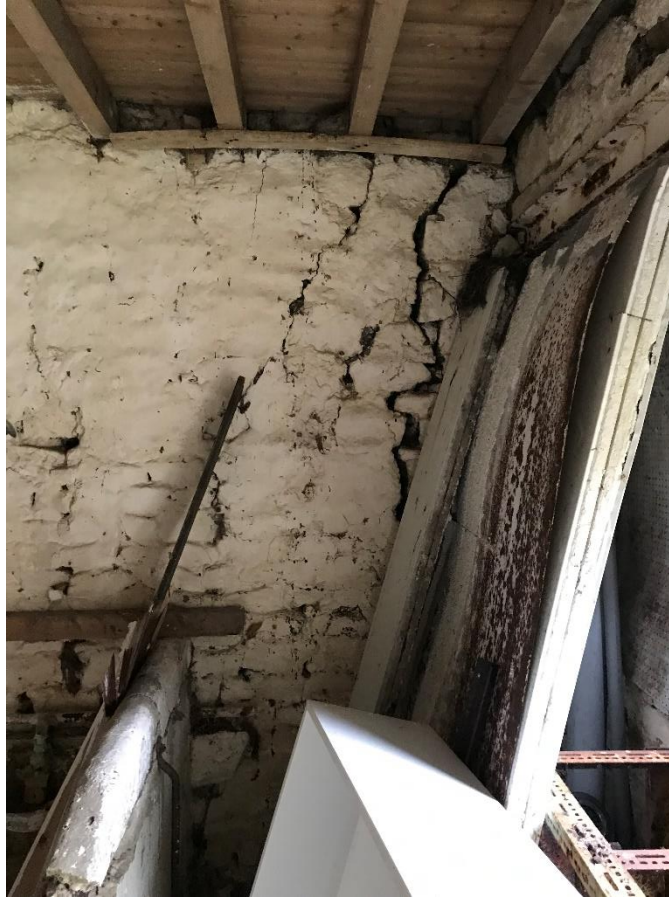
Within the barn at the southern end, cracking is visible through the south gable, where the front elevation infill panel appears to be pulling away. Similar vertical cracking is evident where the beams supporting the front wall over the infill panel are bearing into the brick cross wall.

**5) Cracking to south gable internally**
