STRUCTURAL REPORT
BARN 2
TEEWOOD FARM
WADDINGTON

Our ref: K35392/DH/SF

March 2019

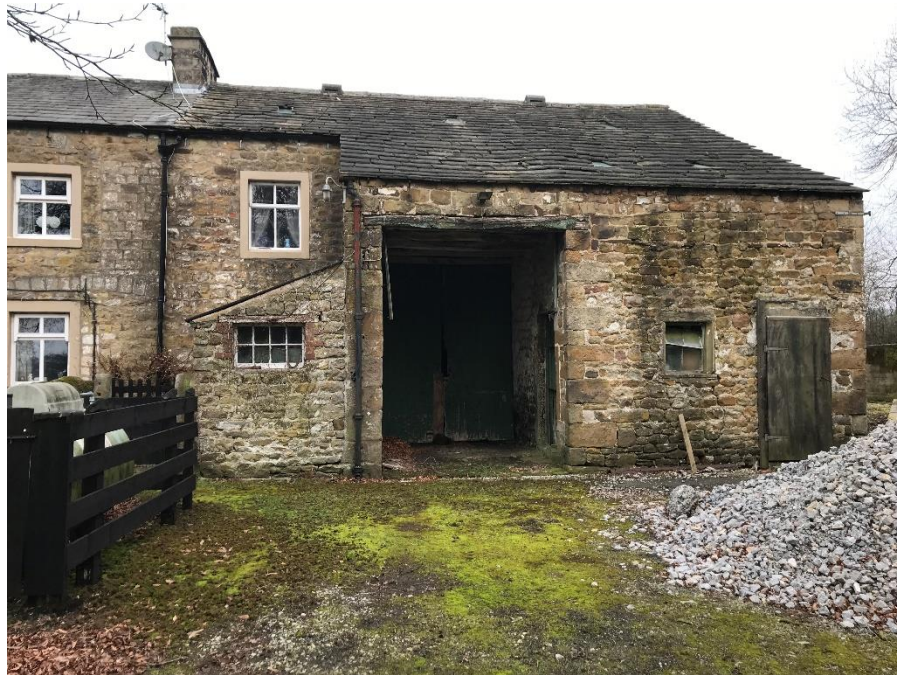
- 2.2 The front (South) elevation has a large barn door opening within it. The wall panel is reasonably straight apart from a slight outward bulge over the single window opening. The lean-to section to the west of the main elevation is open jointed in places.

1) Front elevation

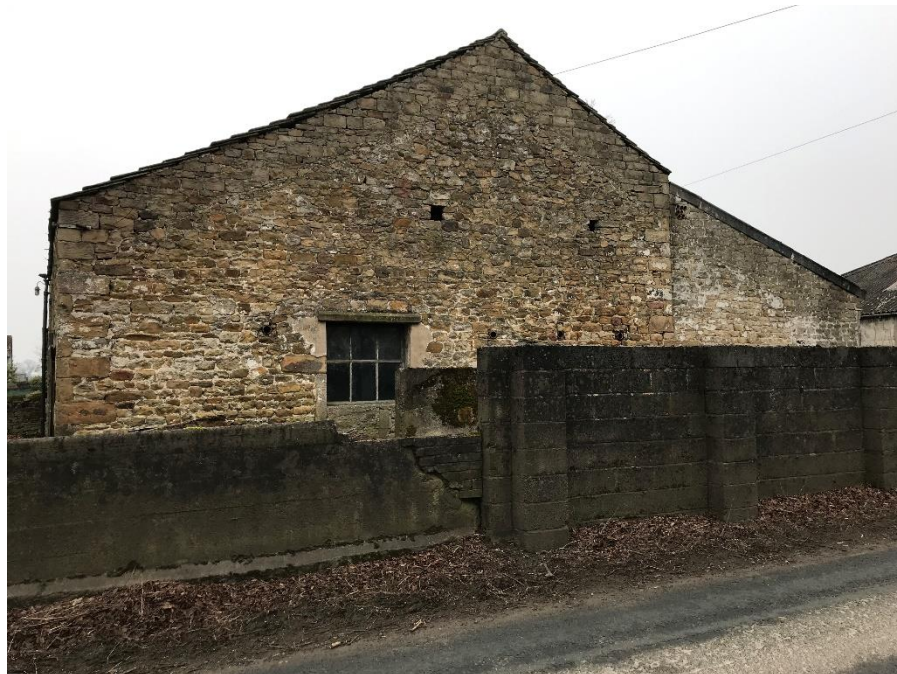
- 2.3 The east elevation is a gable elevation to which has been added a single storey lean-to extension. The stone gable wall is straight and true. The lean-to is also straight but a section of wall towards the rear looks to have been re-built at some point.

2) East gable elevation

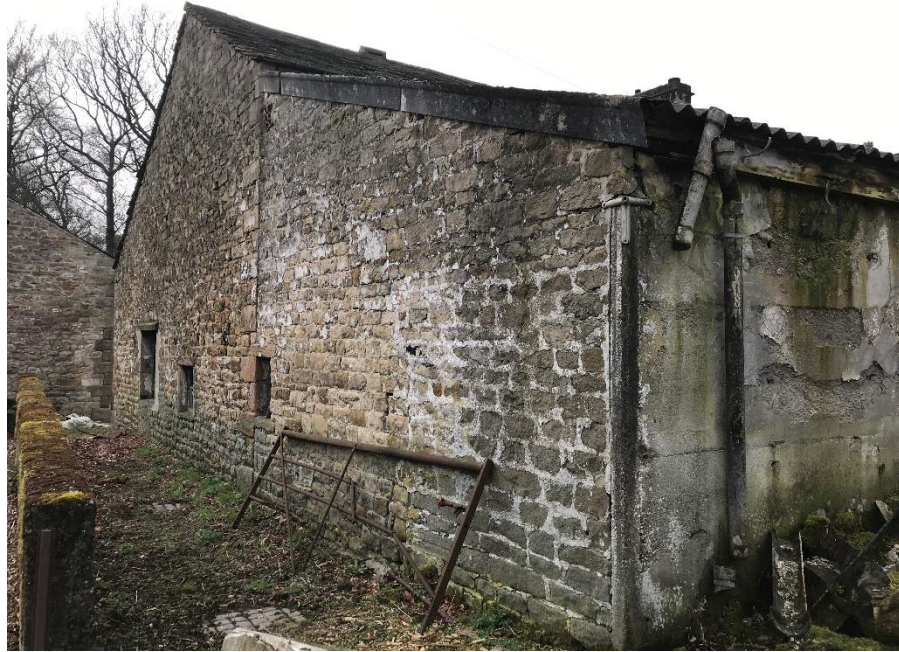
3) East gable and "lean-to" elevations

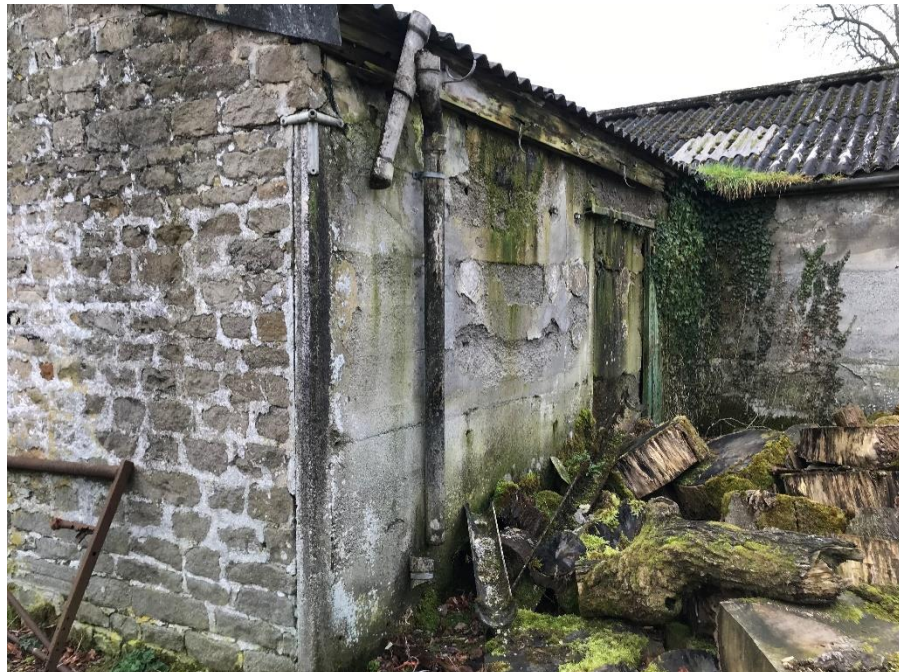
- 2.4 The rear elevation of the lean-to is in a rather dilapidated state and appears to be constructed from concrete panels.

4.1 In general terms the stone walls forming the fabric of the building are in reasonably good condition apart from the rear wall of the lean-to which is shown to be removed as part of the conversion.

4) North elevation of "lean-to"

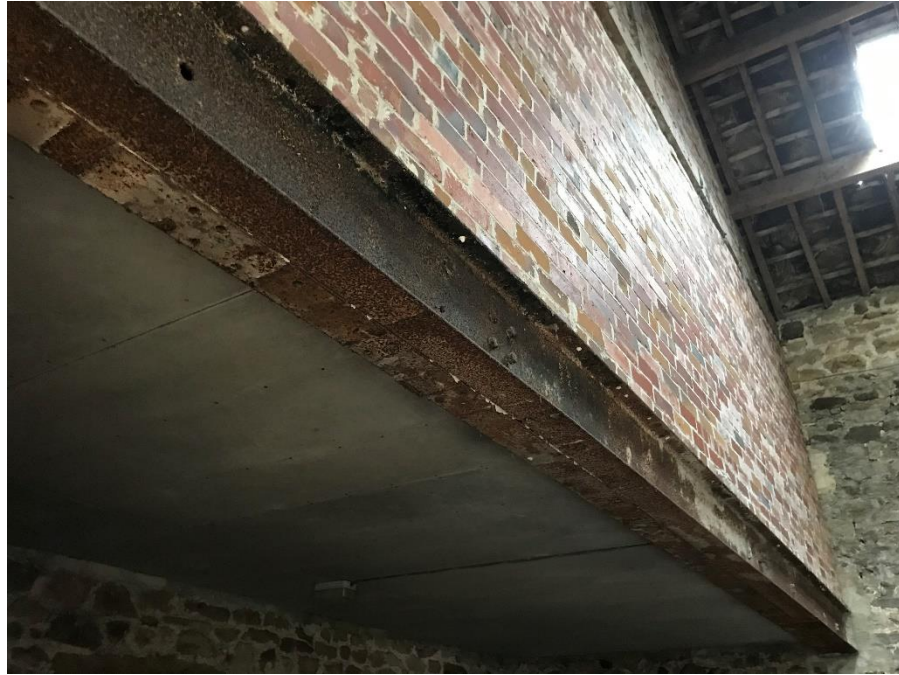
- 3.1 Within the main body of the barn it is immediately apparent that the first floor of the adjoining farmhouse has been built into the barn. A pair of steel beams span between the front and rear of the barn. These support precast concrete plank type units which form the first floor of the farmhouse together with a 225mm (at least) thick brick wall which forms the party wall. Immediately above this wall is one of the original timber trusses supporting the roof structure.

The supporting beams are rusty.

5) Beams spanning across barn supporting party wall and P C planks

4.2 The beams supporting the first floor and party wall to the farmhouse will require mechanical cleaning and the application of a suitable protective paint system. As these are a pair of beams placed side by side, there is no access to the internal areas between the beams, which will not be able to be treated.

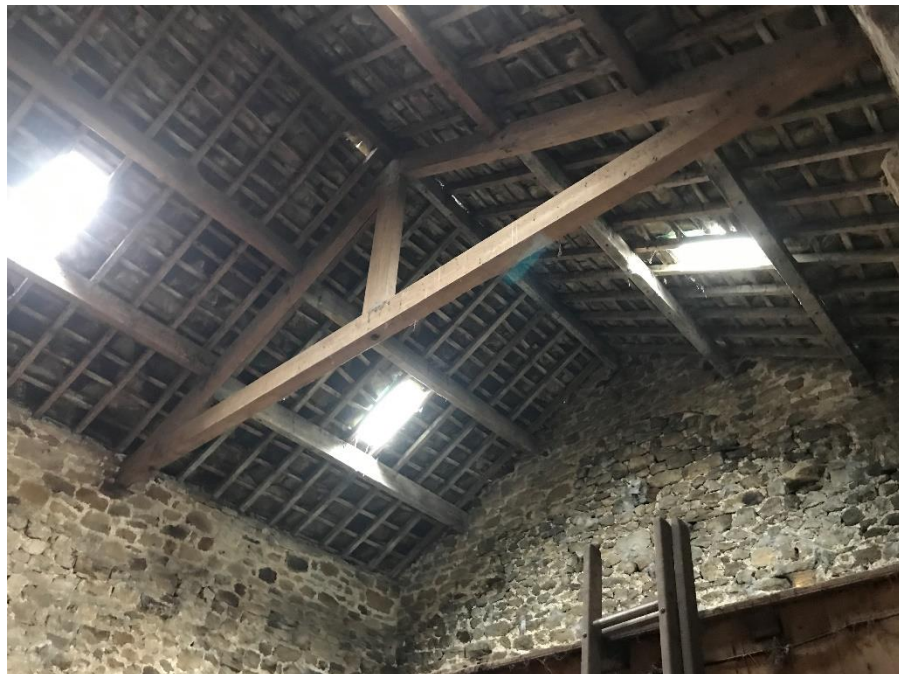
3.3 The original roof structure consists of timber purlins supported on king post timber trusses (without internal struts).

The visible truss looks to be in good condition.

6) General roof construction

4.3 The existing roof truss may be able to be re-used as part of the conversion but may need some minor modifications.

It is possible, subject to assessment, that the purlins may also be able to be re-used.
