Statement of Significance And Condition Report

Betty Barn
Slaidburn Road
Waddington

For Mr Michael and Dr George Fisher
December 2018

Ref. 18102/HS
Rev A 07/02/19

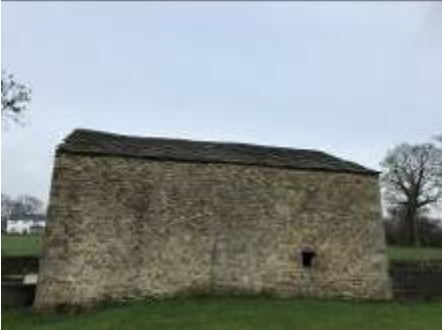
Element	Construction	Condition
<p>Roof, south pitch</p>

<p>Sandstone tiles and sandstone ridge. Three glazed panes of glass built into roof act as rooflights. Internally the roof is partially torched. At verge metal brackets are present to help mitigate wind lift.</p>	<p>There is significant undulation across the plane of the roof which suggests issues with the roof structure. Several sandstone tiles are loose and dislodged. At the west verge there are several tiles missing.</p>
<p>Roof, north pitch</p>	<p>Sandstone tiles and sandstone ridge. Internally the roof is partially torched. At verge metal brackets are present to help mitigate wind lift.</p>	<p>It was not possible to see this roof from ground level but from inside the condition is much the same as the south side.</p>
<p>Walls, south</p>

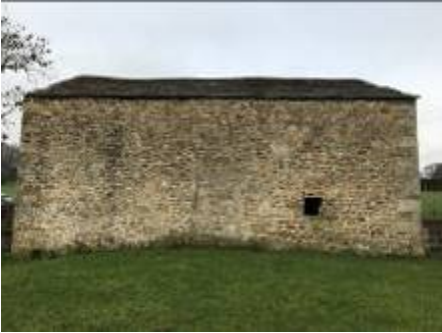
<p>Sandstone rubble walls with dressed quoins. Walls are pointed in a hard mortar. A former doorway is built up and to the left of this is a former slit vent, also blocked up. On the right there is a small opening in the wall. This was perhaps formerly a slit vent which has been enlarged.</p>	<p>Walls in plumb and in reasonable order. There is slight movement at the base of the south east corner of the wall. Pointing mortar has alveolar weathering and there are open joints across the wall. The sandstone jamb to the built up doorway is cracked on the left hand side.</p>

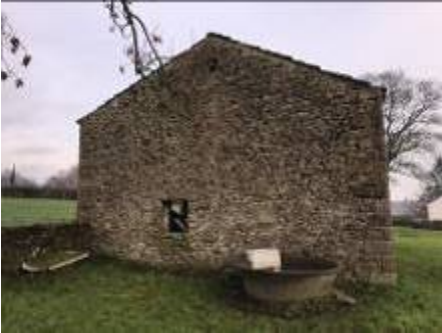
<p>Walls, west</p>

<p>Sandstone rubble walls with dressed quoins. Walls are pointed in a hard mortar. There are two openings, one has been blocked up and both appear later additions. Neither have proper lintels or formed jambs.</p>	<p>Wall is plumb with no obvious signs of movement. Joints are more open here than the south elevation.</p>

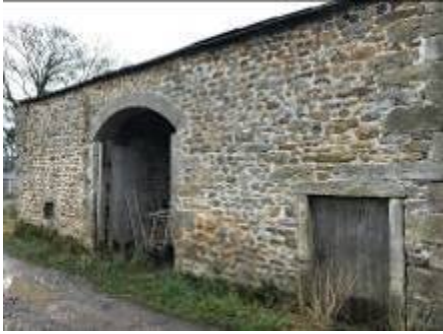
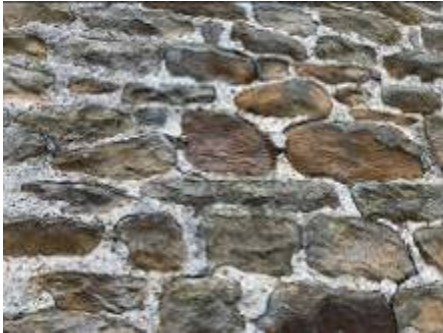
Walls, north

Sandstone rubble walls with dressed quoins. Walls are pointed in a hard mortar and evidence of a softer build mortar is visible below. There is a large cart doorway with dressed jambs and voussoir stones. A smaller personnel door and window have dressed sandstone surrounds. To the right of the cart door is a slit vent that has been blocked up.

Wall is plum. At the north east corner there is evidence of some structural movement. There is also evidence of structural movement over the cart door on the right hand side which correlates with movement internally around the end of the truss tie. Lack of rainwater goods may be part of the cause, see later comment. The mortar on this elevation is more intact than others, it is however much too hard and is causing accelerated decay to the stone. There is grass growing from the joints in the stone at low level, particularly towards the east end.

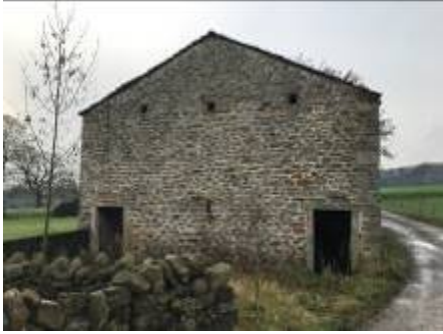
Walls, east

Sandstone rubble walls with dressed quoins. Walls are pointed in a hard mortar and evidence of a softer build mortar is visible below. There are two doorways into the stable / shippon dressed jambs and lintels. Central to the two doors is a slit vent. At high level there are three additional vents into the hayloft.

Wall is plum. The mortar on this elevation is in reasonable condition, it is however much too hard and is causing accelerated decay to the stone. There is damage to the sandstone jambs of both doorways due to corroded iron fixings, see later comments.

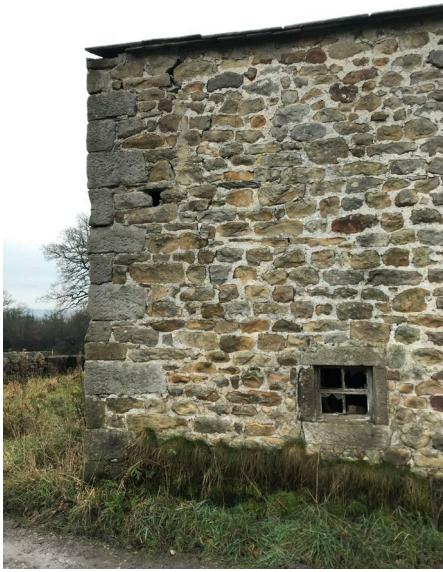
Rainwater goods

There are no rainwater goods on any part of the building.

Lack of rainwater goods will be resulting in water running down face of walls, washing out joints and core and destabilising walls. It will also be leading to the pooling of water at the base of the walls which could be a contributing factor to the structural movement at the base of the south east corner wall. Concentration of pooling water at the base of walls will also be exacerbating the problem of vegetation growth.

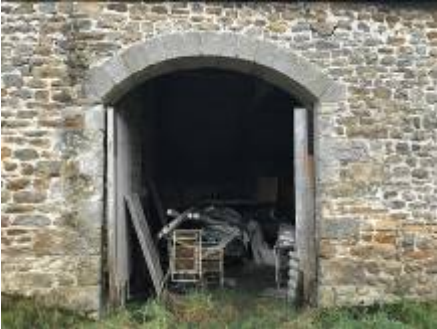
<p>Cart door, north elevation</p>

<p>Doors are timber, on hinges but no frame.</p>	<p>Doors are in very poor condition and no longer functioning having come off their hinges. At the base the doors are severely decayed.</p>
<p>Personnel door, north elevation</p>	<p>Door is timber and chained shut.</p>	<p>Again door is in very poor condition and very decayed at base.</p>
<p>Personnel door, east elevation, south</p>

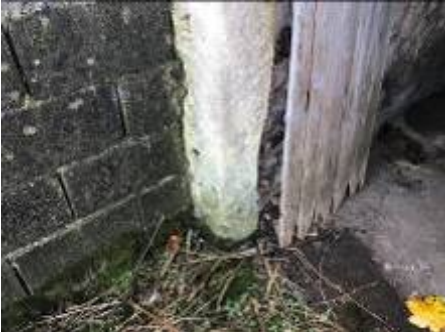
<p>Door is timber and hung on hinges fixed to metal brackets embedded in stone surround.</p>	<p>Door is no longer hung or functioning. The base of the door is very decayed. The stone jambs on both sides of the doorway are fractured where the embedded iron has corroded.</p>
<p>Personnel door, east elevation, north</p>

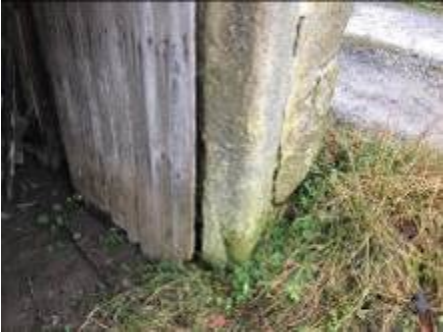
<p>Door is timber and hung on hinges fixed to metal brackets embedded in stone surround.</p>	<p>The base of the door is very decayed. The stone jambs on both sides of the doorway are fractured where the embedded iron has corroded.</p>

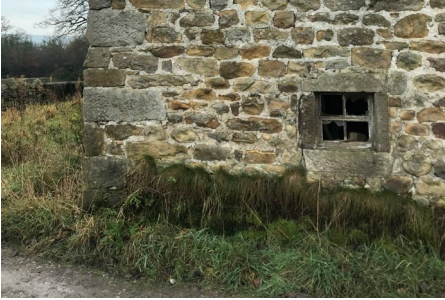
<p>Window, north elevation</p>

<p>Timber window with opening light.</p>	<p>Window is in very poor condition. The glass is all broken and almost all missing. Decoration is almost completely gone and as a result the timber is decaying.</p>

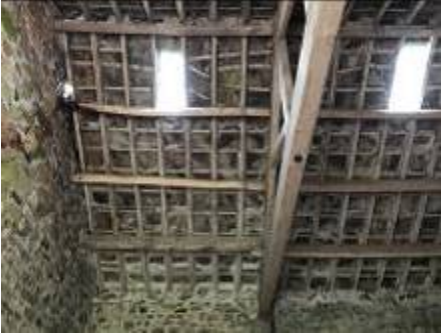
Roof structure, over main space

The underside of the sandstone tiles is visible and these are hung off timber battens. The underside is torched in places. Three intermediate purlins to each pitch and a rooflight centrally over each bay. Almost all of the purlins and the truss are machine cut timber. Four purlins in the central bay (upper two on each side) are riven and partnered to the machine cut timbers. This partnering does not however occur over the truss which is odd. The truss has a strut on both sides, but they are different.

There are signs of significant water ingress. The underside of the slabs are covered in algae and a significant number of battens are completely rotten. Torching has also been lost almost wholly across the roof. Decay is present in the roof members, the purling in the photo, closest to the ridge is completely decayed at its east end and is barely holding on.

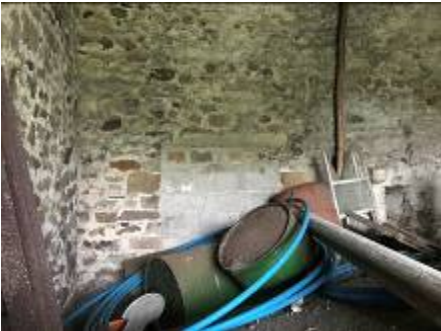
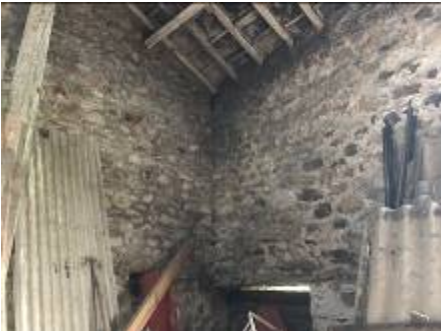
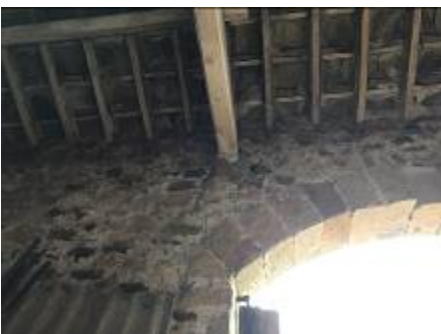
Walls, main barn space

The barn is completely full with storage. Walls internally are random rubble with slobber pointing. The doorway in the south wall is built up in breezeblocks.

At the north west and south west corners there is cracking visible at high level. movement is also visible on the north wall at the bearing point of the truss.

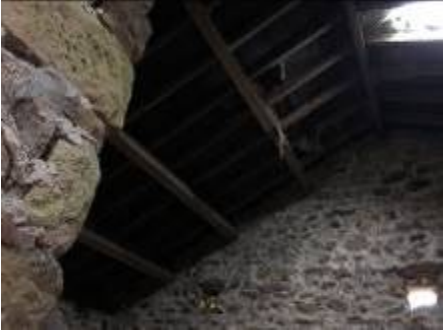
<p>This section of the roof is felted. Roof timbers are all machine cut. There is a rooflight centrally over the space.</p>	<p>This part of the roof has clearly been more recently re-roofed. The felt is badly torn in many places.</p>
<p>Walls, hayloft</p>

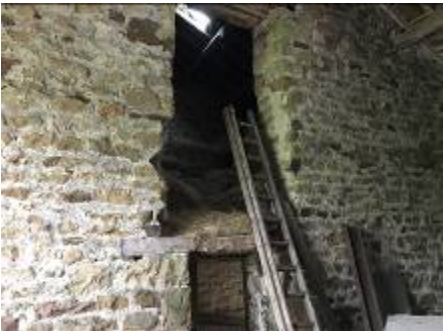
<p>Walls internally are random rubble with slobber pointing. Access into the space is via a high-level opening.</p>	<p>There is some minor cracking visible to the walls. The jamb of the opening through into the hayloft is damaged on its north side. The lintel of this opening on the south side is completely rotten as a result of water ingress above. The lintel of the opening below that also forms the cill of the opening into the hayloft is quite wormy.</p>

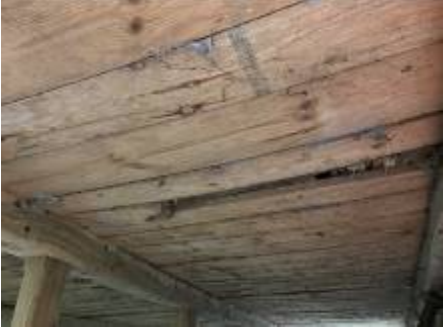
<p>Rough sawn wide timber boards supported off timber beams.</p>	<p>The boards are sagging in places indicating they are spanning too far. The boards are completely rotten in places, likely as a result of the hay above holding water against the boards. There is evidence of woodworm and presence of frass indicates this may be active.</p>
