R. G. PARKINS & PARTNERS LTD
CONSULTING CIVIL & STRUCTURAL ENGINEERS

**REPORT ON 'BETTY BARN'
WADDINGTON**

Our ref: K35392/DH/AG

March 2019

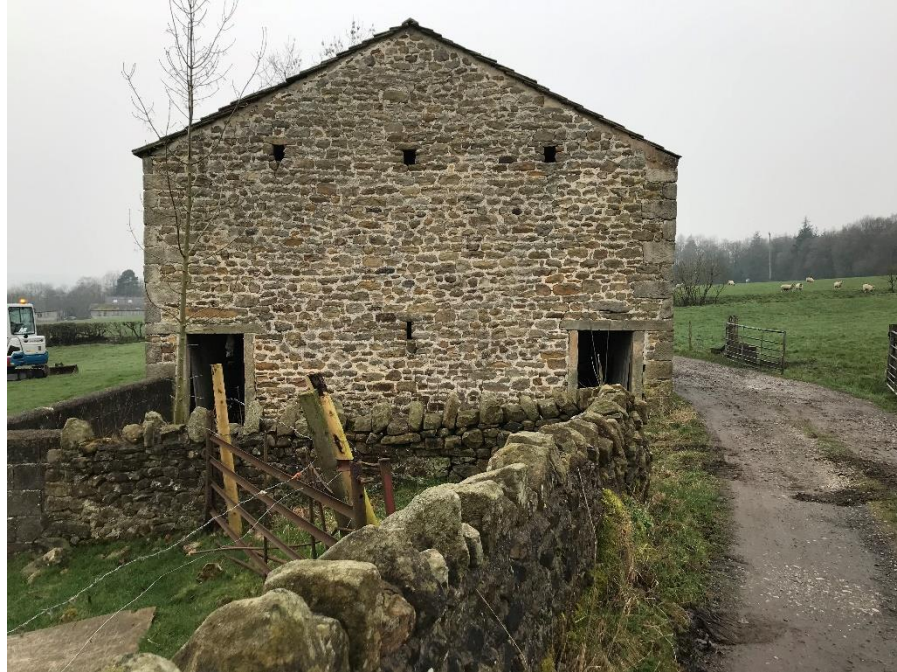
1) East elevation

- 2.5 The east gable wall is reasonably straight with well formed corners. There are two openings at ground level adjacent to each corner, the heads of which are reasonably level. The stonework and pointing are in reasonably good condition.

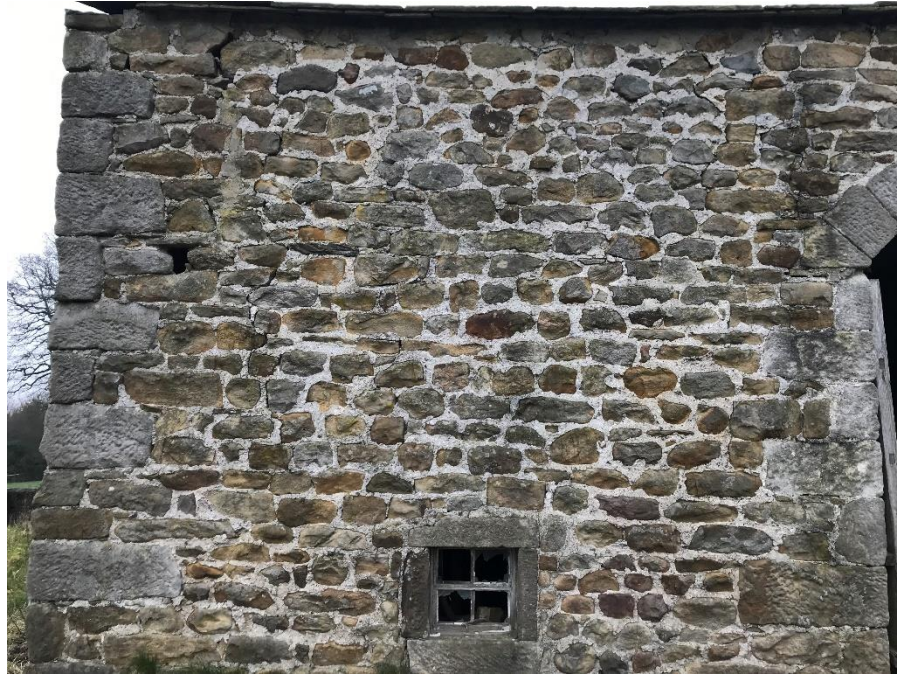
In general, the wall panel, pointing and corners are in good condition, although there is a slight discontinuity adjacent to the east corner.

3) Some open joints and discontinuity to adjacent corner

- 4.1 Our overall view of the barn is that the structure is in good condition for its age. It is unlikely that any of the walls will require taking down and rebuilding, apart from where new openings are proposed.
- 4.2 As with any conversion, discontinuities in the stonework should be re-pointed and stitched if necessary, to knit the fabric together.

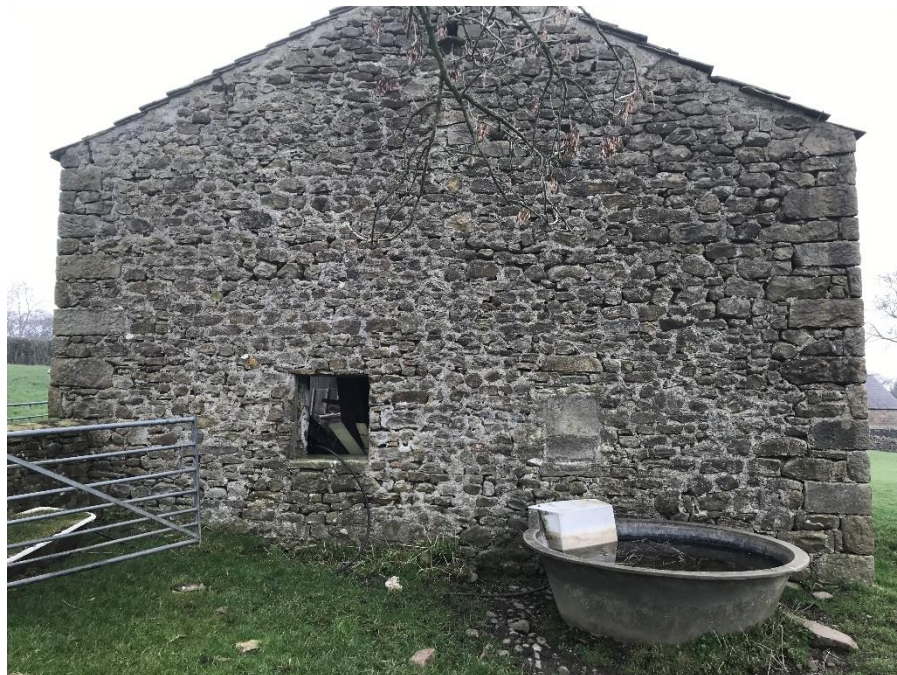
4) West elevation

- 2.6 The west gable wall is generally straight with well formed corners. There is one window opening at ground floor level. An adjacent opening has been blocked up. The masonry towards the south corner, particularly at the top right hand corner, is more open jointed and missing pointing than the rest of the panel.
- 2.7 The south elevation is straight, plumb and in good condition. A previous door opening in the centre of the panel at ground floor level has been infilled.
- 2.8 The roof, which is clad in heavy stone slabs, is undulating on both pitches.

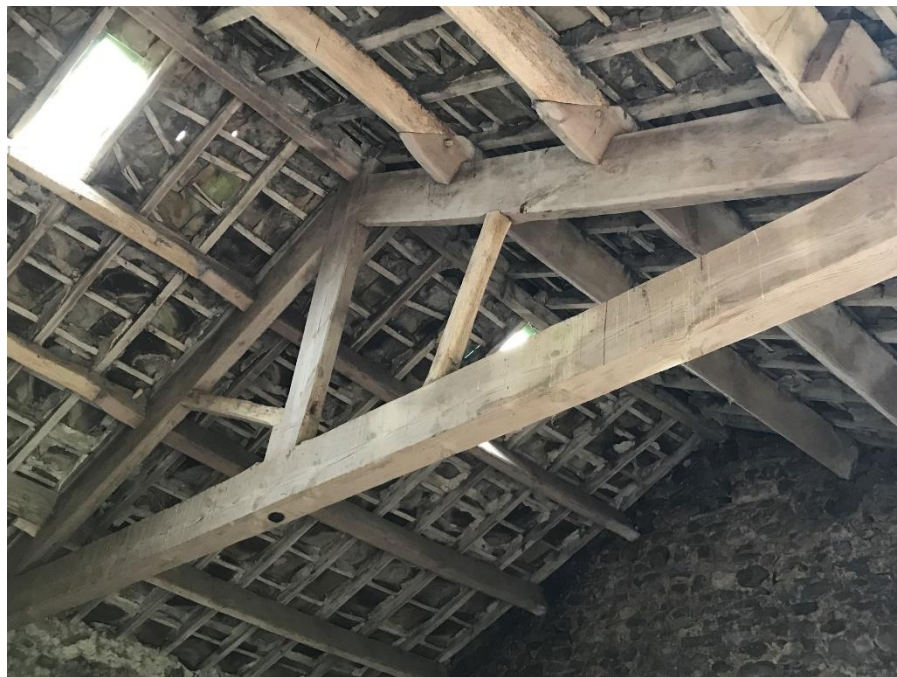
6) Timber roof truss

Due to the weight of the roof slabs the purlins have deflected. The truss looks to be in good condition although one of the internal struts is dislodged.

4.3 It is unlikely that the purlins and rafters will be able to be re-used as part of the conversion. The truss however does look to be in good condition and of adequate proportion to be included as part of the works. The internal strut will require repair/replacement.
