## **Daniels Farm, Alston – Agricultural Building**

### **Structural Condition Survey for Conversion to Dwelling – Barn No. 2**

PSC-357-001- Barn 2

November 2019

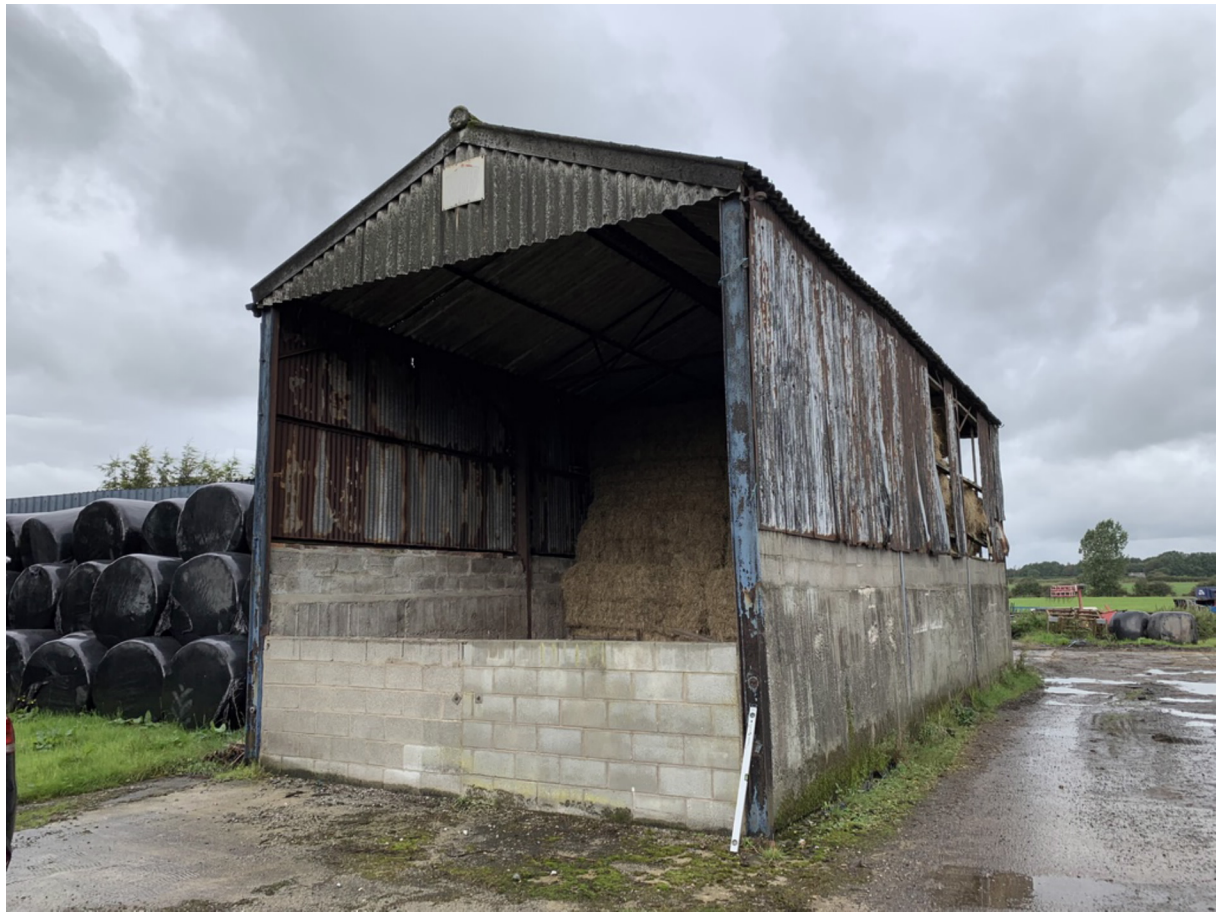
This gable is mainly open as can be seen from the photos. The lower section has blockwork infill and the apex above the eaves has cement sheet cladding. The blockwork infill is plumb and in reasonable condition. The cladding above is in reasonable condition. The steel columns

to this elevation are approximately 160x100 UB sections and are in reasonable condition. They are plumb and although they have paint loss and surface rust, they have not suffered any loss of section.

Photo 1 - South Gable

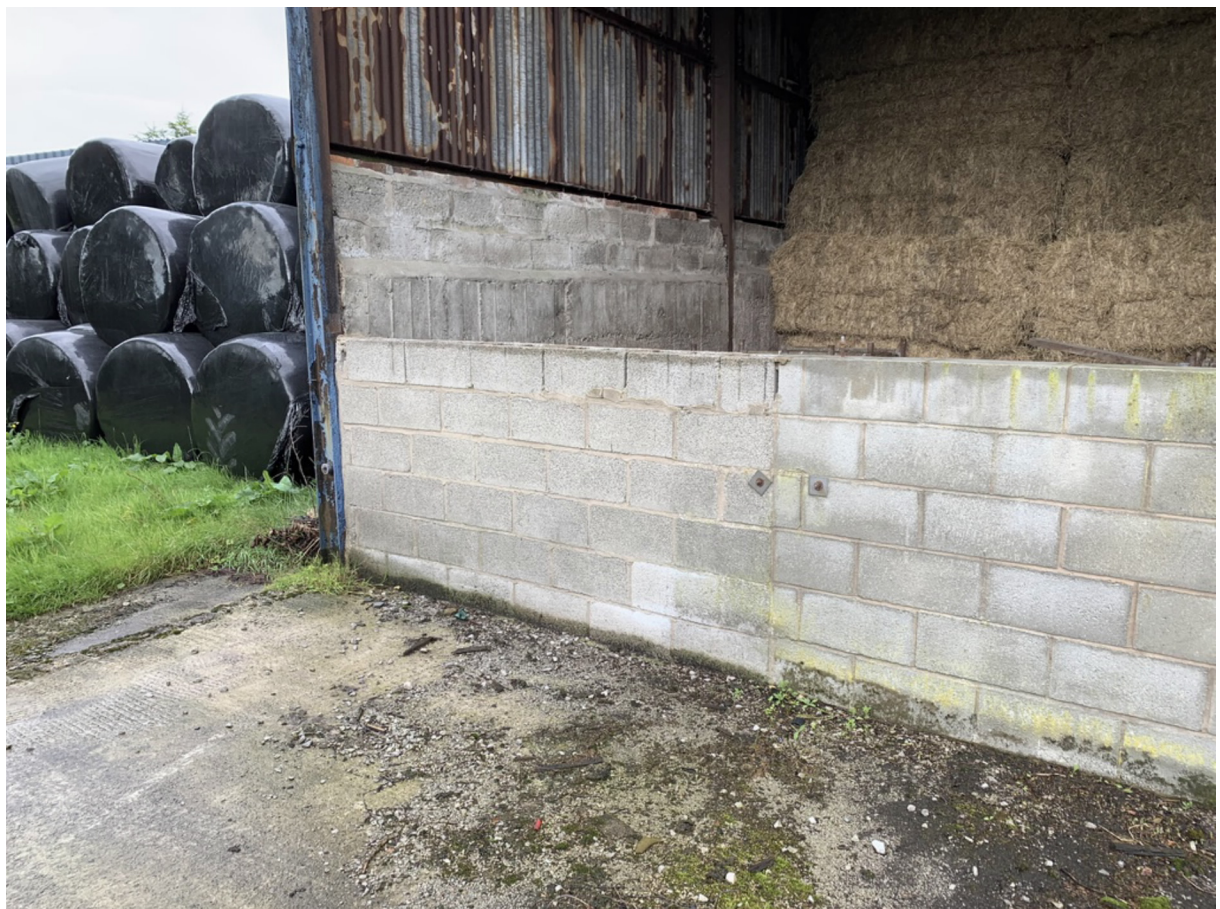
Photo 2 – South Gable - blockwork

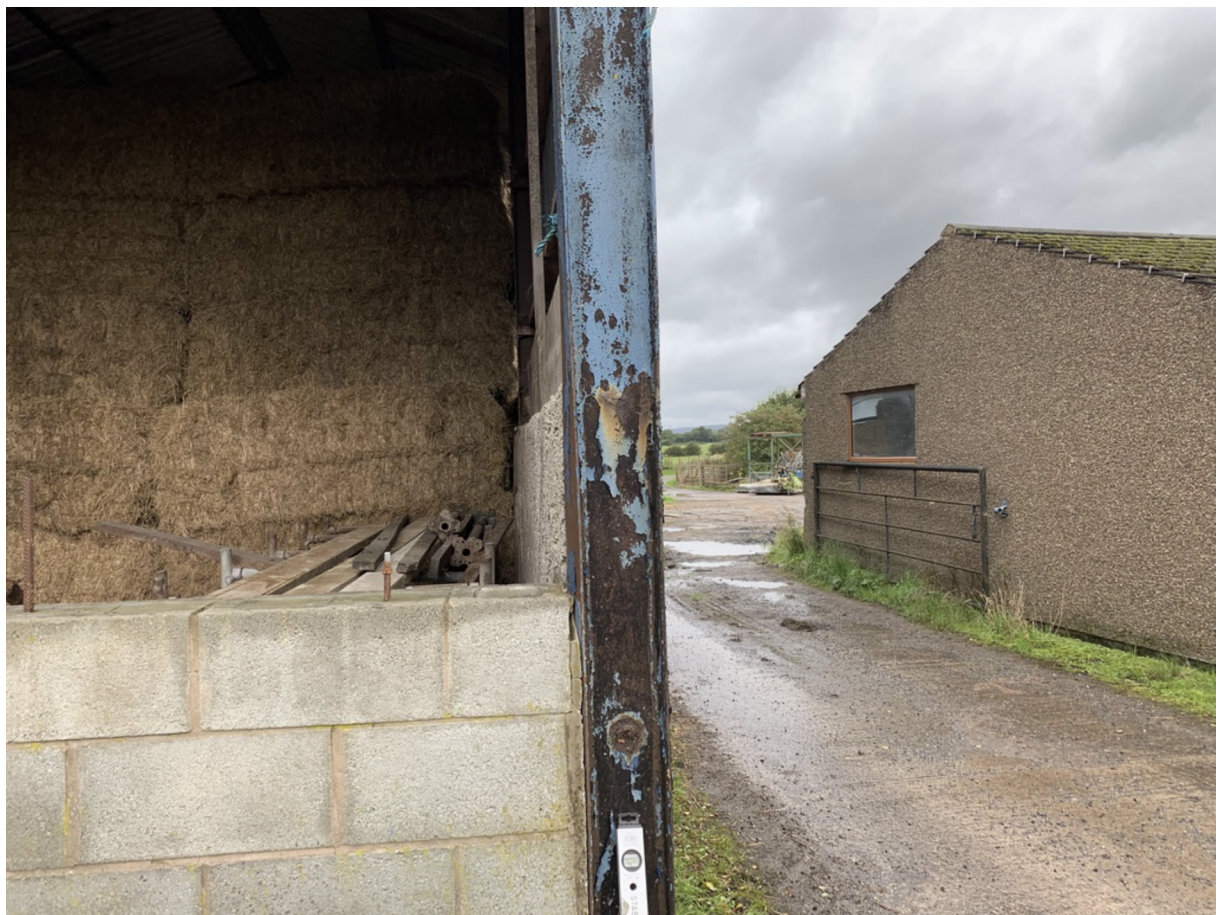
Photo 3- South Gable – Corner Column

The existing steelwork (columns and trusses) will need to be thoroughly cleaned, removing all rust and then given a protective coating. Loading should not be added to the existing structure and conversion actually gives the opportunity to remove loading from the existing frame and place it on new structural walls. This is the recommended option given the lightweight nature of the existing trusses. Care must be taken in supporting the existing frame if existing wall panels between columns are removed and replaced.

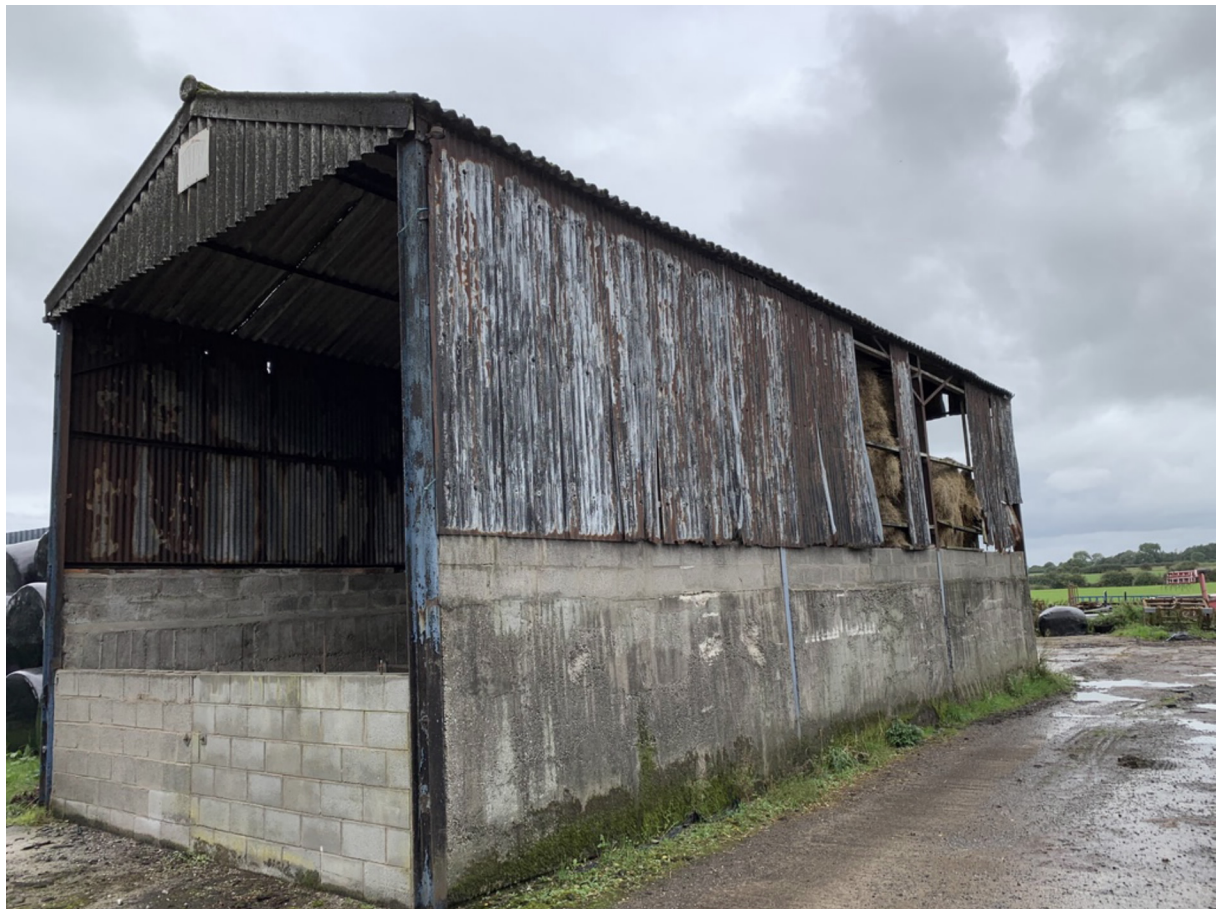
This elevation has a lower concrete wall (160mm thick) with two courses of 100mm blockwork above, with corrugated steel cladding above. The gables have steel columns at each corner and there are two intermediate columns along the elevation. The columns are as noted above for the south gable in terms of size and condition. The concrete wall is plumb and in serviceable condition with no sign of movement. The concrete is however of a rough finish, with some damage where fixings have been made or impact has occurred (photos 5 & 6). The steel cladding is in poor condition with sections missing (photos 4 & 7).

Photo 4 – East Elevation

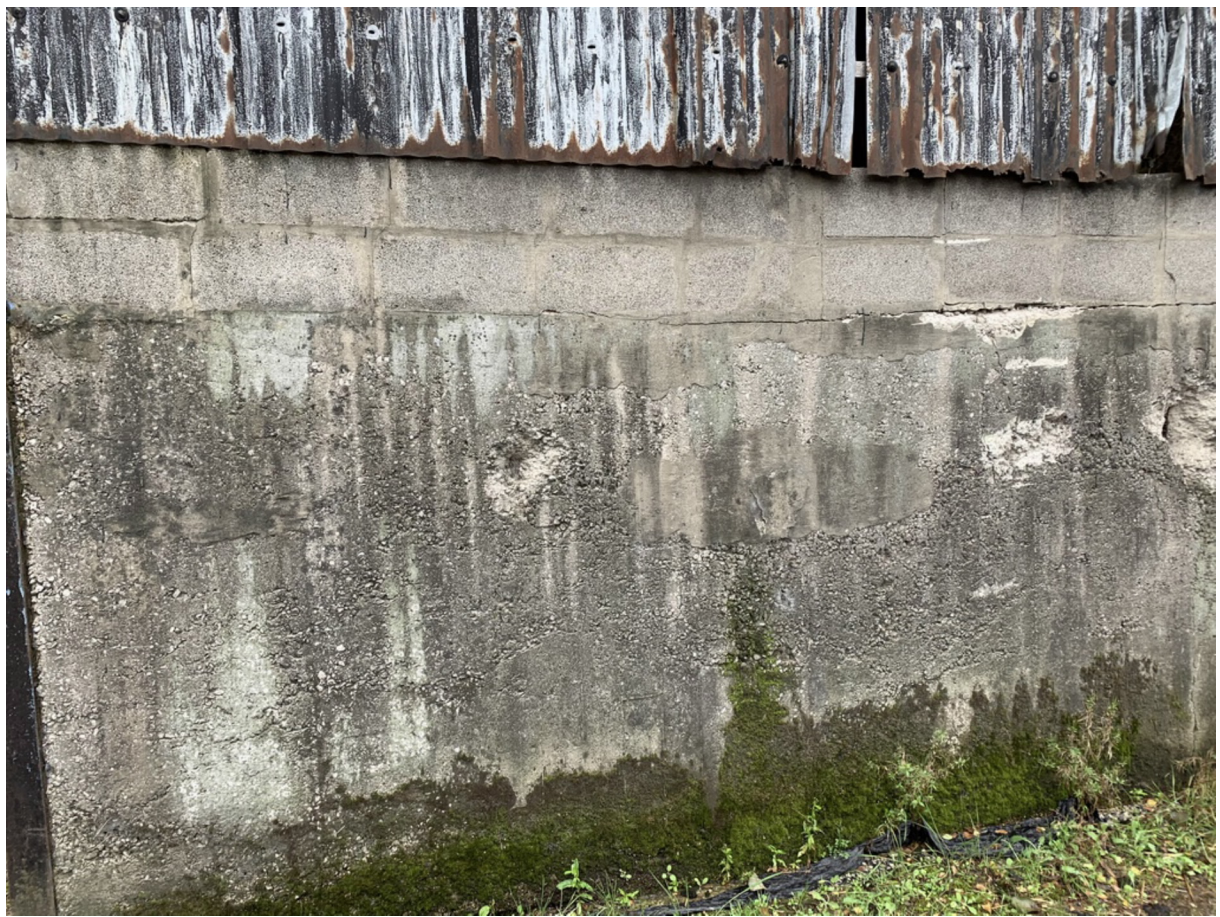
Photo 5 – East Elevation – concrete & block wall

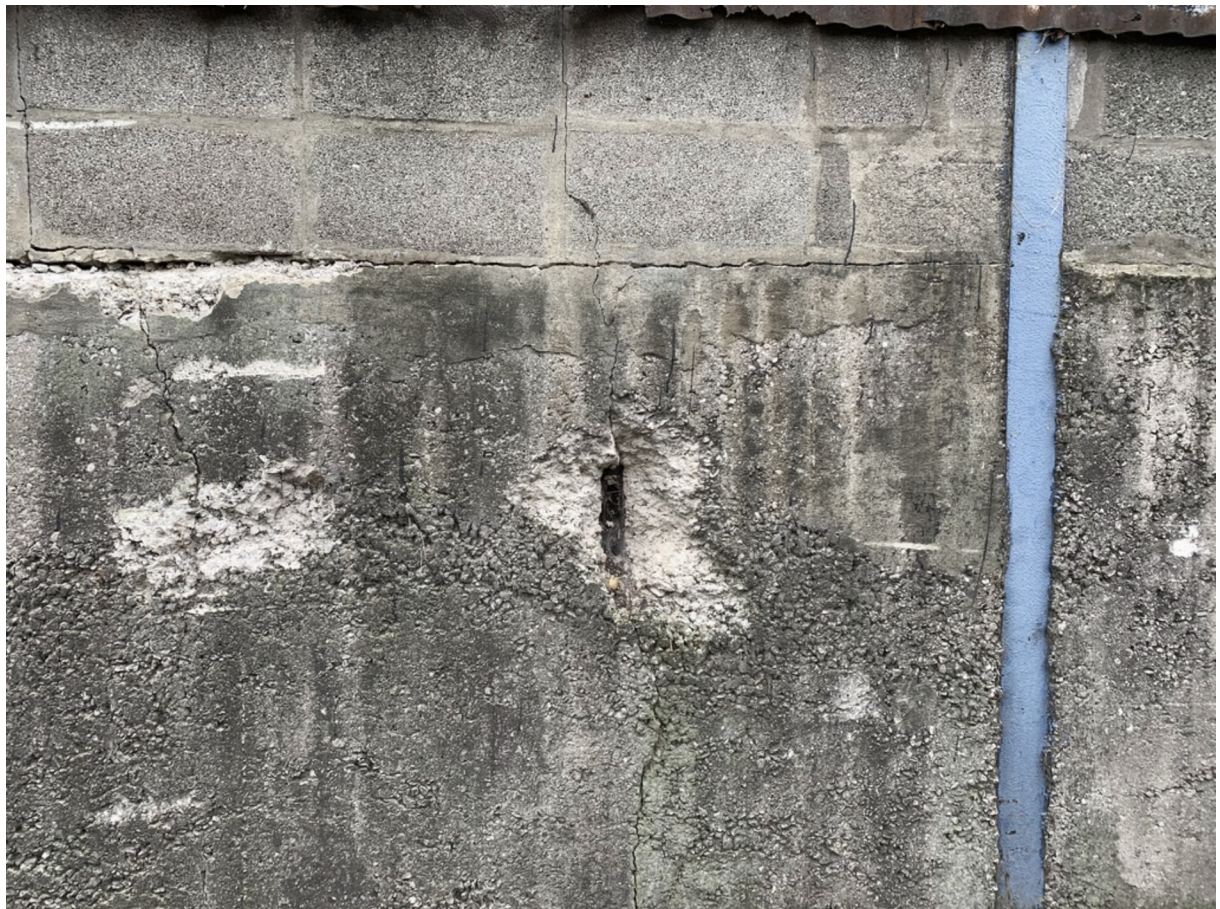
Photo 6 – East Elevation – intermediate column and damage to concrete

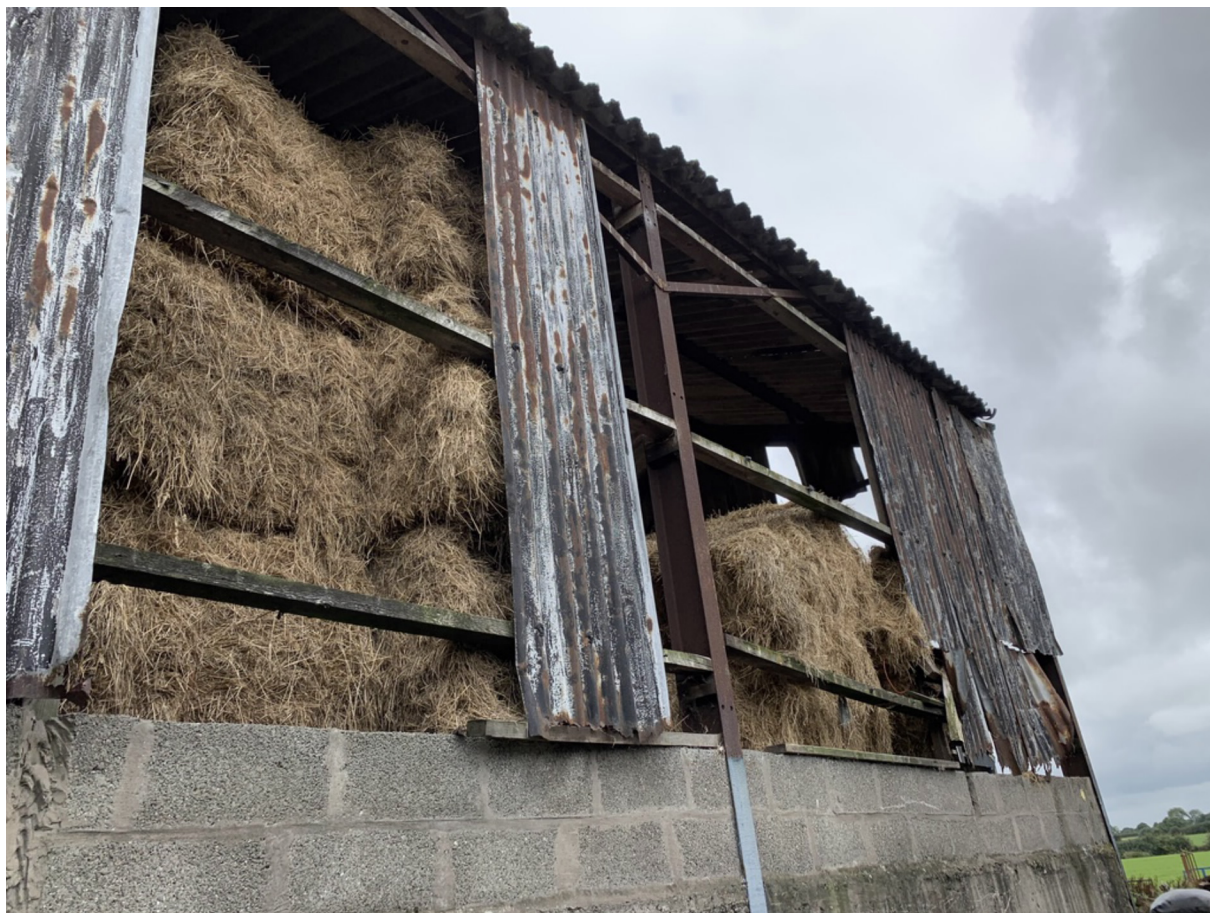
Photo 7 – East Elevation Cladding

In converting the building, it would be necessary to provide an inner skin to the existing external blockwork and cladding, forming an insulated cavity wall. Internal loadbearing walls would also be provided. Consideration may should be given to the use of masonry or Structural Insulated Panels (SIP) to form the new internal leaves and loadbearing walls. These walls would be structurally independent of the existing steel trusses and would take the loading from new floor and ceiling structures. They could be founded off the existing concrete floor slab if this is structurally adequate. Cores could be taken through the slab and the loading capacity analysed for the predicted loading. If the slab is not deemed suitable then foundations would be necessary for any load bearing walls. The conversion would require a new screed to the existing floor slab or a completely new floor slab constructed over the existing slab, with insulation under or over it to the Architects details. The proposals set out would retain the steel frame and trusses whilst replacing the cladding to the building. The roof would be recovered with a suitable lightweight system.

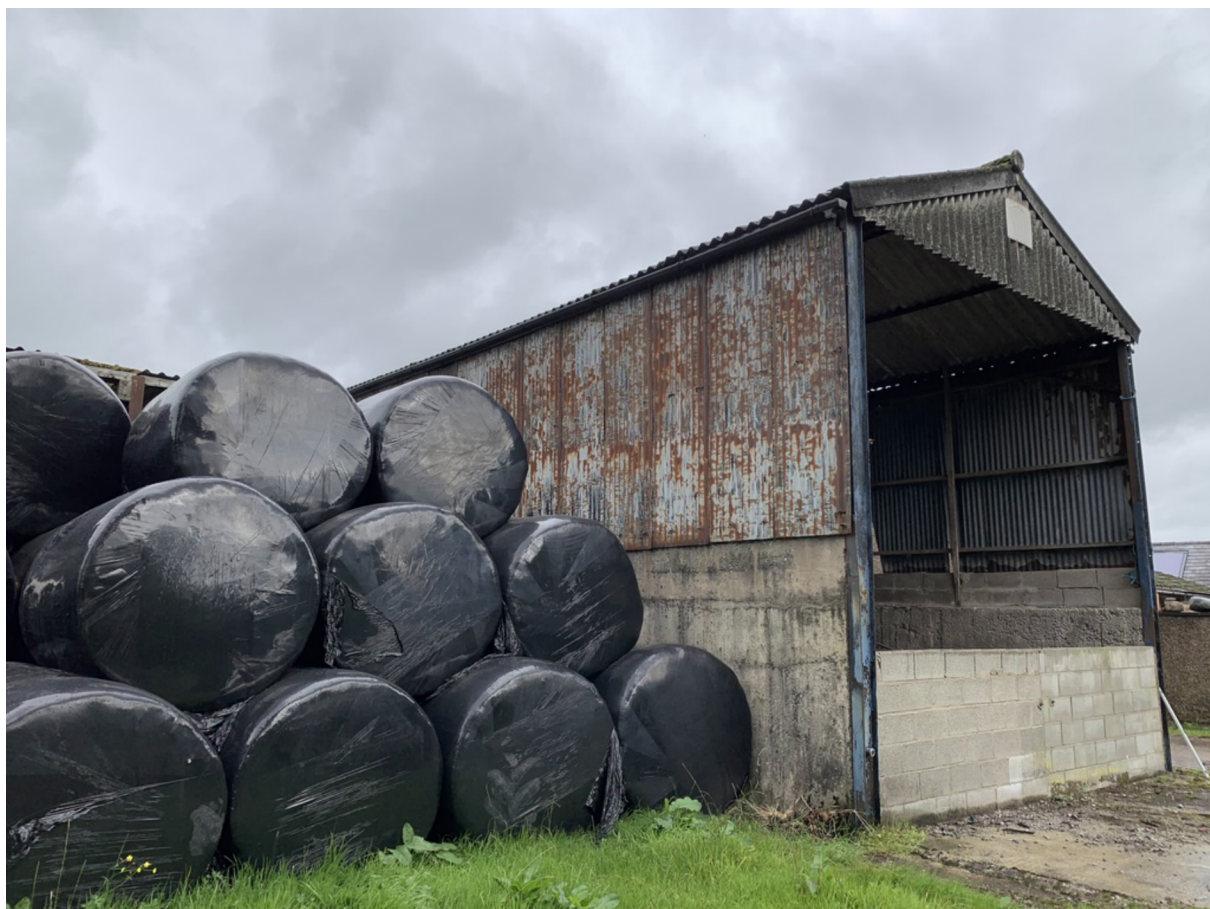
This elevation is of the same construction as the east elevation described above. The walls and columns are plumb and the steel columns are in reasonable condition with only surface rust. The concrete wall and blockwork is of a rough finish but in slightly better condition than the east elevation. The steel cladding is in poor condition but does not have sections missing.

Photo 8 – West Elevation

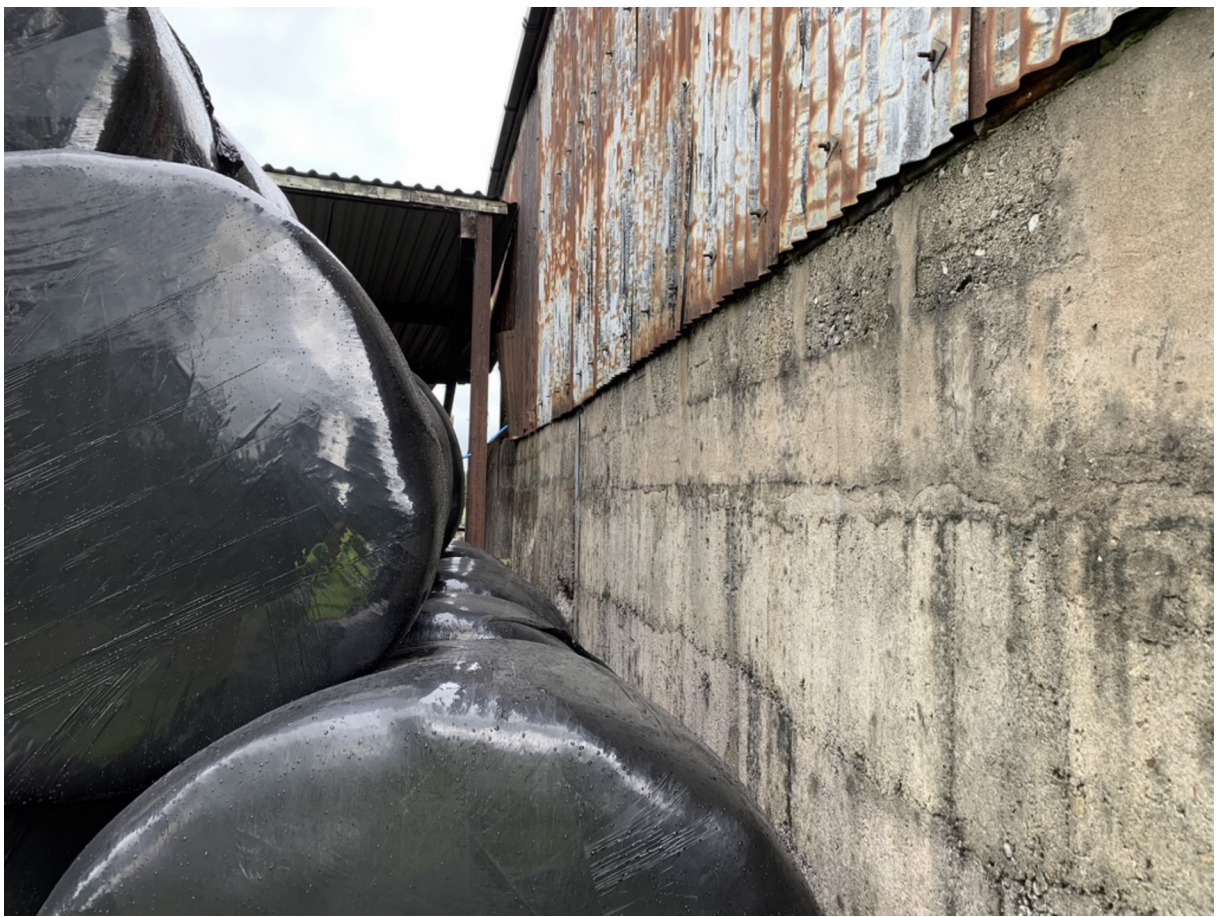
Photo 9 – West Elevation

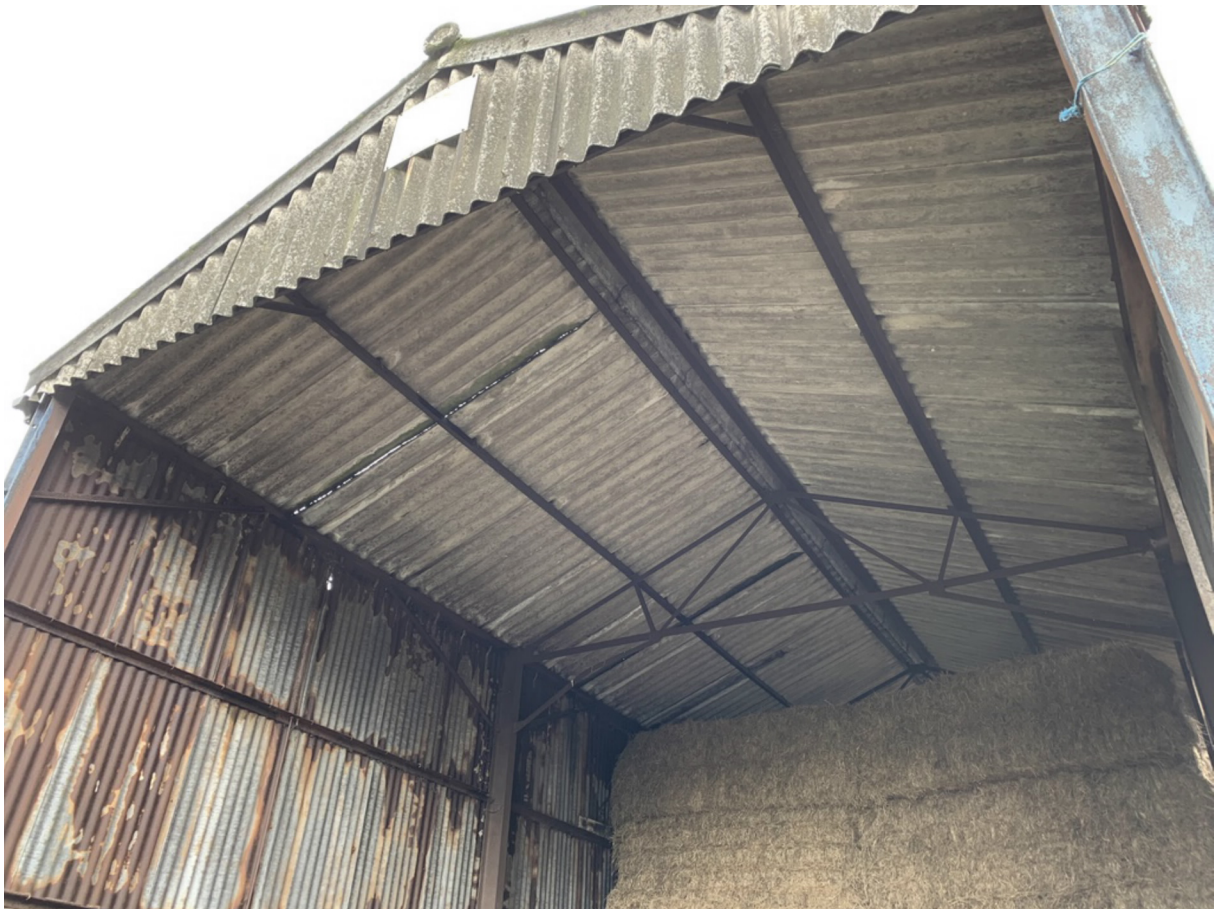
The existing roof is cement or asbestos, profiled sheeting, carried on steel purlins which run between light steel trusses. The roof showed no sign of damage, movement or excessive deflection. The light steel trusses exhibited surface rusting but no loss of section or damaged connections.

Photo 10 – Roof Structure

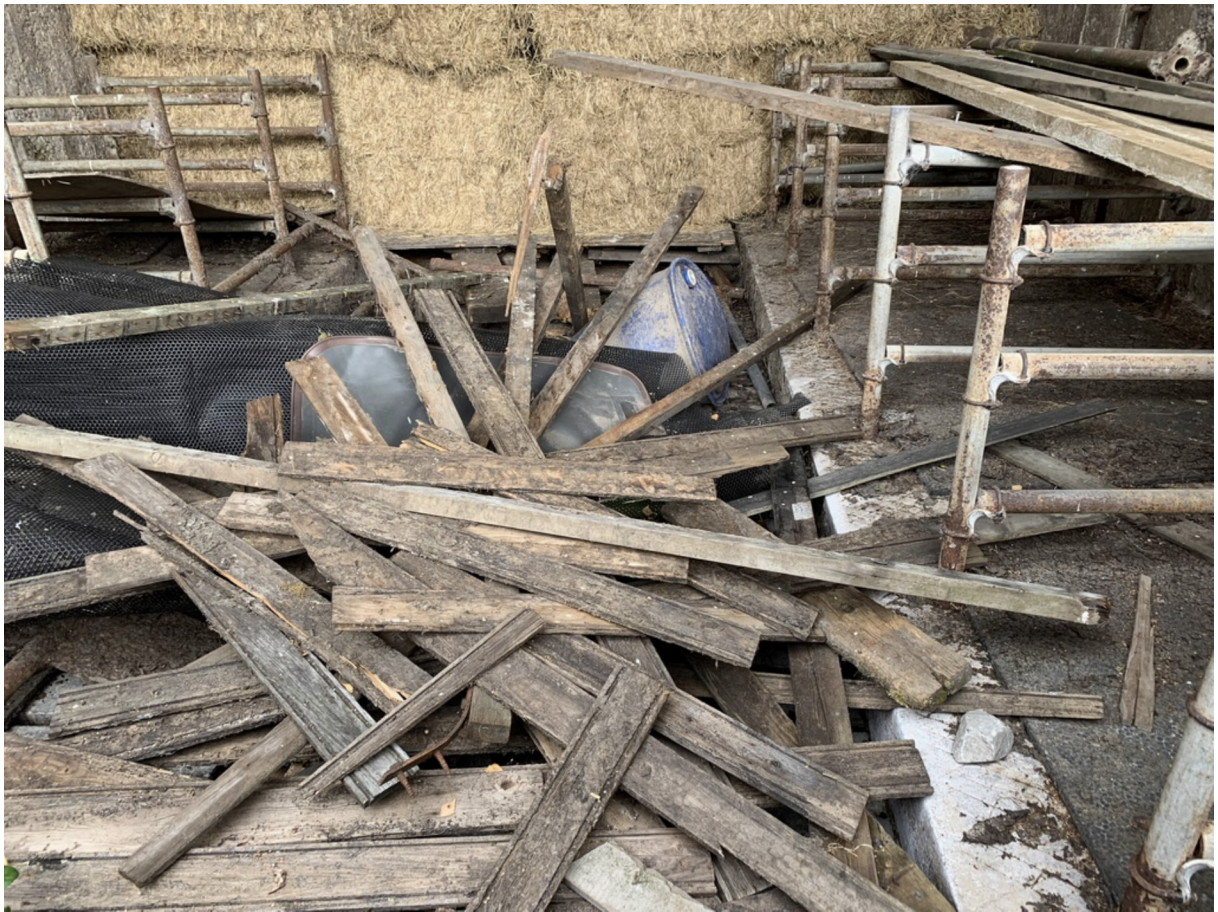
Internal inspection shows concrete floors with concrete & block walls set between the column sections. The floors were raised where cattle stalls have been formed (photo 12). The concrete appeared in reasonable condition where visible.

Photo 11 - Internal

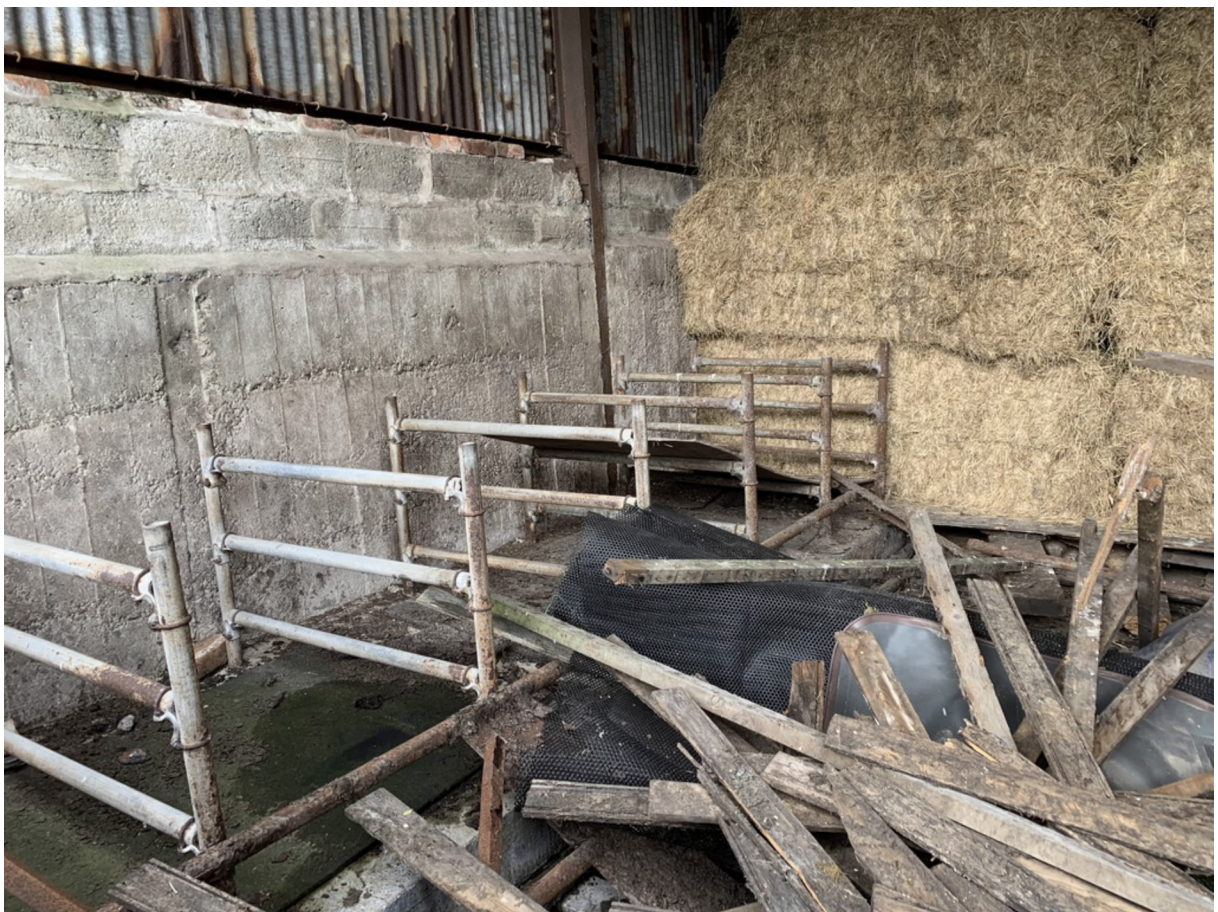
Photo 12 - Internal

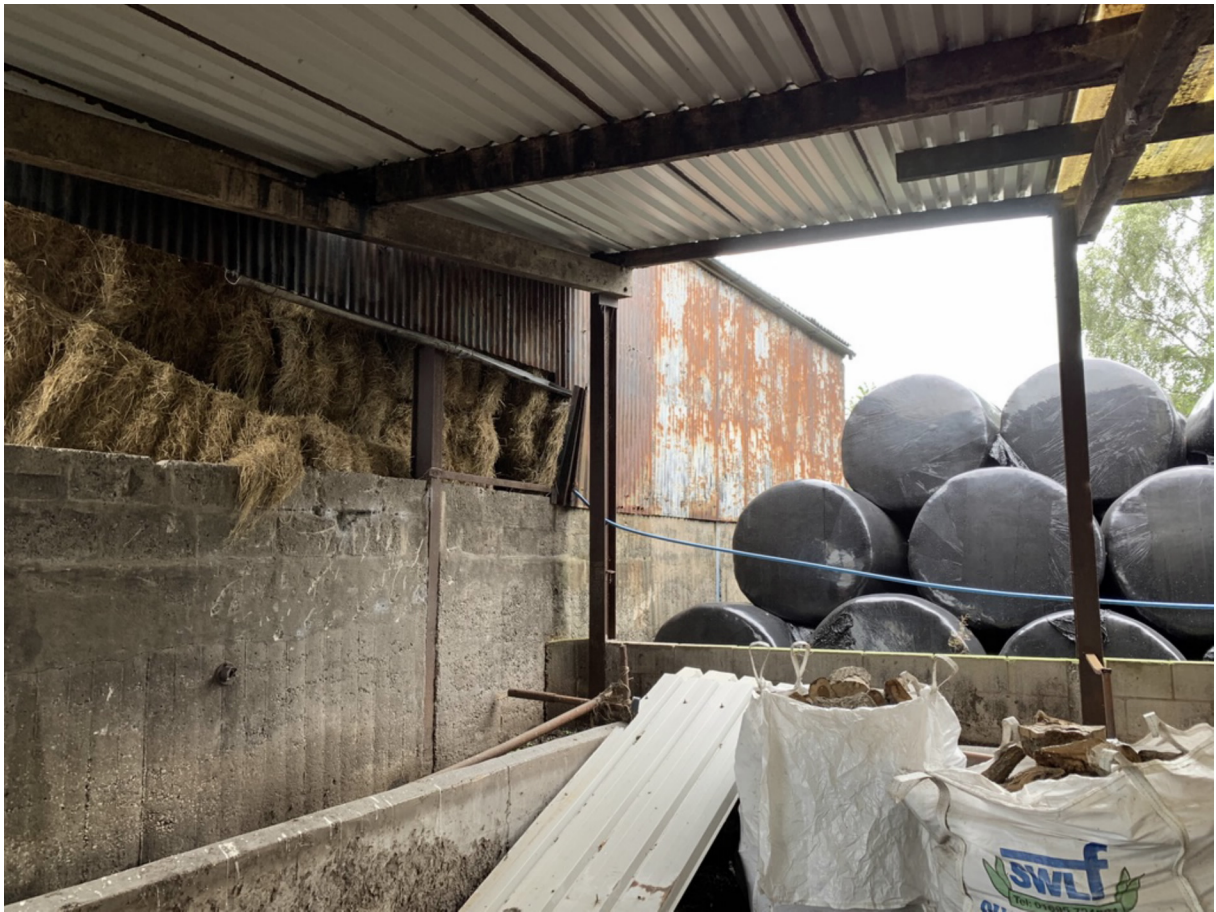
The rear section of this elevation has an adjoining building adjacent to this elevation (photos 13 & 15) and this is understood to be being removed under the proposals

Photo 13 – West Elevation at Rear (north)

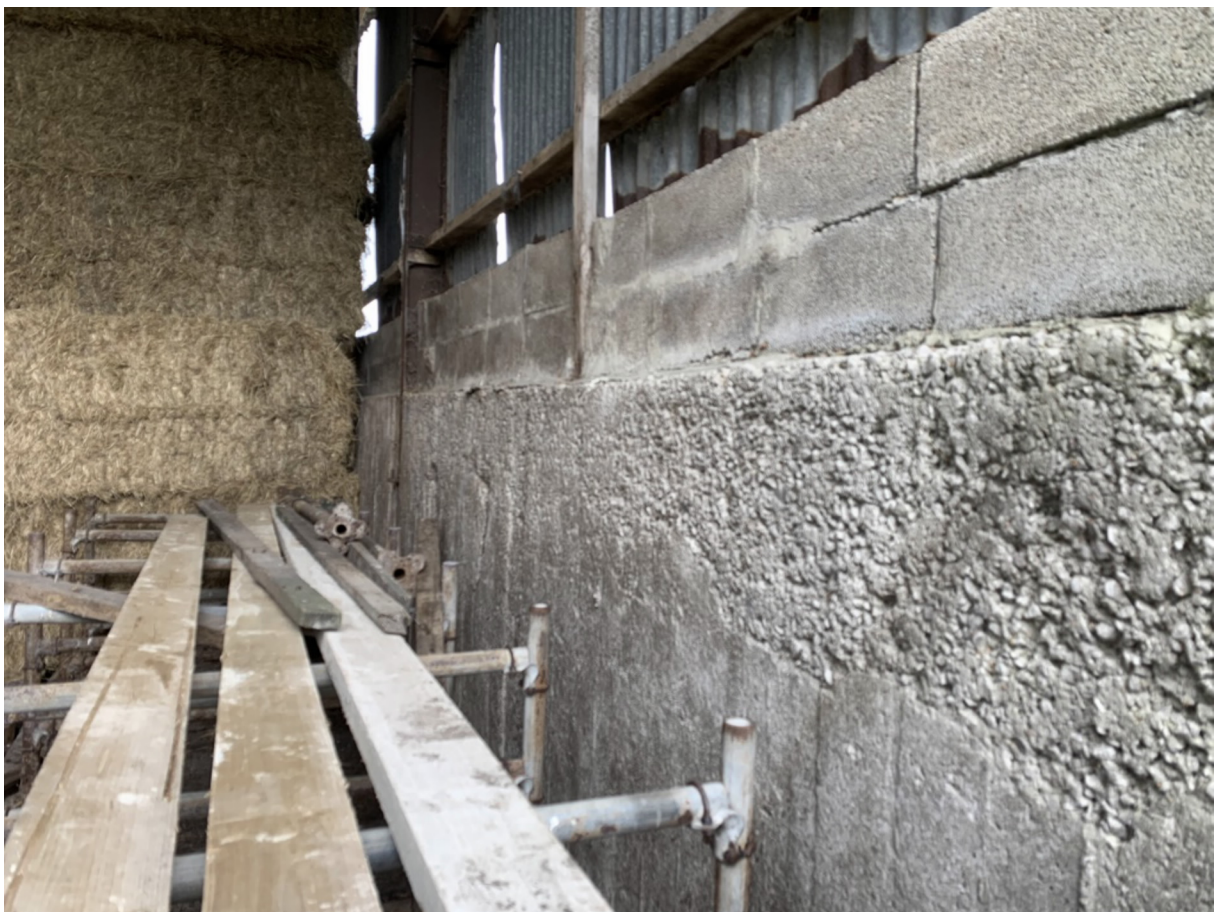
Photo 14 - Internal showing concrete wall

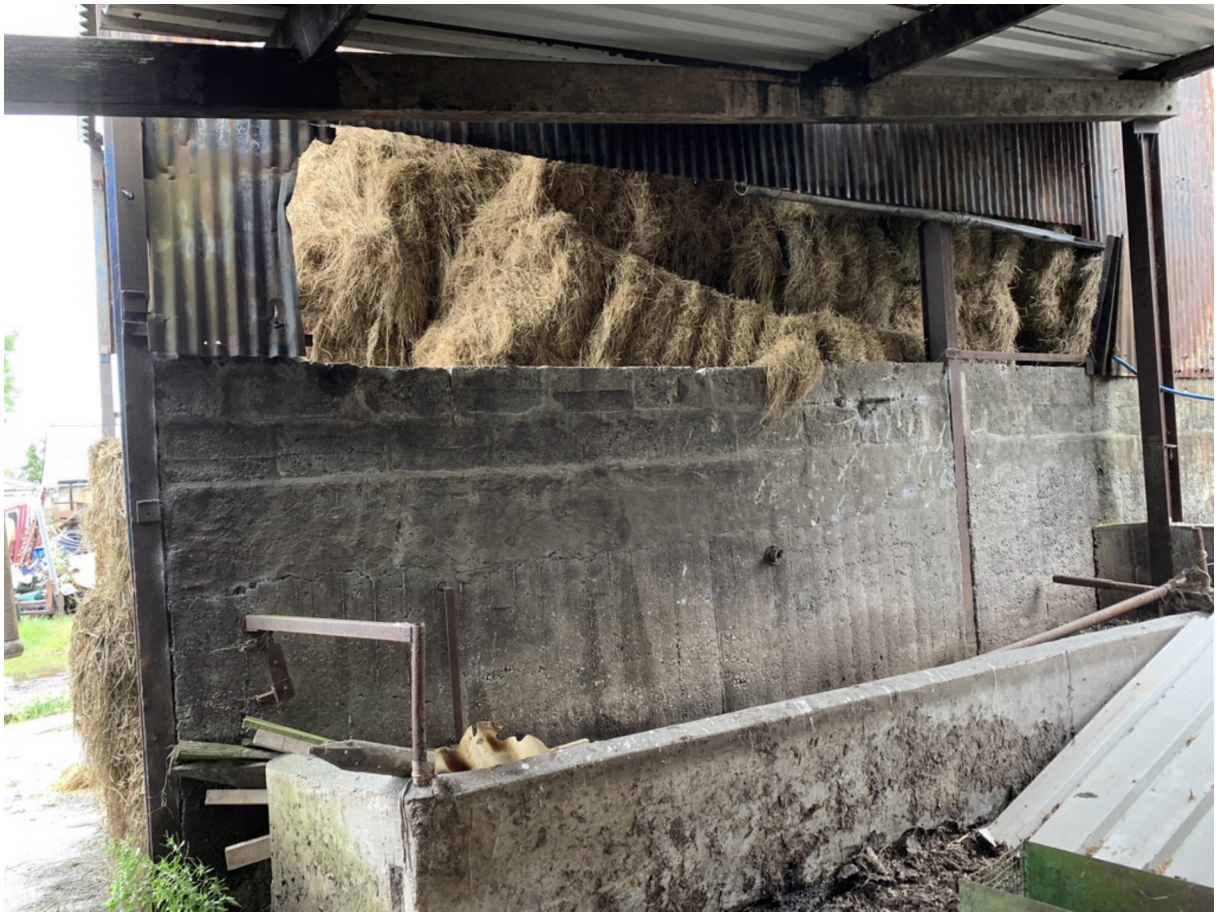
Photo 15 - West Elevation at rear (north)

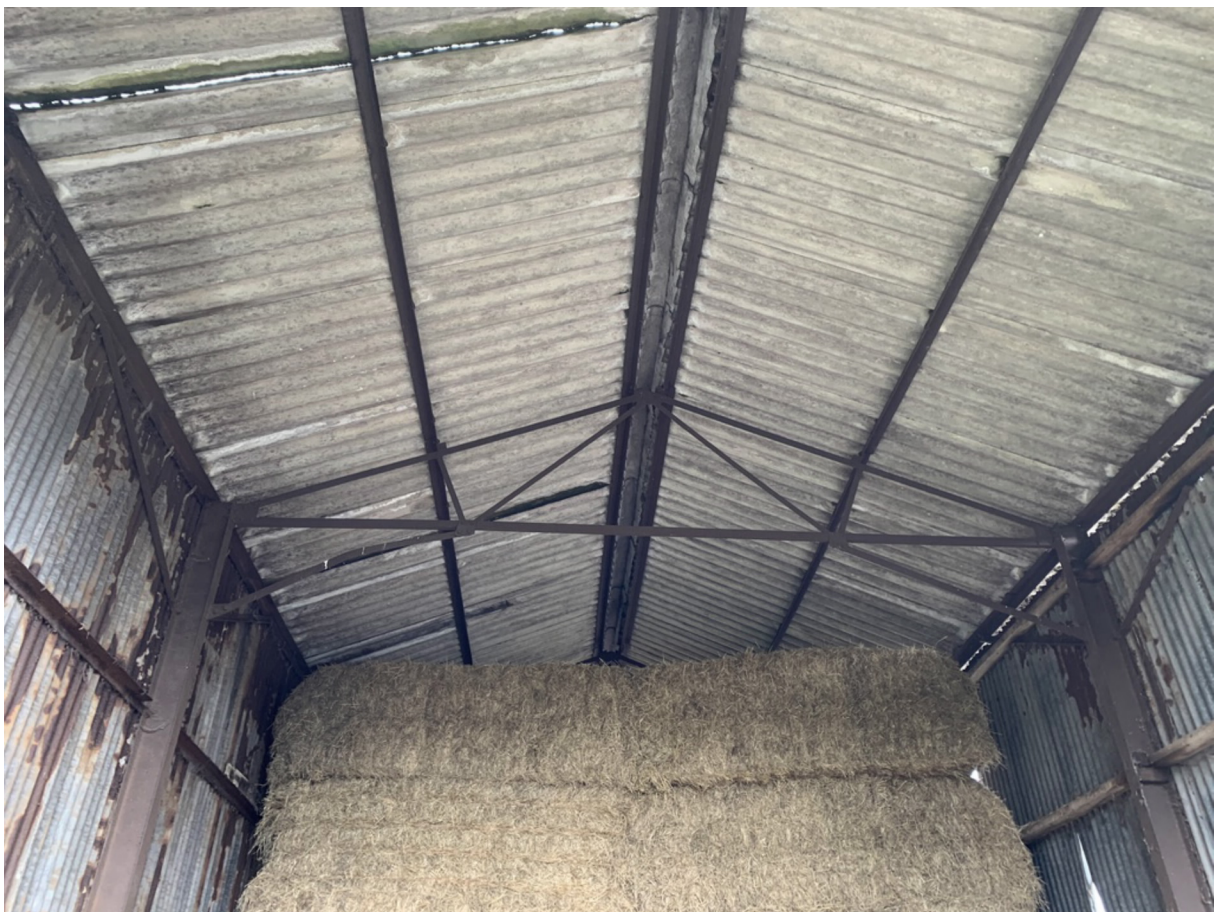
Photo 16 – Roof Structure

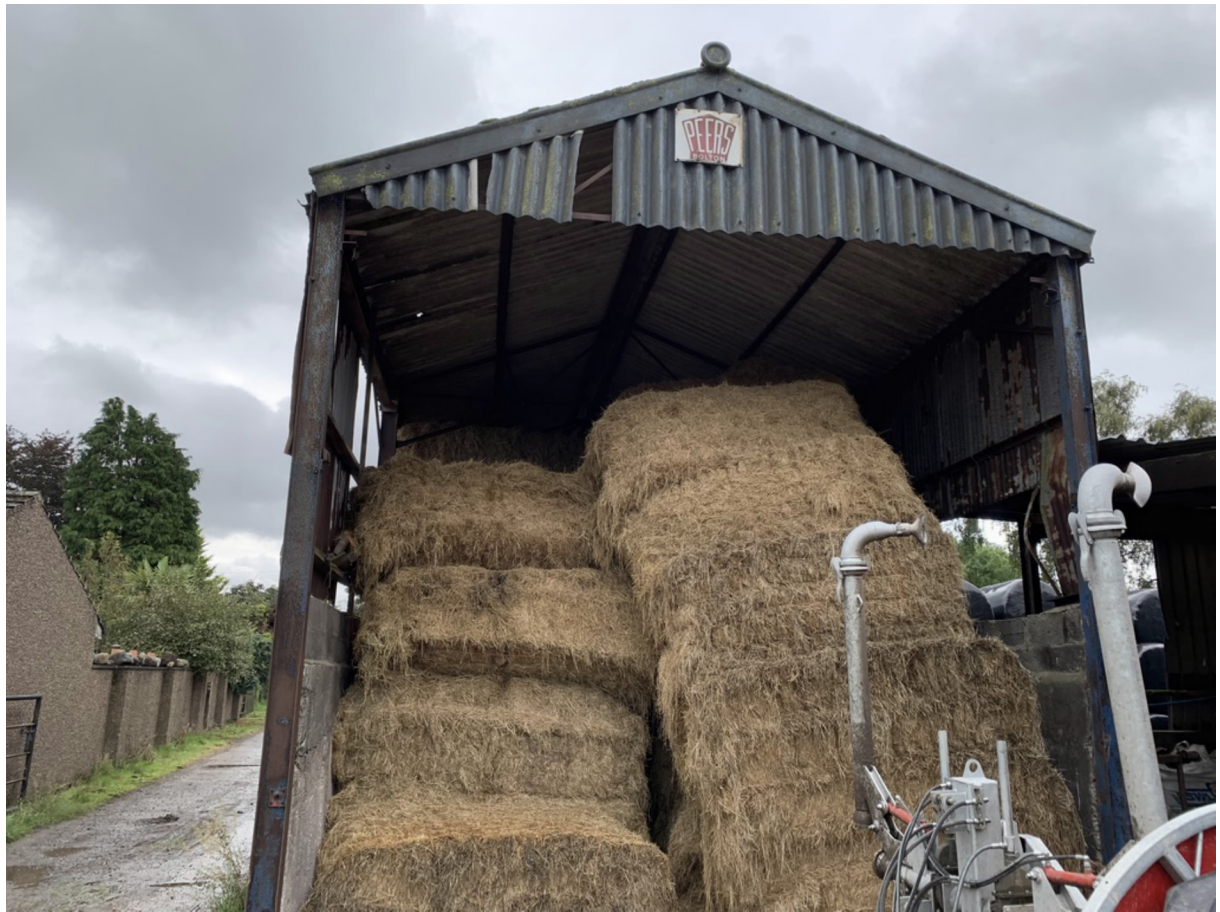
This gable is as per the south gable but without the lower blockwork wall. The cladding to the apex is in poor condition with some sections missing. As with the other gable the columns to the corners are plumb, with surface rusting only.

Photo 17 – North Gable
