Rain water services requiring restoration highlighted GREEN

Main house and outbuildings

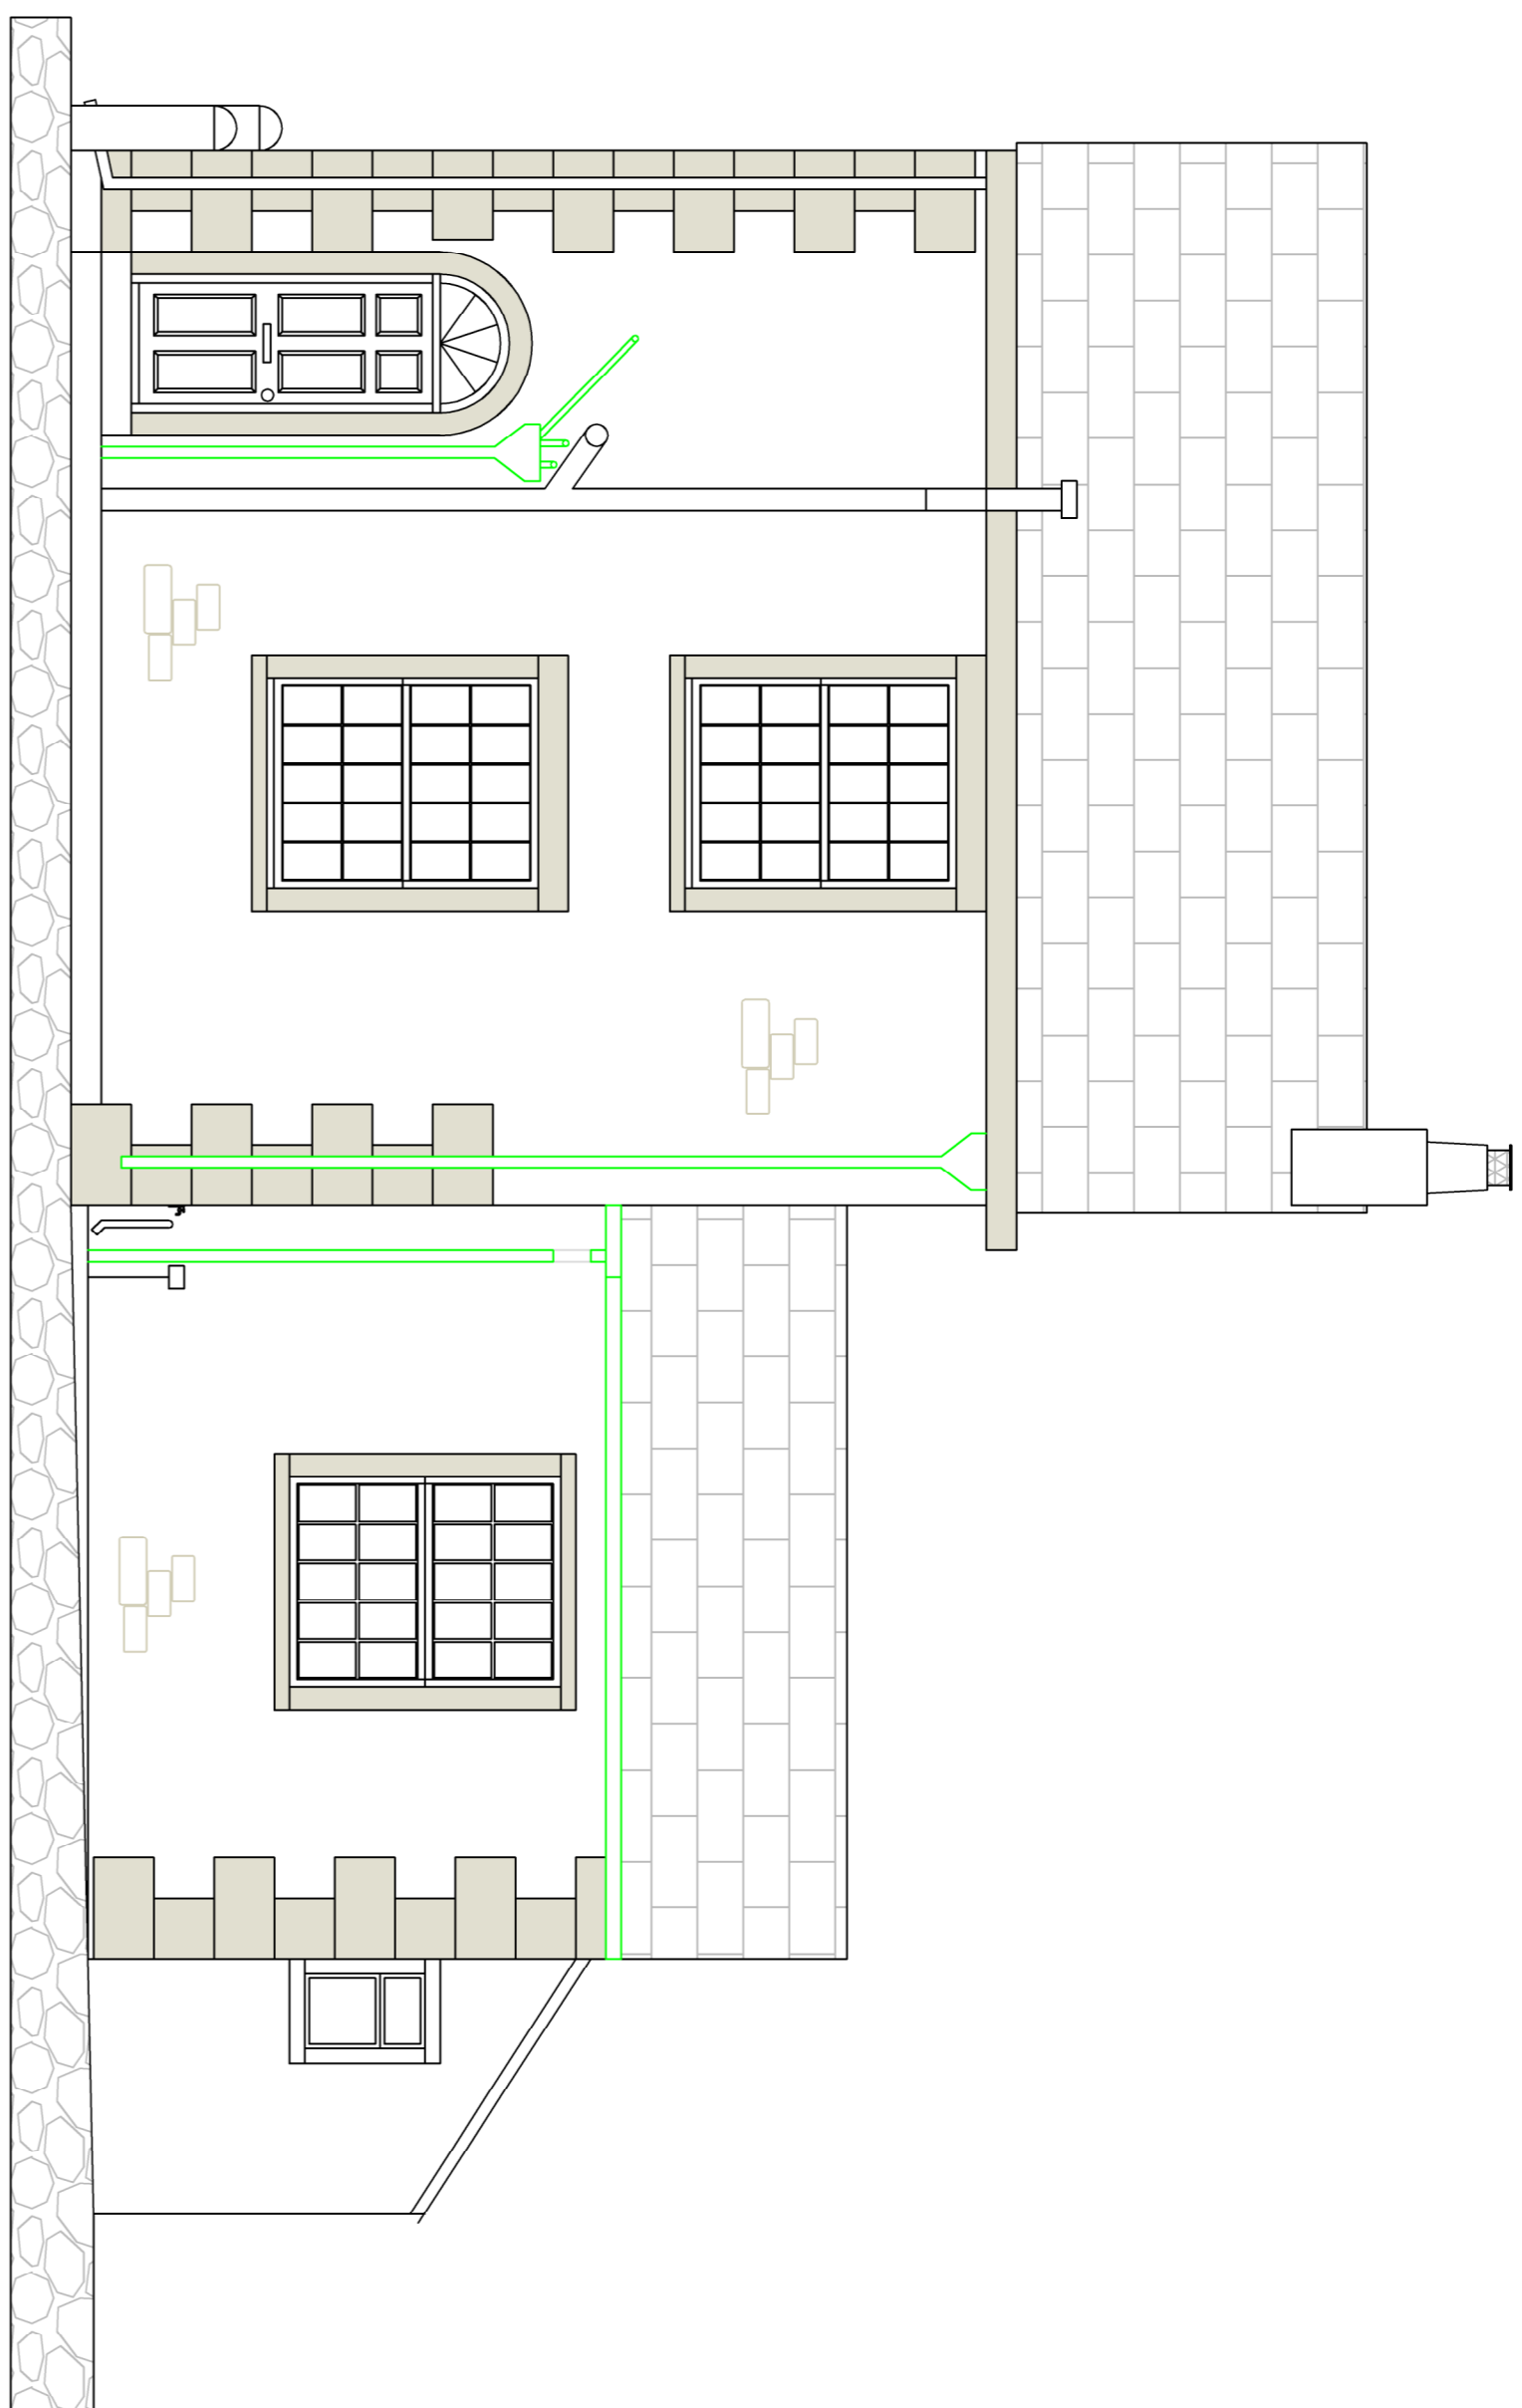
Existing North Elevation (Side view from Malt Kiln Lane)

All fixings except top lugs missing

Large hole to rear where firing lugs have disintegrated

Top downpipe section missing

Top fixings missing, mid section falling

Gutter to downpipe adapter detached, couplings falling

Gutter brackets loose, 2 brackets poorly replaced

Requires removal, full assessment and restoration of pipe where possible, replace damaged/missing sections with new only if necessary

PVC to be replaced where possible

Requires removal, full assessment and restoration of pipe where possible, replacing damaged/missing sections with new only if necessary
