# **QUANTITATIVE TREE RISK ASSESSMENT OF TREES**

## **AT 2 HUNTSMANS COTTAGES, WOODFOLD PARK, MELLOR, BLACKBURN**

**Client:** Mr and Mrs Hartley (resident owners at 2 Huntsmans Cottages)

**Date of Tree Inspection:** 12.2.20

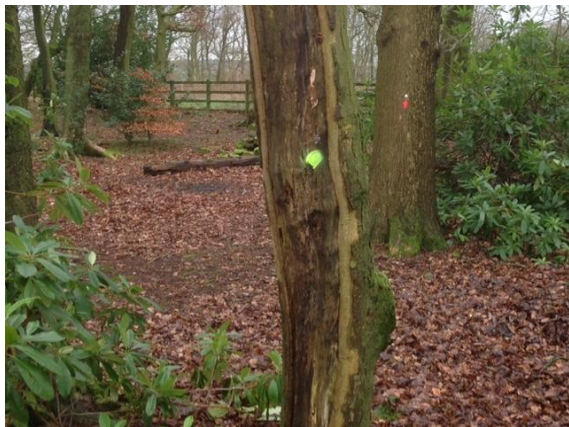
*Sycamore 79*

| No and colour code | Species | Hght (m) | Dbh (approx mm) | Canopy Spread (rad in metres) | Age Class<br>Y/EM/M/LM/OM | Condition (Good/Fair/Poor) | Target rating (H/M/L) | Size Of failure | Likelihood Of failure | Risk of Harm if higher than 1:10,000 | Work required | Priority (H/M/L) |
|---|---|---|---|---|---|---|---|---|---|---|---|---|
| 79 | Sycamore | 17 | 300 | 3e | EM | Fire damage, High HD ration | M | M | L | M | Fell to ground level | H |

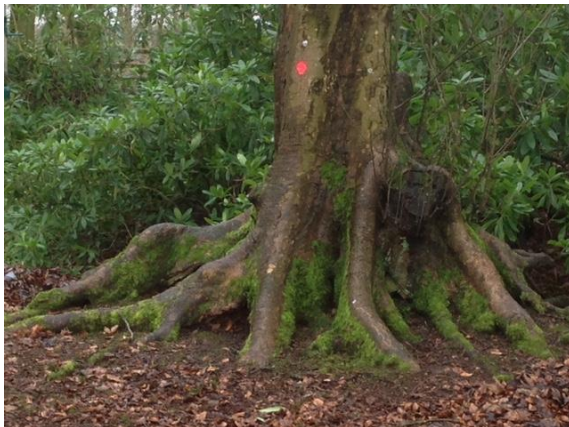
*Sycamore 77*

| No and colour code | Species | Hght (m) | Dbh (approx mm) | Canopy Spread (rad in metres) | Age Class<br>Y/EM/M/LM/OM | Condition (Good/Fair/Poor) | Target rating (H/M/L) | Size Of failure | Likelihood Of failure | Risk of Harm if higher than 1:10,000 | Work required | Priority (H/M/L) |
|---|---|---|---|---|---|---|---|---|---|---|---|---|
| 77 | Sycamore | 18 | 680 | 5 | M | Exposed root system | M | H | M | M | Canopy reduce by 3m at appropriate unions to reduce lever arm stress. | H |

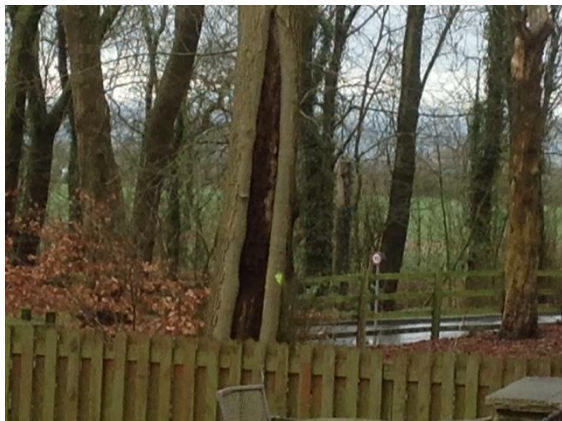
*Ash 61*

| No and colour code | Species | Hght (m) | Dbh (approx mm) | Canopy Spread (rad in metres) | Age Class<br>Y/EM/M/LM/OM | Condition (Good/Fair/Poor) | Target rating (H/M/L) | Size Of failure | Likelihood Of failure | Risk of Harm if higher than 1:10,000 | Work required | Priority (H/M/L) |
|---|---|---|---|---|---|---|---|---|---|---|---|---|
| 61 | Ash | 21 | 350 | 3 | M | 20% bark loss on stem. Decat to 50mm. Canopy thin, High HD ratio | M | M | M | M | Fell to allow Horse Chestnut to flourish | H |

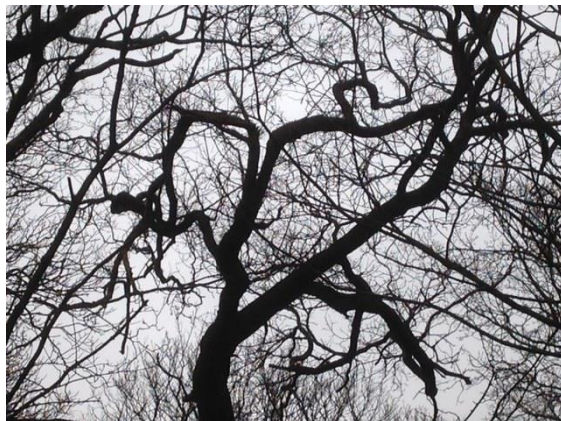
*Oak 75*

| No and colour code | Species | Hght (m) | Dbh (approx mm) | Canopy Spread (rad in metres) | Age Class<br>Y/EM/M/LM/OM | Condition (Good/Fair/Poor) | Target rating (H/M/L) | Size Of failure | Likelihood Of failure | Risk of Harm if higher than 1:10,000 | Work required | Priority (H/M/L) |
|---|---|---|---|---|---|---|---|---|---|---|---|---|
| 75 | Oak | 19 | 620 | 10e | LM | Fork fracture, deadwood and past wind damage | L | M | M | L | Remove split union back to fork union, remove deadwood | H |

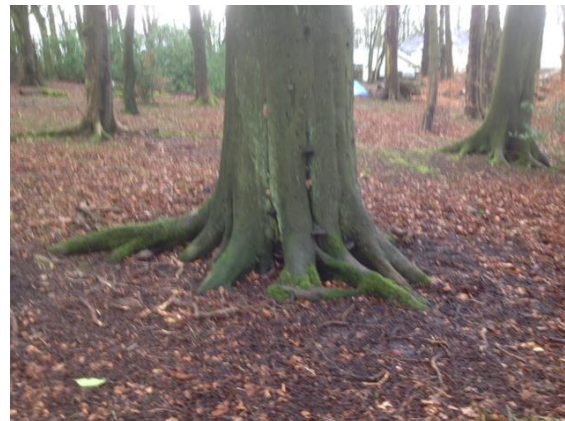
*Beech 72*

| No and colour code | Species | Hght (m) | Dbh (approx mm) | Canopy Spread (rad in metres) | Age Class<br>Y/EM/M/LM/OM | Condition (Good/Fair/Poor) | Target rating (H/M/L) | Size Of failure | Likelihood Of failure | Risk of Harm if higher than 1:10,000 | Work required | Priority (H/M/L) |
|---|---|---|---|---|---|---|---|---|---|---|---|---|
| 72 | Beech | 26 | 910 | 15 | LM | Severe basal decay. Wet ground, Wind throw possible | L | M | M | L | Reduce to 6m monolith | M |
