**Urgent request to remove unstable tree, at Grove House, Chipping, PR3 2GP**

The tree in question is a tall 12M Conifer (T1) located in the south west corner of Grove House front garden, please see attached location map (final page).

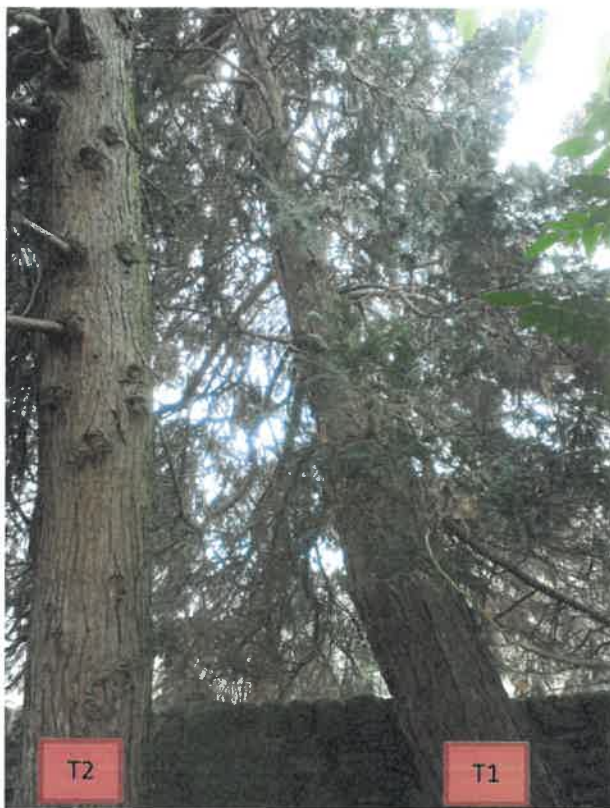
- Pic.1 (below left) 30<sup>th</sup> September 2017 indicates the original leaning position of the tree.
- Pic.2 (below right) 23<sup>rd</sup> May 2020 Indicates current extended lean of the tree from its previous position

The distance of travel over 2 years is well indicated in the photographs by the number of coping stones visible in the background between the two trees.

2018 = 7-1/2

Approximate '2018' lean angle = 19°

It has been observed that as the lean angle increases, so has the rate of movement due to the weight imbalance. This has recently been exacerbated by the exceptionally dry weather during March – April 2020

Permission is sought to carefully remove the large conifer (T1) before it causes further damage and assess the likelihood for removal of 2<sup>nd</sup> smaller conifer (T2) if deemed unstable.

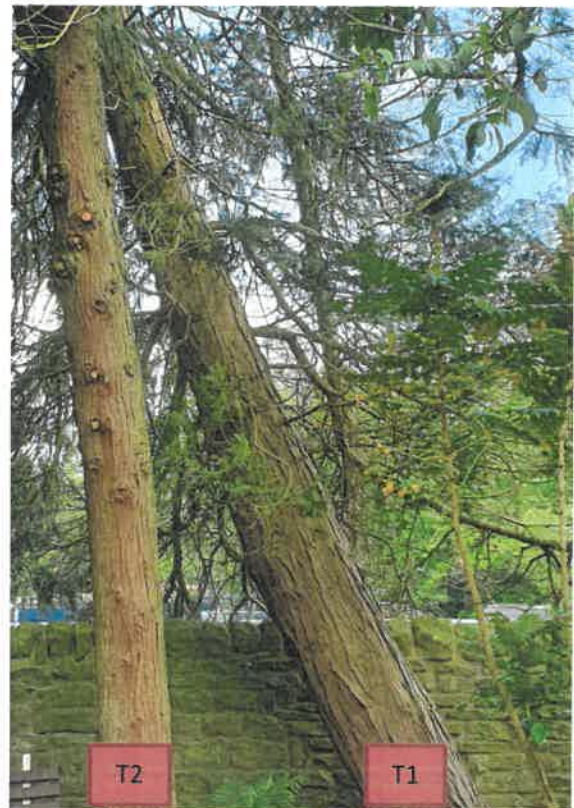
2020 = 4

Movement circa 500mm

Approximate '2020' lean angle = 30°

Lean increase of approx. 11°

The direction of lean is towards the closely neighbouring Kirk Mill Barn and Grove House garage. Should the tree continue to fall it will cause significant destruction to Grove House stone wall boundary and potential damage to Kirk Mill Barn. It should be noted that Grove House stone wall is under an Article 4 protection order. The 2<sup>nd</sup> conifer leans towards Grove House (Grade 2 listed)

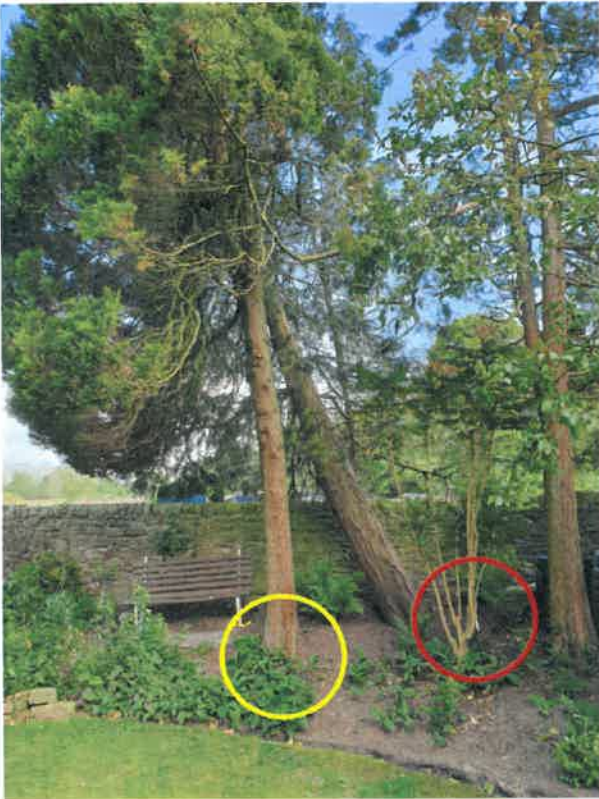
During the high storm-force winds of early 2020 there has been increased visible ground lift (circled red).
