# UK RESTORATION S E R V I C E S

## Condition Report

Fooden Hall, Bolton-by-Bowland

| Condition Report V2 | |

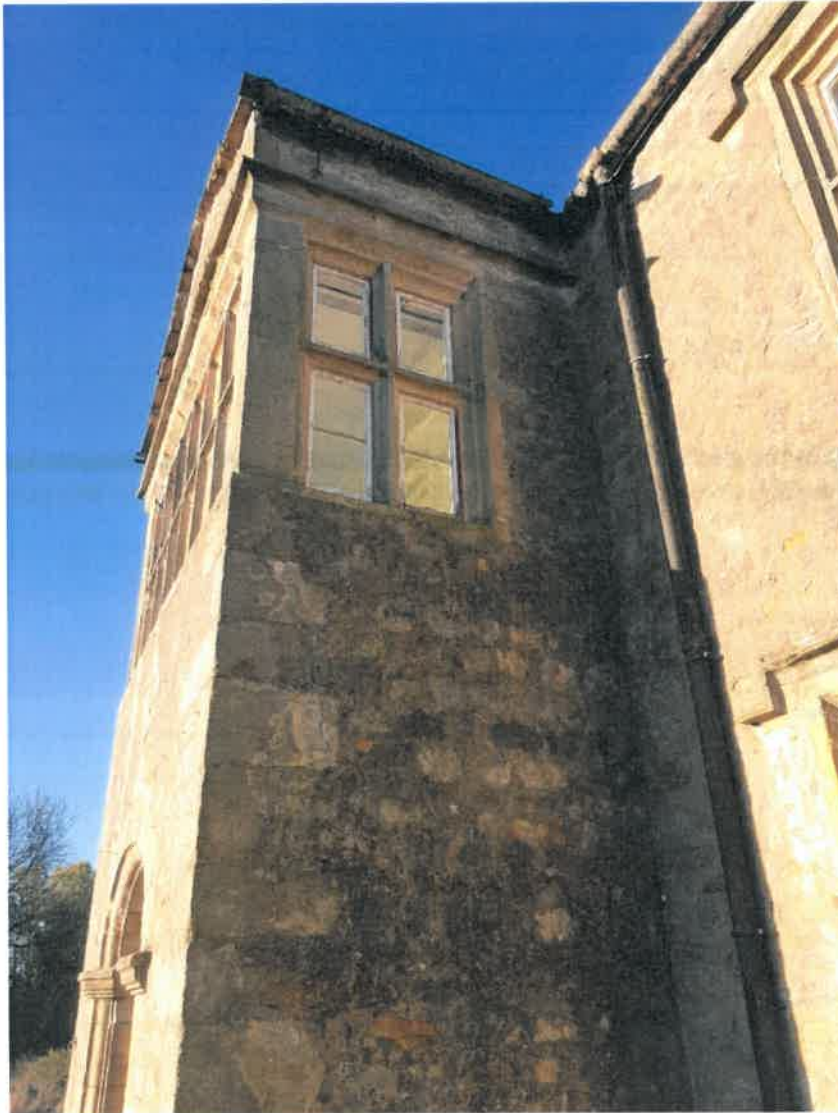
| Reference | Material | Condition | Comments |
|---|---|---|---|
| East Gutters | Asbestos | 1 | Sections missing or damaged, joints failing & full of vegetation |

Photo 1: There are sections of the gutter missing on the east elevation

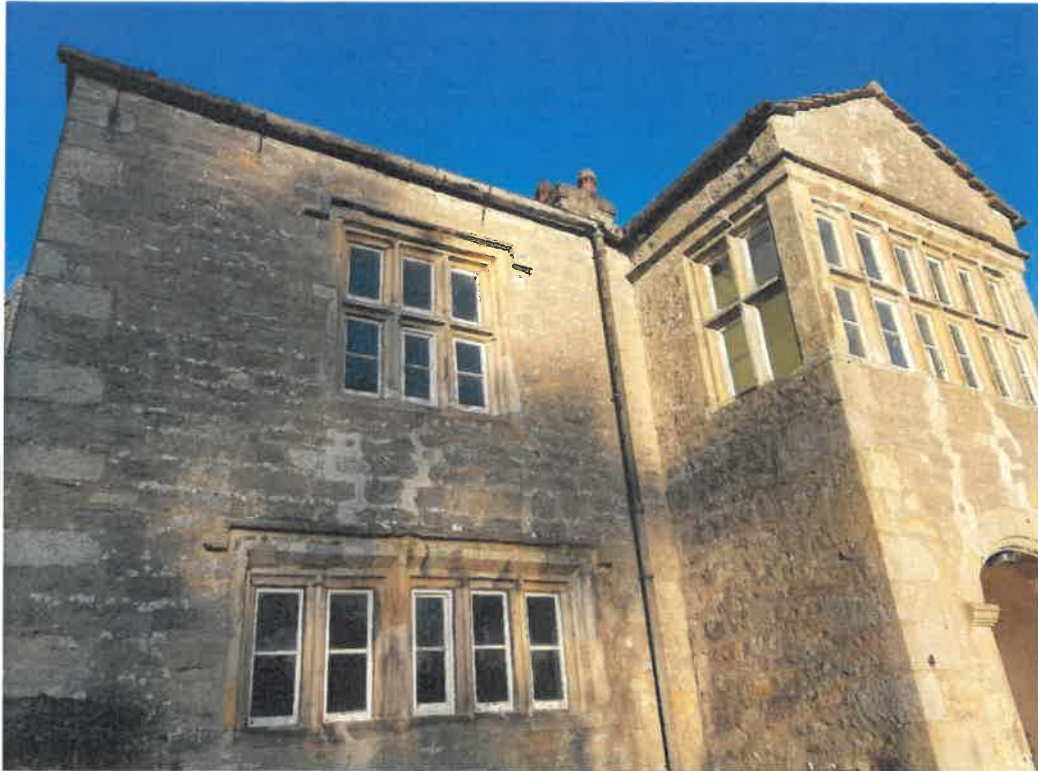
| Reference | Material | Condition | Comments |
|---|---|---|---|
| East Downpipes | Asbestos | 1 | Multiple sections split |

Photo 2: The gutter is damaged and there are multiple splits in the downpipe on the east elevation

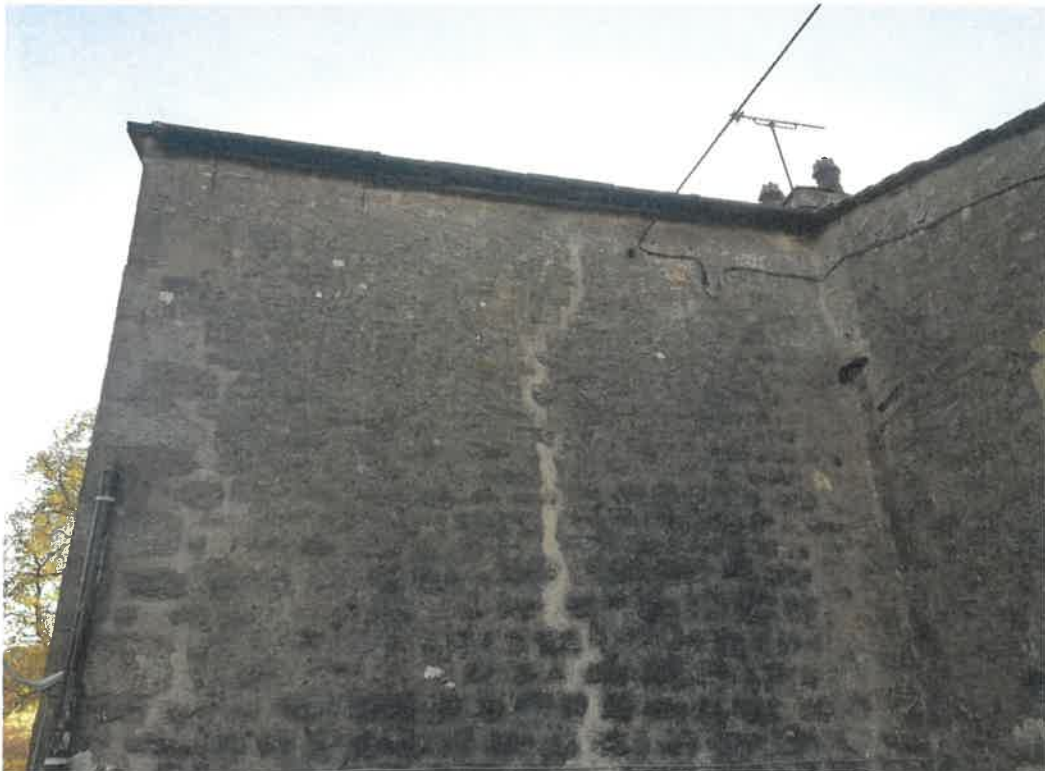
| Reference | Material | Condition | Comments |
|---|---|---|---|
| West Downpipes | Asbestos | 1 | Multiple sections split |

Photo 3: The gutter is damaged, and a large section of downpipe is missing to the west elevation

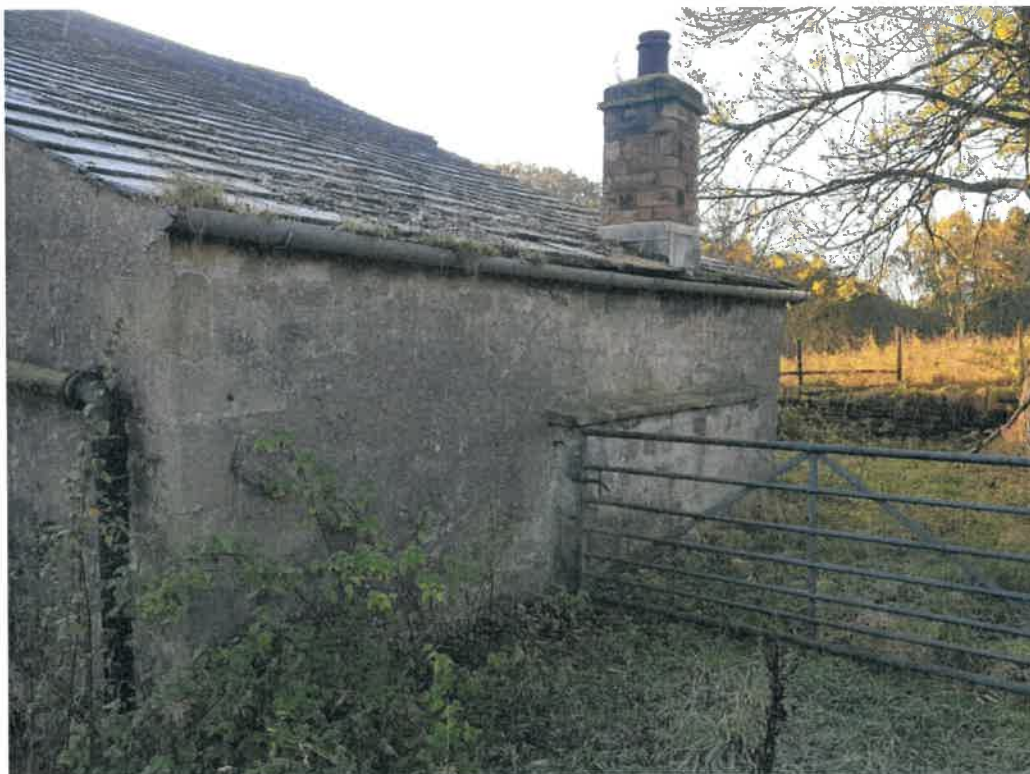
| Reference | Material | Condition | Comments |
|---|---|---|---|
| West Gutters | Asbestos / Plastic | 1 | Sections missing or damaged, joints failing & full of vegetation |

Photo 4: The plastic gutter has no outlet and is full of vegetation to the west elevation

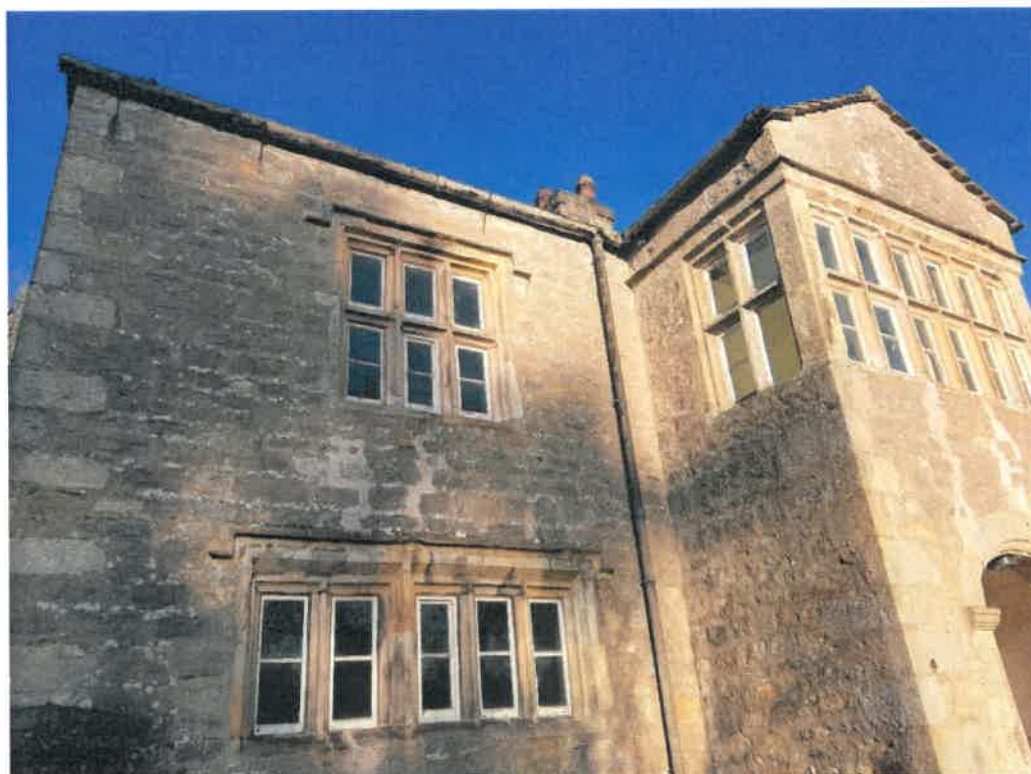
| Reference | Condition | Comments |
|---|---|---|
| East Windows | 1 | Two windows require replacement. All other windows require replacement putty and redecoration. |

Photo 5: There is one missing window that requires replacement, the remaining windows require putty replacement and decoration on the east elevation

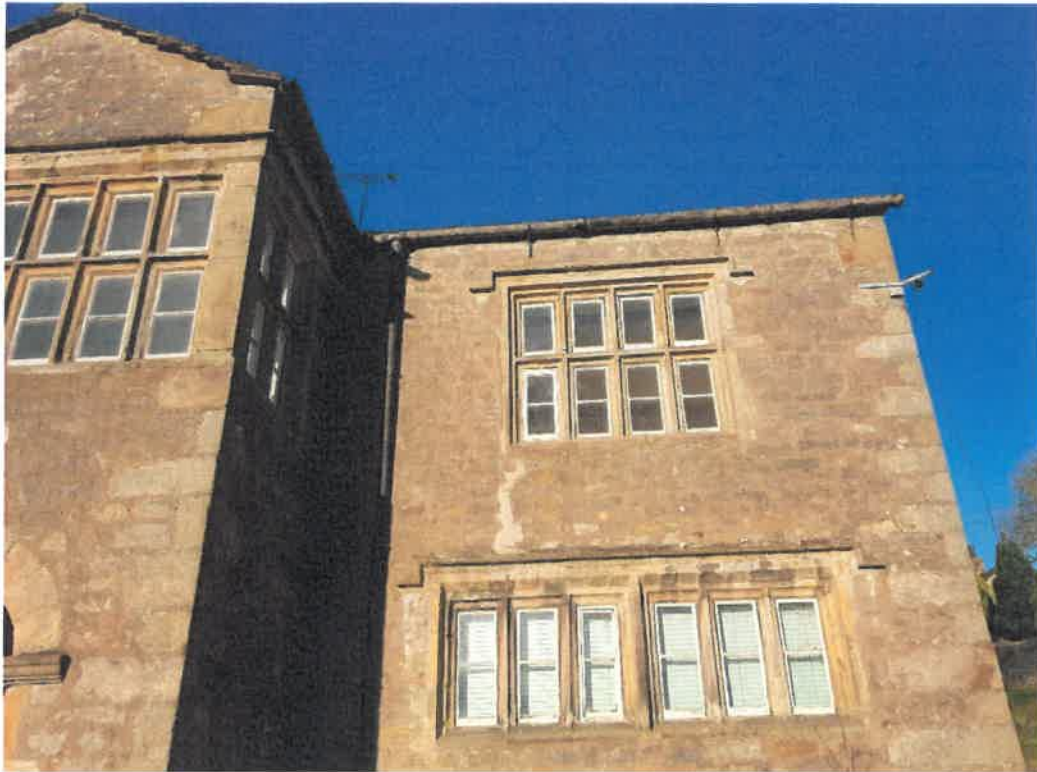
Photo 6: The windows require putty replacement and redecoration on the east elevation

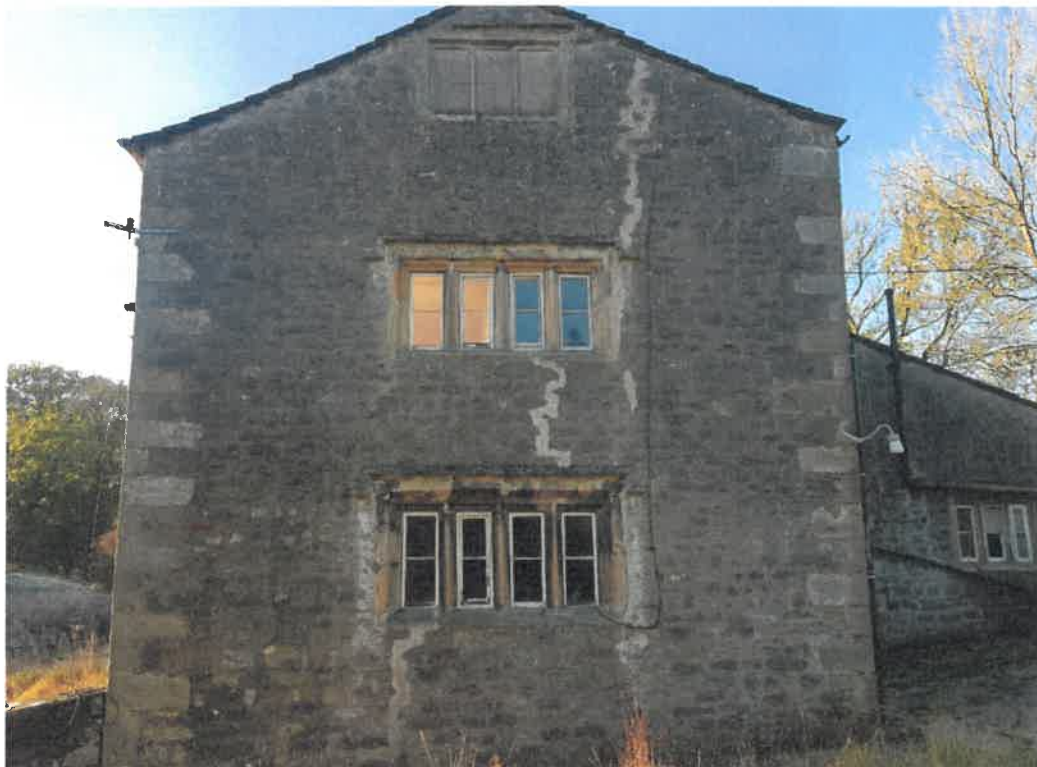
| Reference | Condition | Comments |
|---|---|---|
| North Windows | 1 | One window requires replacement. One window requires reglazing. All other windows require replacement putty and redecoration. |

Photo 7: There is one missing window that requires replacement and one window that requires reglazing, the remaining windows require putty replacement and decoration on the north elevation

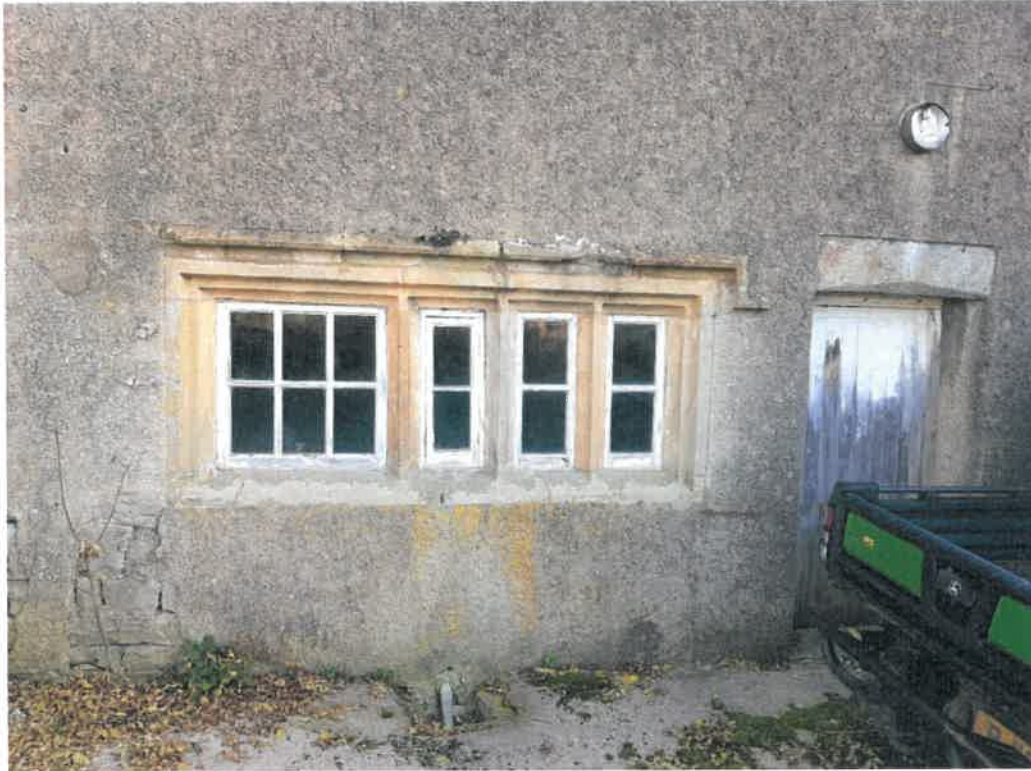
| Reference | Condition | Comments |
|---|---|---|
| South Windows | 2 | All windows require replacement putty and redecoration. |

Photo 8: The windows to the south elevation require putty replacement and decoration. The timber door also requires redecoration.

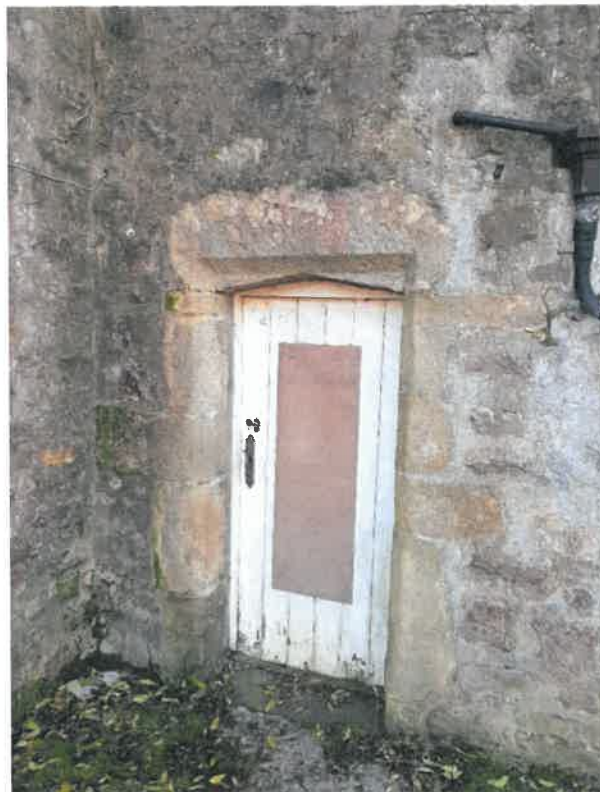
| Reference | Condition | Comments |
|---|---|---|
| North Door | 2 | The door is currently covered with ply boarding which will require repairs |

Photo 9: The timber door is covered with plywood boarding and requires repair and decoration

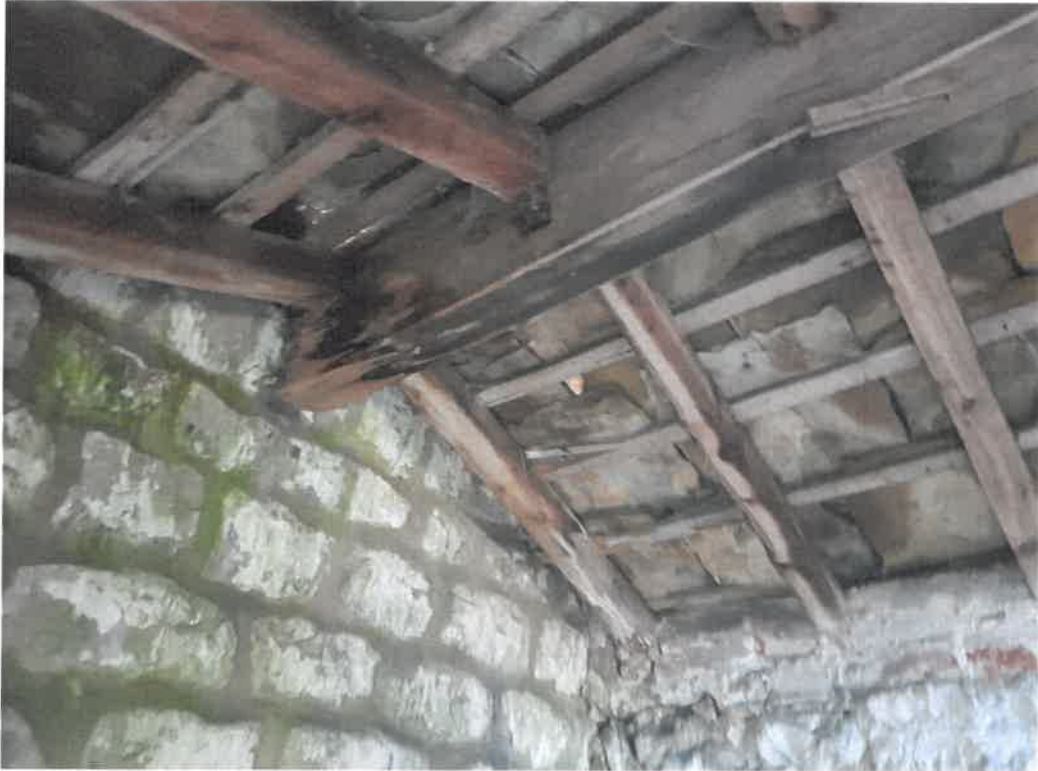
| Outbuilding Ridge Beam | 1 | The ridge beam is rotten and requires a splice repair |

Photo 10: The ridge beam is rotten at the bearing end and will require a splice repair

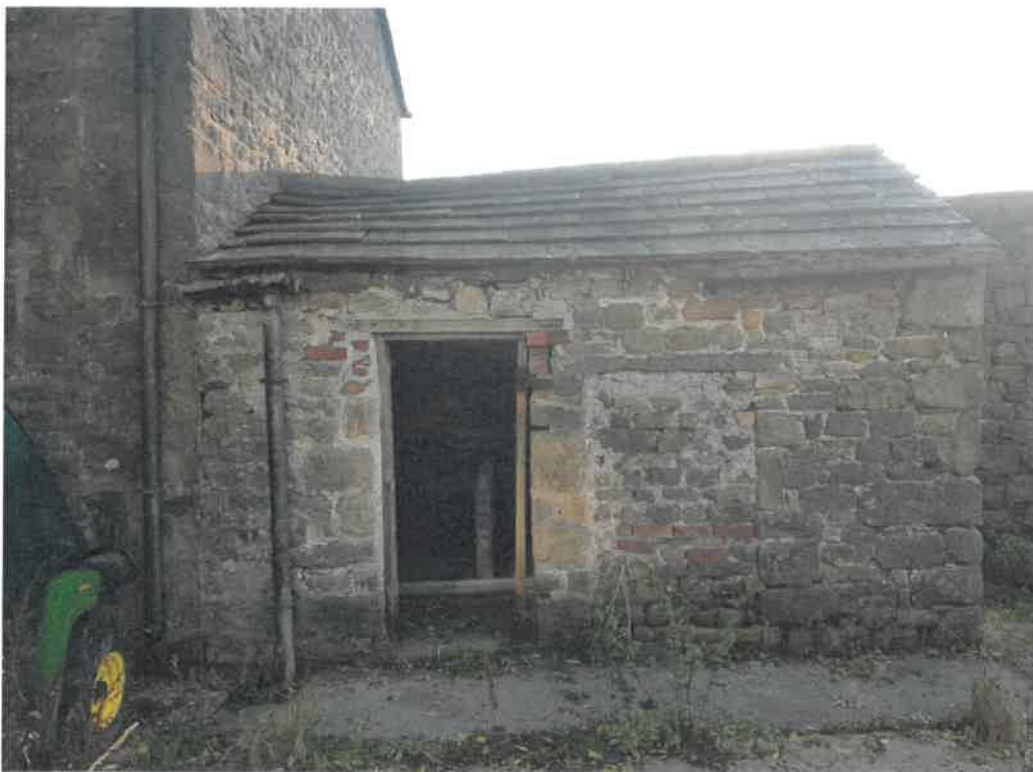
Photo 11: The roof has sunk as a consequence of the rotten ridge beam

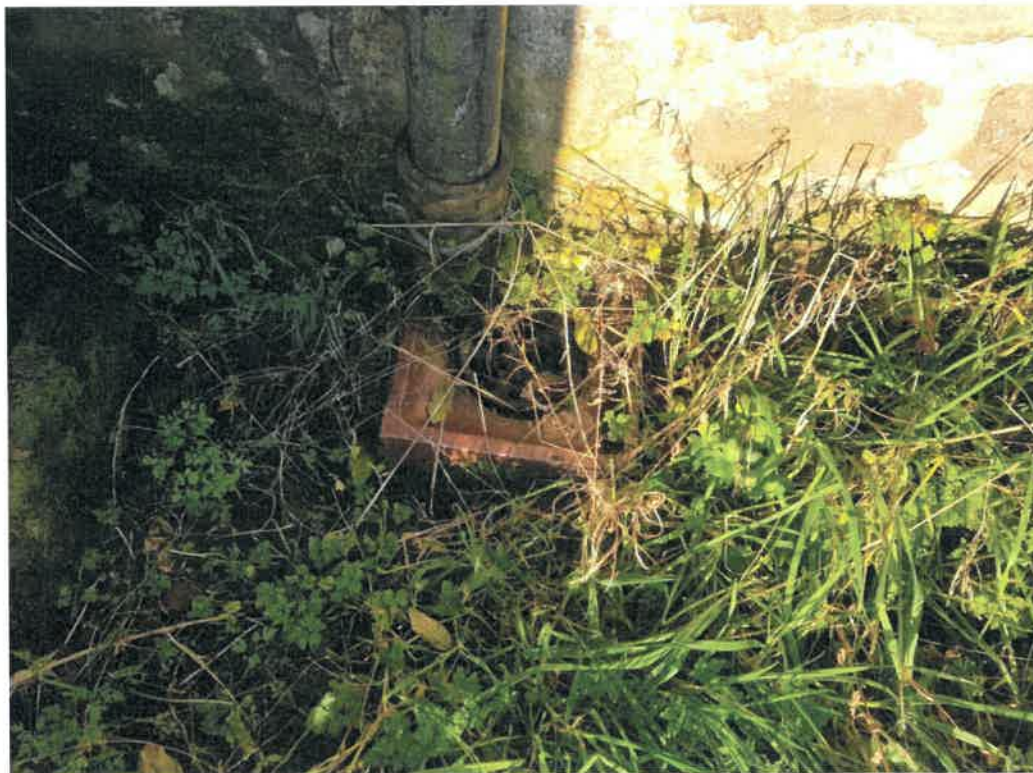
| Reference | Material | Condition | Comments |
|---|---|---|---|
| Gullies | Clay | 1 | All the gullies are blocked and require cleaning out and jetting |

Photo 12: The gullies are blocked and require clearing and jetting

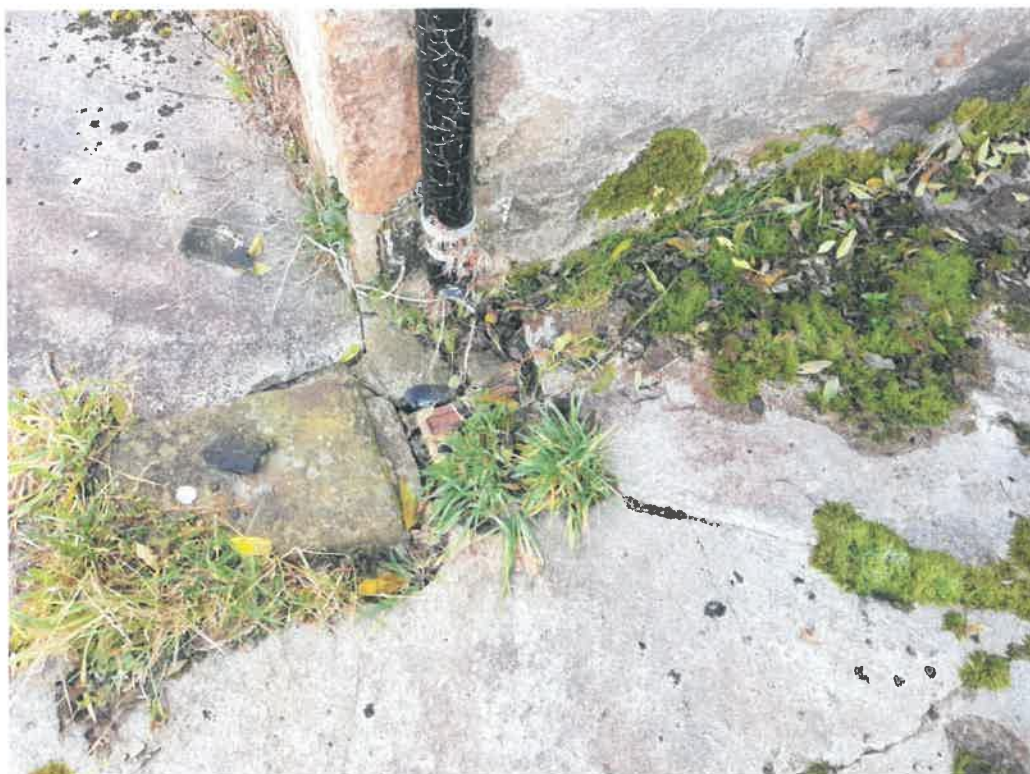
Photo 13: The gullies are blocked and require clearing and jetting

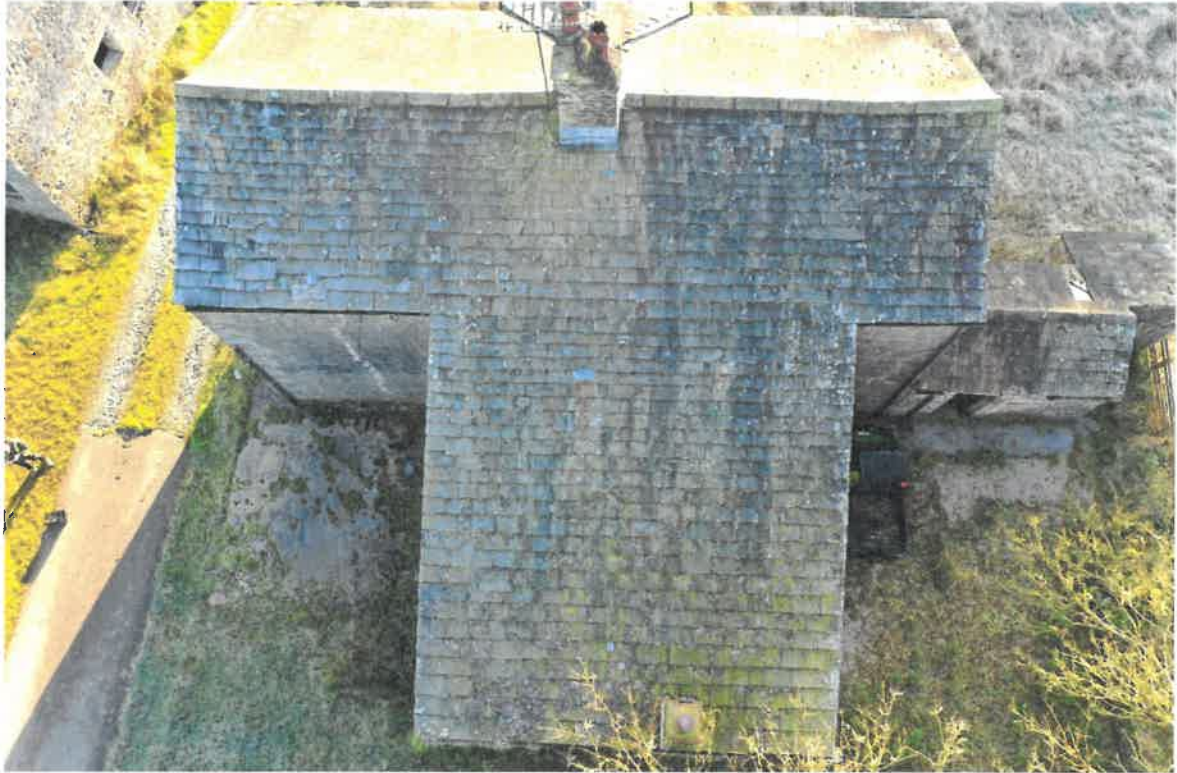
| West Slope | 3 | There are quite a large amount of slates requiring replacement |

Photo 14: The west slope has quite a large amount of slipped or broken slates

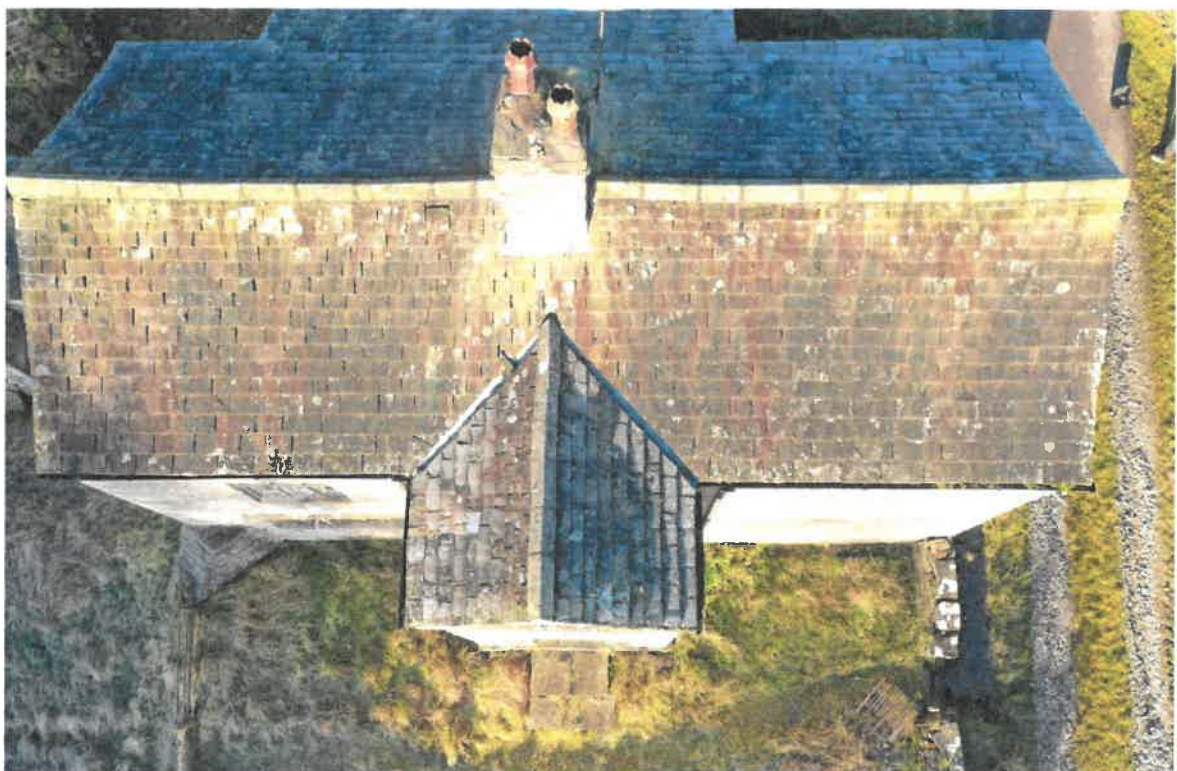
| Reference | Condition | Comments |
|---|---|---|
| East Slope | 4 | The slope is in good condition with only a small number of slates requiring replacement |

Photo 15: The east slope and main entrance slopes have a small amount of slipped or broken slates

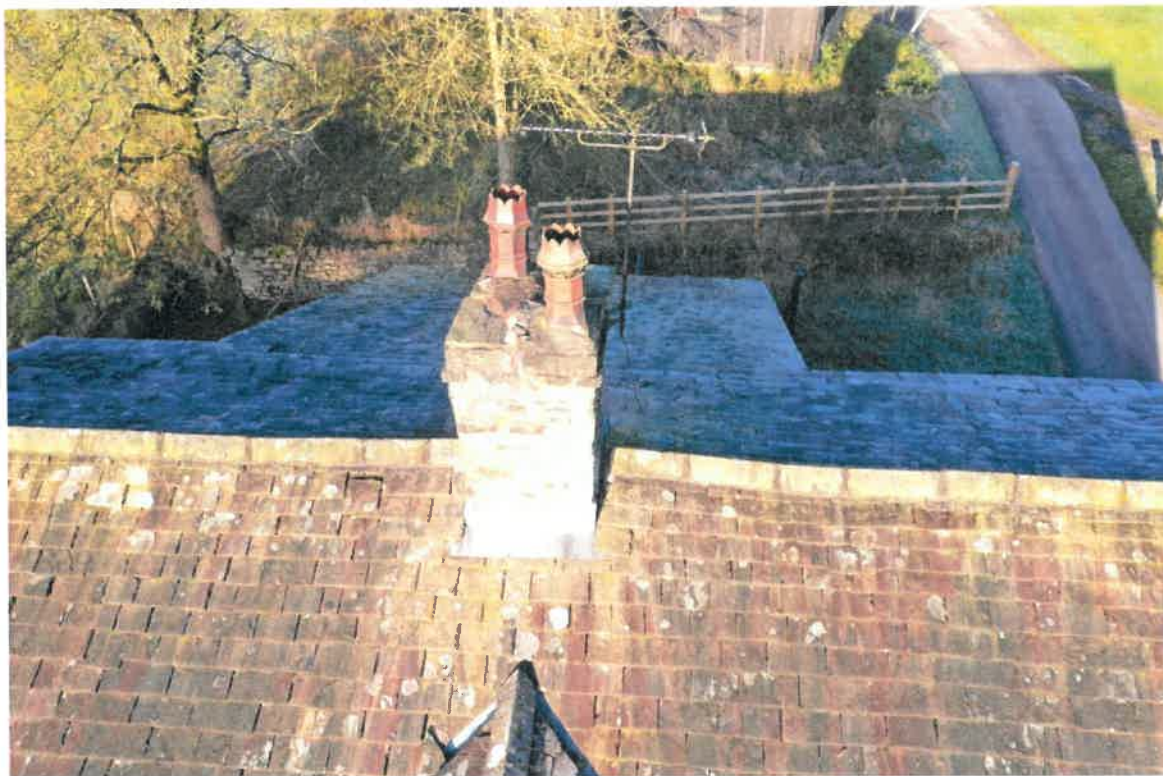
| Chimney 1 | 2 | The flaunching is in a poor state and requires replacement. The pointing is in a reasonable condition |

Photo 16: The flaunching on chimney 1 is in a poor condition and requires replacement

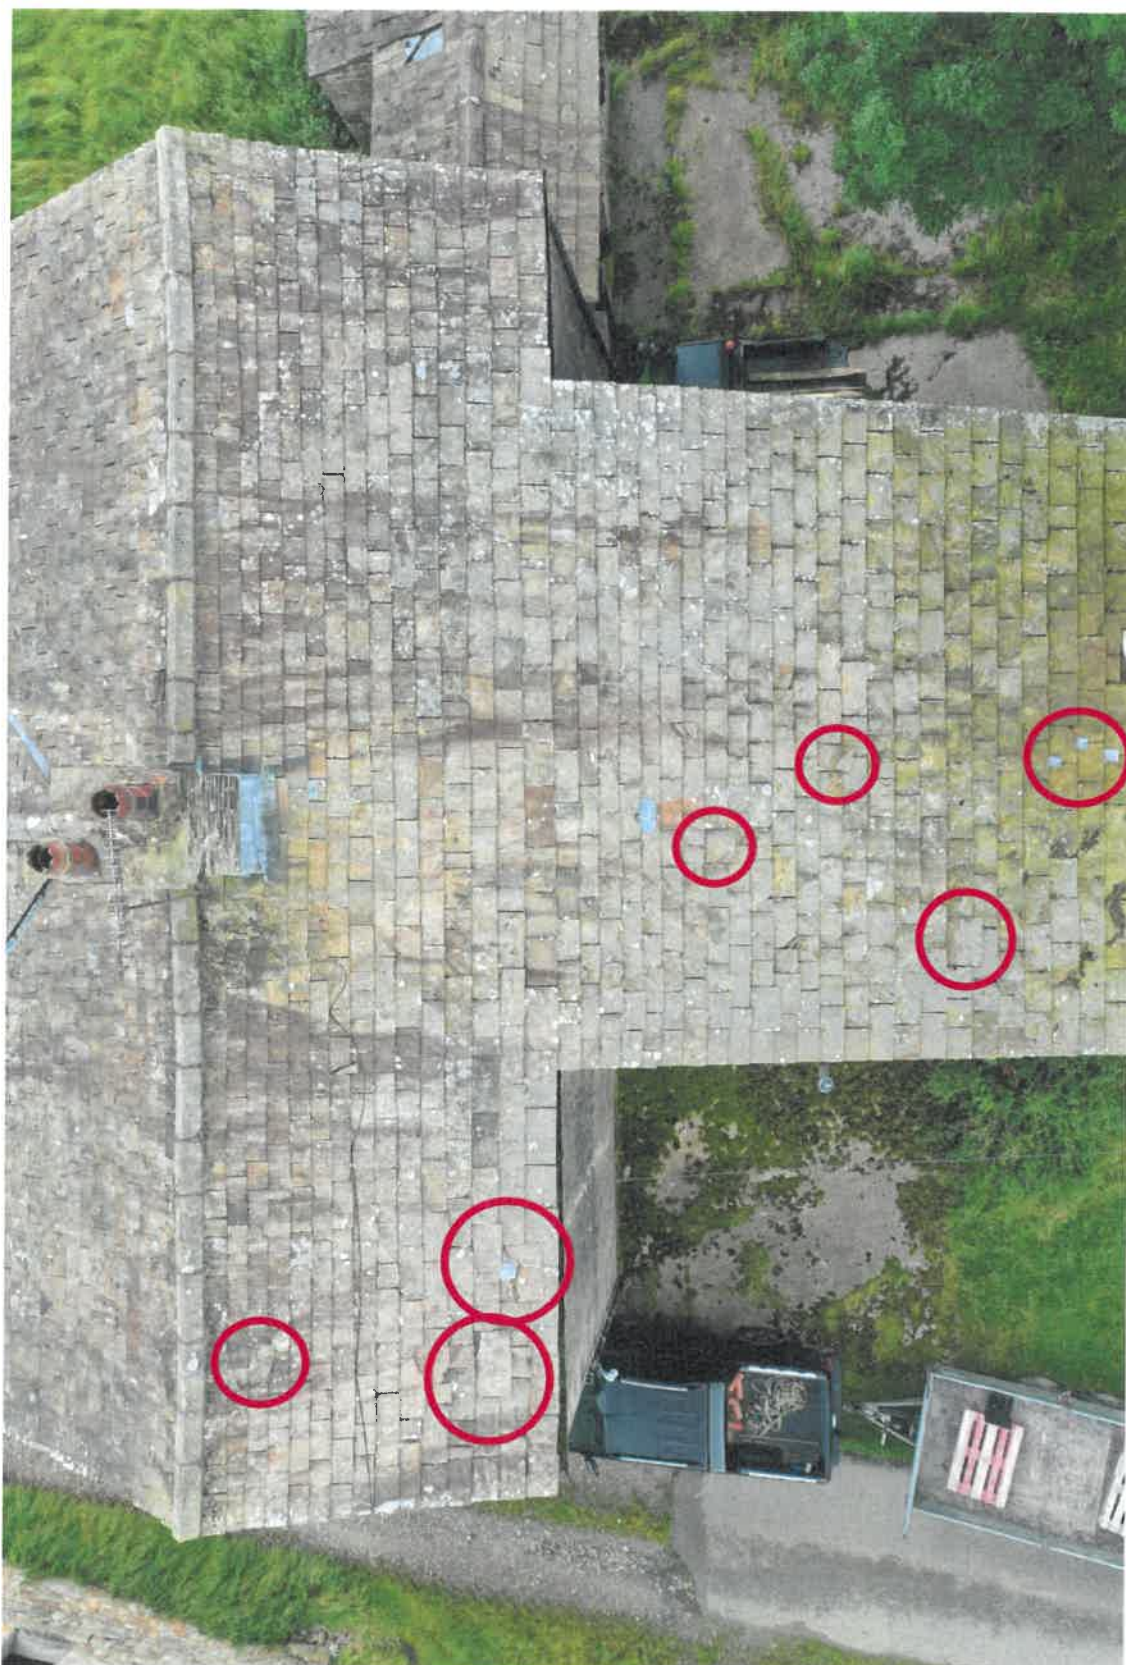
Photo 18: West slope slate repairs required

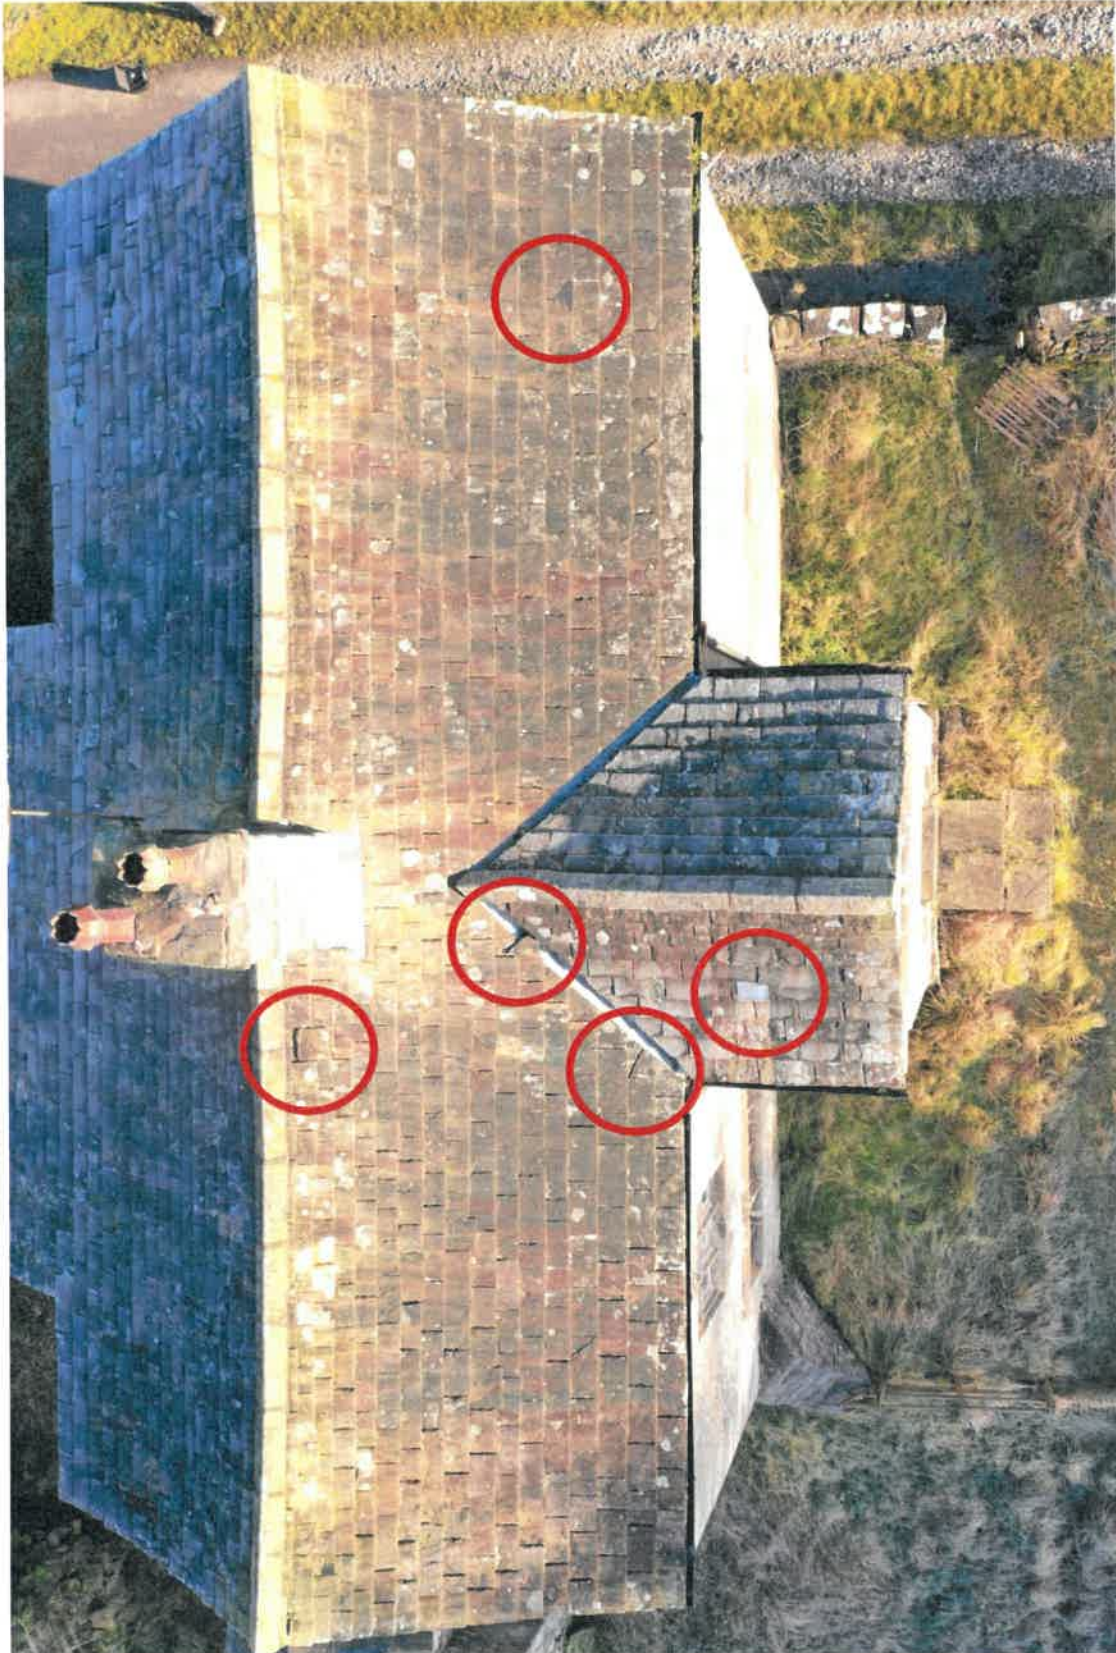
Photo 19: East slope and main entrance slate repairs required
